# Brunswick Mill

Manchester

## Inventory of significant fixtures and fittings

30<sup>th</sup> January  
2025

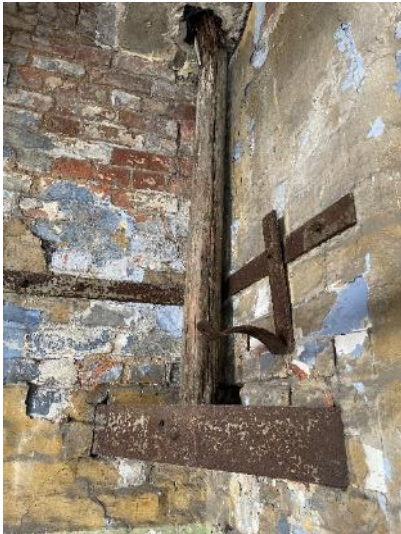
| Inventory of Significant Fixtures & Fittings – Sixth Floor Level | | | | | | |
|---|---|---|---|---|---|---|
| 1 | Base of flagpole | 1 | Base of flagpole, comprising of timber pole base supported by iron support plate and pulley winder. Flag can be seen in historic 1920s view of the mill. | | <p>REMOVE</p> <p>H&amp;S concern as sits within residential living area and significantly corroded</p> | <p>Remove and relocate item to a secure container for assessment.</p> <p>Review and design a heritage display for selected items in the concierge area.</p> <p>Offer any remaining heritage pieces to incoming commercial tenants.</p> <p>if item is used within the scheme it will be restored by specialist</p> |

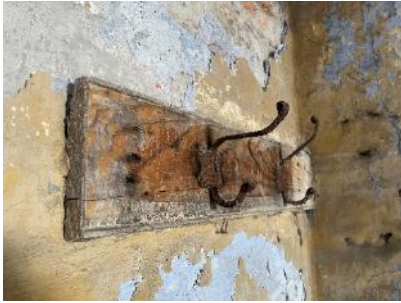
| 2 | Early-20 <sup>th</sup> century mill worker's metal shawl/coat hooks on painted timber planks rails– in varying degrees of completion/condition | 7 | Early-20 <sup>th</sup> century mill workers' shawl/coat rails, originally affixed to each window pier to allow for mill girls to hang their belongings on behind where their station was at the loom. | | <p>REMOVE</p> <p>H&amp;S concern as sits within residential living area and significantly corroded</p> | <p>Remove and relocate item to a secure container for assessment.</p> <p>Review and design a heritage display for selected items in the concierge area.</p> <p>Offer any remaining heritage pieces to incoming commercial tenants.</p> <p>If item is used within the scheme it will be restored by specialist</p> |

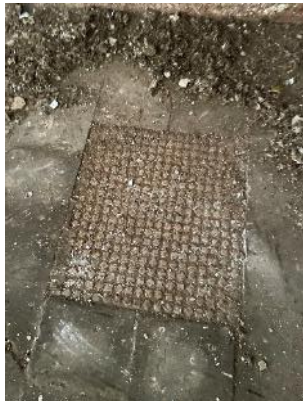
| 8 | C 19 <sup>th</sup> century iron opening cover leading to room below. | 1 | C 19 <sup>th</sup> century iron opening cover leading to room below. (Unknown purpose) | | <p>Will be retained in-situ but will be covered with new floor.</p> <p>No restoration required will be hidden</p> | |

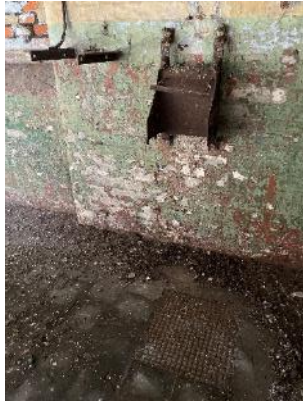
| 9 | Remains of c1909 electrical motor switch gear equipment to looms | 1 | Remains of c1909 electrical motor switch gear equipment to looms – adjacent to metal opening cover | | <p><b>REMOVE</b></p> <p><b>H&amp;S RISK</b></p> <p>In very poor condition and sharp broken edges</p> <p>Will struggle to restore due to corrosion.</p> | |

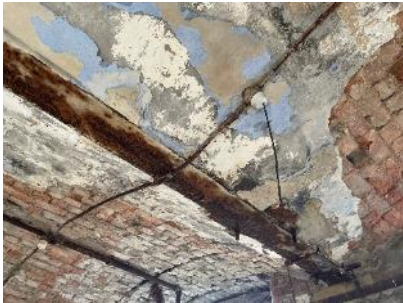
| 10 | C1909 water sprinkler pipes and electric lighting conduits. | / | <p>C1909 water sprinkler pipes and electric lighting conduits (majority with white ceramic pendant roses).</p> <p>Positioned across entire ceiling of room</p> | | <p>REMOVE</p> <p>KEEP sprinkler system in communal areas and restore / paint where possible as indicated by drawings provided</p> | |

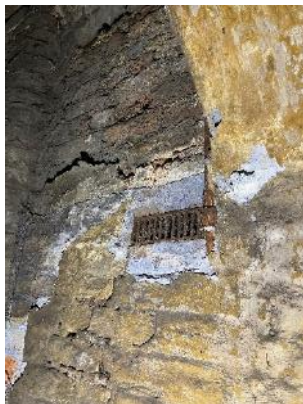
| 2 | Original c1840 cast iron air vent to back of staircase. | 1 | Original c1840 cast iron air vent to back of staircase, presumably giving ventilation to void within semi-circular staircase. | | To retain<br>To be restored by specialist | |

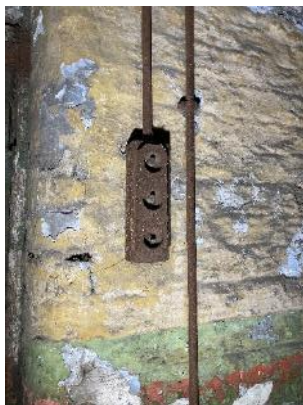
| 3 | Early-20 <sup>th</sup> century industrial metal light switch mob/conduits. | / | Early-20 <sup>th</sup> century industrial metal light switch mob/conduits. | | Keep in situ<br>To be restored by specialist<br>+ | |

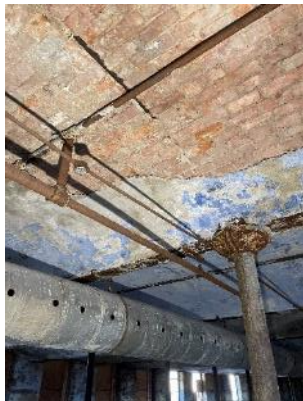
| 3 | Early 20 <sup>th</sup> century sprinkler system piping and outlets | Whole room | Early 20 <sup>th</sup> century electric conduits and a number of white ceramic pendant light roses. Possibly dating to the electrification of the mill in 1909. | | REMOVE<br><br>KEEP sprinkler system in communal areas and restore / paint where possible as indicated by drawings provided | |

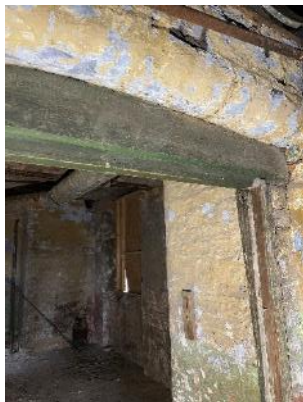
| 4 | Original painted timber doorframe between room D (mill room) and adjacent corridor (room E) | 1 | Original painted timber doorframe between room D (mill room) and adjacent corridor (room E) with "13" etched into the top in historic script. | | KEEP in situ board / block around so not visible | |

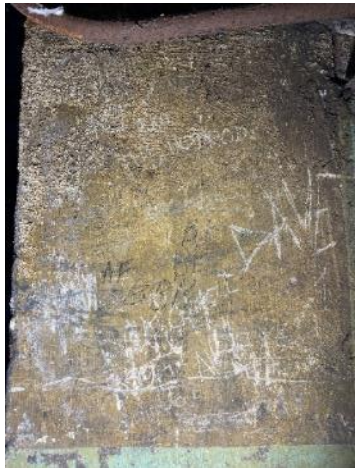
| 6 | Area of mill worker's graffiti located adjacent to hoist. | / | Area of wall adjacent to mill hoist where workers would have stood and waited. Dates go back to at least the 1940s | | REMOVE | |

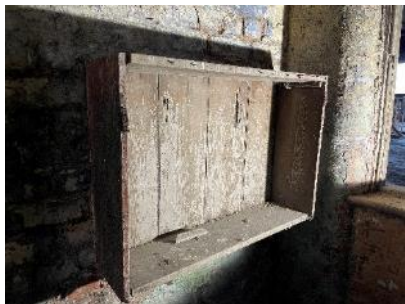
| Room F | | | | | | |
|---|---|---|---|---|---|---|
| 1 | Early 20 <sup>th</sup> century possibly timber fire extinguisher/hose wall mounted cabinet | 1 | Early 20 <sup>th</sup> century possibly timber fire extinguisher/hose wall mounted cabinet, with markings for two removed hooks inside. | | <p><b>REMOVE</b></p> <p><b>FIRE / H&amp;S RISK</b></p> <p>Item will be in sterile area / lobby</p> | <p>Remove and relocate item to a secure container for assessment.</p> <p>Review and design a heritage display for selected items in the concierge area.</p> <p>Offer any remaining heritage pieces to incoming commercial tenants.</p> <p>if item is used within the scheme it will be restored by specialist</p> |

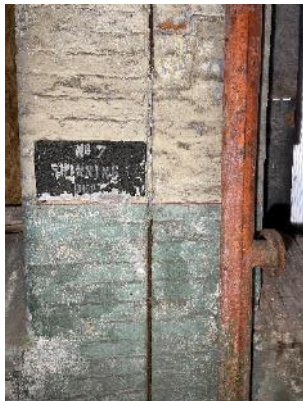
| 2 | Early 20th century painted floor level sign for “No 7 Spinning Dept” | 1 | Early 20th century painted floor level sign for “No 7 Spinning Dept” | | paint scheme to pier to be retained and sealed as a feature. | / |

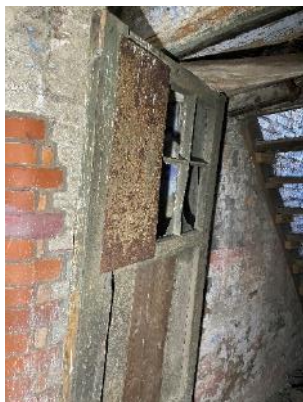
| 3 | Early 20 <sup>th</sup> century panelled door with glazed upper quarter. | 1 | Early 20 <sup>th</sup> century panelled door with glazed upper quarter. | | REMOVE<br><br>FIRE / H&S RISK<br><br>Doesn't hold correct fire protection and is significantly damaged. | |

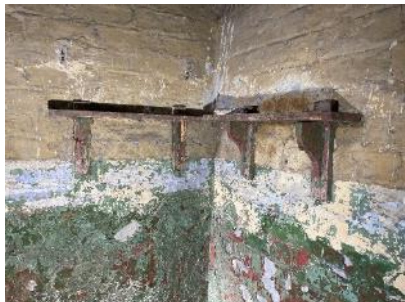
| Plan ref number | Item | Number | Description | Photograph | Proposal/treatment/repair | Location if being removed / relocated |
|---|---|---|---|---|---|---|
| 1 | Early 20 <sup>th</sup> century timber corner shelf. | 1 | Early 20 <sup>th</sup> century timber corner shelf. Right hand side is intact – left hand side has one missing bracket and one broken bracket. | | <p><b>REMOVE</b></p> <p><b>FIRE / H&amp;S RISK</b></p> <p>Item in apartment / bedroom defected and corroded.</p> | <p>Remove and relocate item to a secure container for assessment.</p> <p>Review and design a heritage display for selected items in the concierge area.</p> <p>Offer any remaining heritage pieces to incoming commercial tenants.</p> <p>if item is used within the scheme it will be restored by specialist</p> |

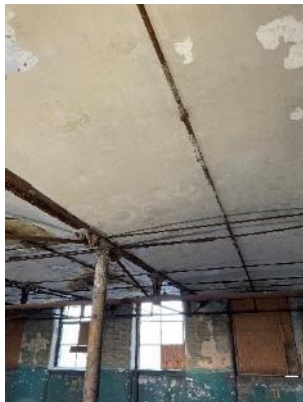
| 3 | C1909 water sprinkler pipes. | / | C1909 water sprinkler pipes. Positioned across entire ceiling of room | | REMOVE<br><br>KEEP sprinkler system in communal areas and restore / paint where possible as indicated by drawings provided | |

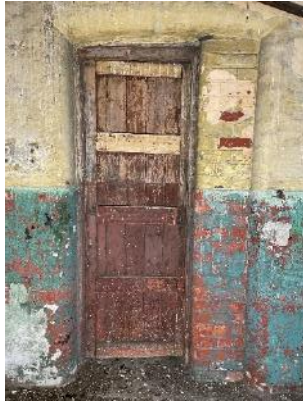
| 4 | Early (c mid-to-late-19 <sup>th</sup> century) framed ledged and braced door into room C. | 1 | Early timber door with distinctive stop mouldings to each board and brace as seen in other doors/gates in the mill. | | Remove<br><br>Doesn't hold correct fire properties and damaged | Remove and relocate item to a secure container for assessment.<br><br>Review and design a heritage display for selected items in the concierge area.<br><br>Offer any remaining heritage pieces to incoming commercial tenants.<br><br>If item is used within the scheme it will be restored by specialist |

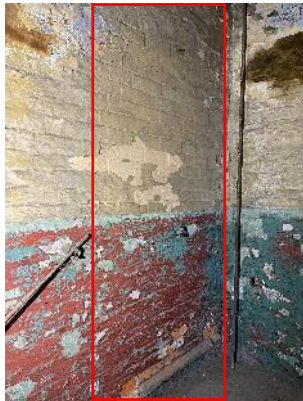
| 5 | Blocked entrance into original 1840 mill worker's latrine. | 1 | Blocked entrance into original 1840 mill worker's latrine. The original narrow room is now inaccessible and marked by the surviving segmental, brick-arched door head and sandstone step. | | Retain projecting stone step and outline of original door opening. | / |

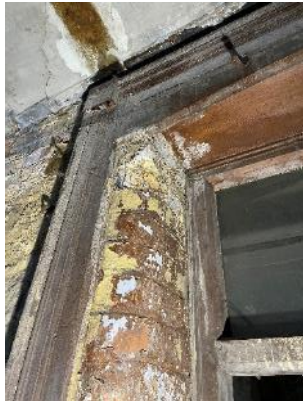
| 6 | A “polite” timber doorcase (and panelled door/fanlight). | 1 | <p>A “polite” timber doorcase (and panelled door/fanlight) leading into the room from room B, dating to the early-1900s. This may have been inserted to form a new room type, such as one of the “recreation rooms” as described in a 1926 article.</p> <p>The original glass panel in the door was later replaced with timber with the sign “mill stores” painted on the outside face.</p> | | <p><b>REMOVE</b></p> <p><b>FIRE / H&amp;S RISK</b></p> <p>Items are in a sterile area / lobby / don’t have the correct fire protection measures.</p> | <p>Remove and relocate item to a secure container for assessment.</p> <p>Review and design a heritage display for selected items in the concierge area.</p> <p>Offer any remaining heritage pieces to incoming commercial tenants.</p> <p>if item is used within the scheme it will be restored by speacilist</p> |

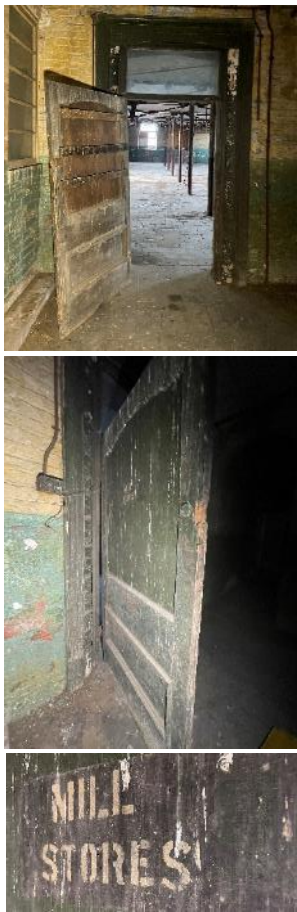
| Room B | | | | | | |
|---|---|---|---|---|---|---|
| 1 | The outer face of the above 1900s panelled door and “polite” timber door surround. | 1 | The outer face of the above 1900s panelled door and “polite” timber door surround. With “Mill stores” painted on upper part of door. | | <p><b>REMOVE</b></p> <p><b>FIRE / H&amp;S RISK</b></p> <p>Items located in sterile areas / lifts / lobbies and don't hold the correct fire protection measures</p> | <p>Remove and relocate item to a secure container for assessment.</p> <p>Review and design a heritage display for selected items in the concierge area.</p> <p>Offer any remaining heritage pieces to incoming commercial tenants.</p> <p>if item is used within the scheme it will be restored by specialist</p> |

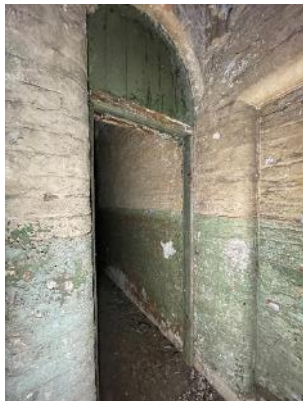
| 2 | Boarded fanlight and timber doorframe to corridor between rooms C and B. | 1 | Original/early boarded fanlight and timber doorframe to corridor between rooms C and B. | | <p><b>REMOVE</b></p> <p><b>FIRE / H&amp;S RISK</b></p> <p>Items located in sterile areas / lifts / lobbies and don't hold the correct fire protection measures.</p> | <p>Remove and relocate item to a secure container for assessment.</p> <p>Review and design a heritage display for selected items in the concierge area.</p> <p>Offer any remaining heritage pieces to incoming commercial tenants.</p> <p>If item is used within the scheme it will be restored by specialist</p> |

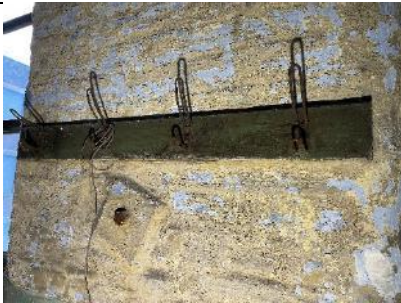
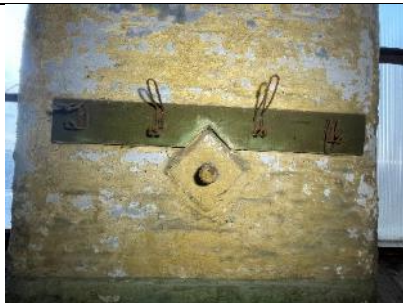
| 2 | Early-20 <sup>th</sup> century mill worker's metal shawl/coat hooks on painted timber planks rails– in varying degrees of completion/condition | 31 | Early-20 <sup>th</sup> century mill workers' shawl/coat rails, originally affixed to each window pier to allow for mill girls to hang their belongings on behind where their station was at the loom. | | <p><b>REMOVE</b></p> <p><b>FIRE / H&amp;S RISK</b></p> <p>BC – highlighted the dangers of the hook been corroded and been a eye level</p> | <p>Remove and relocate item to a secure container for assessment.</p> <p>Review and design a heritage display for selected items in the concierge area.</p> <p>Offer any remaining heritage pieces to incoming commercial tenants.</p> <p>if item is used within the scheme it will be restored by specialist</p> |

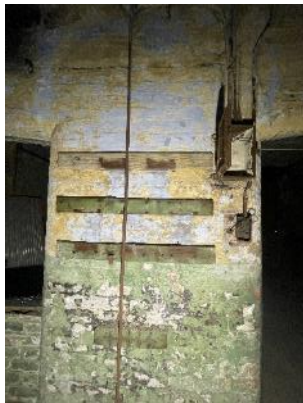
| 3 | Bank of timber rails originally supporting 5 c1909 electric fuse boxes/switches? | / | Bank of timber rails originally supporting 5 c1909 electric fuse boxes/switches? Connecting to surviving fuse box. | | <p><b>REMOVE</b></p> <p><b>FIRE / H&amp;S RISK</b></p> <p>BC – highlighted the dangers of the hook been corroded and been at eye level</p> | <p>Remove and relocate item to a secure container for assessment.</p> <p>Review and design a heritage display for selected items in the concierge area.</p> <p>Offer any remaining heritage pieces to incoming commercial tenants.</p> <p>if item is used within the scheme it will be restored by specialist</p> |

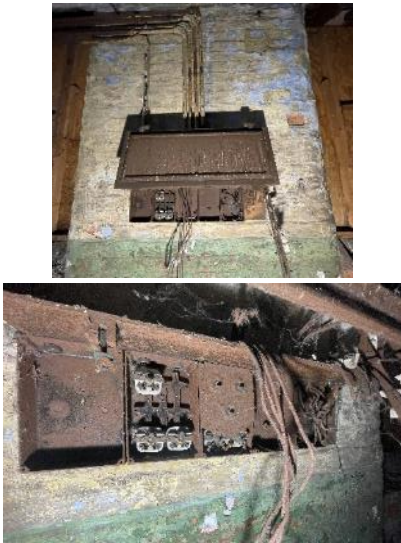
| 4 | C1909 iron fuse and switch box for powering looms | 1 | C1909 iron fuse and switch box for powering looms. Bottom panel has a bank of originally 20 toggle light switches with covers, approx 4 remain. | | <p>In way of partition line and in a bedroom – remove</p> <p>Badly corroded with sharp edges</p> | |

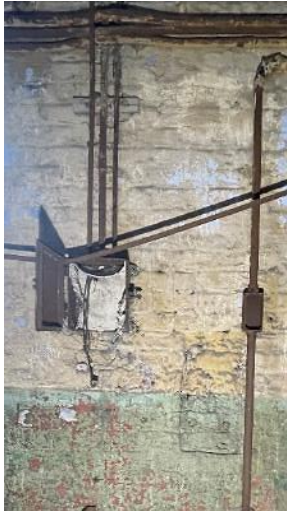
| 5 | C1909 fuse box/conduits | / | C1909 fuse box/conduits | | <p>In way of partition line and in a bedroom – remove</p> <p>Badly corroded and will effect fire strategy</p> | |

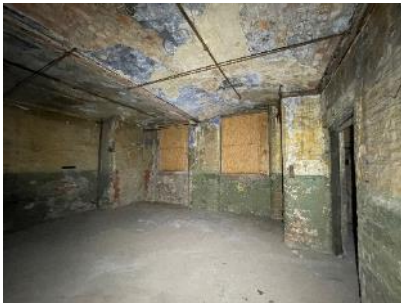
| Room E | | | | | | |
|---|---|---|---|---|---|---|
| 1 | C1909 water sprinkler pipes. | / | C1909 water sprinkler pipes. Positioned across entire ceiling of room | | sprinklers significantly corroded / damaged – remove<br><br>issues with new sprinkler installation<br><br>fire and compartment issues | / |

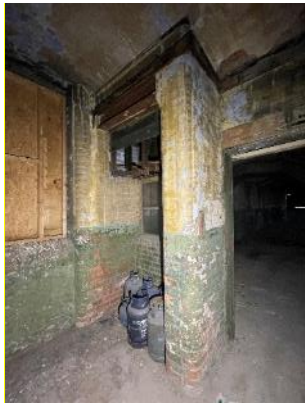
| Room E | | | | | | |
|---|---|---|---|---|---|---|
| 2 | An opened-out example of an original mill worker's latrine | 1 | It is unknown why this is the only example in the building to have been opened-out and fitted with an internal window into room D. | | To remove and keep current architectural plans and layouts as planned | |

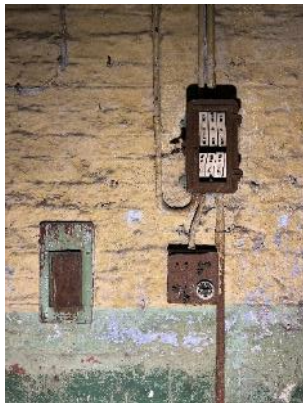
| Plan ref number | Item | Number | Description | Photograph | Proposal/treatment/repair | Location if being removed / relocated |
|---|---|---|---|---|---|---|
| 1 | Early 20 <sup>th</sup> century (likely 1909) metal Ediswan fuse box and bank of four dolly light switches. | / | C1909 Ediswan metal fuse box with porcelain insulators for original lights and bank of four dolly light switches.<br><br>(company formed by Edison and Swan) | | <p>In living room - remove</p> <p>Badly corroded and damaged</p> | |

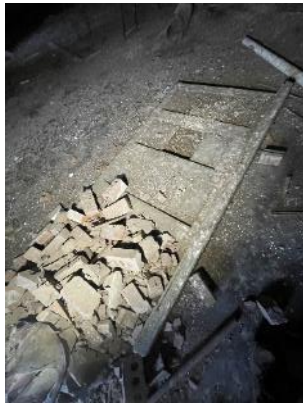
| 3 | C 19 <sup>th</sup> century framed, braced and battened timber door originally located between room A and B. | 1 | C 19 <sup>th</sup> century framed, braced and battened timber door originally located between room A and B. | | <p><b>REMOVE</b></p> <p><b>FIRE / H&amp;S RISK</b></p> <p>Badly damaged and not in original area / doesn't hold correct fire certification</p> | |

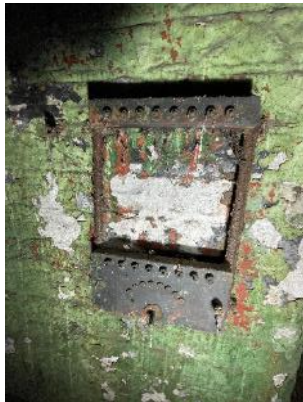
| 5 | C1909 electric rheostat | 1 | A rheostat is a variable resistor which is used to control current. This example would have been fitted as part of the 1909 electrification of the mill, in order to regulate current to the looms. Dial handle missing. | | REMOVE<br><br>FIRE / H&S RISK<br><br>Corroded and damaged / sharp edges | Remove and relocate item to a secure container for assessment.<br><br>Review and design a heritage display for selected items in the concierge area.<br><br>Offer any remaining heritage pieces to incoming commercial tenants.<br><br>if item is used within the scheme it will be restored by specialist |

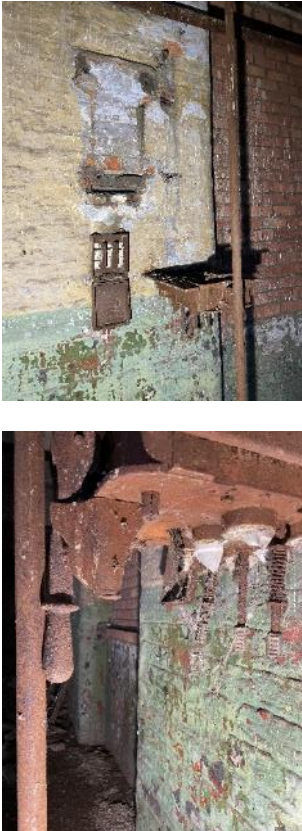
| 7 | Location of 1909 loom motor, fuse box and remains of iron electric oil switch. | 1 | <p>Location of 1909 loom motor, fuse box and remains of iron electric oil switch (forming iron shelf, plunger handle and handle mechanism/cross bar.</p> <p>An oil switch is a high-voltage switch whose contacts are opened and closed in oil so that the oil will break the circuit when the switch is opened.</p> <p>The iron frame will have held the mechanism and insulators, the switch is connected to a cross bar which in turn moves together the individual finger contacts, which were each submerged within oil in individual white ceramic tubes.</p> | | <p><b>REMOVE</b></p> <p><b>FIRE / H&amp;S RISK</b></p> <p>Significantly corroded and damaged</p> | |

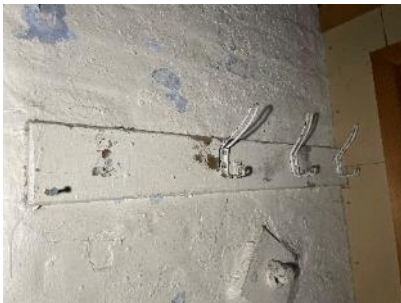
| 4 | Early-20 <sup>th</sup> century mill worker's metal shawl/coat hooks on painted timber planks rails– in varying degrees of completion/condition | 3 | Early-20 <sup>th</sup> century mill workers' shawl/coat rails, originally affixed to each window pier to allow for mill girls to hang their belongings on behind where their station was at the loom. | | <p><b>REMOVE</b></p> <p><b>FIRE / H&amp;S RISK</b></p> <p>Pose risk due to been at eye level as stated by BC</p> | <p>Remove and relocate item to a secure container for assessment.</p> <p>Review and design a heritage display for selected items in the concierge area.</p> <p>Offer any remaining heritage pieces to incoming commercial tenants.</p> <p>If item is used within the scheme it will be restored by specialist</p> |

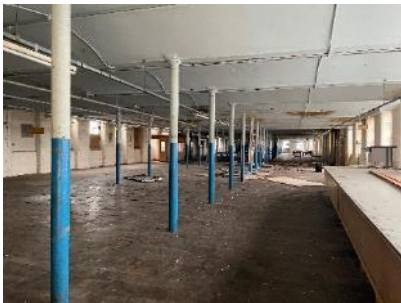
| 5 | C1909 water sprinkler pipes and electric lighting conduits. | / | <p>C1909 water sprinkler pipes and electric lighting conduits (majority with white ceramic pendant roses).</p> <p>Positioned across entire ceiling of room</p> | | <p><b>REMOVE</b></p> <p><b>KEEP sprinkler system in communal areas and restore / paint where possible as indicated by drawings provided</b></p> | / |

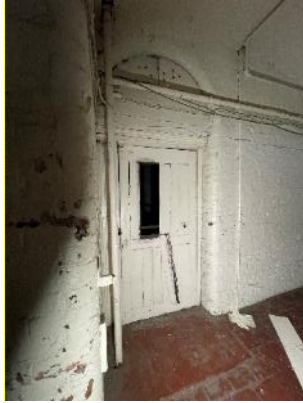
| 2 | 19 <sup>th</sup> /early-20 <sup>th</sup> century mill bale hoist door/fanlight – with ironmongery/mechanism on the inside face | 1 | 19 <sup>th</sup> /early-20 <sup>th</sup> century mill bale hoist door/fanlight – with ironmongery/mechanism on the inside face | | Remove -In way of new lift lobbies<br><br>In sterile area and doesn't have correct fire ratings | |

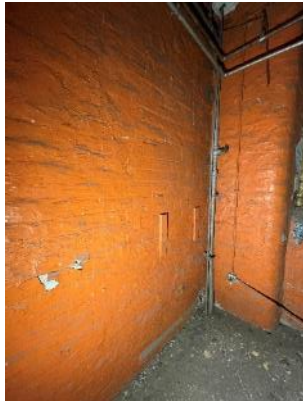
| Inventory of Significant Fixtures & Fittings – Third Floor Level | | | | | | |
|---|---|---|---|---|---|---|
| 2 | Blocked entrance into original 1840 mill worker's latrine. | 1 | Blocked entrance into original 1840 mill worker's latrine. The original narrow room is now inaccessible and marked by the surviving segmental, brick-arched door head and sandstone step. | | Retain outline of original door opening. | |

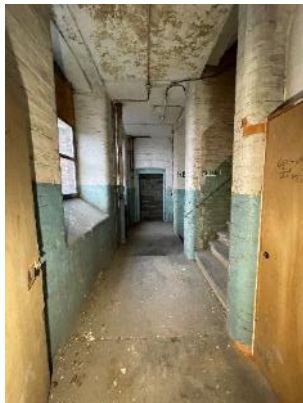
| Room C | | | | | | |
|---|---|---|---|---|---|---|
| 1 | C1909 water sprinkler pipes. | / | C1909 water sprinkler pipes. | | <p>REMOVE</p> <p>KEEP sprinkler system in communal areas and restore / paint where possible as indicated by drawings provided</p> | / |

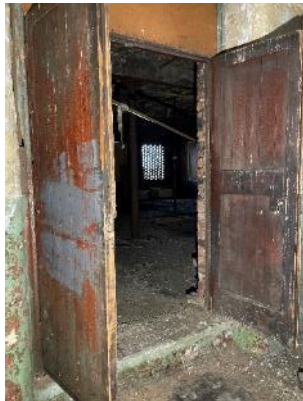
| Room D | | | | | | |
|---|---|---|---|---|---|---|
| 1 | Pair of reinforced steel doors from room D into the c1920s air ventilation plant room. | 2 | Pair of reinforced steel doors from room D into the c1920s air ventilation plant room. | | <p>Remove</p> <p>Currently sits in bathroom / bedroom so not viable to keep in situ</p> <p>happy to feature in lobby or concierge if it doesn't work in current location</p> | <p>Remove and relocate item to a secure container for assessment.</p> <p>Review and design a heritage display for selected items in the concierge area.</p> <p>Offer any remaining heritage pieces to incoming commercial tenants.</p> <p>if item is used within the scheme it will be restored by specialist</p> |

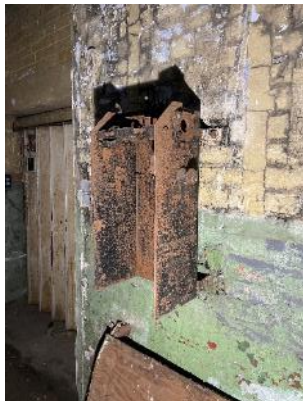
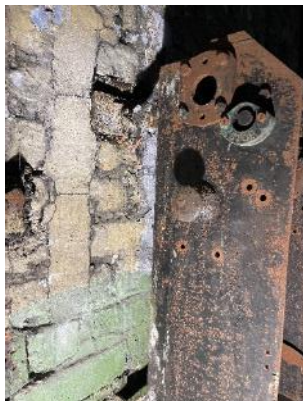
| 2 | Remains of metal possible switch gear system with “Stop” button. | 1 | Remains of metal possible switch gear system with “Stop” button. | | <p><b>REMOVE</b></p> <p><b>H&amp;S RISK</b></p> <p>Sharp and corroded metal situated in apartment at low level</p> | <p>Remove and relocate item to a secure container for assessment.</p> <p>Review and design a heritage display for selected items in the concierge area.</p> <p>Offer any remaining heritage pieces to incoming commercial tenants.</p> <p>if item is used within the scheme it will be restored by speacilist</p> |

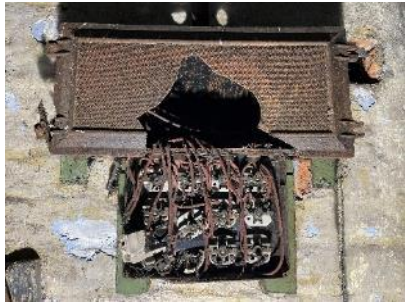
| 4 | Broken glass fronted fuse box with bank of 12 dolly switches. | 1 | Broken glass fronted fuse box with bank of 12 dolly switches. | | REMOVE<br><br>H&S RISK<br><br>Corroded and sharp elements situated in apartment | |

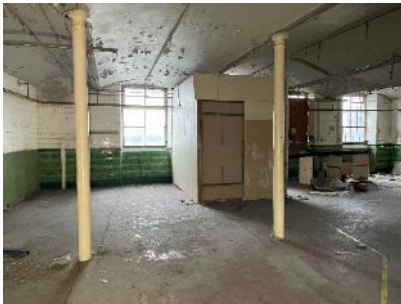
| Room H | | | | | | |
|---|---|---|---|---|---|---|
| 1 | C1909 water sprinkler pipes and electric lighting conduits. | / | C1909 water sprinkler pipes and electric lighting conduits (majority with white ceramic pendant roses).<br><br>Positioned across entire ceiling of room | | REMOVE<br><br>KEEP sprinkler system in communal areas and restore / paint where possible as indicated by drawings provided | / |

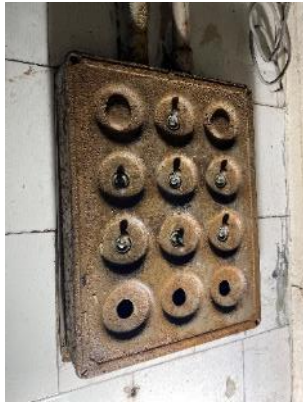
| 3 | C1909 12 gang metal toggle light switch. | 1 | C1909 12 gang metal toggle light switch installed when this room was turned into the mill’s tiled dining room. | | Retain and restore item | |

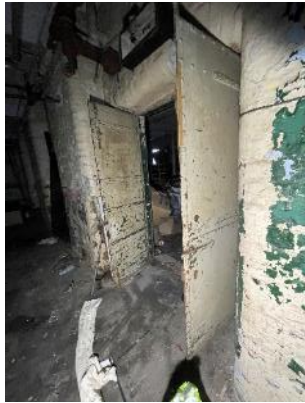
| Inventory of Significant Fixtures & Fittings – Second Floor Level | | | | | | |
|---|---|---|---|---|---|---|
| 2 | Pair of circa early-20 <sup>th</sup> centre steel doors. | 2 | Pair of circa early-20 <sup>th</sup> centre steel doors. | | Remove<br><br>Won't be up to fire and soundproofing requirements | |

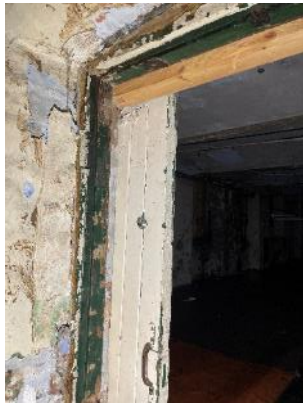
| 3 | Blocked entrance into original 1840 mill worker's latrine. | 1 | Blocked entrance into original 1840 mill worker's latrine. The original narrow room is now inaccessible and marked by the surviving segmental, brick-arched door head and sandstone step. | | Retain outline of original door opening. | / |
|---|---|---|---|---|---|---|
| 1 | Original timber doorframe between room B and A. | 1 | Original timber doorframe between room B and A. | | KEEP in situ but block both sides so not visible | / |

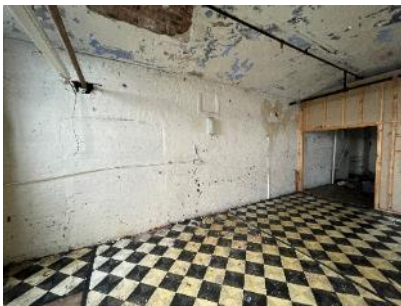
| 3 | C1909 water sprinkler pipes. | / | C1909 water sprinkler pipes. | | REMOVE<br><br>KEEP sprinkler system in communal areas and restore / paint where possible as indicated by drawings provided | / |
|---|---|---|---|---|---|---|
| 1 | Cast iron opening (now filled) originally allowing steam engine beam to pass between room E and D. | 1 | Cast iron opening (now filled) originally allowing steam engine beam to pass between room E and D. | | Remove | / |

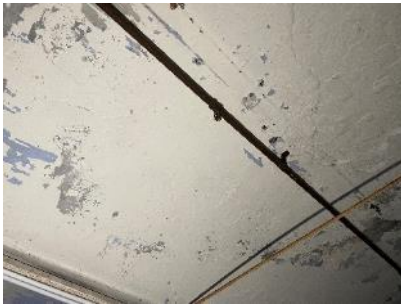
| 3 | C1909 water sprinkler pipes. | / | C1909 water sprinkler pipes. | | <p><b>REMOVE</b></p> <p><b>KEEP sprinkler system in communal areas and restore / paint where possible as indicated by drawings provided</b></p> | / |

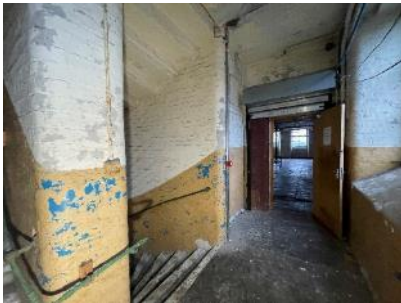
| Plan ref number | Item | Number | Description | Photograph | Proposal/treatment/ repair | Location if being removed / relocated |
|---|---|---|---|---|---|---|
| 1 | C1909 water sprinkler pipes. | / | C1909 water sprinkler pipes. | | REMOVE<br><br>KEEP sprinkler system in communal areas and restore / paint where possible as indicated by drawings provided | / |

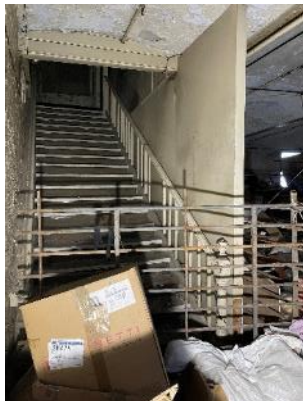
| 1 | Timber staircase with turned timber newel post. | 1 | Timber staircase with turned timber newel post, installed in the 1920s when the floor above was constructed. | | Not up to BC standards<br><br>now sits within an apartment - Remove. | |

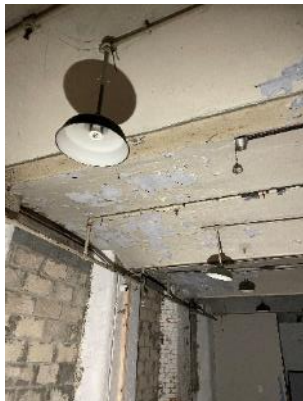
| 2 | C1909 water sprinkler pipes and c 1920s/30s electric light conduits and green and white enamel shades. | / | C1909 water sprinkler pipes and c 1920s/30s electric light conduits and a number of green and white enamel shades. | | KEEP | Will salvage the light shades for reuse in concierge |

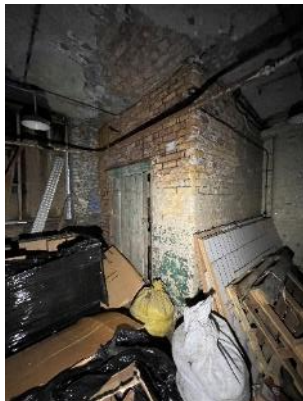
| 3 | 1920s brick hoist enclosure and timber door/ | 1 | 1920s brick hoist enclosure and timber door/ | | sits within apartment – remove.<br>Significantly damaged | |

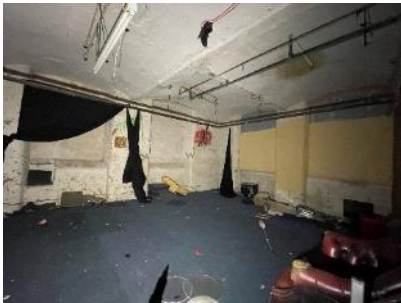
| Inventory of Significant Fixtures & Fittings – First Floor Level | | | | | | |
|---|---|---|---|---|---|---|
| 1 | C1909 water sprinkler pipes. | / | C1909 water sprinkler pipes. Positioned across entire ceiling of room | | Remove due to condition and issues with new sprinkler installation<br><br>fire and compartment issues | / |

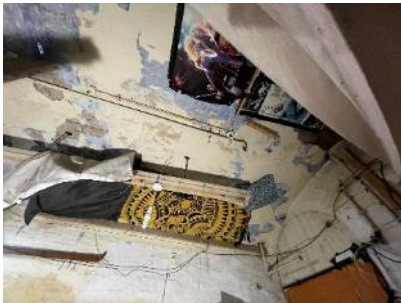
| Room D | | | | | | |
|---|---|---|---|---|---|---|
| 1 | C1909 water sprinkler pipes. | / | C1909 water sprinkler pipes. | | REMOVE<br><br>KEEP sprinkler system in communal areas and restore / paint where possible as indicated by drawings provided | / |

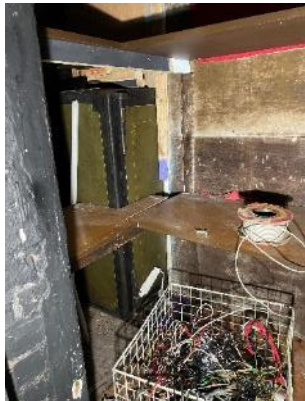
| Room D | | | | | | |
|---|---|---|---|---|---|---|
| 2 | Late 19 <sup>th</sup> /early-20 <sup>th</sup> century free standing safe. | 1 | Late 19 <sup>th</sup> /early-20 <sup>th</sup> century free standing safe. | | Remove free-standing safe<br><br>As advised by heritage officer and is situated in an apartment | / |

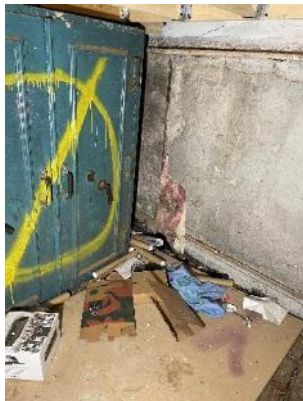
| 1 | Late 19 <sup>th</sup> /early-20 <sup>th</sup> century free standing safe. | 1 | Late 19 <sup>th</sup> /early-20 <sup>th</sup> century free standing safe. | | Remove free standing safe<br><br>As advised and also site in an apartment | / |

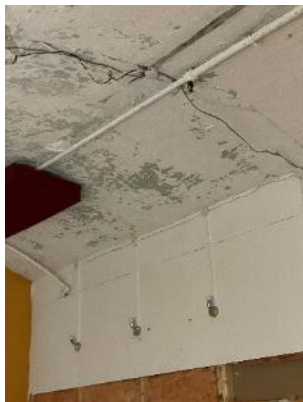
| 2 | C1909 water sprinkler pipes. | / | C1909 water sprinkler pipes. | | REMOVE<br><br>KEEP sprinkler system in communal areas and restore / paint where possible as indicated by drawings provided | / |

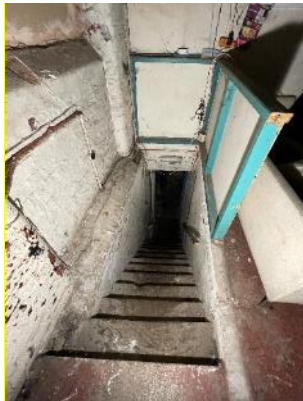
| Room L | | | | | | |
|---|---|---|---|---|---|---|
| 1 | Original 1840 sandstone stairs from original ground floor office entrance up to former offices. | 1 | Original 1840 sandstone stairs from original ground floor office entrance up to former offices. | | Steps to remain in situ | Steps to remain in situ |

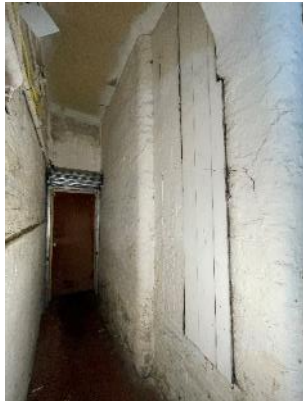
| 2 | Area of original timber tongue and groove giving access into the void to the back of the staircase. | 1 | Area of original timber tongue and groove giving access into the void to the back of the staircase. | | <p>REMOVE</p> <p>FIRE /H&amp;S RISK</p> <p>Wont have sufficient fire proofing</p> | <p>Remove and relocate item to a secure container for assessment.</p> <p>Review and design a heritage display for selected items in the concierge area.</p> <p>Offer any remaining heritage pieces to incoming commercial tenants.</p> <p>if item is used within the scheme it will be restored by speacilist</p> |

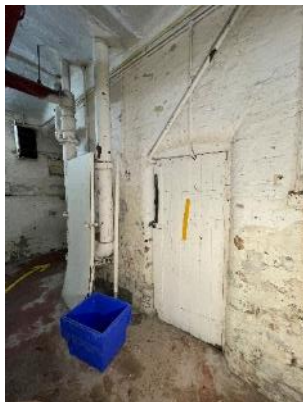
| 3 | Length of original/early plastered dado to link corridor between room B and C. | 1 | Length of original/early plastered dado to link corridor between room B and C. | | <p>REMOVE</p> <p>FIRE /H&amp;S RISK</p> <p>Timber in sterile areas</p> | |
|---|---|---|---|---|---|---|
| 4 | Original timber ledged and braced door into downstairs cupboard with rimlock. | 1 | Original timber ledged and braced door into downstairs cupboard with rimlock. (see entry below) | | <p>Keep in situ</p> | |

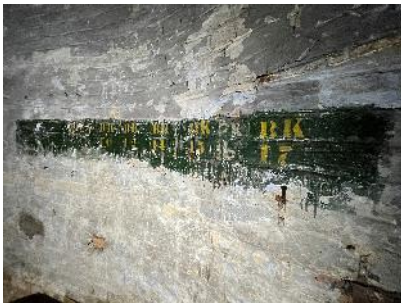
| 2 | Two c1920s/30s painted signs to north and south understairs cupboard walls. | 2 | Two c1920s/30s painted signs to north and south understairs cupboard walls (with some hooks/nails surviving) which would have held floor and department keys. | | <p><b>RETAIN</b></p> <p>Will be behind lift services so won't need any works doing to it</p> | |

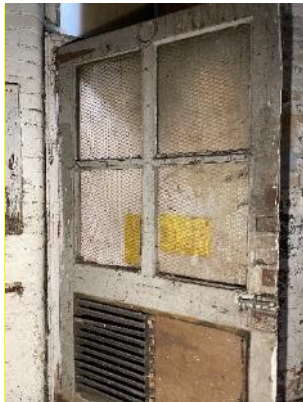
| Room D | | | | | | |
|---|---|---|---|---|---|---|
| 1 | Original 1909 half-glazed door with ventilation panel below into the transformer house. | 1 | <p>Original 1909 half-glazed door with ventilation panel below into the transformer house.</p> <p>Upper glass panels are modern. Half of original timber ventilation panel missing.</p> | | <p><b>REMOVE</b></p> <p><b>FIRE /H&amp;S RISK</b></p> <p>Wont have the sufficient fire rating and damaged</p> | |

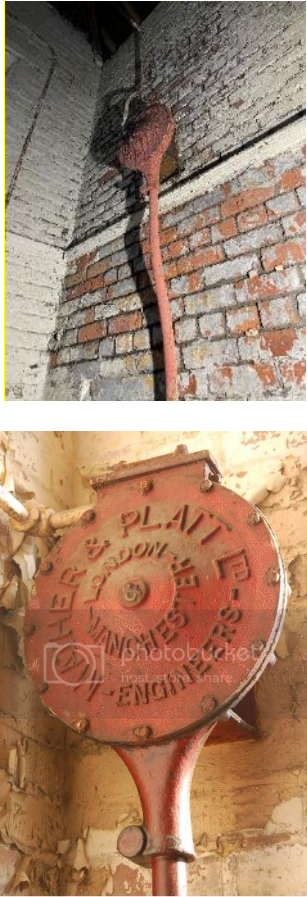
| 2 | Late-1890s, early-1900s Mather and Platt wall-mounted fire alarm bell system | 1 | <p>Late-1890s, early-1900s Mather and Platt wall-mounted water-powered fire alarm bell system connected to an external fire bell.</p> <p>If a fire started in the mill, the mill's sprinkler system would activate water from the roof storage tank, which would then pass through this device, driving a wheel within it and sounding the external bell to the mill yard.</p> | <p>(a clearer example of the same unit as seen in a Garnett's Cabinet Works in Warrington)</p> | Retain and redecorate | |

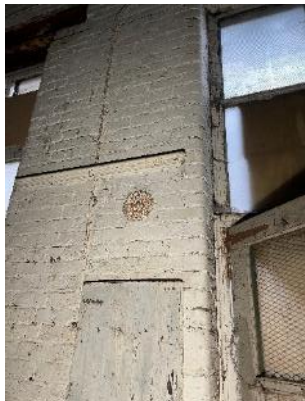
| 3 | Areas of surviving 1909 timber picture rail around perimeter of transformer room. | / | Areas of surviving 1909 timber picture rail around perimeter of transformer room. | | Keep in situ<br>Restore and decorate | |

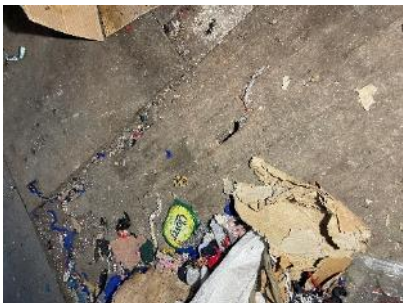
| 4 | Surviving 1909 timber floorboards across former transformer room. | / | Surviving 1909 timber floorboards across former transformer room. | | Remove<br>Floors have been ruled out due to fire risk and structural unknown element | / |

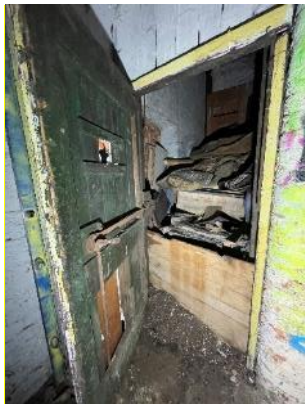
| Plan ref number | Item | Number | Description | Photograph | Proposal/treatment/ repair | Location if being removed / relocated |
|---|---|---|---|---|---|---|
| 2 | 19 <sup>th</sup> /early-20 <sup>th</sup> century mill bale hoist door/fanlight – with ironmongery/mechanism on the inside face. | 1 | 19 <sup>th</sup> /early-20 <sup>th</sup> century mill bale hoist door/fanlight – with ironmongery/mechanism on the inside face. | | Floors to be taken out and this will be a void | |

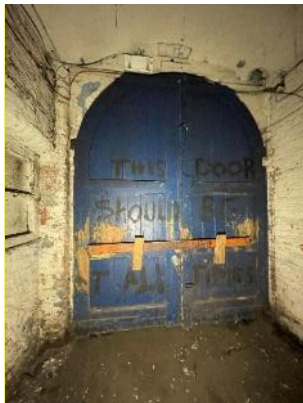
| Plan ref number | Item | Number | Description | Photograph | Proposal/treatment/ repair | Location if being removed / relocated |
|---|---|---|---|---|---|---|
| 1 | Pair of original/early timber gates/ironmongery from courtyard into former eastern cartway. | 2 | Pair of original timber gates/ironmongery from courtyard into former eastern cartway, using the same moulded detail as seen in door within room A (fifth floor). | | Gates to be pinned back as feature in the arch or take off and rehung within the archway<br><br>Restore and decorate | |
