Gas Membrane Installation  
Validation Report  
Casey Construction  
Former Greenbow Social Club  
Greenbow Road  
Wythenshawe  
Manchester  
M23 2TU

## Appendix 1 – Site Survey Sheets

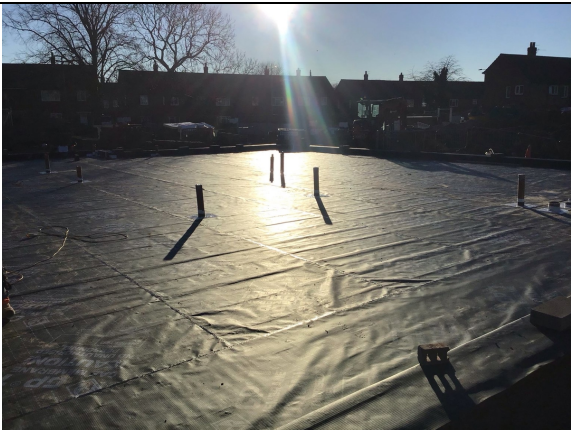
Plots 9 to 13 apartment block overview

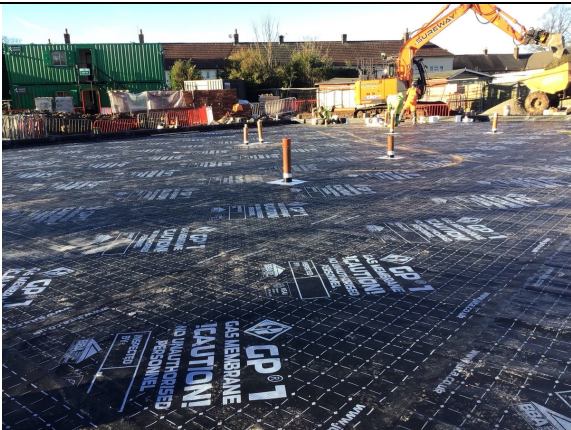
Plots 9 to 13 apartment block alternate overview

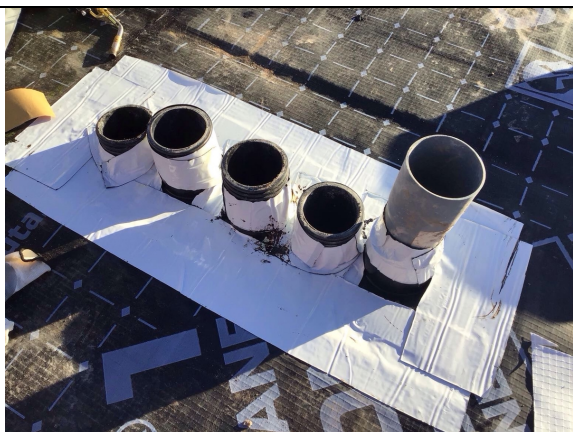
Detailed pipe penetrations

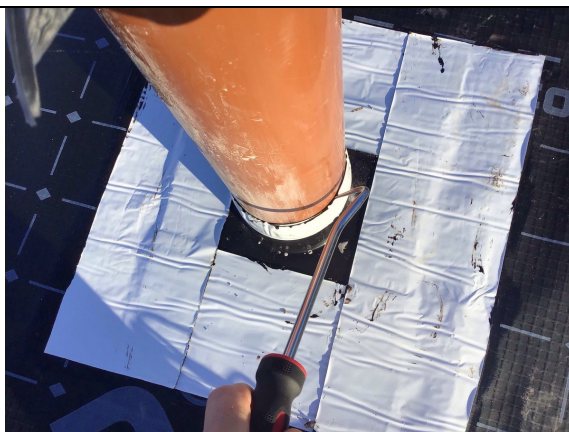
Testing pipe detailing

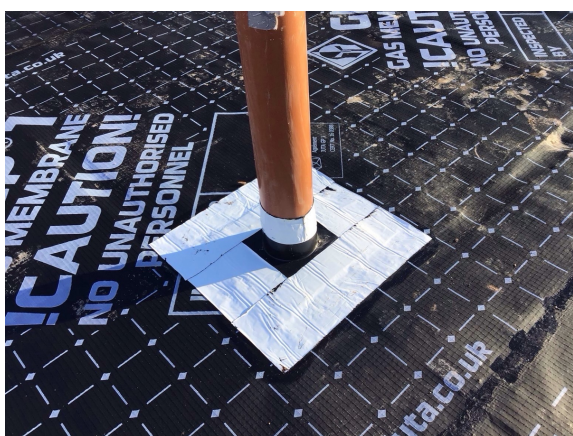
Detailed pipe penetration

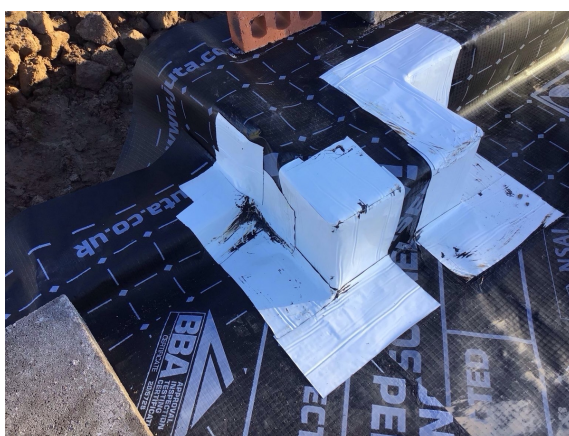
| Housebuilder Name: Casey Construction - Former Greenbow Social Club | | Date: 16/01/2025 | |
|---|---|---|---|
| <b>Door Threshold Seal Method:</b> Door Thresholds have been sealed using strips of self-adhesive gas membrane, this is an approved and recognised method in CIRIA C735 | | | |

Threshold detailing

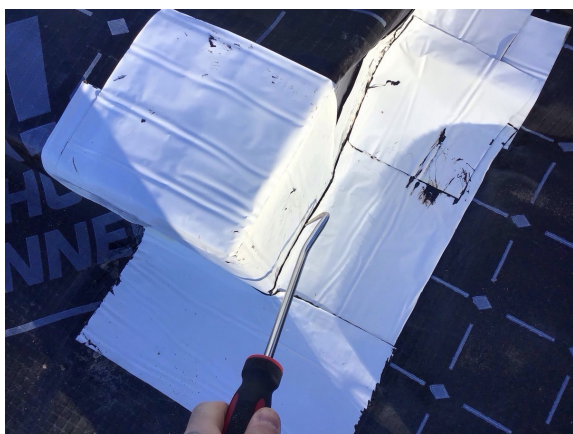
Testing threshold detailing

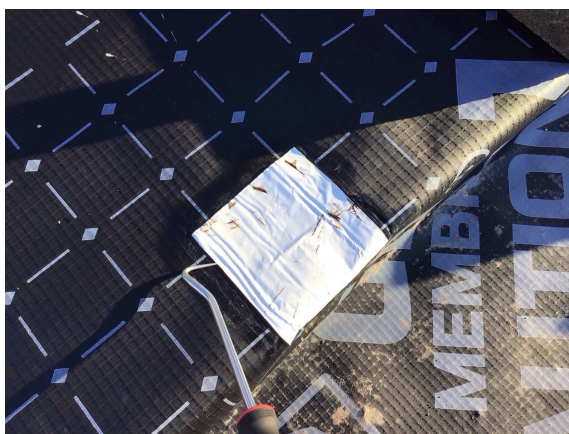
| Plot Number | (Section 3, Defects List) | Action Required |
|---|---|---|
| 9 to 13 apartment block | No Defects recorded at the time of our inspection. The installers made patch repairs prior to our inspection under their own CQA using Juta GP SAM | N/A |

Testing installers CQA patch repair

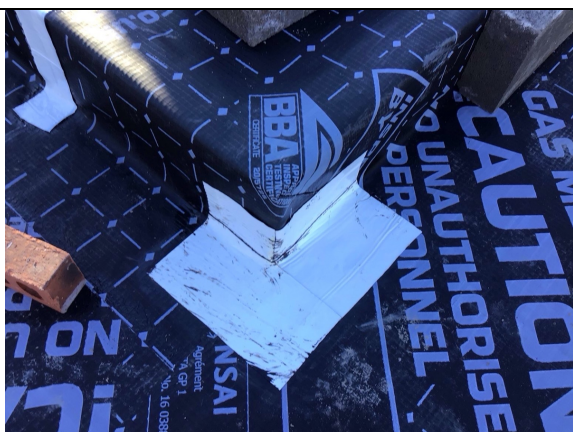
| Housebuilder Name: Casey Construction - Former Greenbow Social Club | | Date: 16/01/2025 | |
|---|---|---|---|
| <b>Corner Seal Method:</b> Corners have been sealed using strips of self-adhesive gas membrane, this is an approved and recognised method in CIRIA C735 | | | |

Corner detailing

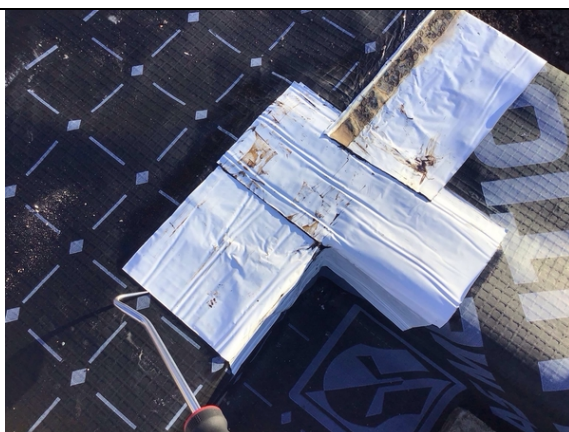
Testing corner detailing

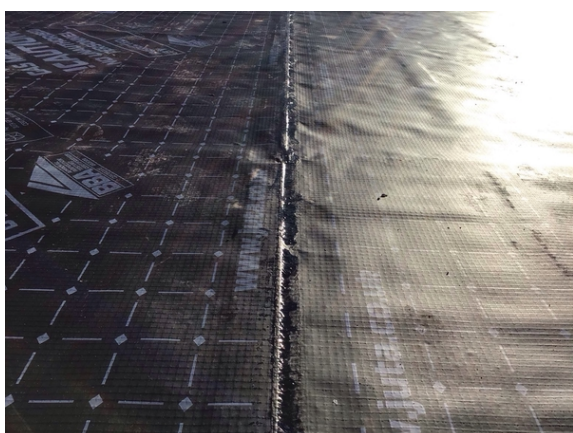
| Housebuilder Name: Casey Construction - Former Greenbow Social Club | | Date: 16/01/2025 | |
|---|---|---|---|
| <b>Material Jointing Method:</b> The membrane has been overlapped sufficiently to achieve a sound joint, the joint is clean and dry and has been joined by means of hand welding with a hot air gun and neoprene roller, the width of the welded joint is a minimum of 30mm. | | | |

Hand welded membrane lap joint

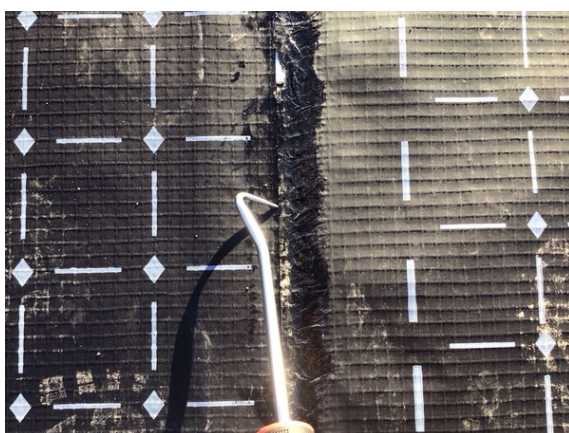
Testing hand welded membrane lap joint
