| Location/Beam | Decay viewed from<br>bearing side | Cross plan view | | Photographs | Confirmed agreed repairs with<br>Structural engineer comment in bold |

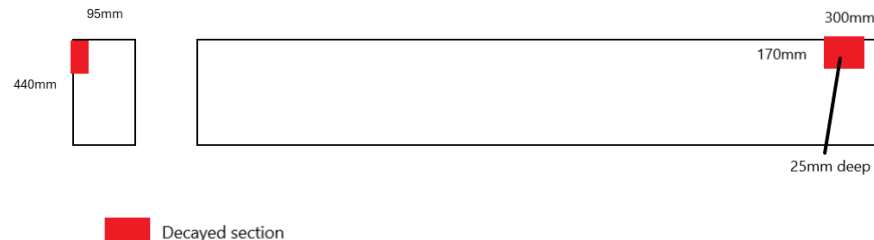
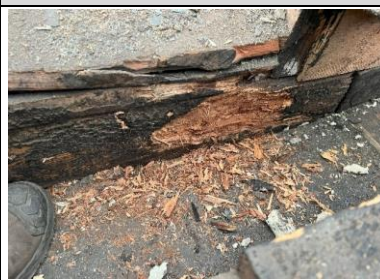
| Location/Beam | Decay viewed from<br>bearing side | Cross plan view | | Photographs | Confirmed agreed repairs with<br>Structural engineer comment in bold |
|---|---|---|---|---|---|
| G/VB2<br><br>Bearing end to<br>beam opposite<br>VB4<br>section | | 300mm from the bearing end<br>opposite VB4 pocket of decay<br>25mm deep 300x170mm<br>in section | | <b>Recommendations</b><br>De-frass the decay back to sound<br>timber and splice a new section wedge<br>shaped glue with Sikadur 31 EF 2 Part<br>Epoxy Structural adhesive<br><br><b>Buro Happold Comment</b><br><b>Agreed with repair as per<br/>standard notes as per BH email<br/>dated 2-12-2024</b> | |

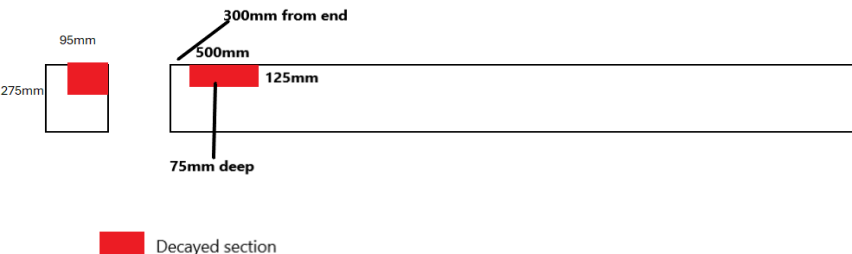
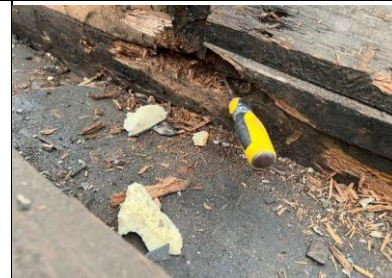
| Location/Beam | Decay viewed from<br>bearing side | Cross plan view | | Photographs | Confirmed agreed repairs with<br>Structural engineer comment in bold |
|---|---|---|---|---|---|
| G/VB/6<br><br>Bearing end<br>opposite VB4 | | 300mm from the bearing end<br>opposite VB4 pocket of decay<br>75mm deep 500mmx125mm<br>in section | | <b>Recommendations</b><br>Flitch beam plate repair as per<br>drawings and calculation<br>provided by WMI Consulting<br><br><b>Buro Happold Comment</b><br><b>Agreed with repair as per<br/>standard notes as per BH email<br/>dated 2-12-2024</b> | |

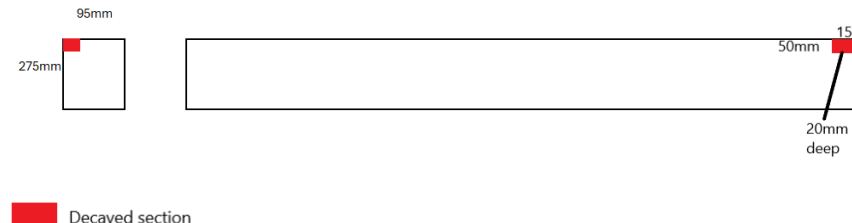
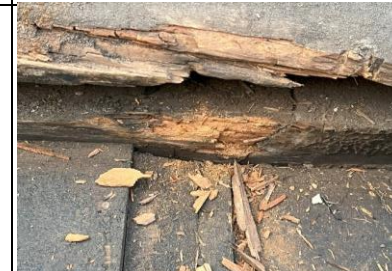
| Location/Beam | Decay viewed from<br>bearing side | Cross plan view | | Photographs | Confirmed agreed repairs with<br>Structural engineer comment in bold |
|---|---|---|---|---|---|
| G/VB/8<br><br>Bearing end<br>opposite VB10 | | Small pocket of rot to top edge<br>50x150mm in section to<br>maximum depth of 20mm | | <b>Recommendations</b><br>Defrass the beam end back to sound<br>timber and treat with Probor 20<br>fungicide gel<br><br><b>Buro Happold Comment</b><br><b>Agreed with repair as per<br/>standard notes as per BH email<br/>dated 2-12-2024</b> | |

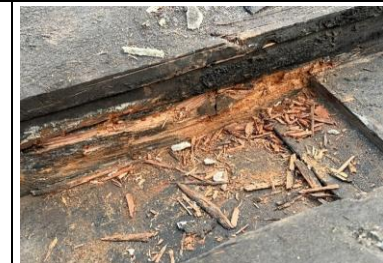
| Location/Beam | Decay viewed from<br>bearing side | Cross plan view | | Photographs | Confirmed agreed repairs with<br>Structural engineer comment in bold |
|---|---|---|---|---|---|
| G/VB/9<br><br>Bearing end<br>opposite VB7 | | Rot to top edge 50x400mm<br>wide to maximum depth of<br>20mm | | <b>Recommendations</b><br>Defrass the beam end back to sound<br>timber and treat with Probor 20<br>fungicide gel<br><br><b>Buro Happold Comment</b><br><b>Agreed with repair as per<br/>standard notes as per BH email<br/>dated 2-12-2024</b> | |

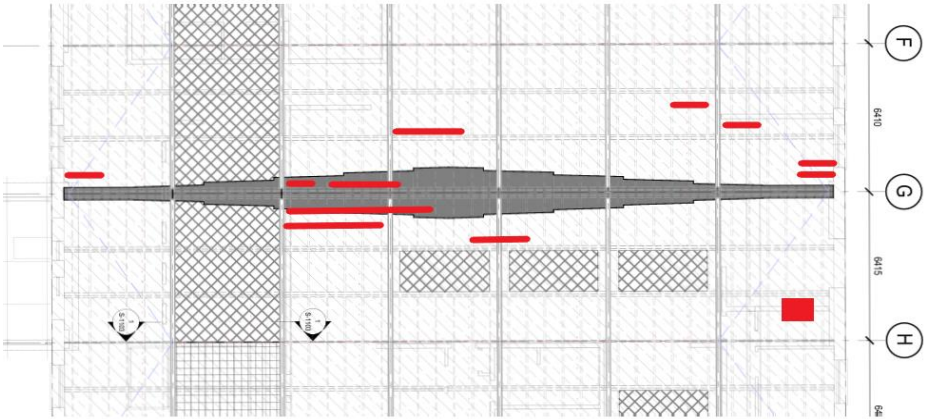
Sarking board

Renew damaged and decayed sarking boards

Renew with Redwood 19x225mm boards

**Buro Happold Comment**  
**Replace all decayed sarking boards**  
**like for like as per BH email**  
**dated 2-12-2024**
