Phase II Geoenvironmental Site Assessment  
Vine Street, Gorton

Reference: 14-944-R1-3  
Date: October 2023

## **PHASE II GEOENVIRONMENTAL SITE ASSESSMENT**

Land off Vine Street  
Gorton  
Manchester  
M18 8SR

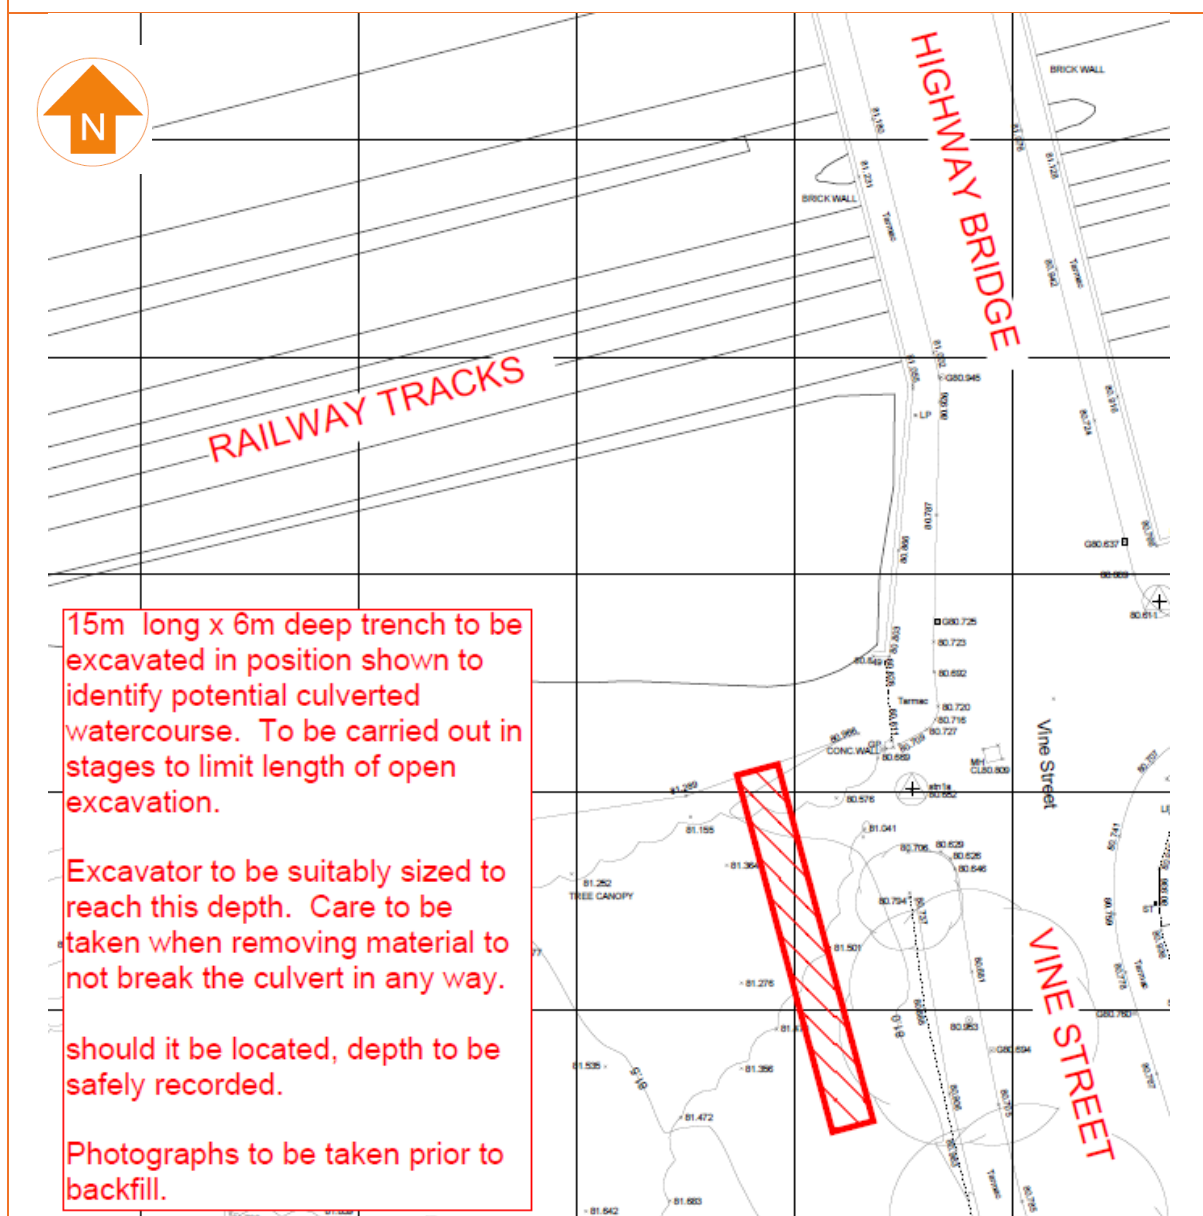
FIGURE 5.1 CULVERT TRENCH LOCATION PLAN

However, during the enabling works, it is recommended that a watching brief is completed in this area to confirm the presence or absence of the feature.
