# Preliminary Roost Assessment

Equitable Building, Manchester  
Reference: 81-971-R1  
Date: December 24

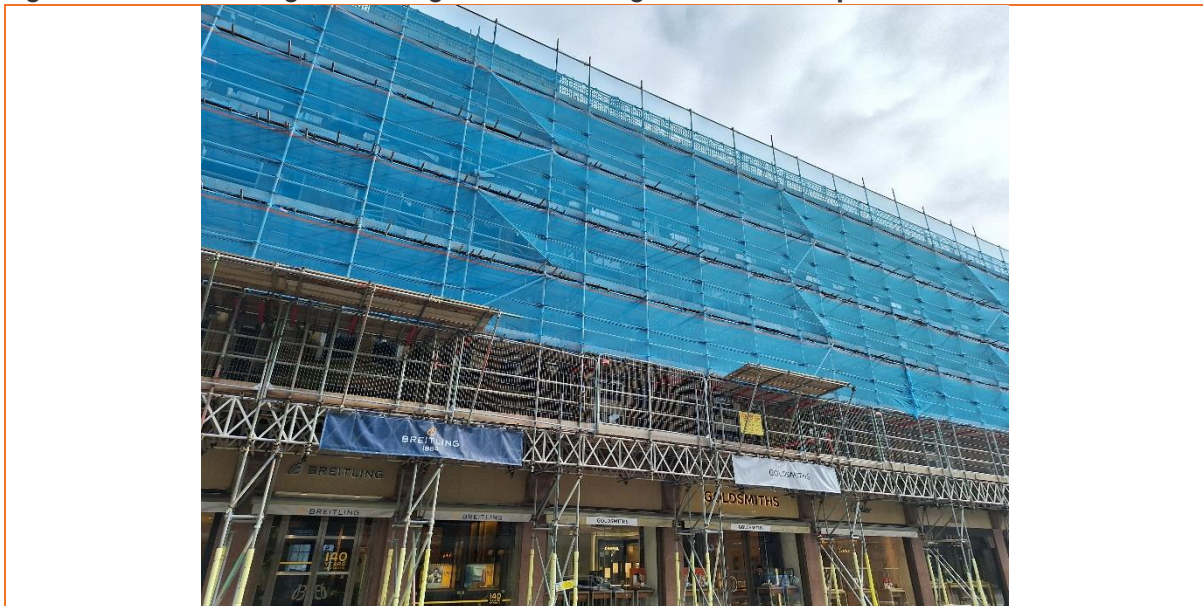
**Figure 2** Showing Scaffolding and Bird Netting on Southern Aspect

The on-site building comprised an inactive four-storey commercial building with a basement. The building was undergoing roof repair works at the time of survey. As such, scaffolding with associated bird netting was present on the western, southern and eastern aspects, covering from the second to the fourth storey. It is understood that the scaffolding was erected in April 2024 prior to repair works commencing. The building could not be assessed for its potential to support roosting bats from ground level on the western, southern and eastern aspects due to reduced visibility caused by the bird netting.

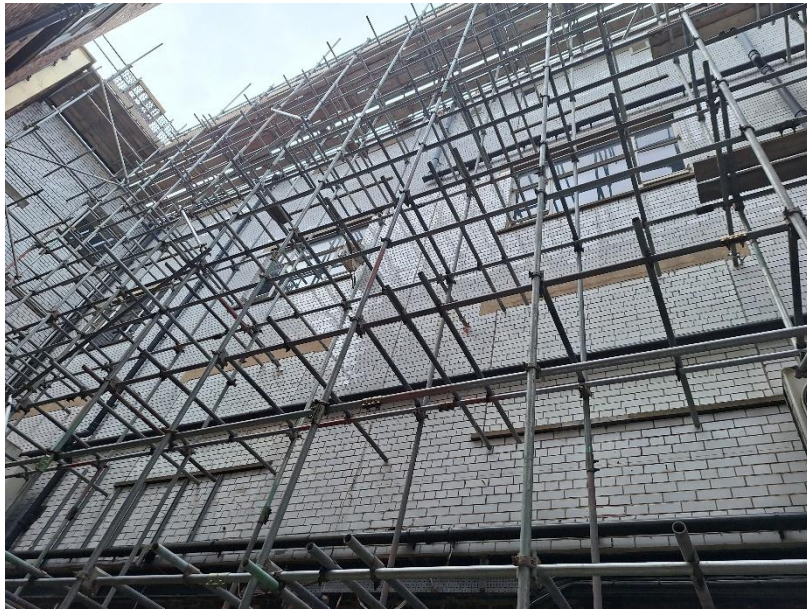
**Figure 3** Showing Scaffolding on Northern Aspect

Scaffolding was also present on the northern aspect of the building, however bird netting was not present on this section of the building. As such, a full visual inspection could not be undertaken from ground level. The northern aspect of the building comprised tile walls. The tiles and surrounding grouting were in good condition, with no signs of damage or exposed brickwork that could lead to potential cavities or provide an access point for bats into the building. Multiple casement windows were also present on the northern aspect. The windows were in good condition, with no cracks or crevices present between the window frame and adjacent brickwork/tiles.

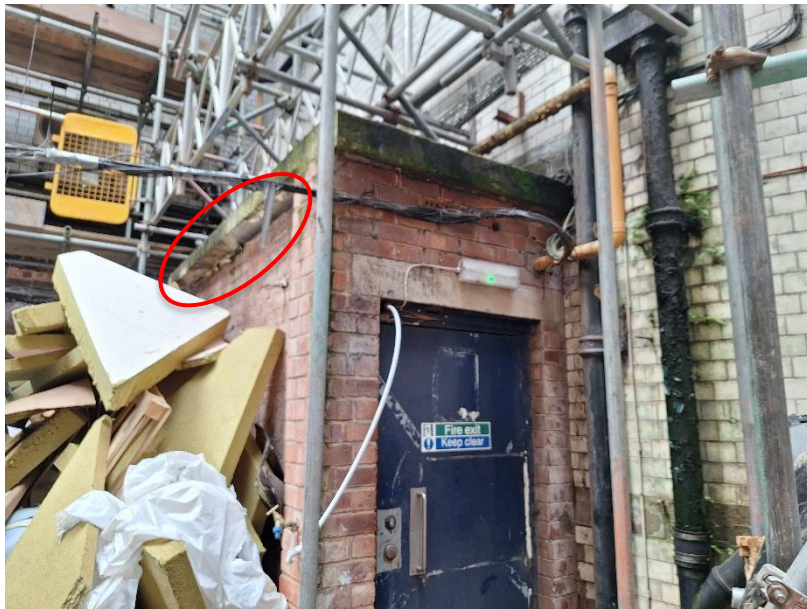
**Figure 4** Showing Fire Exit

A single-storey fire exit was present within the courtyard on the northern aspect of the building. The fire exit comprised red brick with a flat roof. Some damage was noted on the eastern aspect of the fire escape, however it was determined that the damage was superficial, with no gaps or crevices that could be utilised by opportunistic bat species. Additionally, the drop zone below the superficial feature was cluttered with rubbish.

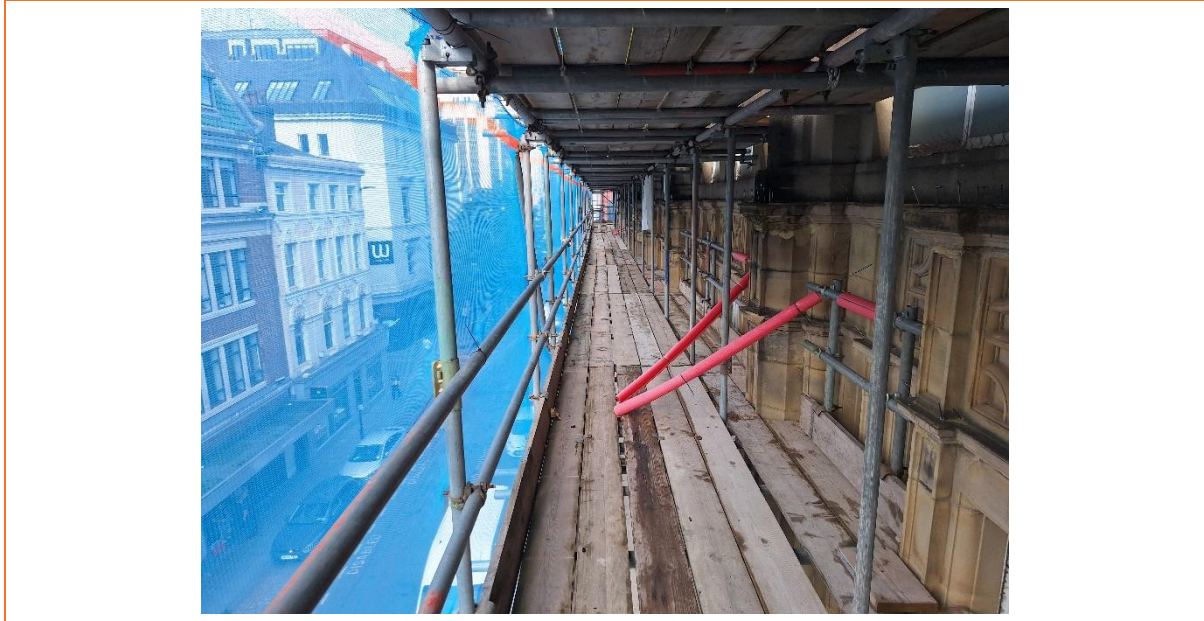
**Figure 5**      **Showing Scaffolding and Bird Netting**

An external visual inspection of the western, southern and eastern aspects of the building were undertaken via the scaffolding present.

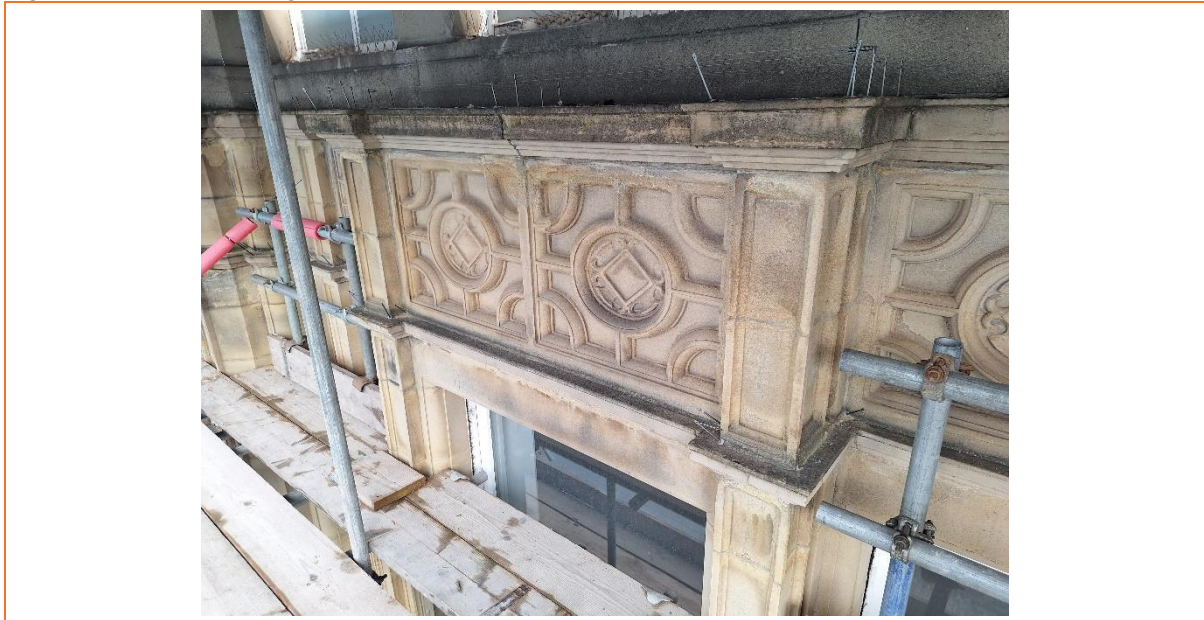
**Figure 7**      **Showing Stonework Facade**

The western, southern and eastern aspects comprised stone façade. The stone façade on all aspects were in good condition, with no signs of damage identified which could be utilised by crevice-dwelling bat species. Additionally, no exposed brickwork that could provide potential roost features or access points for bat species into the building were identified.

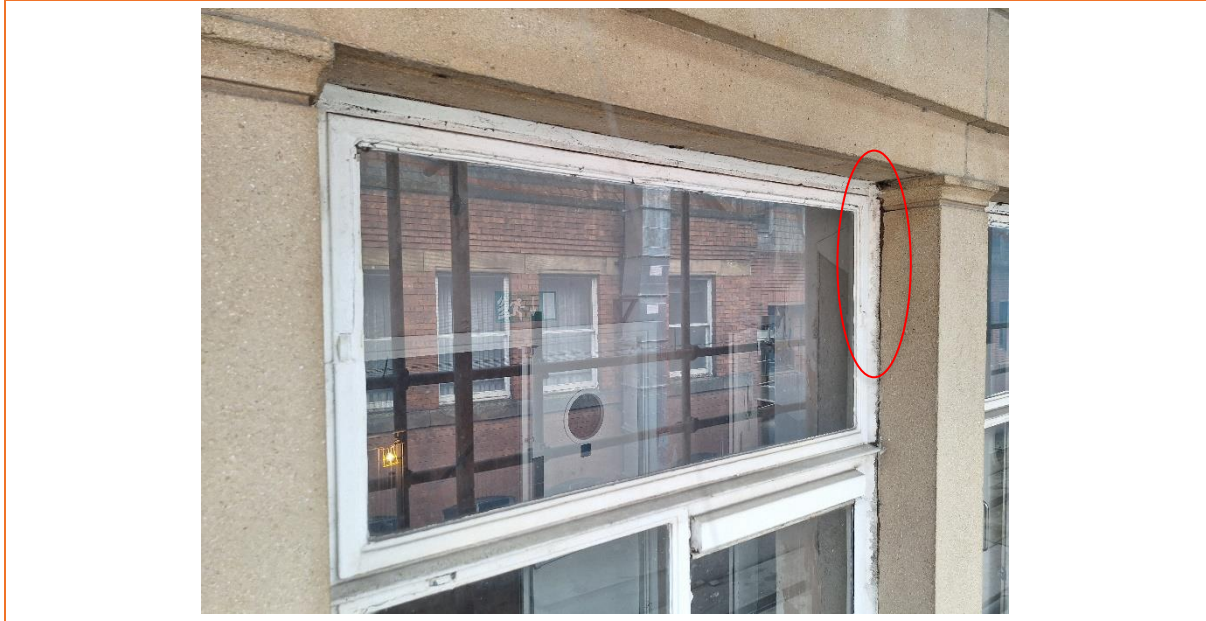
**Figure 8**      **Showing Window**

Single-glazed casement windows were present on all above ground stories of the western, southern and eastern aspects of the building. As with the stone façade, the windows were in good condition, with no cracks or crevices identified between the window frames and surrounding stone façade. Some gaps between the windows and stone façade were noted; however it was determined that these gaps were too narrow to provide roosting opportunities for crevice-dwelling bat species.

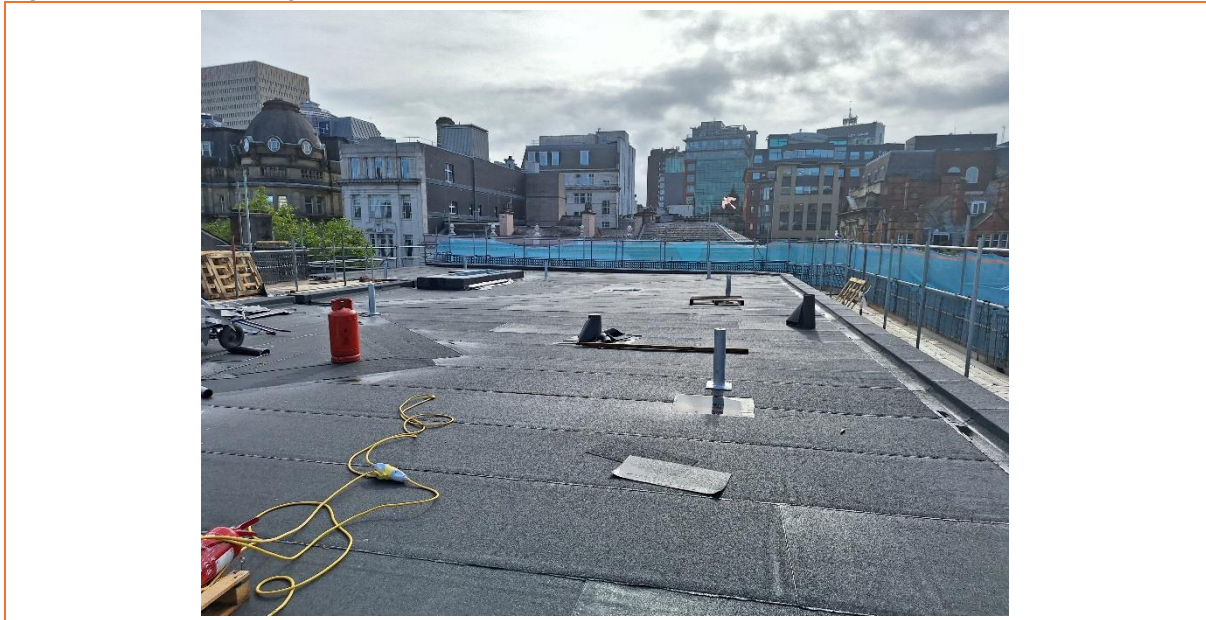
**Figure 9**      **Showing Flat Roof**

An inspection of the flat roof was undertaken during the survey. The roof was actively being repaired at the time of the survey. The flat roof comprised bitumen sheeting, which was being installed during the inspection. Due to the nature of the flat roof and the materials it comprised, it was determined that no suitable bat roost features were present.

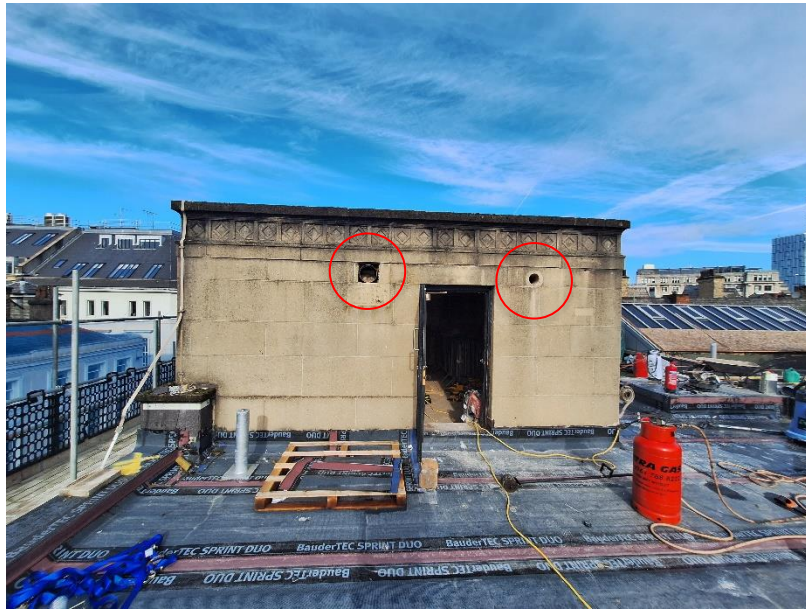
**Figure 10** Showing Flat-Roofed Structure

The roof is accessible from the third floor via a flat-roofed structure. The flat-roofed structure comprised a single-storey with stone façade on all aspects and a flat roof. The stone façade on all aspects of the flat-roofed structure were in good condition, with no signs of damage identified which could be utilised by crevice-dwelling bat species. Additionally, no exposed brickwork that could provide potential roost features or access points for bat species into the building were identified. Externally, it appeared that two access points were present on the eastern aspect; however, upon closer inspection it was determined that these features had been filled in and therefore preventing access into the building for bat species.

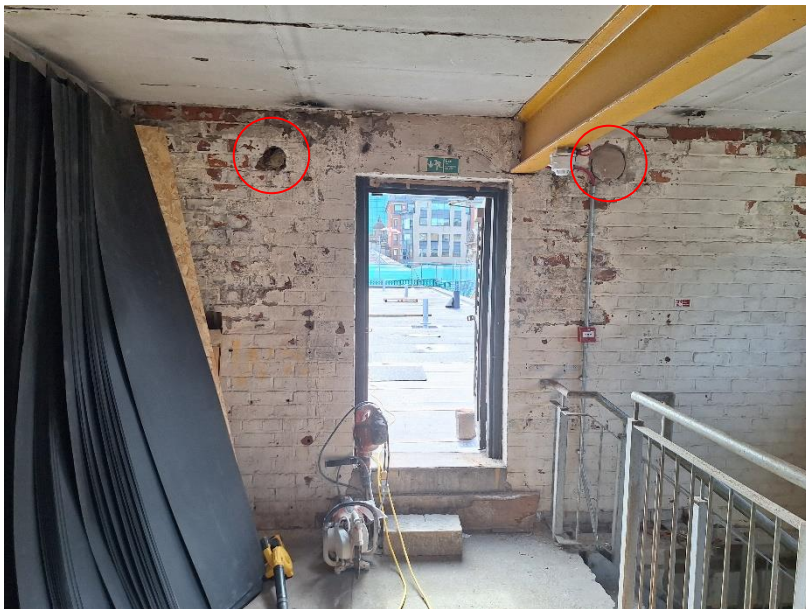
**Figure 11** Showing Sealed Holes in Brickwork

The flat-roofed structure was currently in use for storage of construction equipment. It is therefore assumed that the door of the flat-roofed structure is closed when not in use to protect the equipment. As such, the flat-roofed structure cannot be utilised as an access points for bats into the building.

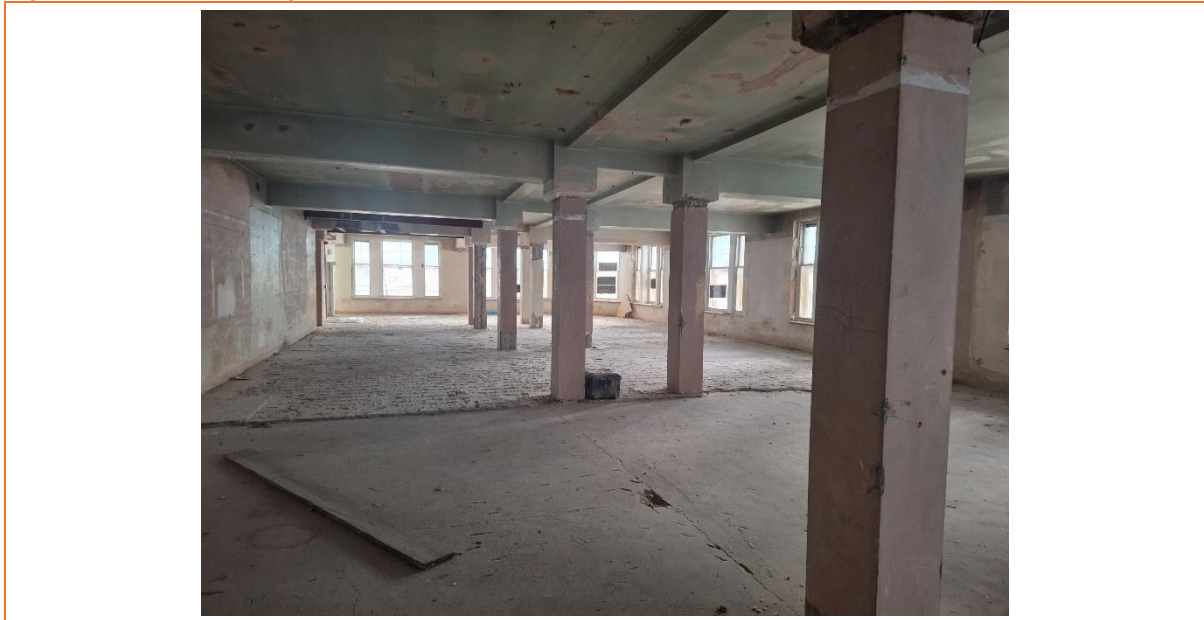
**Figure 12**      **Showing First Floor Internals**

An internal inspection of the building was undertaken during the survey. Internally, most of the building comprised concrete floors and ceilings with plastered walls and pillars. The concrete and plaster were mostly in good condition, however some signs of damage were noted.

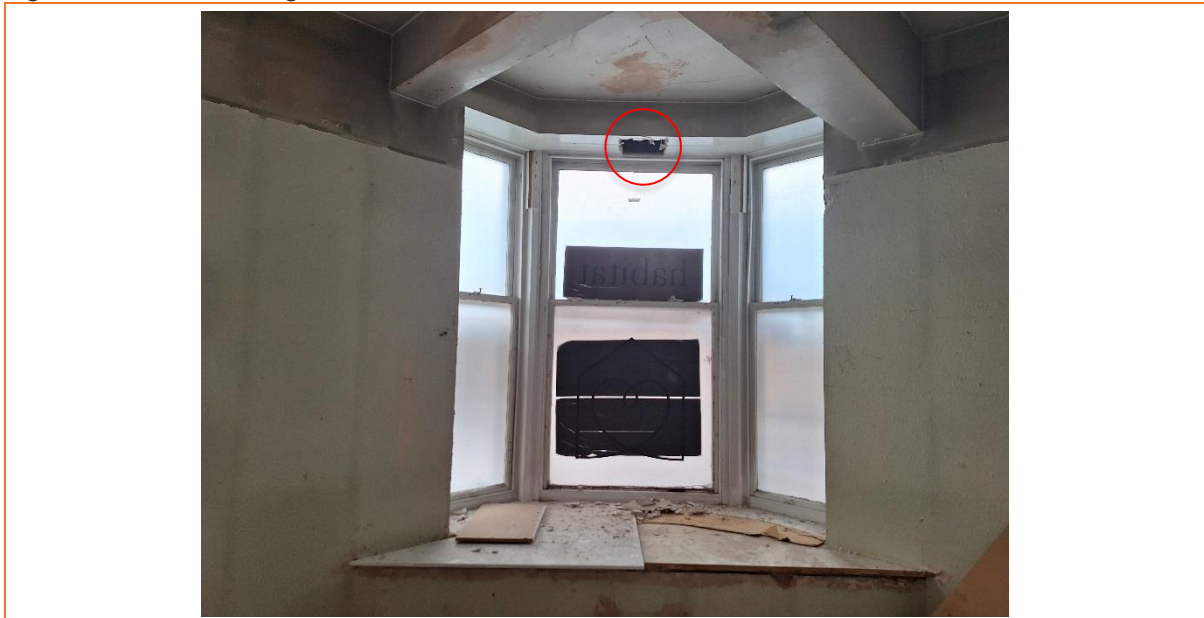
**Figure 13**      **Showing Internal Window**

Internally, the windows were well-sealed. The tops of the window frames and ledges were made of wood. Signs of damage to the top of the window frames were identified across multiple windows, internally. It is assumed that the damage was caused during a search for electrical wiring across the building. The damage within the tops of the window frames could be utilised by void-dwelling bat species; however, no potential access points identified which would allow bat species access into the building.

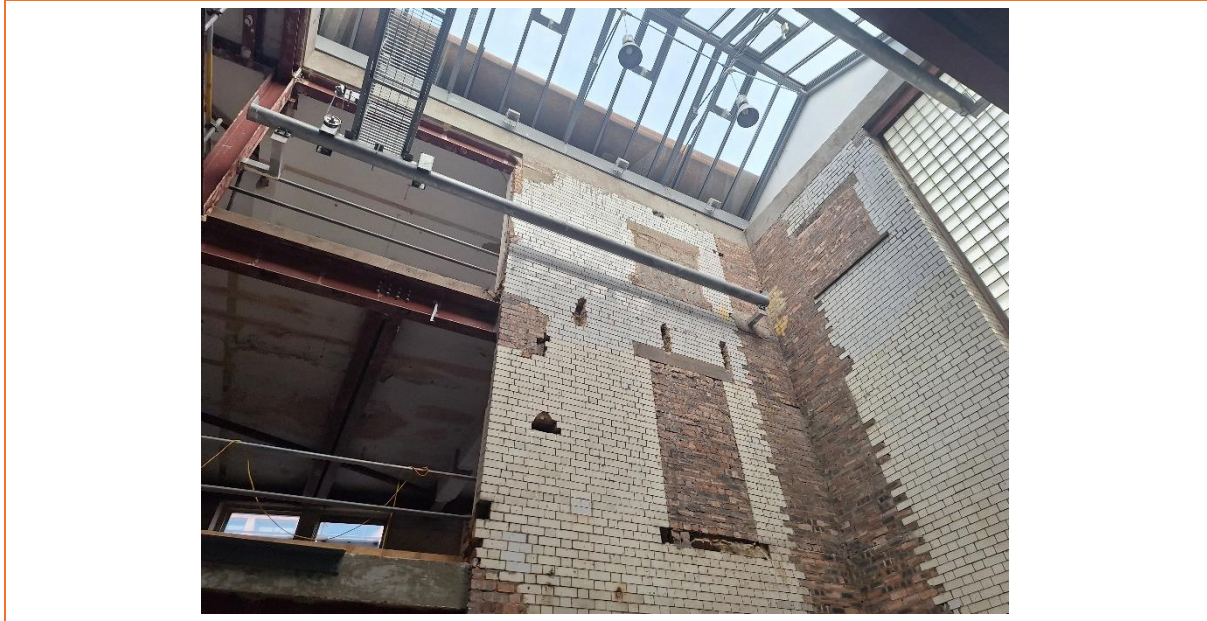
Figure 14 Showing Internal Damaged Brickwork

Internally, one section of the building comprised red brick and tiles. This section was in poor condition, with multiple cracks and crevices noted which could be utilised by crevice-dwelling bat species; however, as no access points into the building for bats were identified, such features would not be able to be utilised, and as such are ruled out of further consideration.

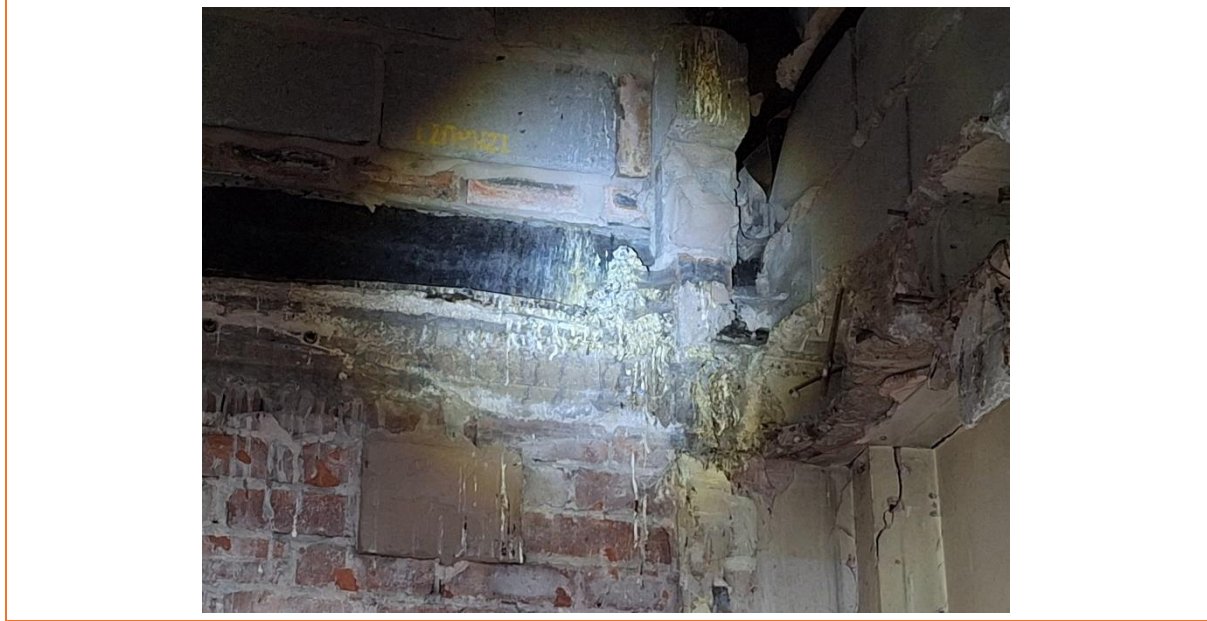
**Figure 15** Showing Bird Droppings

Gull species (*Larus* sp.) and feral pigeon were identified on the roof of buildings adjacent to the north of the building; however, no bird species were identified utilising the on-site building or roof. Bird droppings were noted internally on the fourth floor of the building. No nearby access point for bird species into the building were identified.

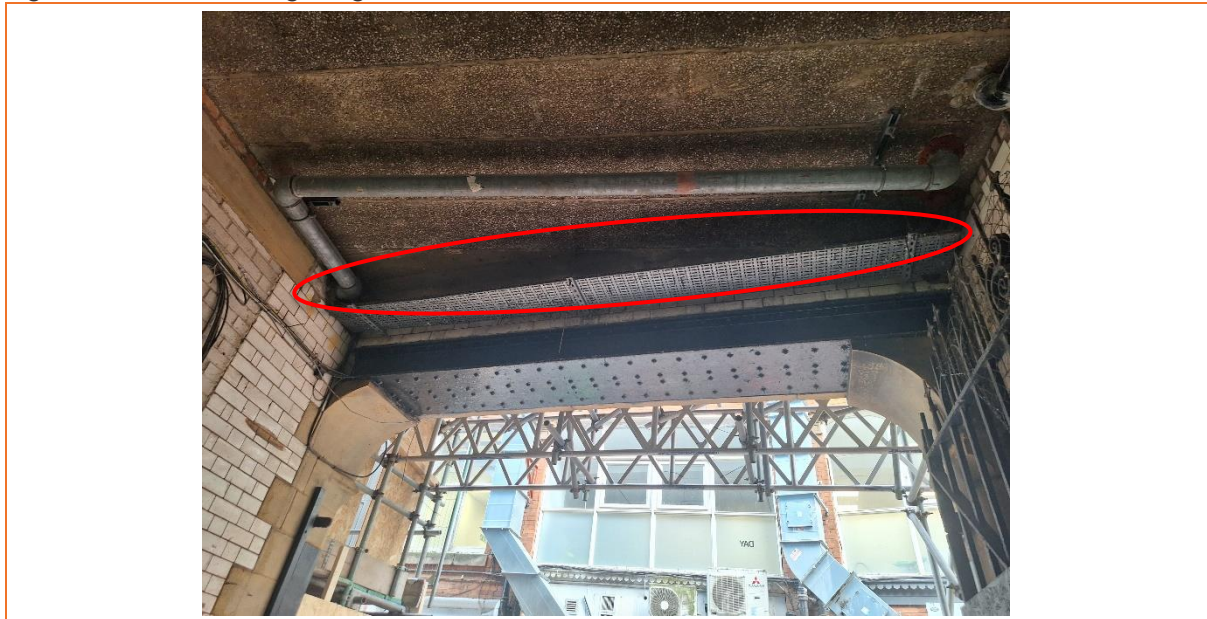
**Figure 16** Showing Ledge

Feral pigeon were identified perched on a ledge above the access into the courtyard at the time of the survey.

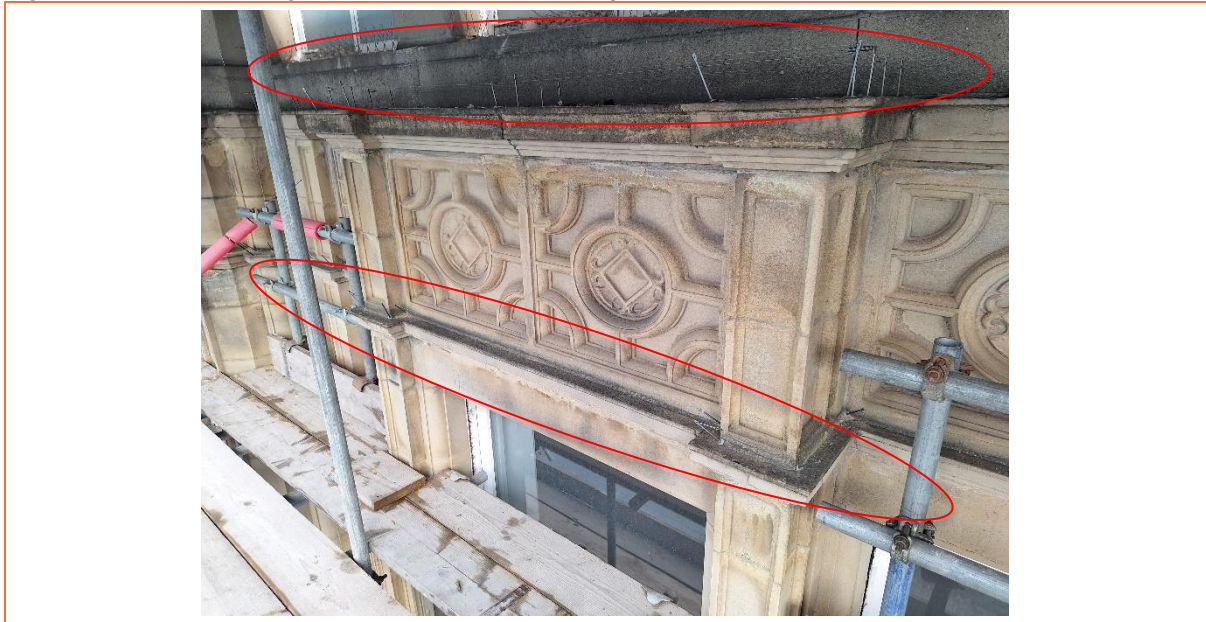
**Figure 17**      **Showing Bird Deterrent Wire and Spikes**

Bird deterrent wire and spikes were identified across multiple ledges on the stone façade on the western, southern and eastern aspects. These deterrents will reduce the suitability of the building to support

nesting birds. Due to a lack of available crevices within the stone façade, it was determined that the building will not support black redstart.
