# Condition Report

## 652 CHORLTON LIBRARY ROOF LIGHT

The following report looked at the condition of the Glazing  
bars

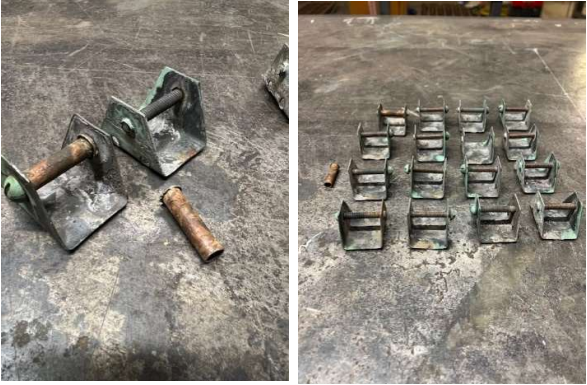
| | 17 | 48 | Copper inserts for all glazing bars need replacing. 48 off required | 48 |
