## Schedule of Condition

102-104 Market Street and  
2-4 Fountain Street  
Manchester  
M1 1PB

Dated: 8<sup>th</sup> April 2024

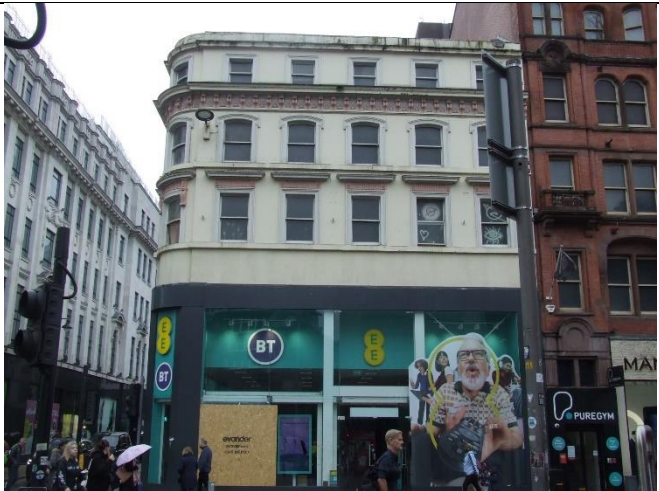
| <i>comments</i> | <i>photograph</i> | <i>comments</i> | <i>photograph</i> |
|---|---|---|---|
| <p>Brick, render and stone featureful Edwardian facade in need of some render and stone masonry repairs and some redecoration.</p> <p>Distressed timber windows with aged and flaking decoration.</p> | | <p>Brick, render and stone featureful Edwardian facade in need of some render and stone masonry repairs and some redecoration.</p> <p>Distressed timber windows with aged and flaking decoration.</p> | |

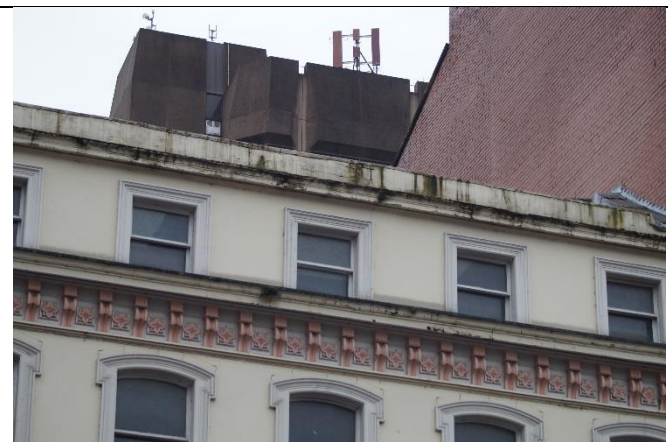
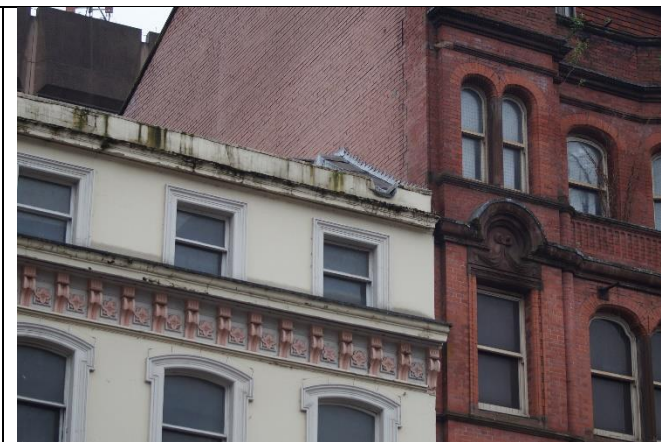
| <p> Renders added and delaminated generally along the parapets in the main but to some other areas of the main featureful facade.</p> <p>Repairs required to string mouldings and facade heavily soiled with water runoff staining.</p> | | <p> Renders added and delaminated generally along the parapets in the main but to some other areas of the main featureful facade.</p> <p>Repairs required to string mouldings and facade heavily soiled with water runoff staining.</p> | |

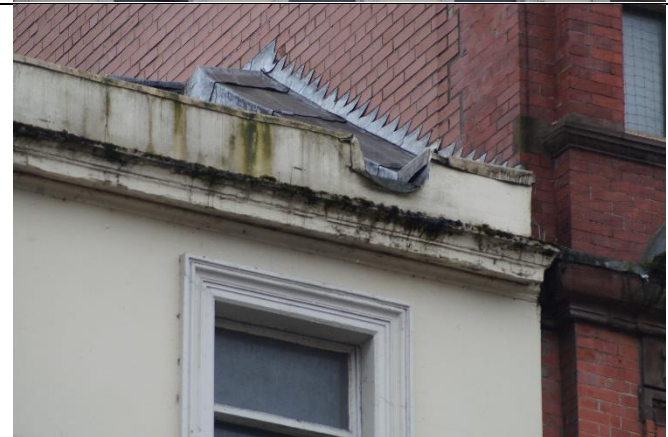
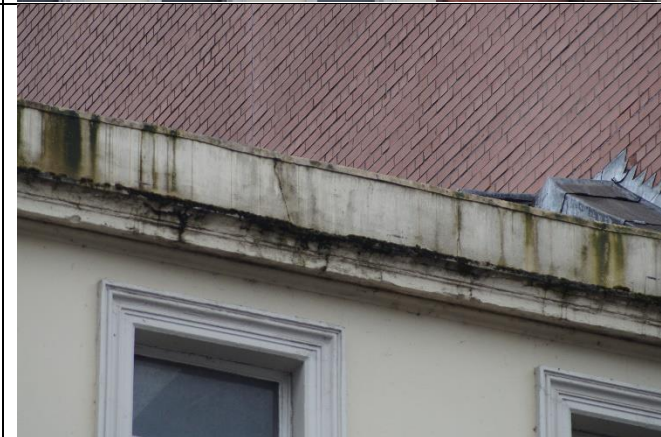
| <p>Some cracking to the masonry brickwork below the main facade, and in particular the parapets will need some further investigation by structural engineer into the cause of the cracking and may need some crack stitch repairs.</p> | | <p>Some damaged and soft stone to the mouldings will need repair.</p> | |

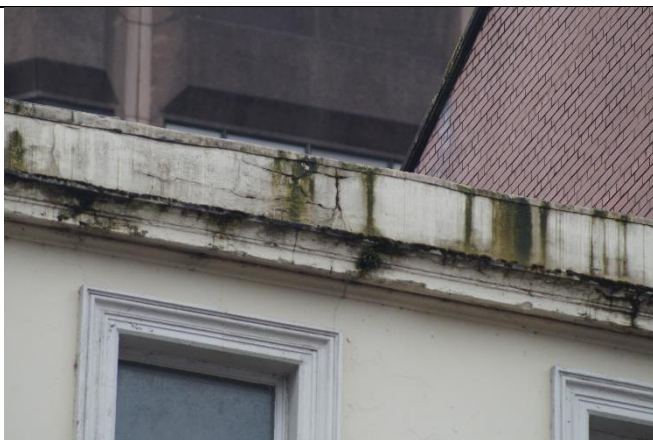
Some cracking to the masonry brickwork below the main facade, and in particular the parapets will need some further investigation by structural engineer into the cause of the cracking and may need some crack stitch repairs.

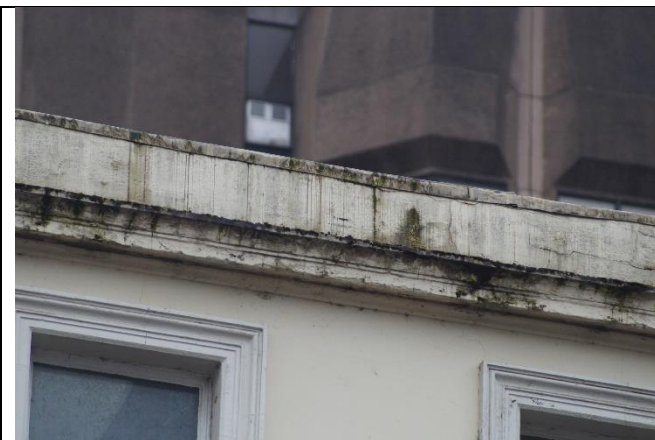
Some damaged and soft stone to the mouldings will need repair.

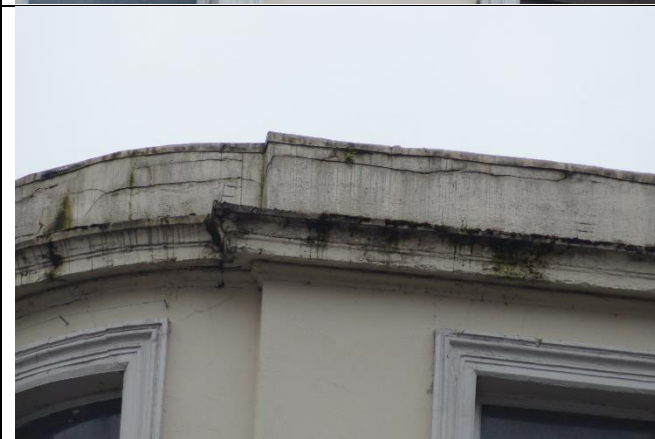
Some cracking to the masonry brickwork below the main facade, and in particular the parapets will need some further investigation by structural engineer into the cause of the cracking and may need some crack stitch repairs.

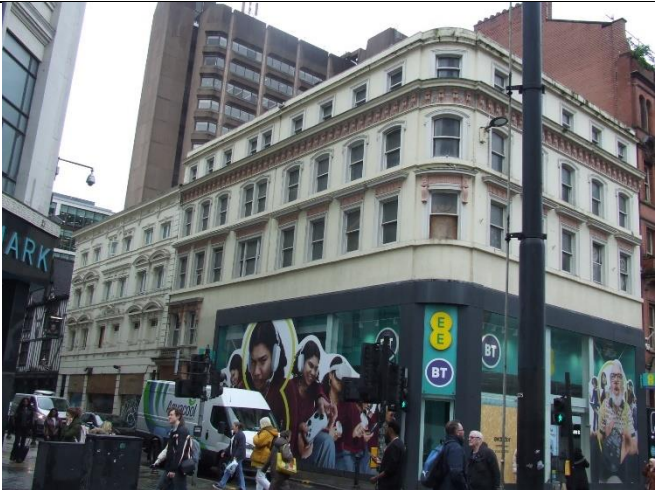
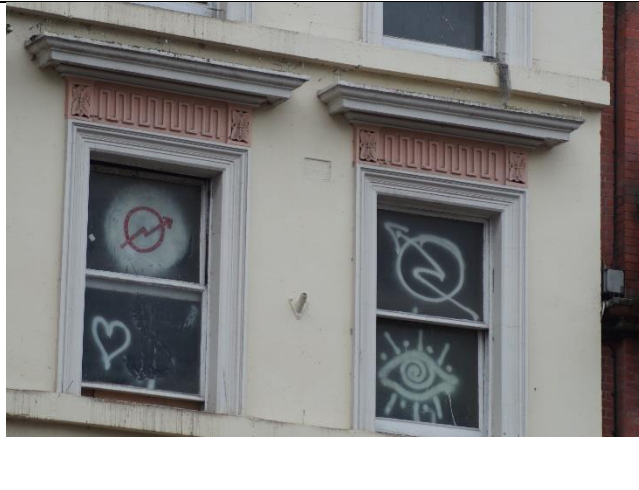
| <p>Brick, render and stone featureful Edwardian facade in need of some render and stone masonry repairs and some redecoration.</p> <p>Distressed timber windows with aged and flaking decoration.</p> | | <p>The decoration to the main facade, including the features and the timber windows is distressed, soiled and has flaking paint. Redecoration of the exterior of the property is very much now due.</p> | |

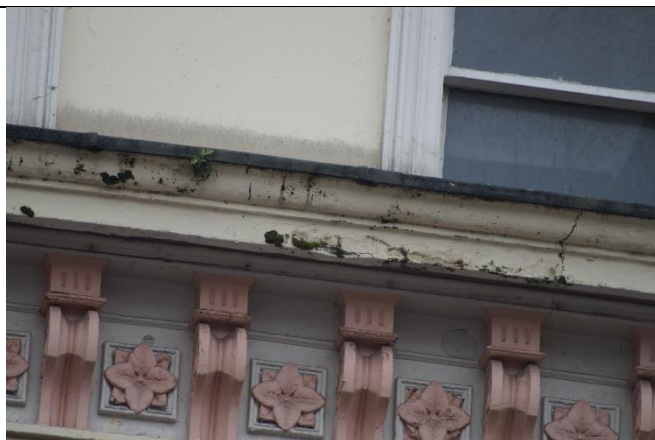
Some damaged and soft stone to the mouldings will need repair.

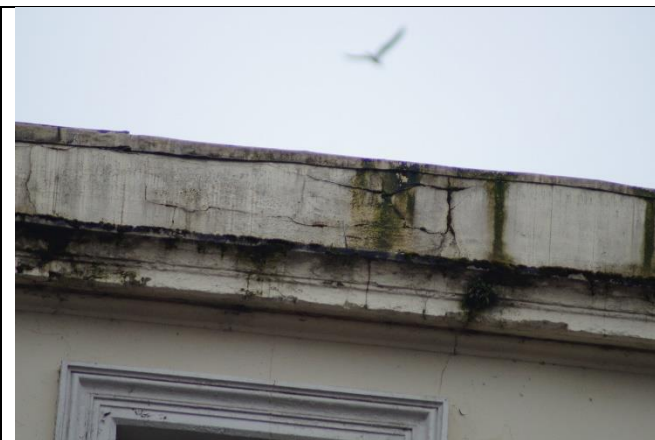
Some cracking to the masonry brickwork below the main facade, and in particular the parapets will need some further investigation by structural engineer into the cause of the cracking and may need some crack stitch repairs.

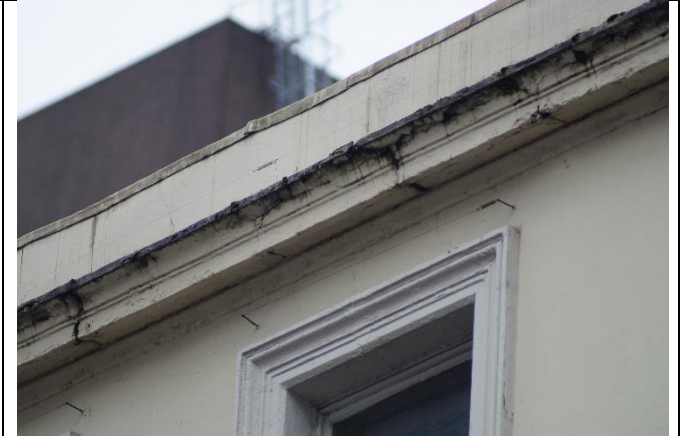
Some damaged and soft stone to the mouldings will need repair.

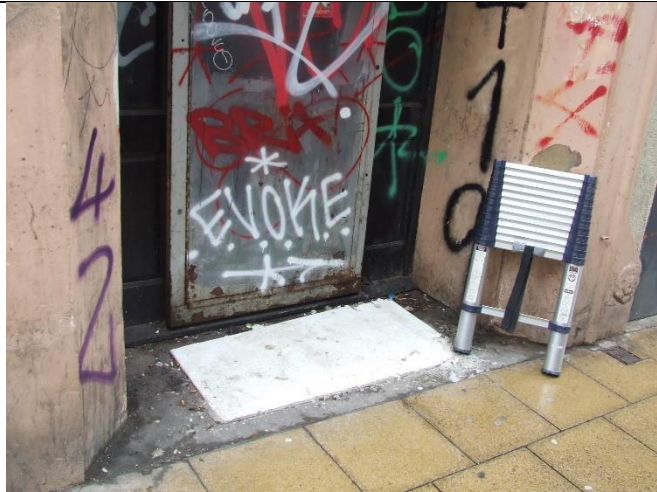
Distress to the main entrance to the office suites is in need of repair, decoration and tidying up

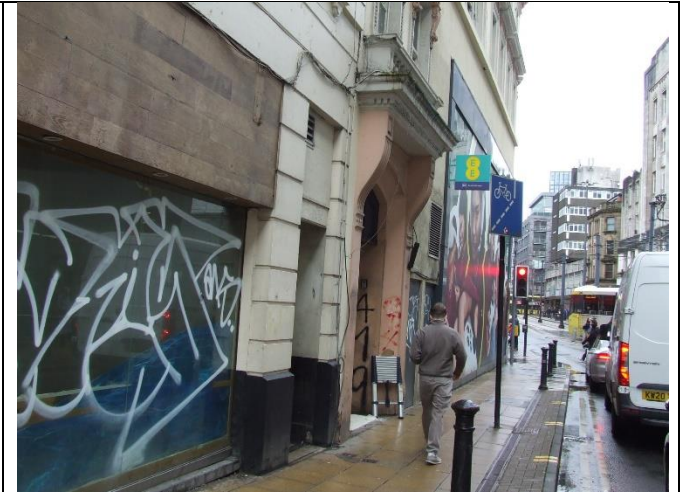
Distress to the main entrance to the office suites is in need of repair, decoration and tidying up

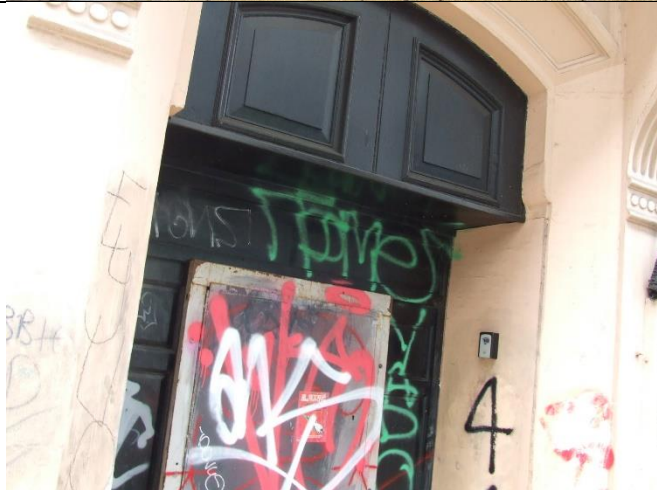
Distress to the main entrance to the office suites is in need of repair, decoration and tidying up

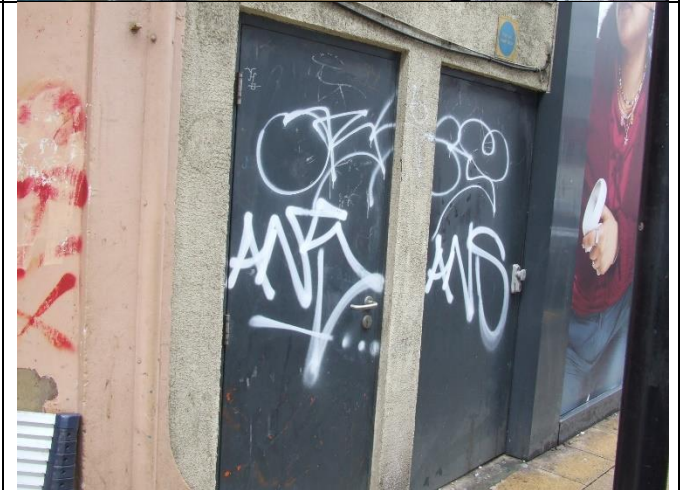
Distress to the main entrance to the office suites is in need of repair, decoration and tidying up

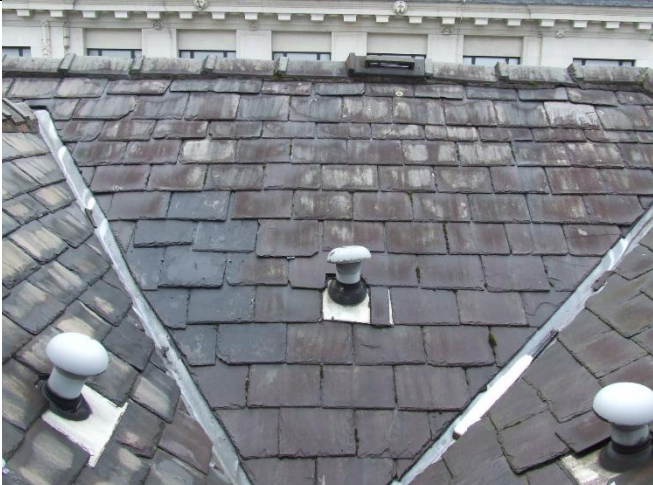
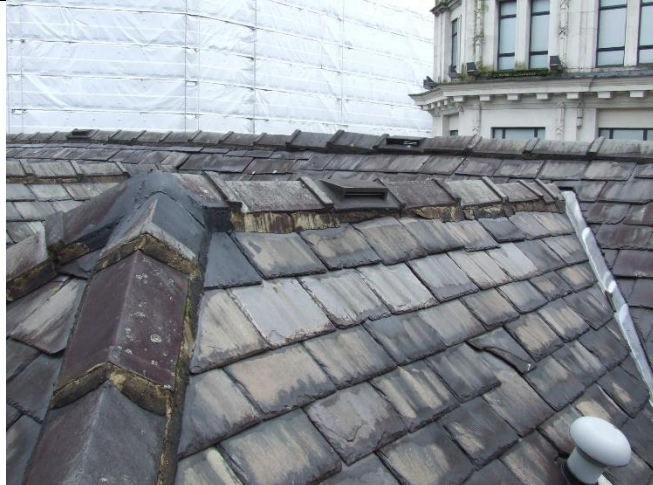
| <p>The natural slate roofing is aged with numerous patches of repair including tingles and some liquid sealants. There are numerous slipped, loose and broken slates generally and the roof is not fitted with a sarking layer below the slate's secondary protection.</p> | | <p>Bedding to ridges and hips is cracked, broken and missing.</p> | |

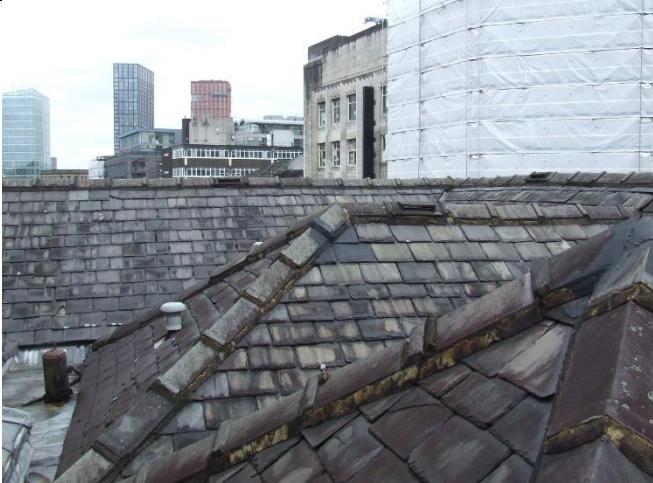
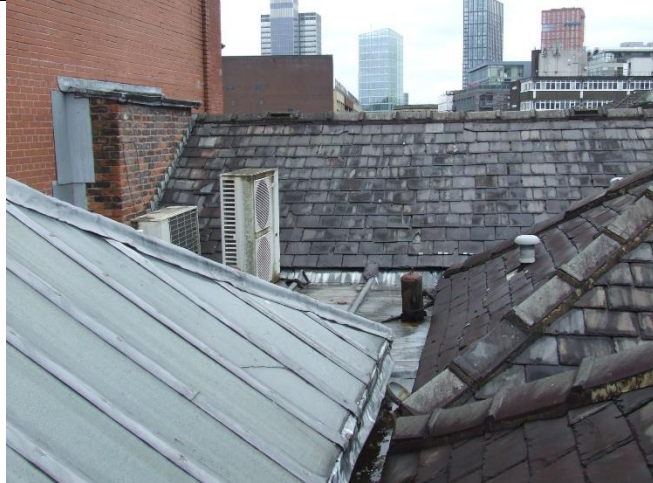
| <p>Bedding to ridges and hips is cracked, broken and missing.</p> | | <p>The lead trims to the patent glazing trim and bar systems are damaged and loose or slipped out and the timber frames are rotten. There are substantial leaks internally.</p> | |

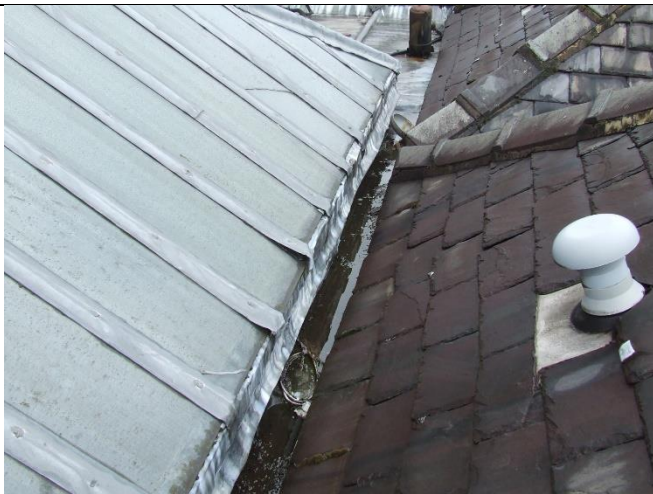
The lead trims to the patent glazing trim and bar systems are damaged and loose or slipped out and the timber frames are rotten. There are substantial leaks internally.

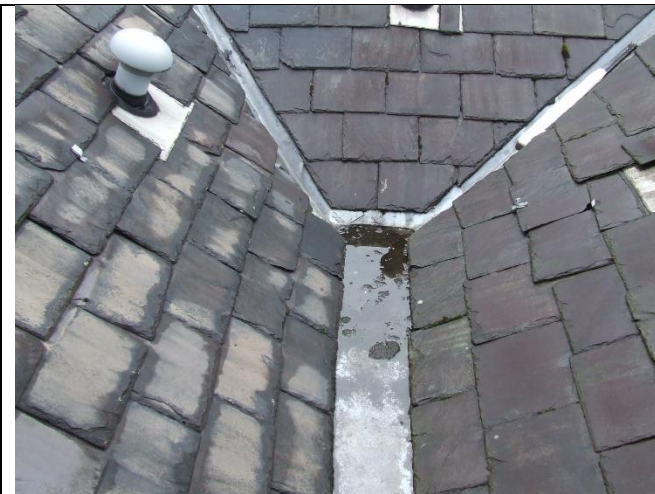
The natural slate roofing is aged with numerous patches of repair including tingles and some liquid sealants. There are numerous slipped, loose and broken slates generally and the roof is not fitted with a sarking layer below the slate's secondary protection.

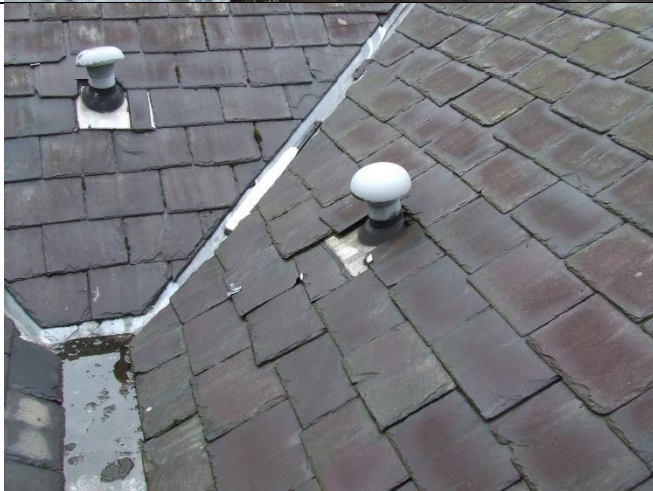
The natural slate roofing is aged with numerous patches of repair including tingles and some liquid sealants. There are numerous slipped, loose and broken slates generally and the roof is not fitted with a sarking layer below the slate's secondary protection.

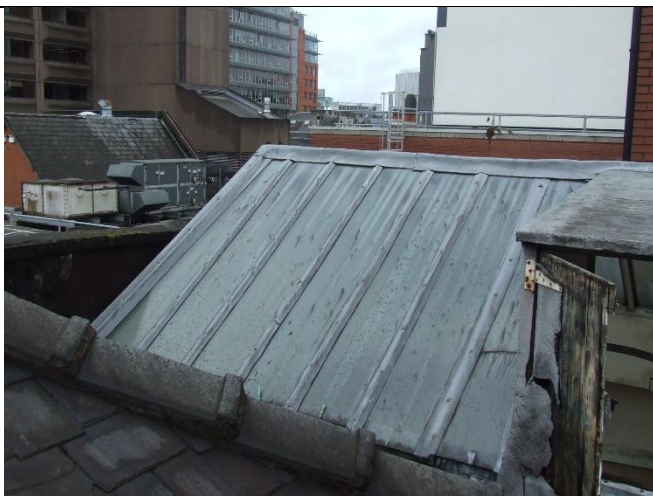
Patent glazing roof light is leaking with rot in the frame and aged and split lead capping's.

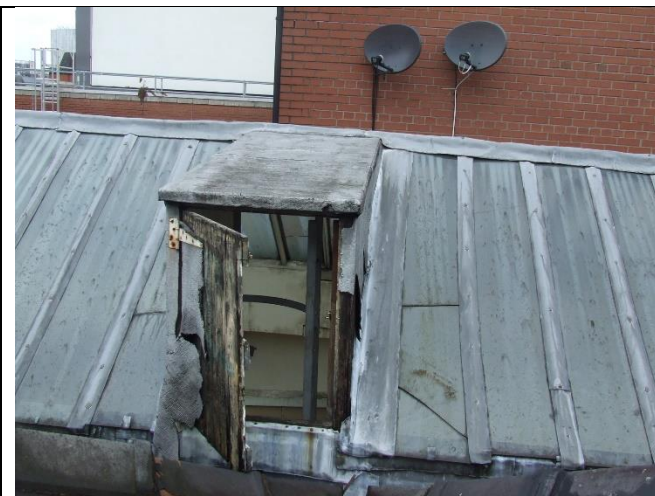
Distressed timbers to the roof access hatch. Lead and membrane roof and cheeks to access hatch distressed.

Broken glazed panes.

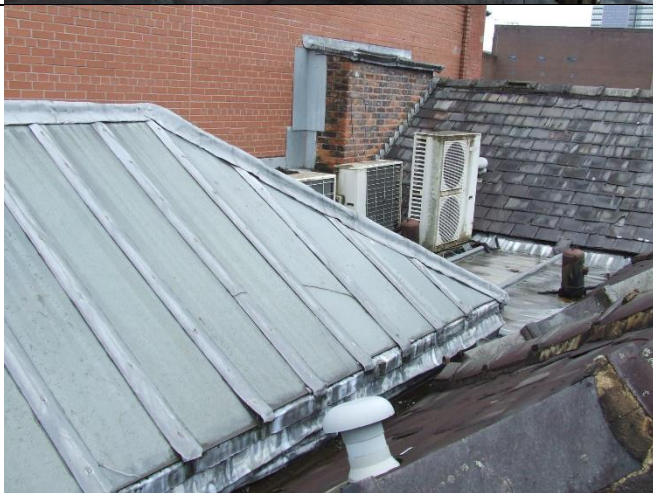
Patent glazing roof light is leaking with rot in the frame and aged and split lead capping's.

Broken glazed panes.

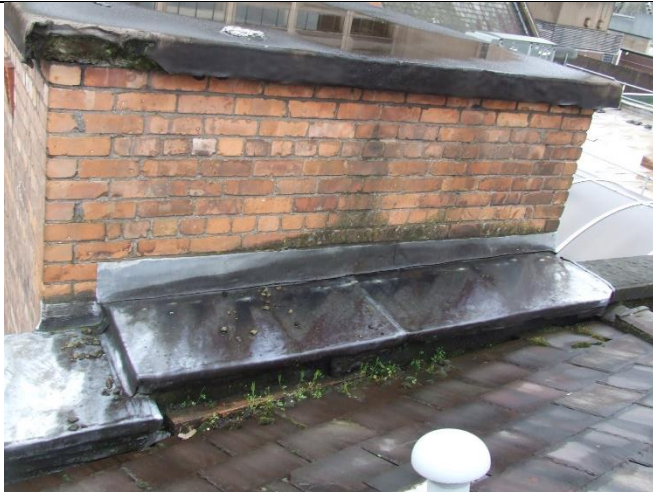
Triama nd parapet stop distressed and aged and with evidence of leaks below.

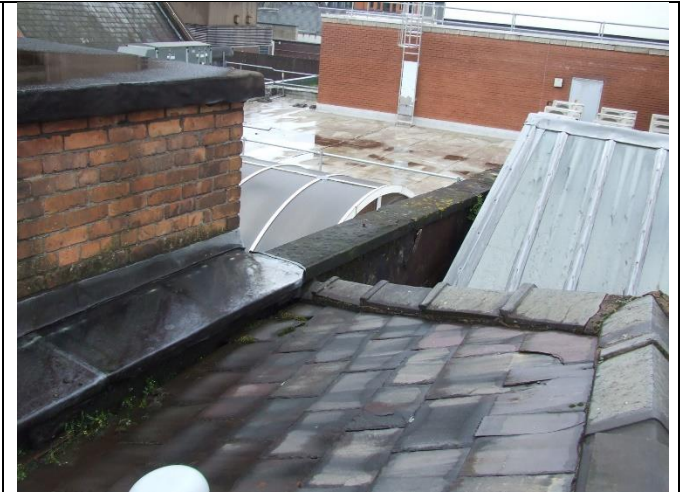
Bedding to ridges and hips is cracked, broken and missing.

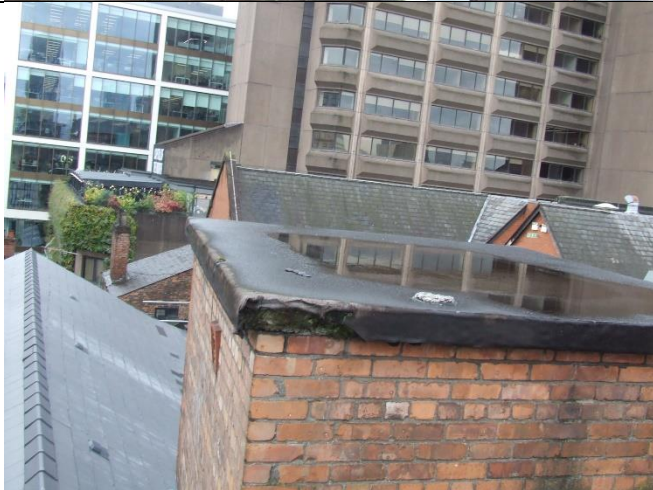
Damaged and leaking asphalt roof topping to the plant room.

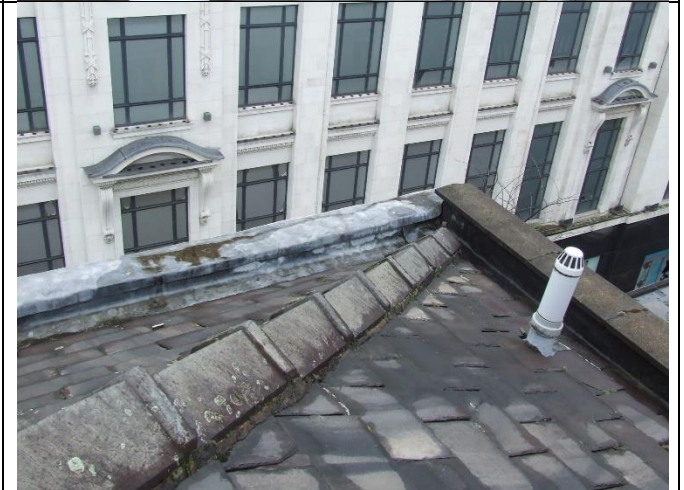
Bedding to ridges and hips is cracked, broken and missing.

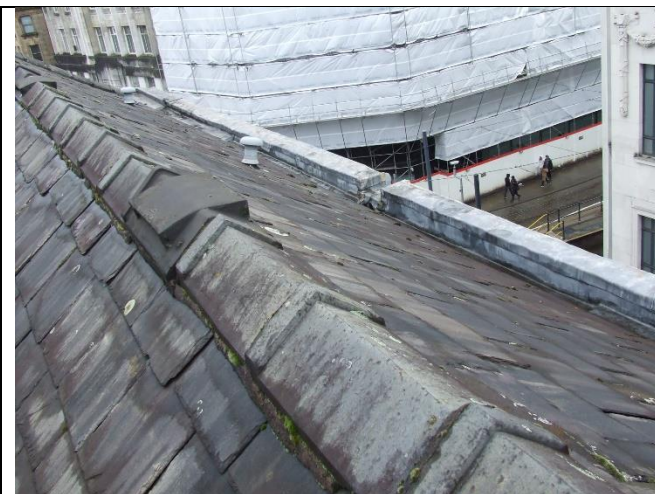
Bedding to ridges and hips is cracked, broken and missing.

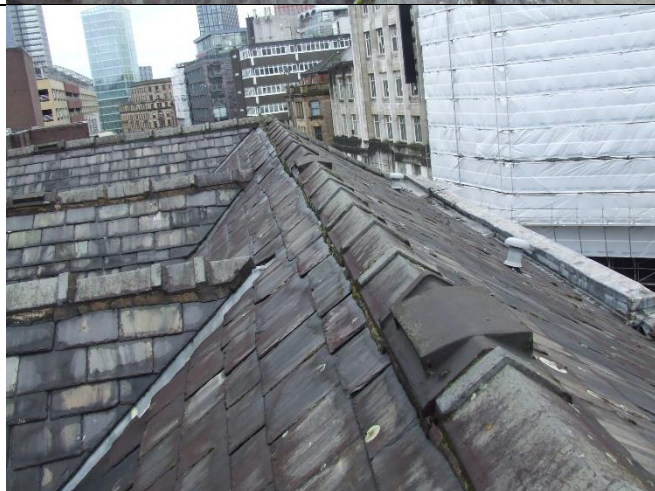
The natural slate roofing is aged with numerous patches of repair including tingles and some liquid sealants. There are numerous slipped, loose and broken slates generally and the roof is not fitted with a sarking layer below the slate's secondary protection.

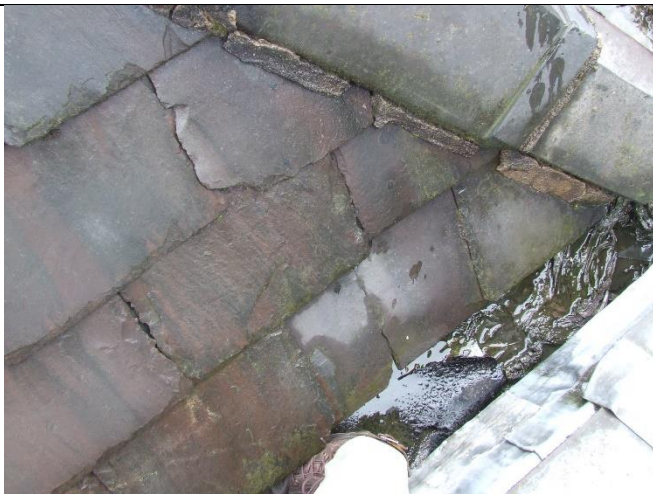
Internal valley gutters or aged with old and with split lead linings which are currently leaking. Internal gutters are also overflowing and substantially blocked with debris, common weeds and silt.

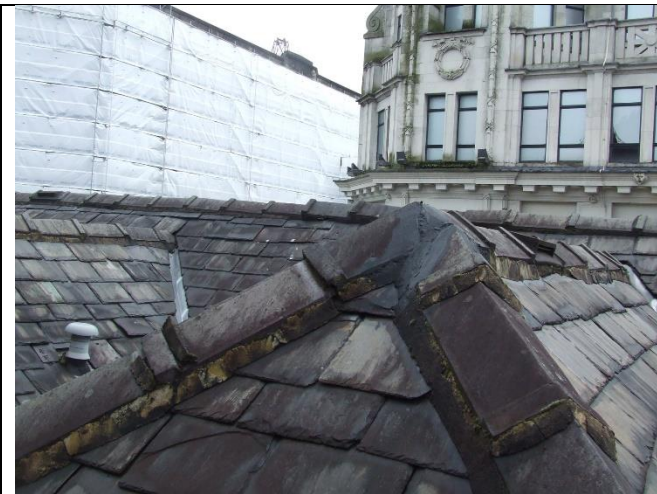
The natural slate roofing is aged with numerous patches of repair including tingles and some liquid sealants. There are numerous slipped, loose and broken slates generally and the roof is not fitted with a sarking layer below the slate's secondary protection.

Bedding to ridges and hips is cracked, broken and missing.

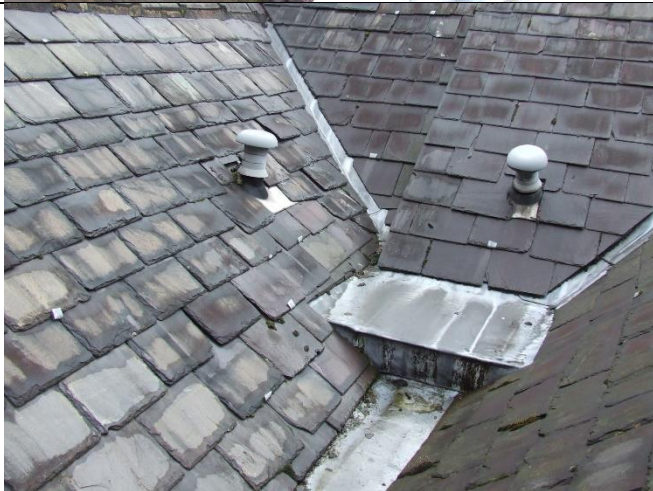
The natural slate roofing is aged with numerous patches of repair including tingles and some liquid sealants. There are numerous slipped, loose and broken slates generally and the roof is not fitted with a sarking layer below the slate's secondary protection.

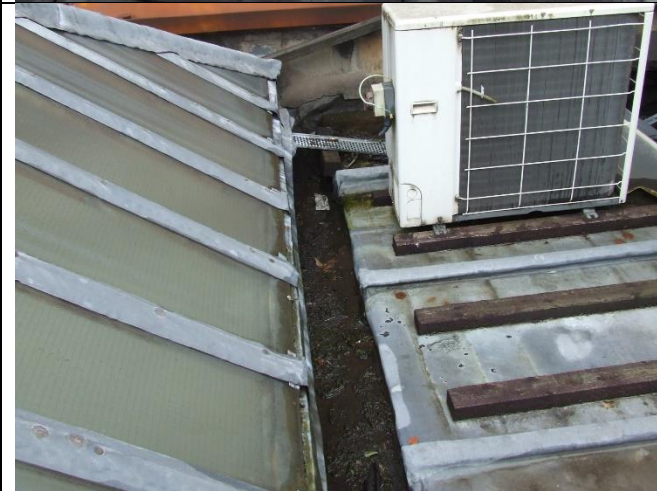
The lead trims to the patent glazing trim and bar systems are damaged and loose or slipped out and the timber frames are rotten. There are substantial leaks internally.

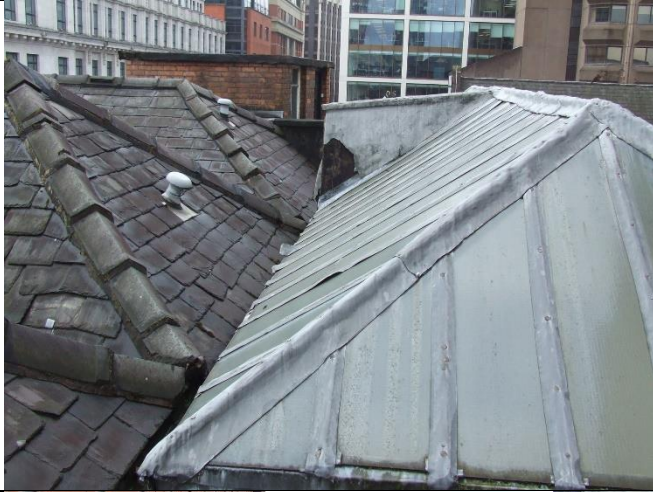
The lead trims to the patent glazing trim and bar systems are damaged and loose or slipped out and the timber frames are rotten. There are substantial leaks internally.

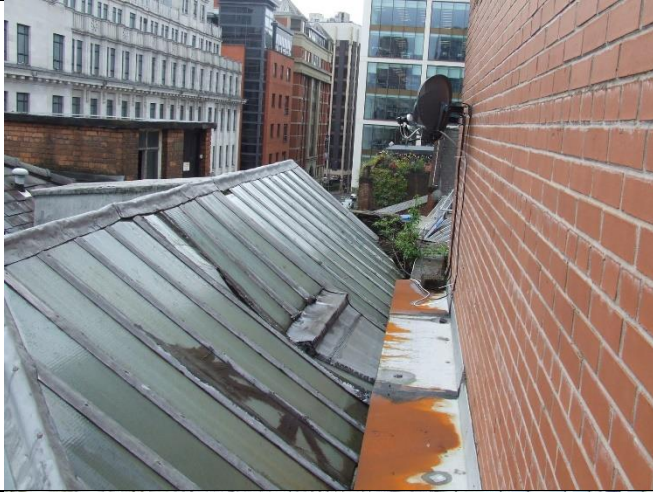
The lead trims to the patent glazing trim and bar systems are damaged and loose or slipped out and the timber frames are rotten. There are substantial leaks internally.

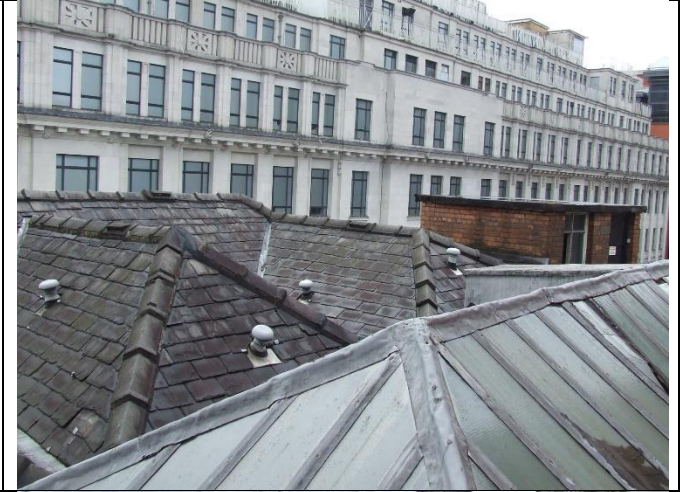
The lead trims to the patent glazing trim and bar systems are damaged and loose or slipped out and the timber frames are rotten. There are substantial leaks internally.

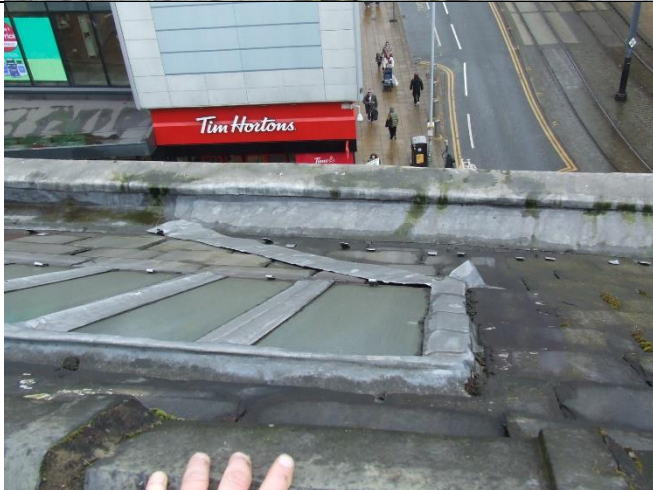
The lead trims to the patent glazing trim and bar systems are damaged and loose or slipped out and the timber frames are rotten. There are substantial leaks internally.

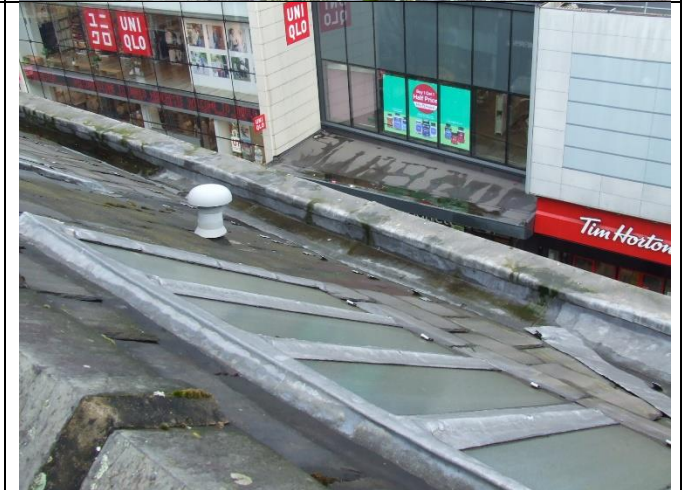
The lead trims to the patent glazing trim and bar systems are damaged and loose or slipped out and the timber frames are rotten. There are substantial leaks internally.

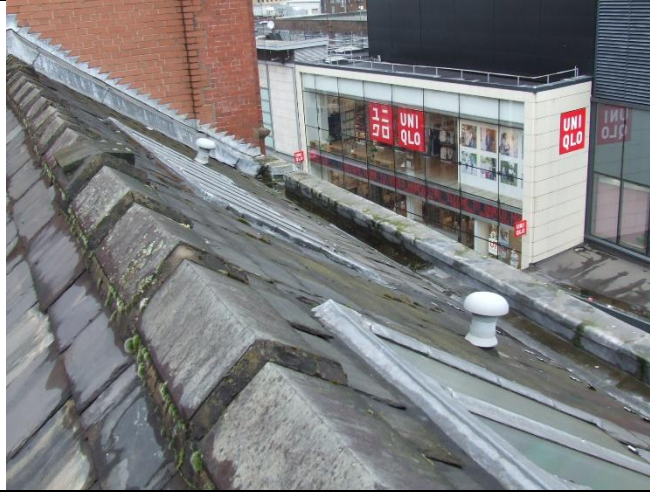
The lead and membrane linings to the parapet gutters appears to be distressed. There is evidence of split and damaged leads and numerous liquid patch repairs to the gutters generally.

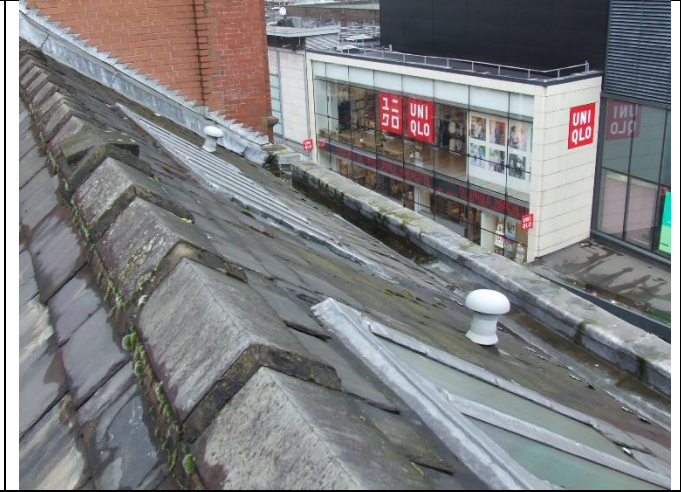
The lead and membrane linings to the parapet gutters appears to be distressed. There is evidence of split and damaged leads and numerous liquid patch repairs to the gutters generally.

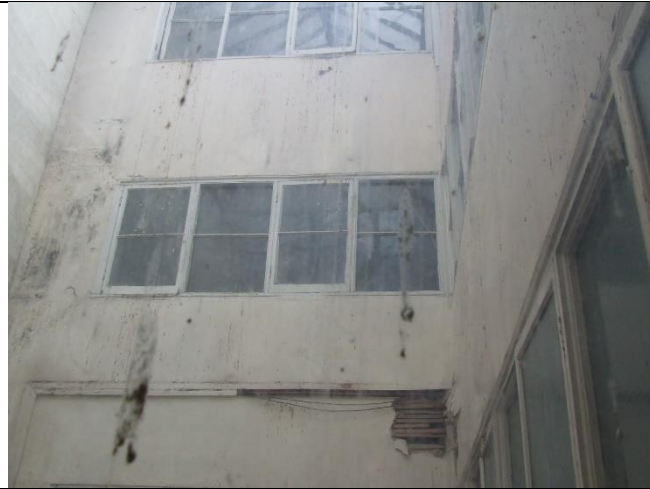
The internal lightwell is suffering from water ingress distress in the plasters, renders and timber joinery.

The patent glazed roof light above is leaking.

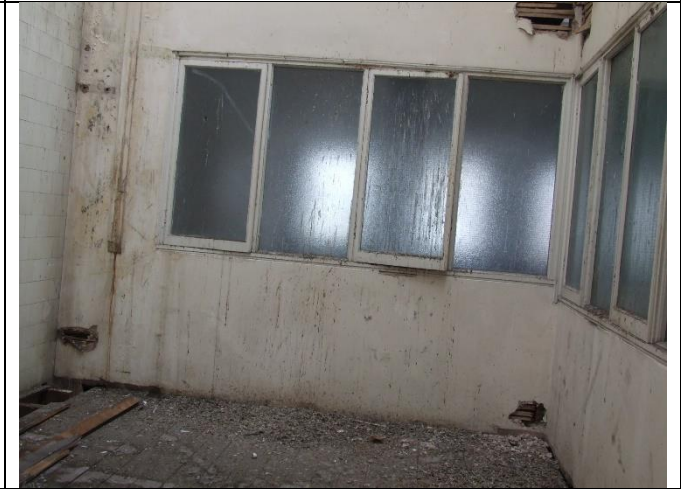
The internal lightwell is suffering from water ingress distress in the plasters, renders and timber joinery.

The patent glazed roof light above is leaking.

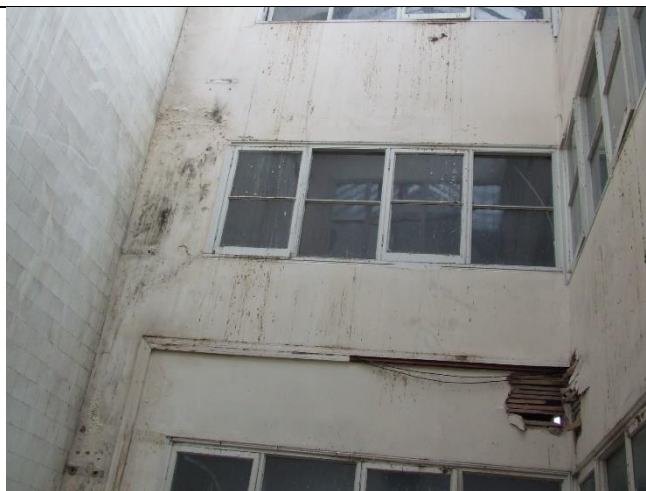
Water ingress  
damage generally  
from roof leaks.

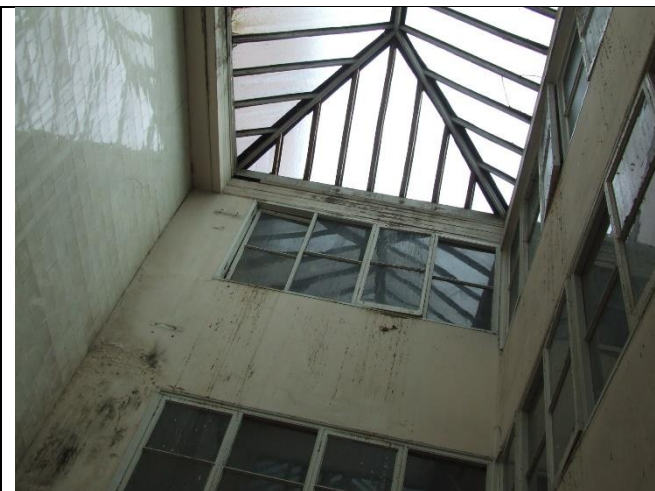
The internal lightwell is  
suffering from water  
ingress distress in the  
plasters, renders and  
timber joinery.

The patent glazed roof  
light above is leaking.

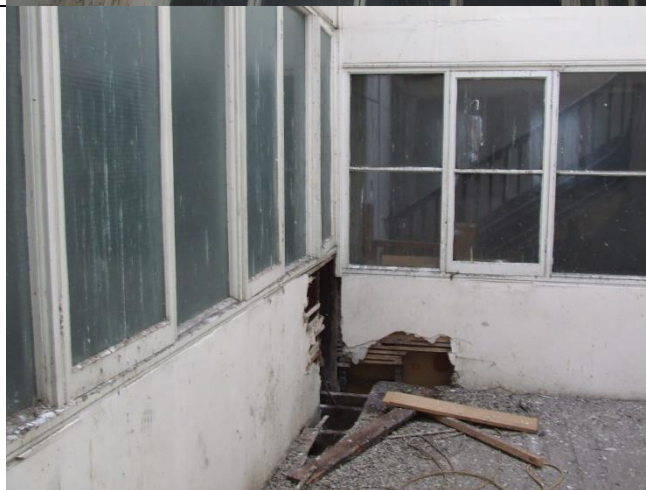
Water ingress  
damage generally  
from roof leaks.

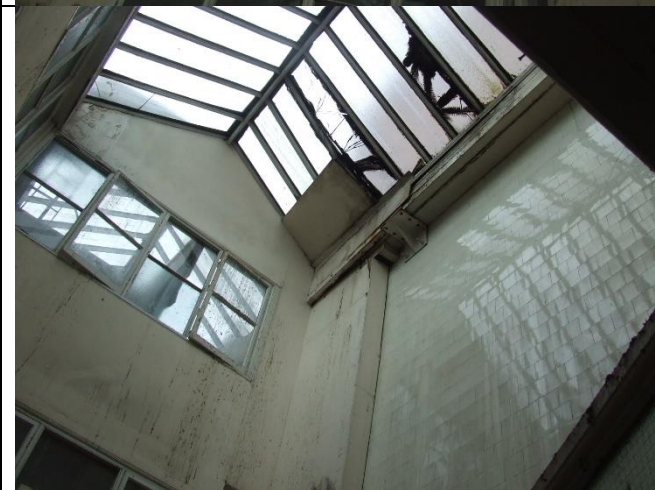
Water ingress damage  
generally from roof leaks.

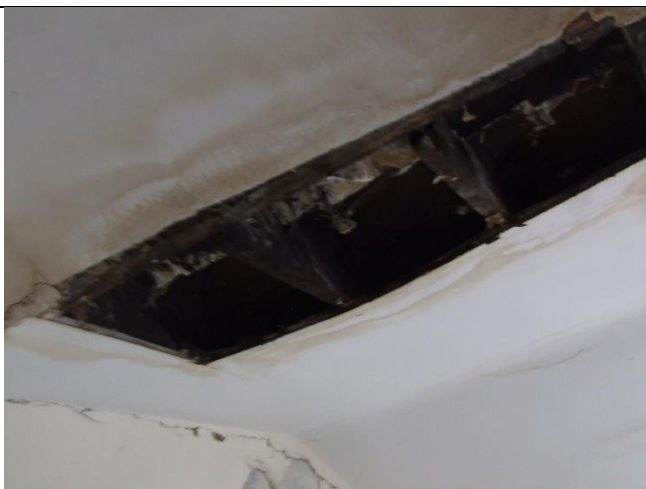
Damaged finishes, plaster work, timber window frames and ceiling systems as a result of parapet gutter leaks and roof leaks generally.

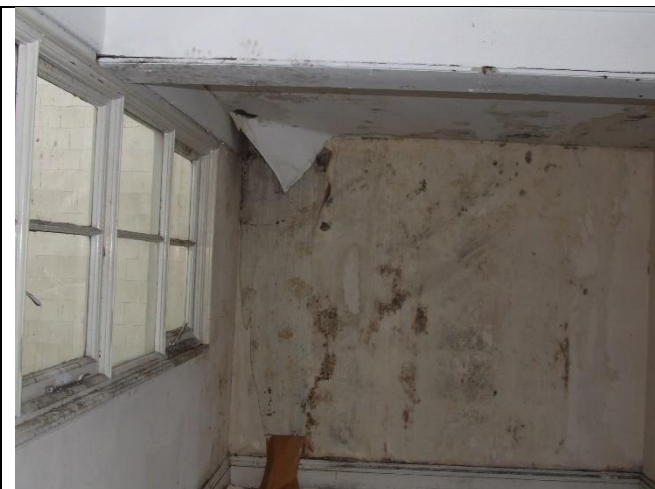
Damaged finishes, plaster work, timber window frames and ceiling systems as a result of parapet gutter leaks and roof leaks generally.

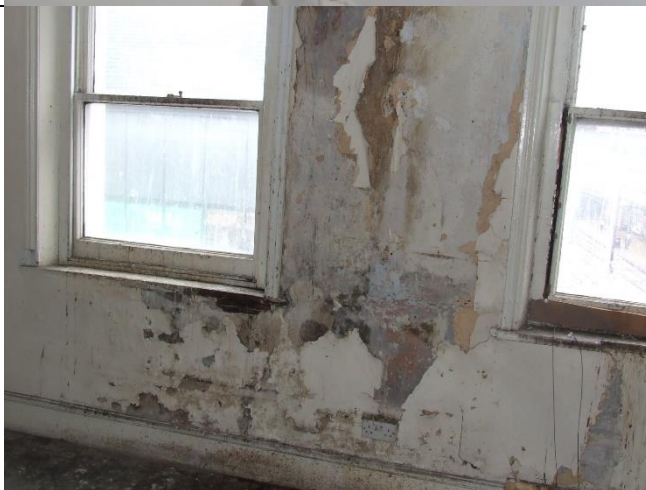
Damaged finishes, plaster work, timber window frames and ceiling systems as a result of parapet gutter leaks and roof leaks generally.

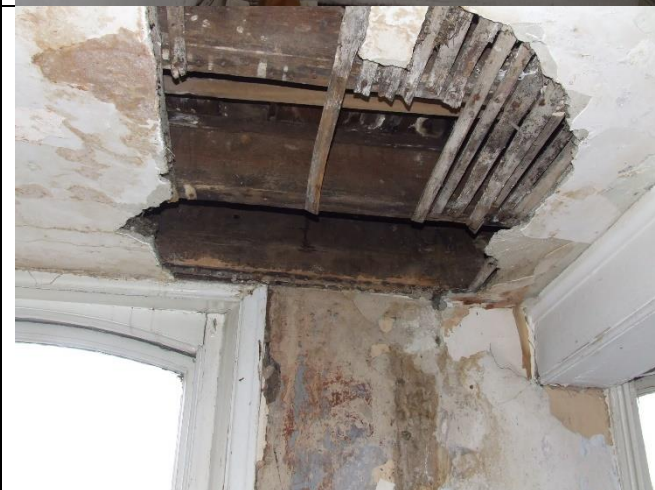
Damaged finishes, plaster work, timber window frames and ceiling systems as a result of parapet gutter leaks and roof leaks generally.

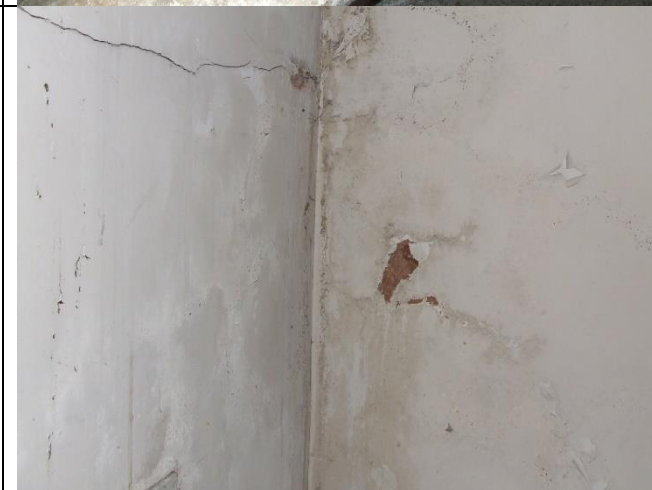
Water ingress damage generally from roof leaks.

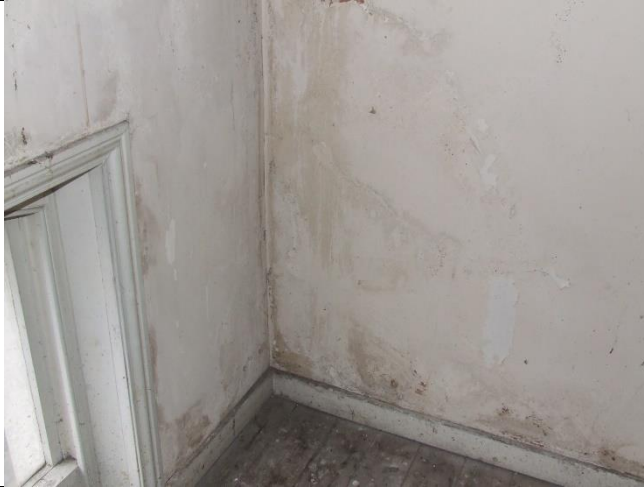
Water ingress damage generally from roof leaks.

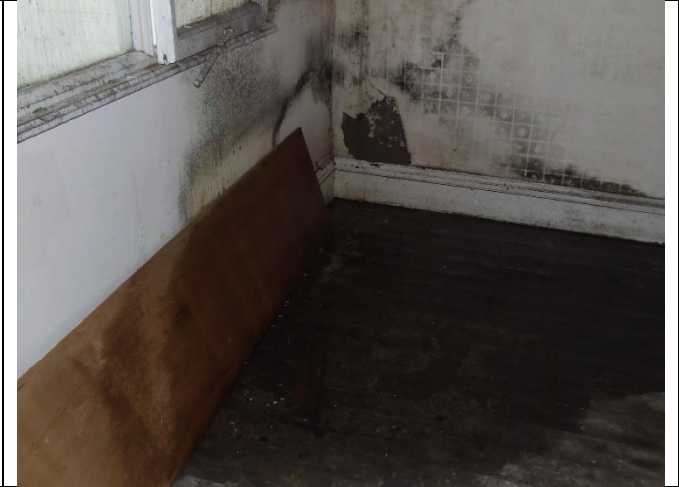
Water ingress damage generally from roof leaks.

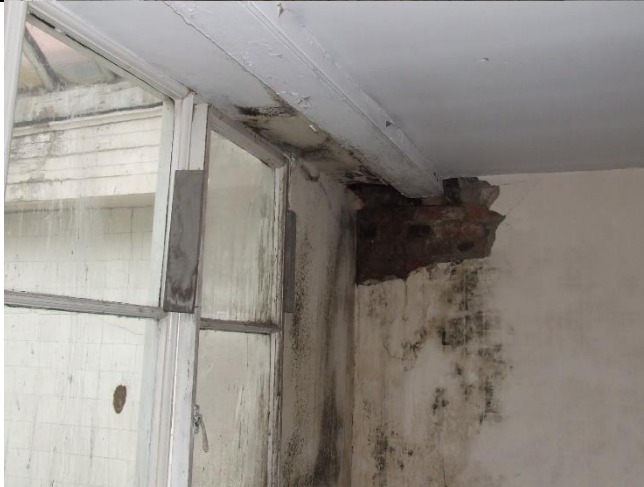
Water ingress damage generally from roof leaks.

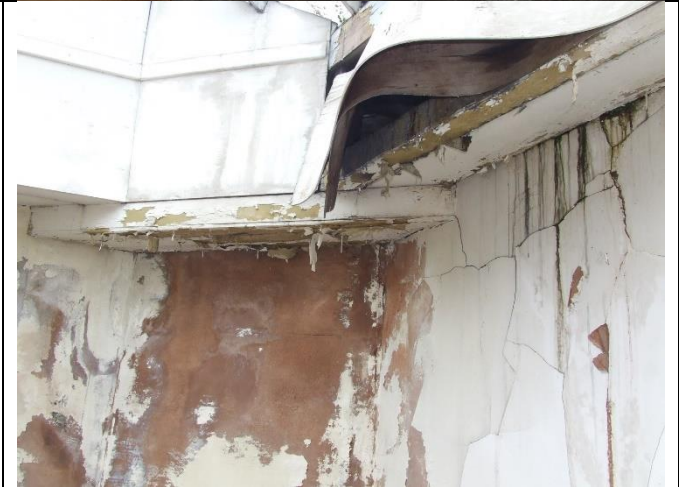
Water ingress damage generally from roof leaks.

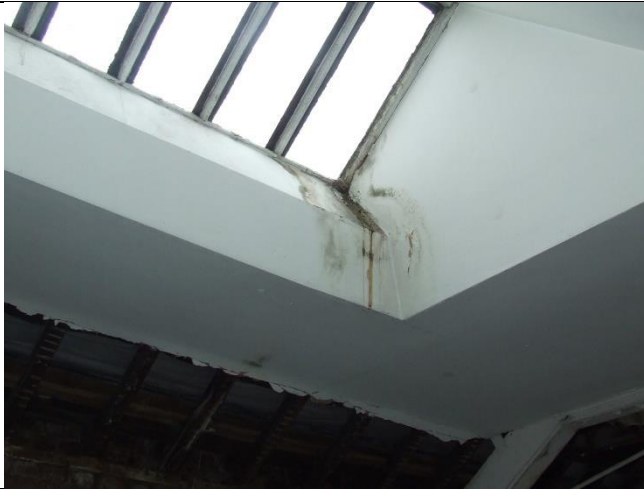
Water ingress damage generally from roof leaks.

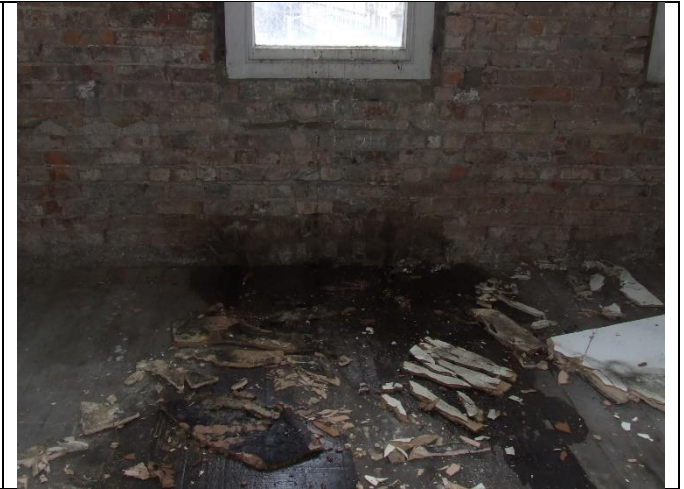
Water ingress damage generally from roof leaks.

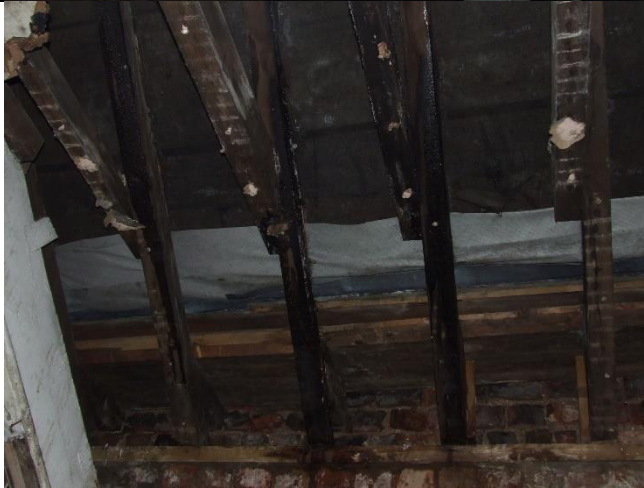
Water ingress damage generally from roof leaks.

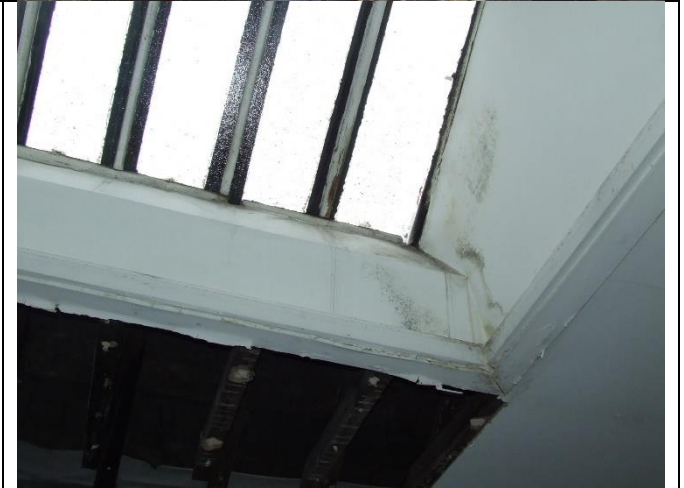
Water ingress damage generally from roof leaks.

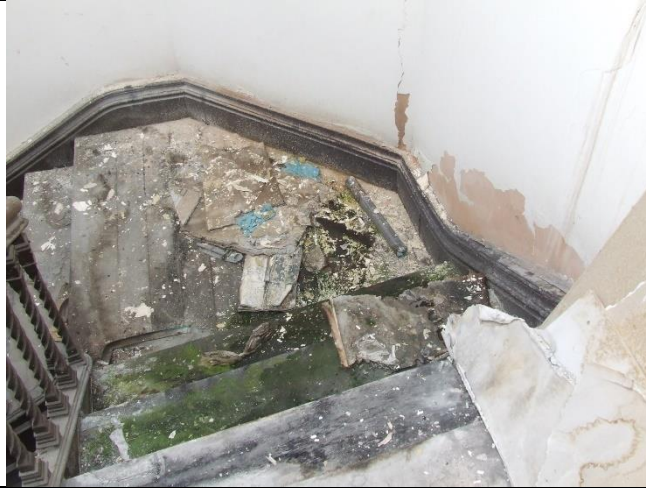
Water ingress  
damage generally  
from roof leaks.
