Client  
The National Trust

Project Title  
Castlefield Viaduct  
Phase 2

Drawing Title  
Remedials  
Lattice Girders  
Top & Bottom Chords

| ID | CVI-ARUP-ZZ-ZZ-DR-S-4014 | | |

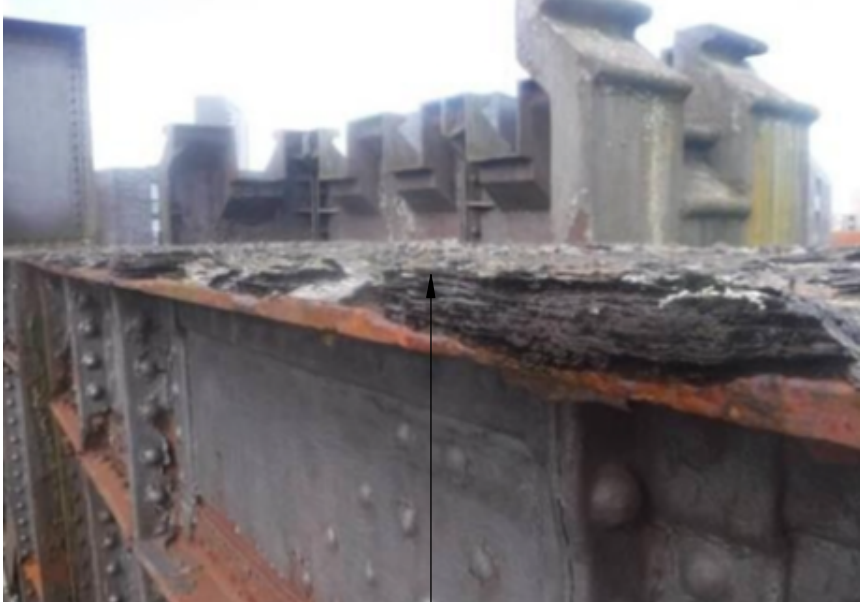
Example 1  
- Span 5, north truss

Corrosion product to top of top flange

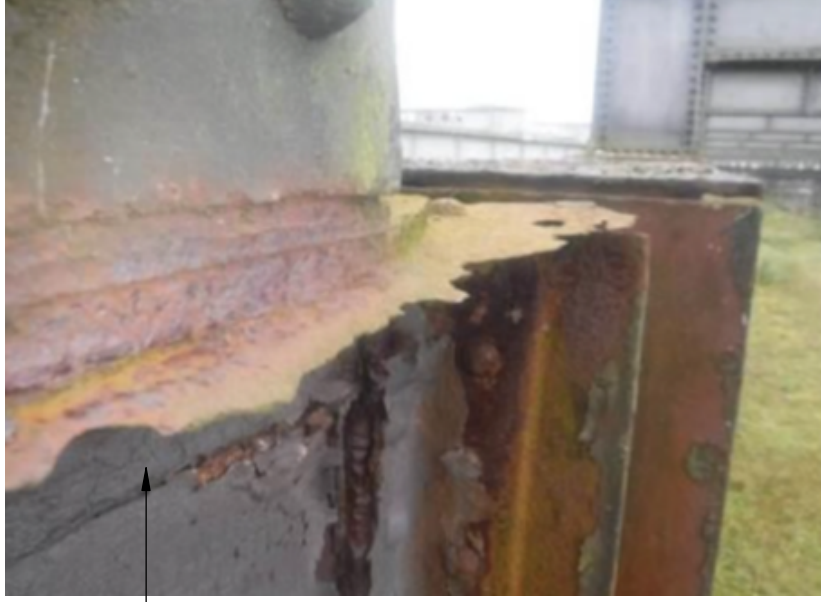
Example 2  
- Span 4, south truss

Loss of section at inner top flange, at support

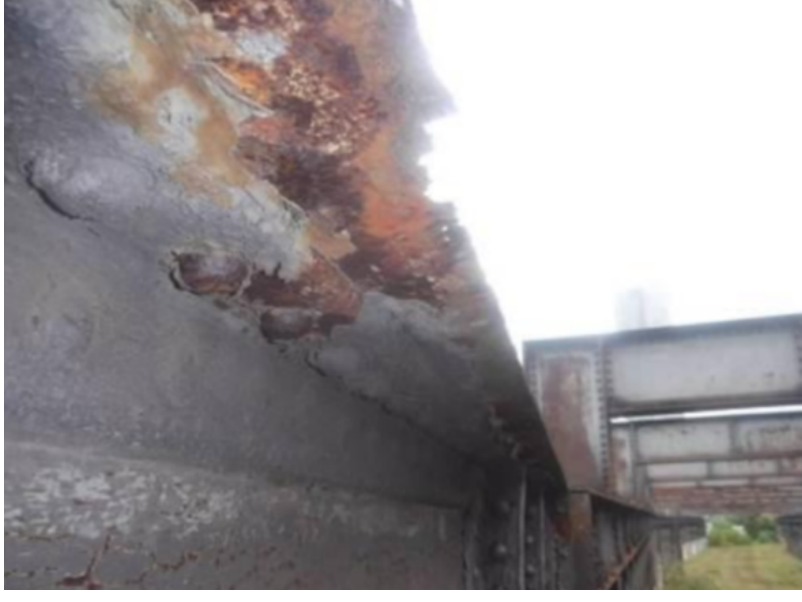
Example 3  
- Span 4, north truss

External stiffener

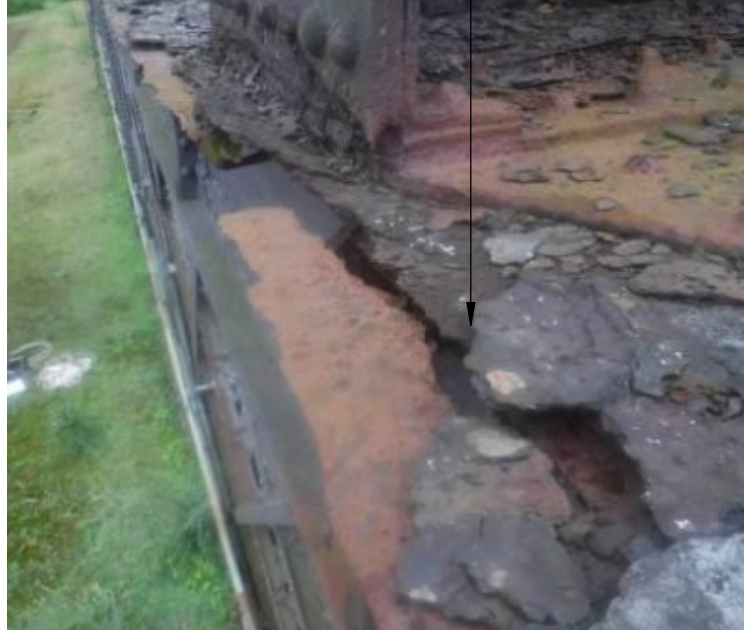
Example 4  
- Span 2, south truss

Loss of section and loose material

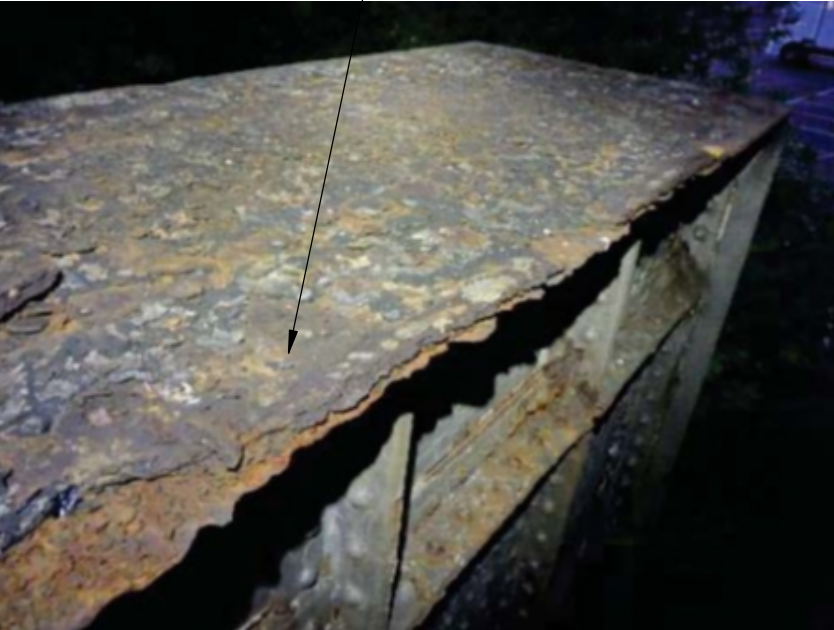
Example 5  
- Span 1, south truss

Loss of section, knife edging, spiked rivets

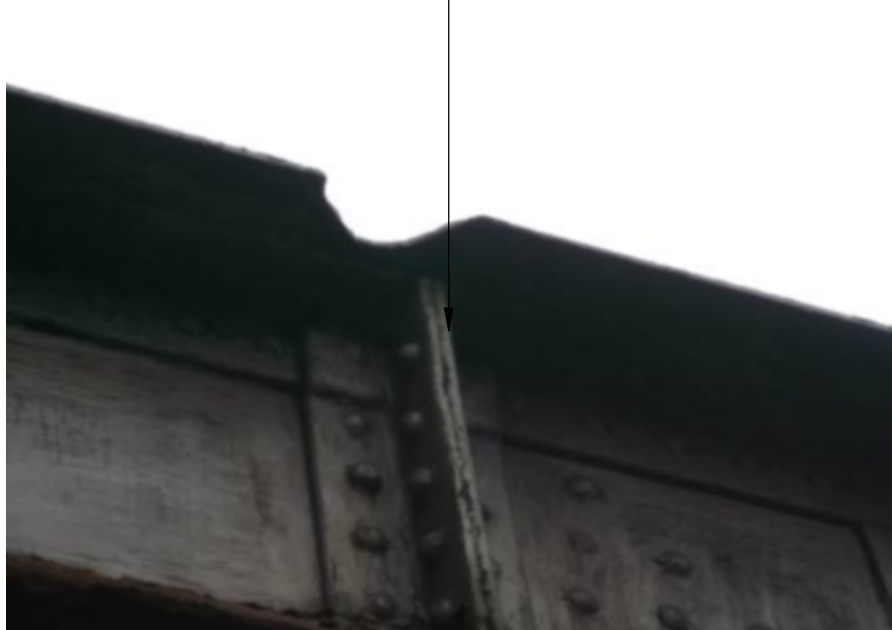
Example 6  
- Span 6, north truss

External stiffener

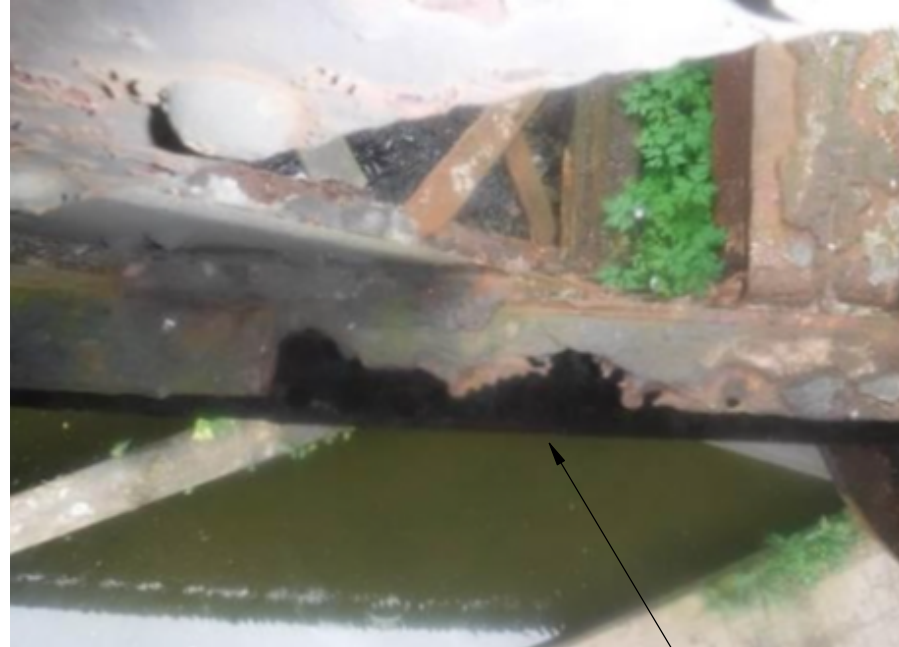
Example 1  
- Span 3, south truss

Loss of section to chord flange

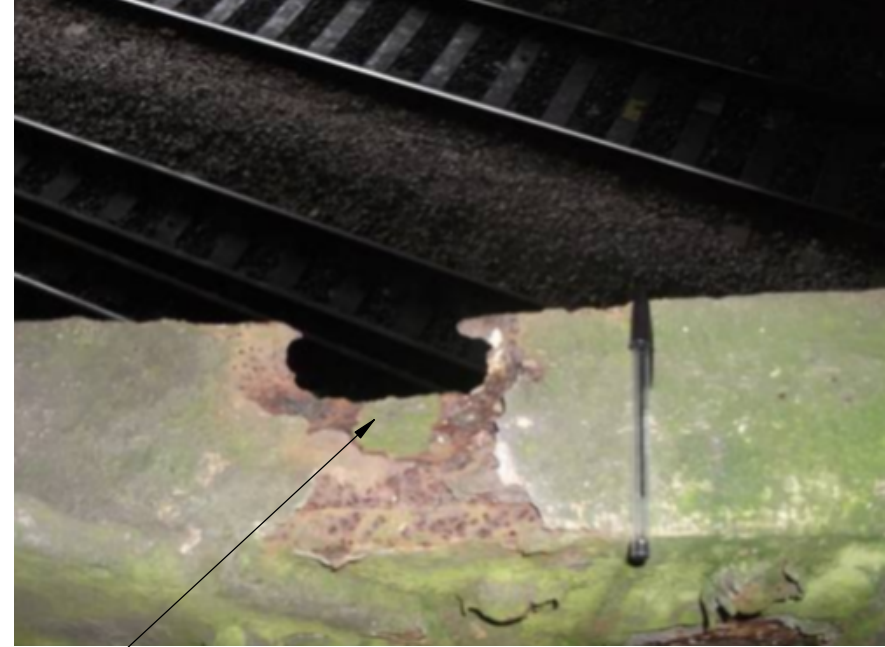
Example 2  
- Span 1, south truss

Loss of section to chord flange

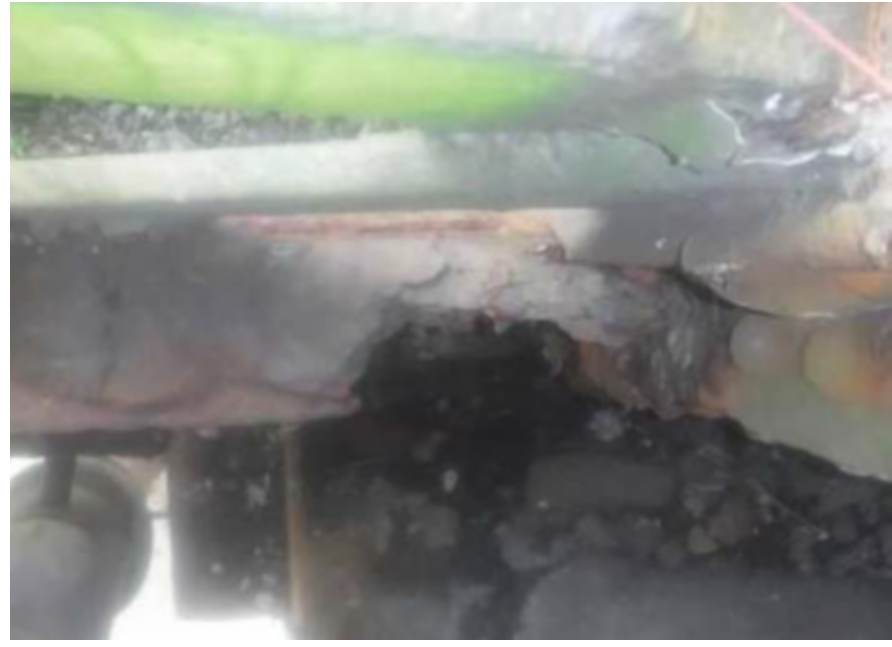
Example 3  
- Span 4, south truss

Loss of section to bottom flange

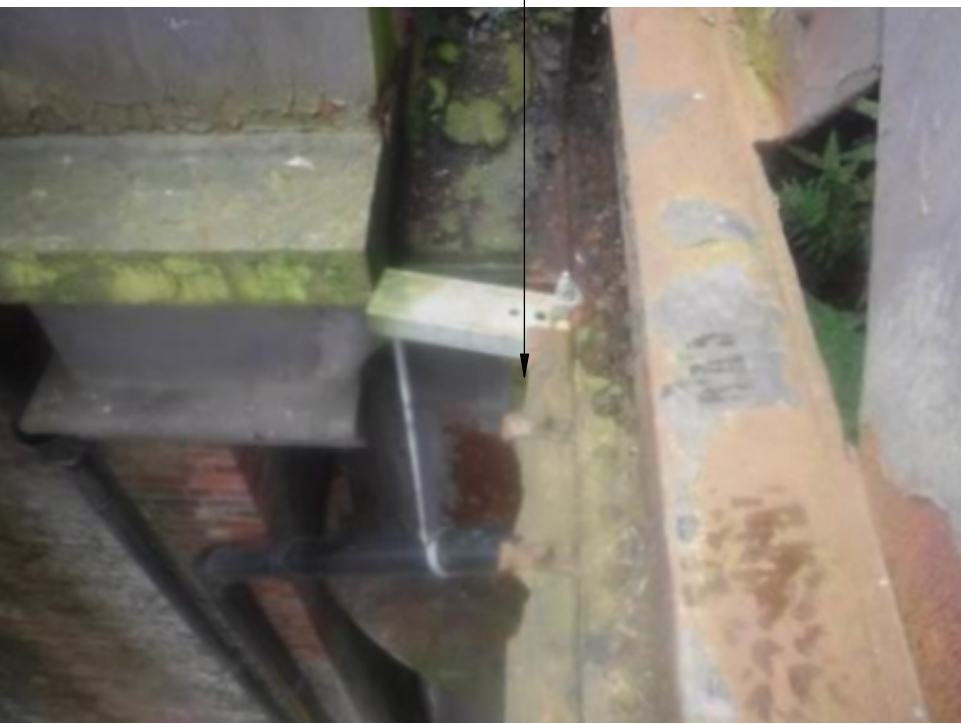
Example 4  
- Span 7, south truss

Loss of section to bottom flange

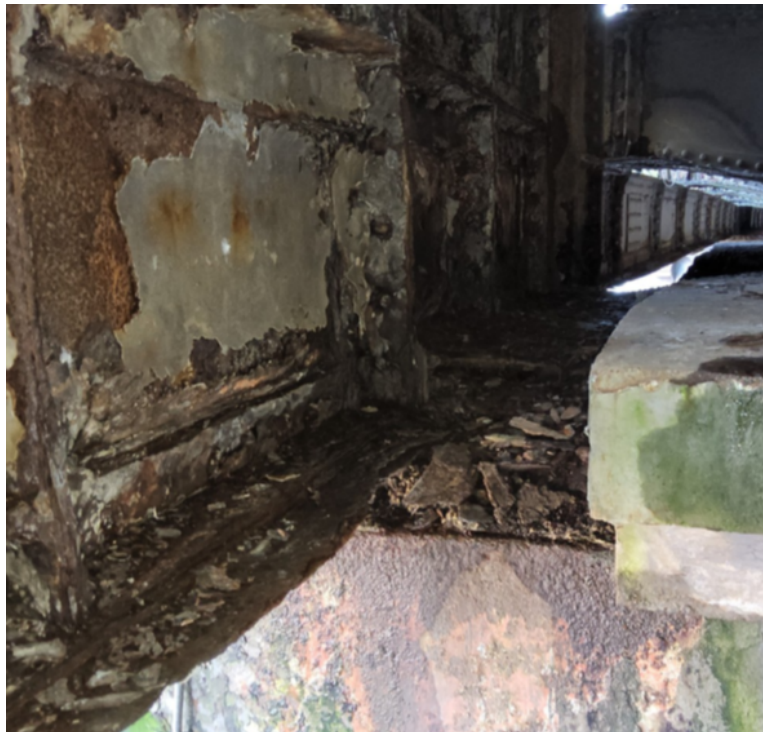
Example 5  
- Span 3, north truss

Loss of section to bottom flange

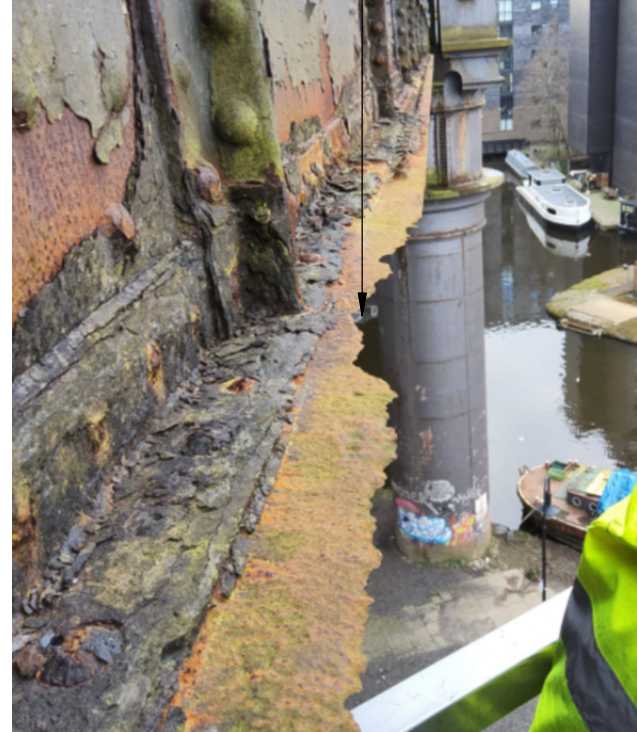
Example 6  
- Span 4, north truss

Loss of section to bottom flange
