**Project**

**Project Name:** Russell Road  
**Project Description:** CCTV Survey  
**Project Number:** 23343  
**Project Status:** Complete  
**Project Date:** 13/12/2024  
**Inspection Standard:** MSCC5 Sewers & Drainage GB (SRM5 Scoring)

## Section Inspection - 13/12/2024 - MH 25X

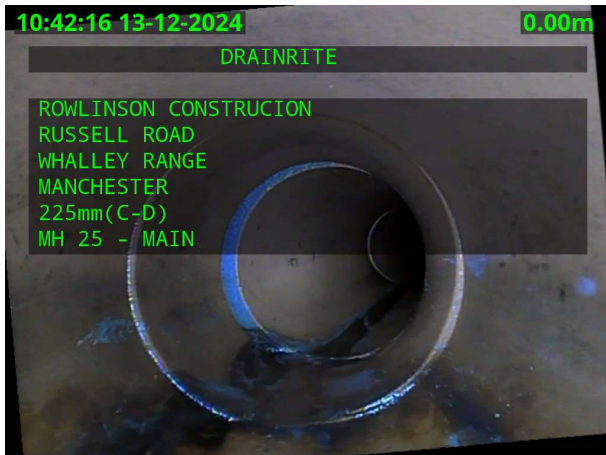
MH  
25X\_88bd38b9-748d-4684-a8e0-00284db91ae9\_20241213\_1  
31702\_630.jpg, 0.00 m  
Water level, 0% of the vertical dimension

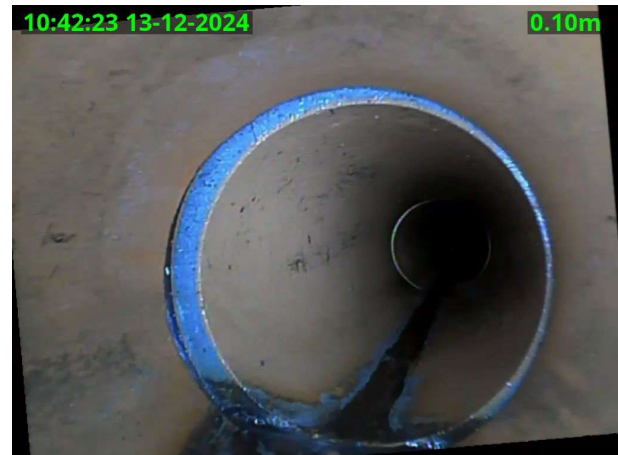
| Section | PLR | Grade | Description |
|---|---|---|---|
| 1 | MH 25X | 3 | Joint displaced, medium |

MH  
25X\_f5a04bc5-c807-455a-9cfc-f273a1b82d66\_20241213\_131  
736\_616.jpg, 00:00:12, 0.10 m  
Joint displaced, medium

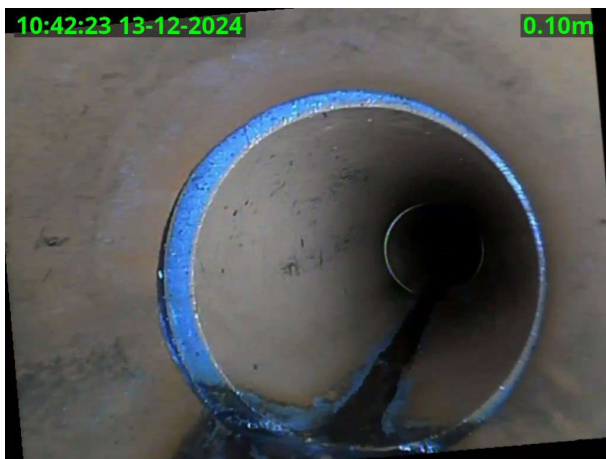
MH  
25X\_c25be6f0-a5b6-48f4-ac28-247a3d333981\_20241213\_13  
1802\_748.jpg, 00:00:12, 0.10 m  
Line deviates right

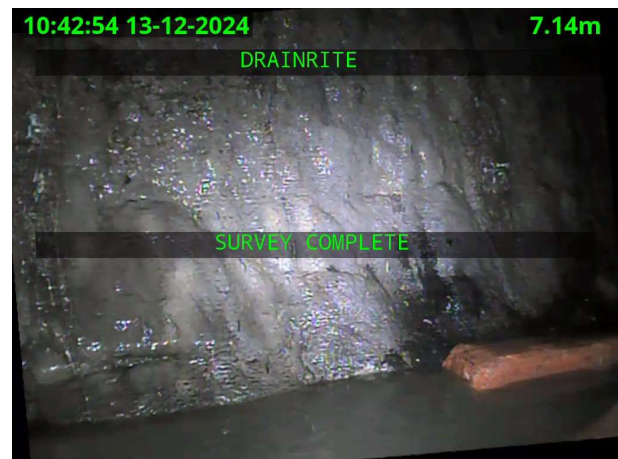
MH  
25X\_18025c35-1e8a-446b-a412-240a4fc0d8b0\_20241213\_13  
1905\_379.jpg, 00:00:43, 7.14 m  
Finish node, manhole, reference: MAIN

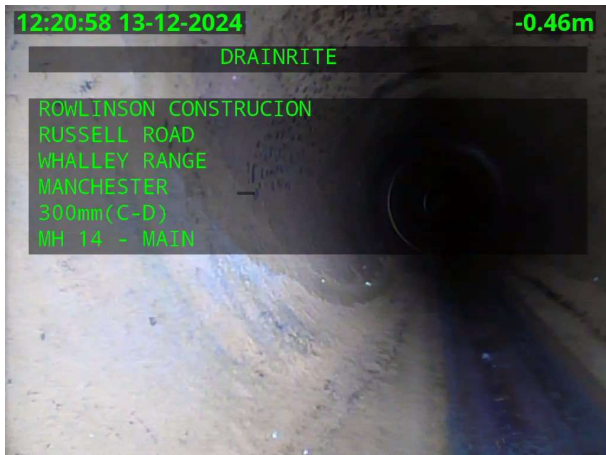
MH  
 14X\_065e9c99-63dc-40ba-a226-db2774414a60\_20241213\_1  
 32147\_427.jpg, 0.00 m  
 Water level, 0% of the vertical dimension

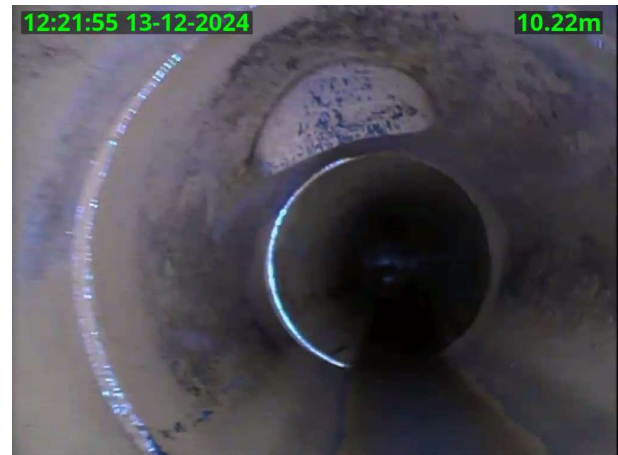
MH  
 14X\_96301134-c358-4c4a-b97f-c43d5f708b58\_20241213\_13  
 2617\_984.jpg, 00:00:59, 0.00 m  
 Junction at 11 o'clock, 150mm dia

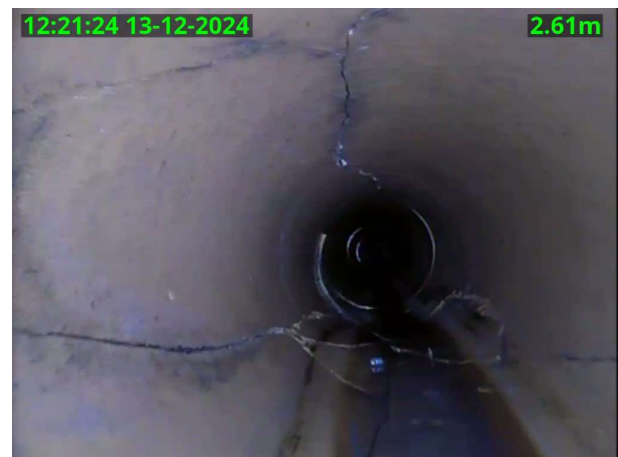
| Section | PLR | Grade | Description |
|---|---|---|---|
| 2 | MH 14X | 4 | Fractures, multiple from 12 o'clock to 12 o'clock |

| Scale: | 1:149 | Position [m] | Code | Observation | MPEG | Photo | Grade |
|---|---|---|---|---|---|---|---|
| | 2.77 | FM | Fractures, multiple from 12 o'clock to 12 o'clock | 00:00:29 | | MH<br>14X_b49e<br>79ca-91c7 | 4 / 2 |

MH  
 14X\_b49e79ca-91c7-4a55-a4d0-64c3836b8e3e\_20241213\_1  
 32359\_309.jpg, 00:00:29, 2.61 m  
 Fractures, multiple from 12 o'clock to 12 o'clock

Grade 4: Best practice suggests consideration should be given to repairs to avoid a potential collapse.

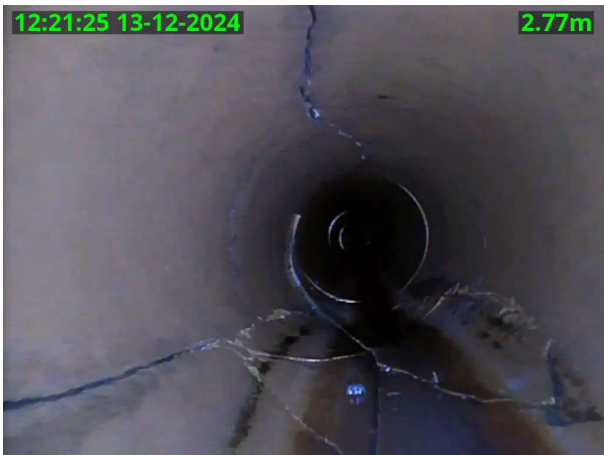
| Scale: | 1:149 | Position [m] | Code | Observation | MPEG | Photo | Grade |
|---|---|---|---|---|---|---|---|
| | | D | Deformed sewer or drain, 5% | 00:00:29 | | MH<br>14X_625b<br>cc0b-507e | 2 / 2 |

MH  
 14X\_625bcc0b-507e-4196-946c-ad69b5581467\_20241213\_1  
 32410\_047.jpg, 00:00:29, 2.77 m  
 Deformed sewer or drain, 5%

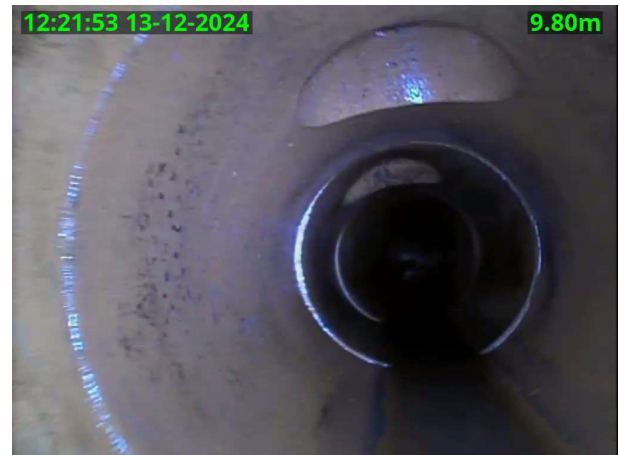
MH  
 14X\_b6d000e5-2370-4220-87f3-02461de9b09d\_20241213\_1  
 32520\_770.jpg, 00:00:57, 9.80 m  
 Junction at 12 o'clock, 150mm dia

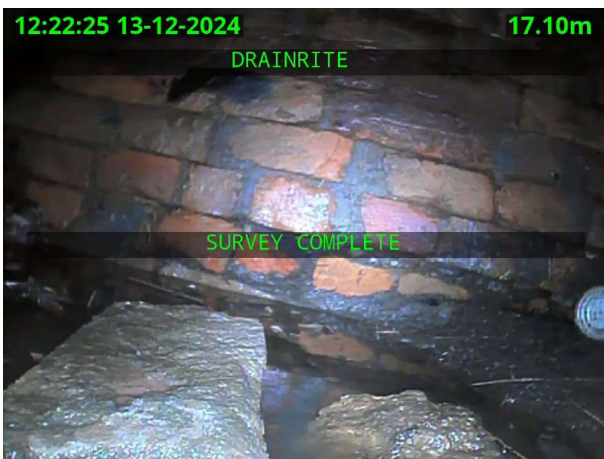
MH  
 14X\_e907fa0c-6733-493b-bab0-421952fc6e6e\_20241213\_13  
 2940\_886.jpg, 00:01:29, 17.10 m  
 Finish node, manhole, reference: MAIN
