**Approval of details reserved by a condition (discharge)**

Address: Chorlton District Library, Manchester Road, Chorlton, Manchester, M21 9PN

Reference: PP-13082579

**The Application is made in connection with application number: 134349/LO/2022**

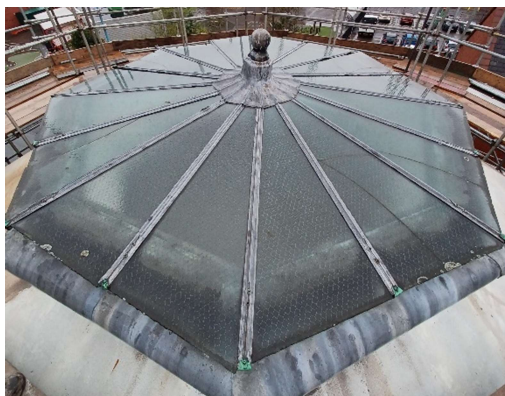
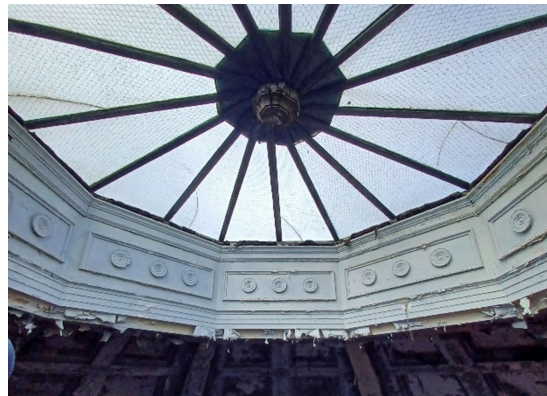
When the roof lantern was first viewed from below, before scaffold was erected for access, it was agreed that 9 pairs of cracked glazing needed to be replaced. However, upon closer inspection it was found the roof lantern was in far worse condition than initially thought including the leadwork, timber finial and glazing bars.

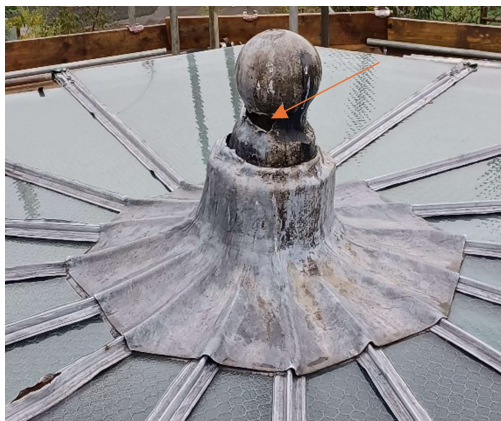
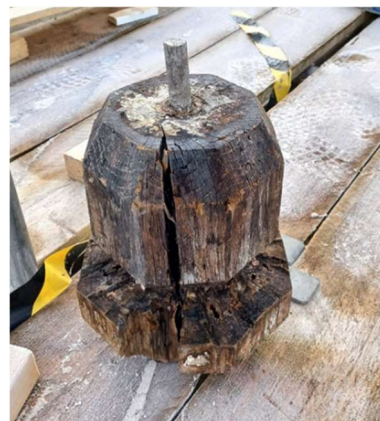
A hole was found in the leadwork ball causing damage and rot to the timber finial below.

Danish oil-soaked oak finial base including a stainless spigot inside to reattach the original ball top following the installation. Code 5 lead is to be used to cover the finial including a skirt flashing extending down over the top of the glazing bars.

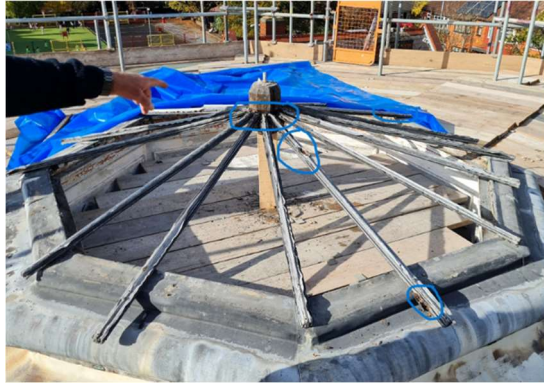
A number of corroded glazing bars were viewed on site where repairs are required to make them structurally sound again. Many others were found to be quite rusty but had not yet expanded enough to split the lead covers. As the glazing bars are an important structural element of the roof lantern and could pose a possible H&S concern given their condition, they were carefully removed from site and surveyed more closely. Please refer to the Condition Report of the glazing bars - 652 CHORLTON LIBRARY ROOF LIGHT.

Right - Picture of a corroded glazing bar extracted from the Condition Report

Following a review of the condition report it was decided to strip, blast clean and then make up repairs with weld and insert new iron material where required, then treat all to a full quality paint system (grey) before returning them to site; the glazing bars are evenly set out to their original positions and screw fix to the ring beam and new oak finial using copper screws.

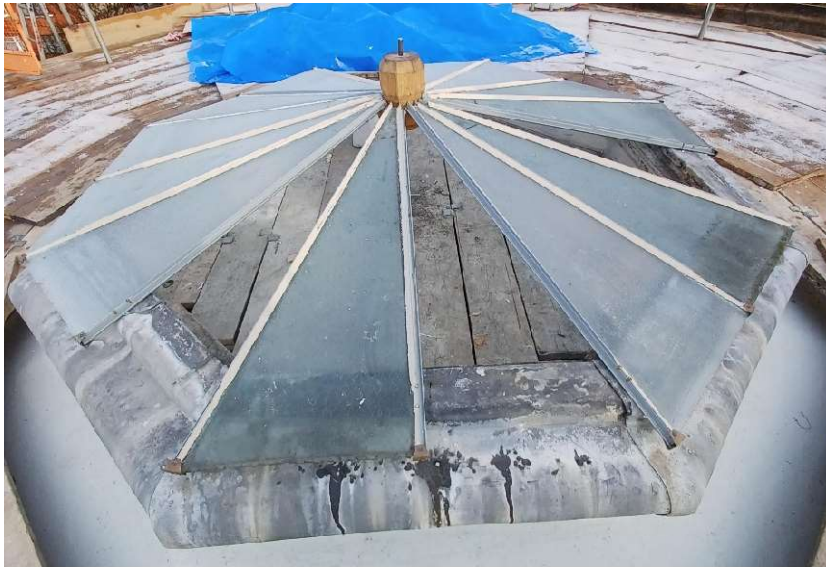
Partially complete roof lantern including new oak finial and restored glazing bars have been installed. The glazing has been bedded on heritage putty and fronted with multipurpose putty.

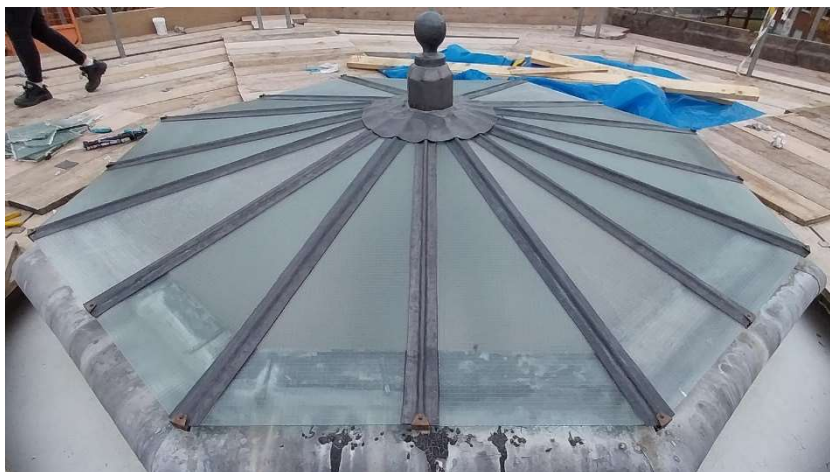
Fully restored roof lantern including new code 5 lead to the finial, new code 4 lead to the glazing bars capped at the end with restored copper end caps and new copper inserts, new Georgian wire glass and existing pains installed.

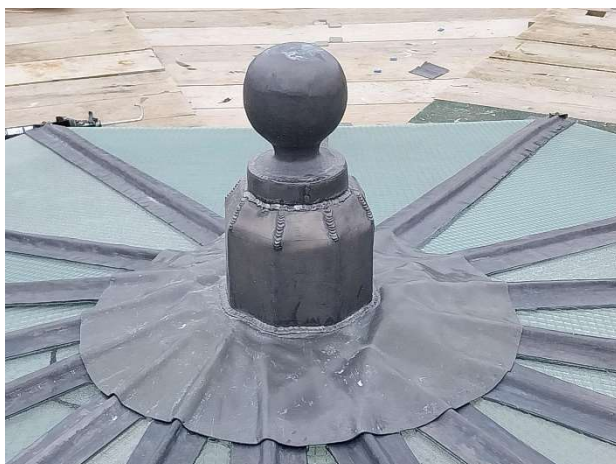
Closeup of the finished finial including new Danish oil-soaked oak finial covered in code 5 lead extending down forming a flashing over the top of the glazing code 4 glazing bars.
