Sunlight House,  
Quay Street,  
Manchester  
M3 3HP

Façade Condition Survey  
February 2024

REF 24008-PAYE-RPT-001 **P03**

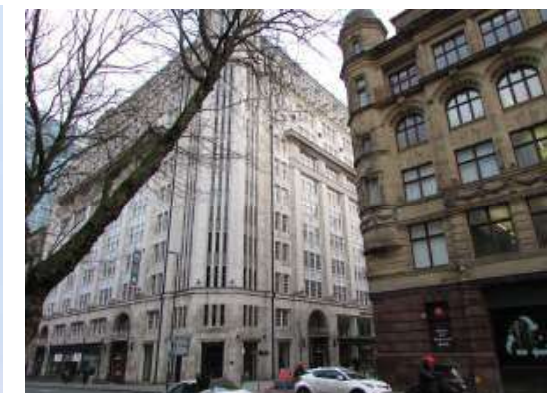
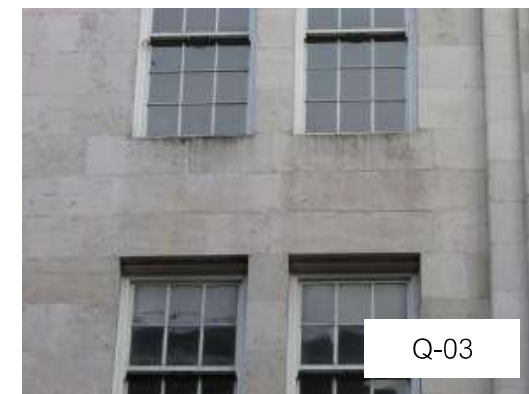
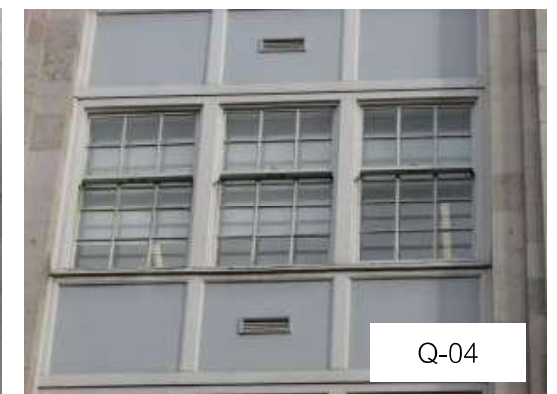
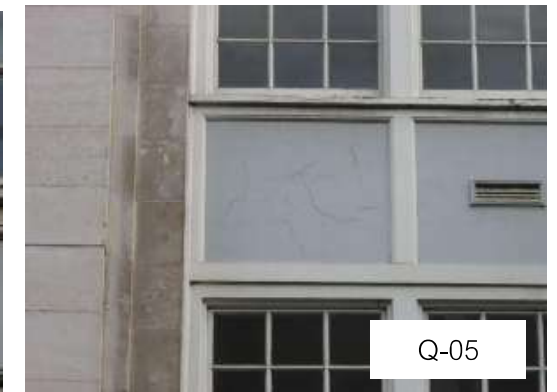
PHOTOS: Q-04, -05, (D)LQ-22

It appears that the curtain walling between the pilasters are formed from timber windows and spandrel panel. Decay was observed to several of the timber windowsills. Hairline cracks were observed to the paint of several spandrel panels. It is recommended to undertake a full condition survey of the timber windows and spandrels. Undertaking repairs – e.g., timber splice repairs - and re-decoration will improve the longevity of the windows.

*Common typical defect photographs; staining, rainwater goods, launching staining to stone windowsills, timber decay and flaking paint to timber sills.*

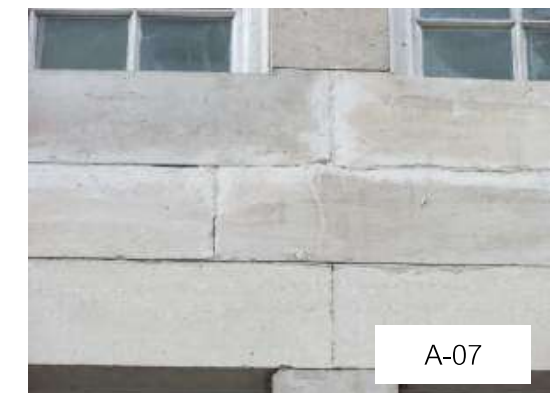
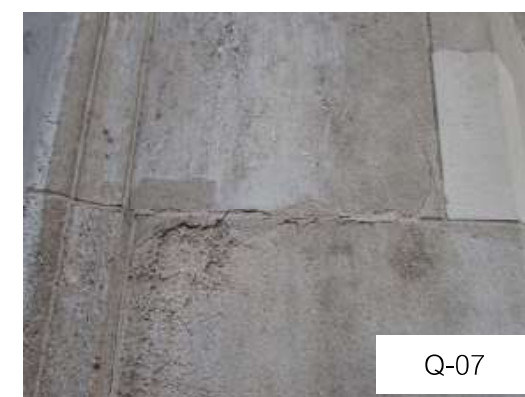
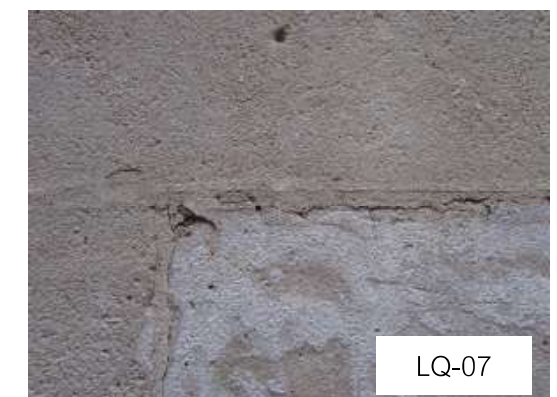
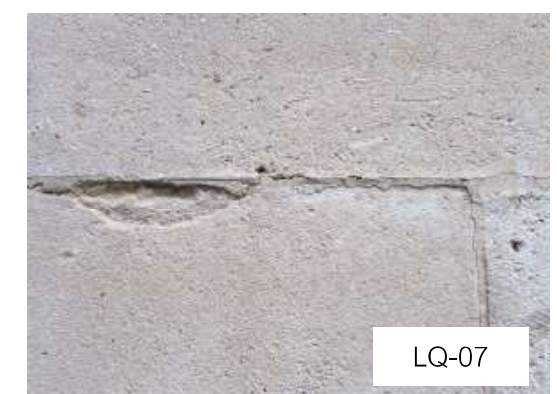
PHOTOS: Q-07, LQ-07

Cementitious pointing is impervious to water and will cause deterioration to the facing Portland stone. Any trapped moisture migrates into the masonry as it cannot pass through the impermeable joints. The stone around the joints become saturated and break down over time through freeze-thaw.

Cement pointing is also stronger than the Portland stone, and therefore any differential movement in the façade will result in cracking through the stone and not the pointing.

*Common typical defect photographs; friable pointing, cementitious pointing observed to the ground floor.*

Although cracks and deterioration was only observed to localised areas at ground floor, this issue will only worsen over time. Consider making an allowance to rake out all joints to the ground and first floor and repoint with a lime-base mortar.

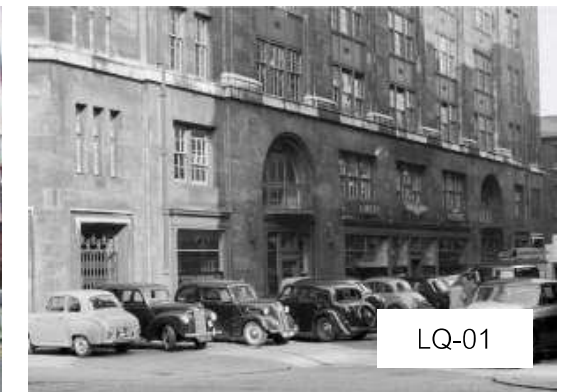
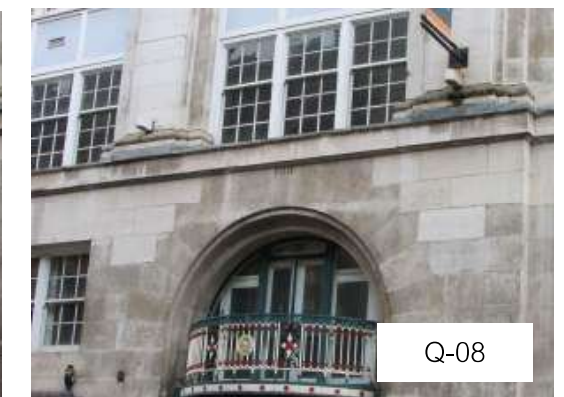
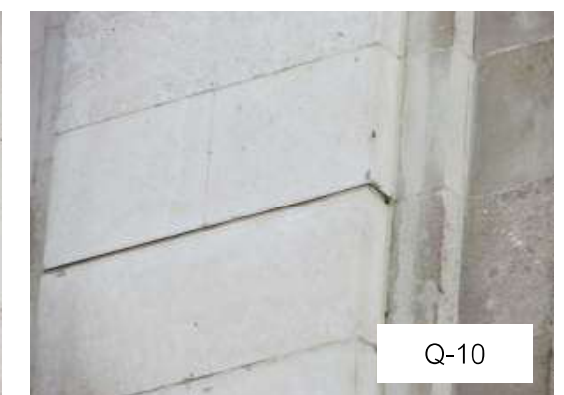
There is evidence of extensive repairs to all vertical pilasters and to the 2<sup>nd</sup> floor cornice, that were likely a result of historic steel frame corrosion. When steel corrodes it can expand x8-13 times its original volume, resulting in fractures to the Portland stone masonry. It is likely that the fractures to the façade (and extent of steel frame corrosion) was widespread as all pilasters appear to have been replaced with new “plant on” stone. From observations it can be concluded that the below works were undertaken.

1. The masonry between the 2<sup>nd</sup> floor windows and cornice has been replaced (with the exemption of the arched keystones which appear original). This may also have been part of the façade modifications which were undertaken to entrance on Little Quay Street.
2. All central pilasters (between L02- L06 and L08-L09) have been replaced with new ‘cladding’ built off corbel brackets at every floor level. A silicone movement joint has been included at the new-old stone vertical reveal joint and horizontally at every floor level.
3. All quoin / turret pilasters (between L02- L09) have been replaced with new ‘cladding’ built off corbel brackets at every floor level. A silicone movement joint has been included at the new-old stone vertical reveal joint and horizontally at every floor level.

*Notable defect photographs; modifications to ground floor (note ‘new’ stone below the cornice), movement joints observed to the pilasters*

It is strongly recommended to consult with a structural engineer and obtain the as-built drawings and photographs for the extensive repairs to confirm that the works was undertaken to a high standard and align with modern building codes.

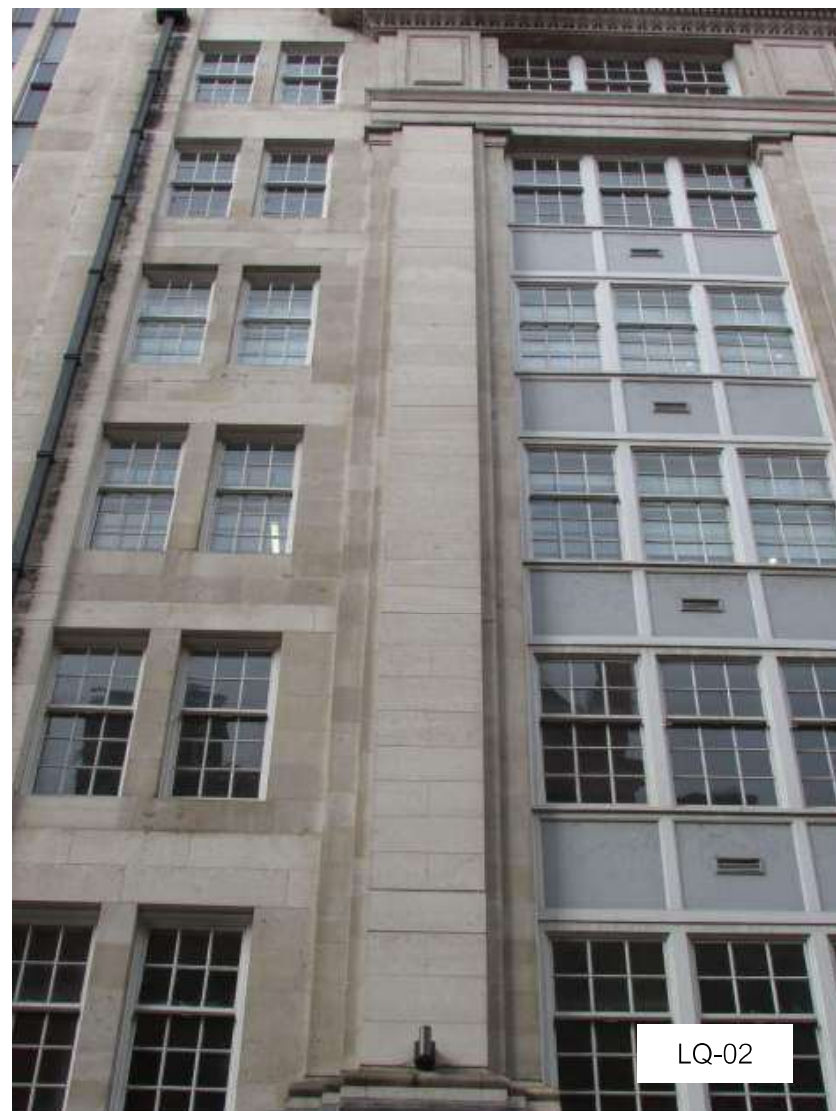
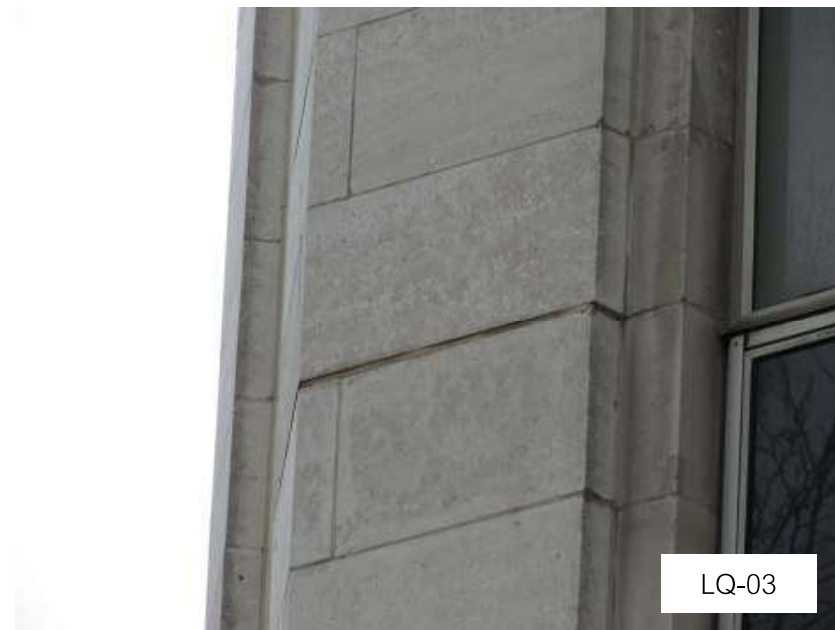
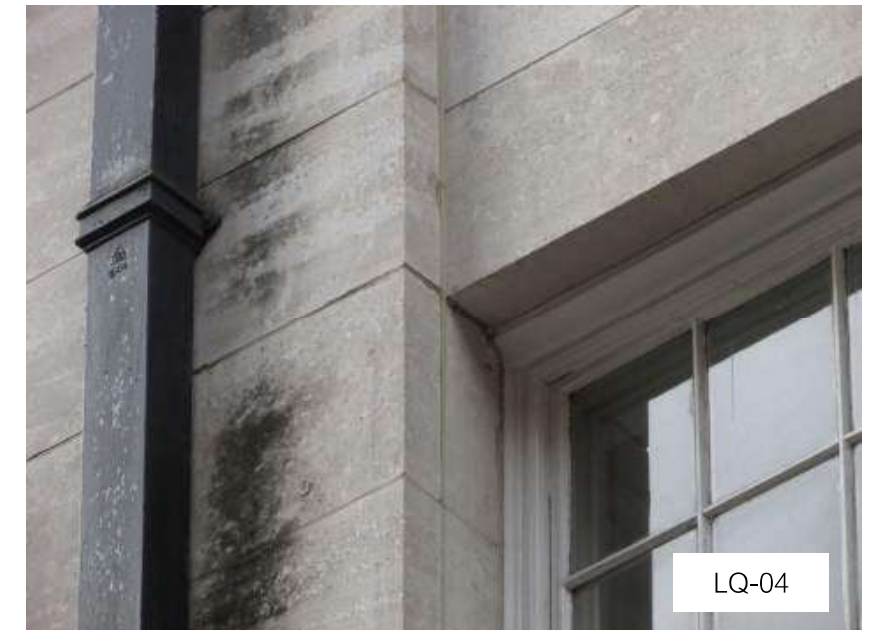
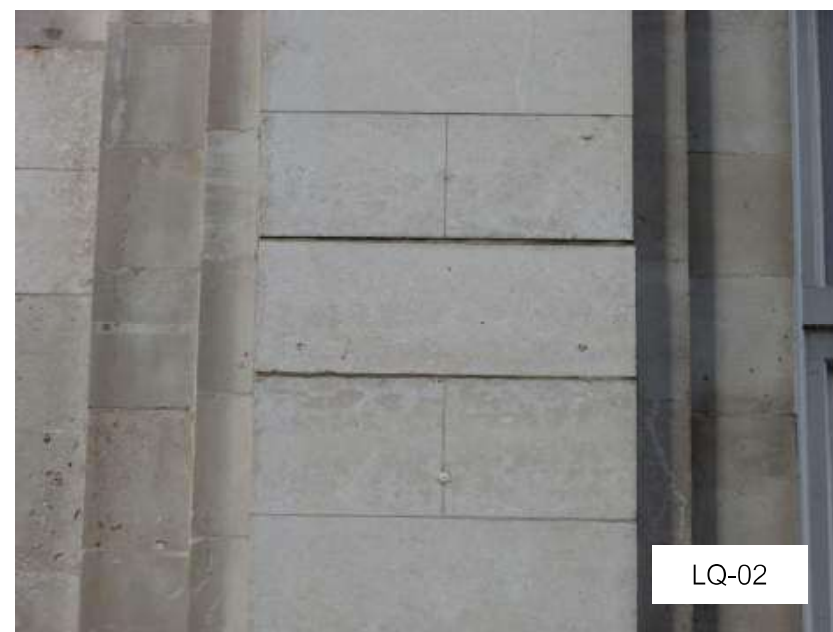
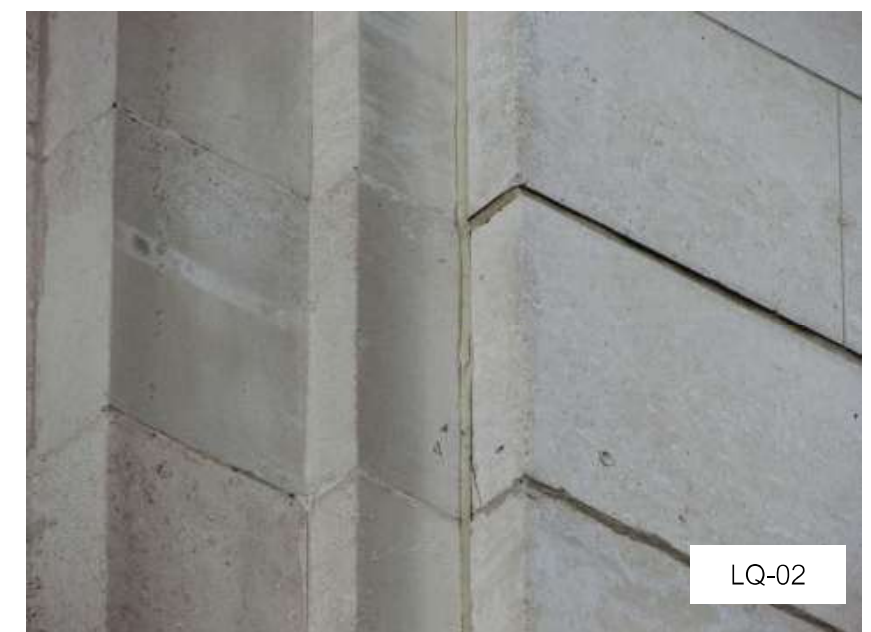
*Notable photographs; modifications to pilasters. Note the 'new' stone and movement joints observed to the pilasters*

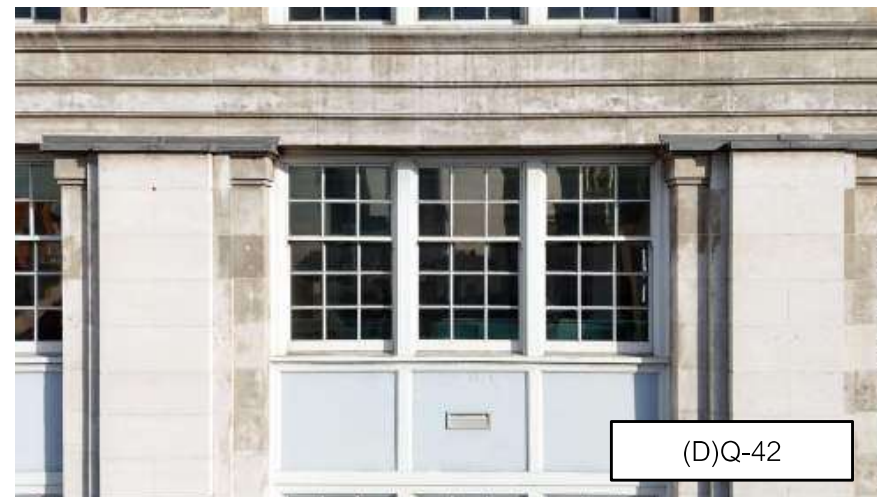
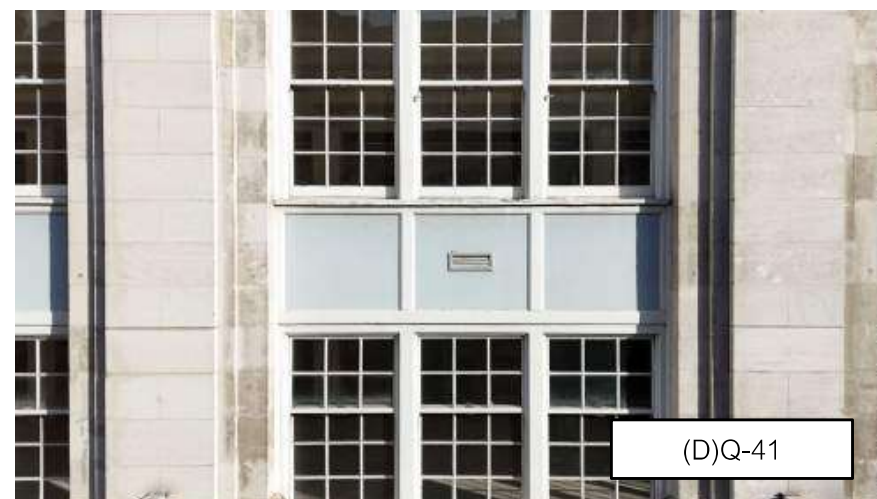
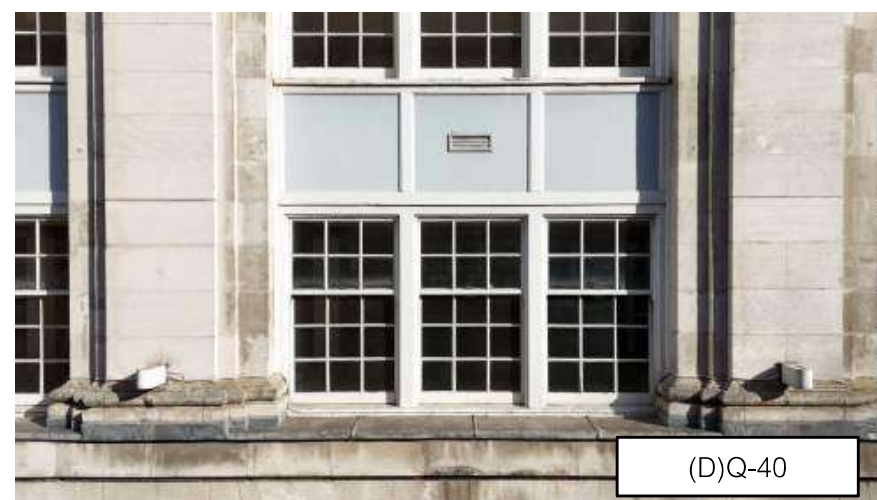
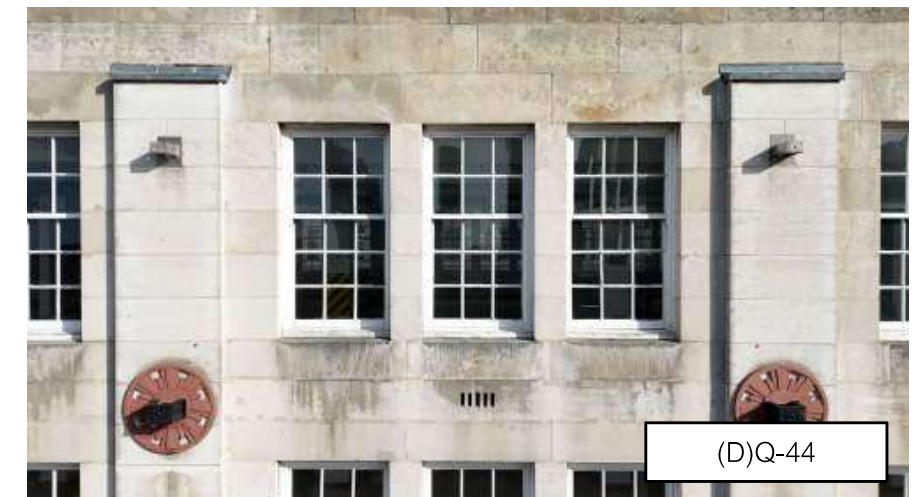
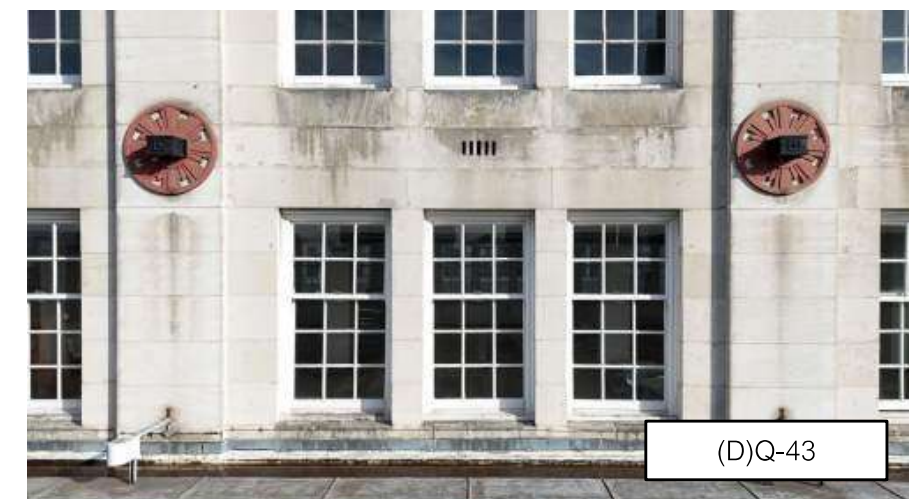
*Notable photographs; modifications to pilasters. Note the 'new' stone and movement joints observed to the pilasters. A structural engineer should be consulted regarding the L08 flagpole modillions, with regards to the fixing detail back to the façade or steel frame.*

A structural engineer should be consulted regarding the L08 flagpole modillions, with regards to the fixing detail back to the façade or steel frame. They appear to be made from painted mild steel. There is a risk that corrosion could be occurring to part of the fixing embedded in the wall.

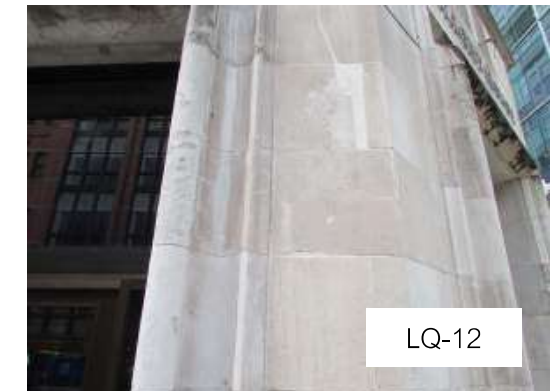
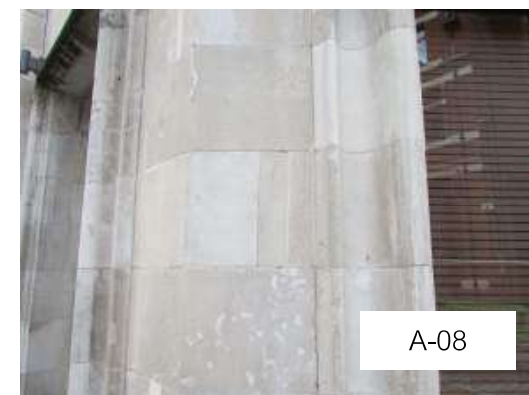
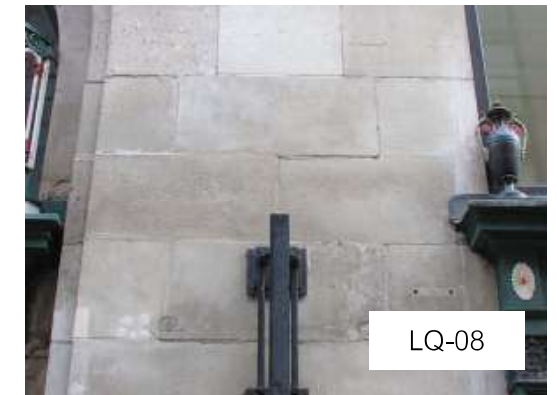
PHOTOS: (D)A-21, -23, -24

Fractures (category 0 to 2) and displacement were observed to the ground floor. The cause for the fractures may be steel frame corrosion – with the ground floor not part of the historic repairs. Recommend consultation with a structural engineer.

A continuous vertical hairline fracture was observed to the NE turret to Little Quay Street. The cause of the fractures may be settlement or steel frame corrosion. Recommend consultation with a structural engineer.

Horizontal hairline fractures were observed to a ninth-floor window lintel on Atkinson Street. The stone joint arrangement suggests the likelihood of a steel beam behind. The cause for the fractures may be steel frame corrosion. Although in its infancy, there is a risk that if left untreated it could deteriorate (especially due to the proximity the parapet hidden gutter). Historic mortar repairs were observed to the same bed joint three bays over (see (D)A-23 & -24), which suggest there may have been a historic issue. Recommend consultation with a structural engineer and further investigations (if required).

*Notable defect photograph; fractures observed through masonry to lower levels possibly caused by steel frame corrosion*

Repairs could include cutting out the masonry to inspect and treat the steel frame or thumb pointing over the fractures to maintain the buildings weathertightness and continue to monitor for further defects as part of the Pre-Planned Maintenance.

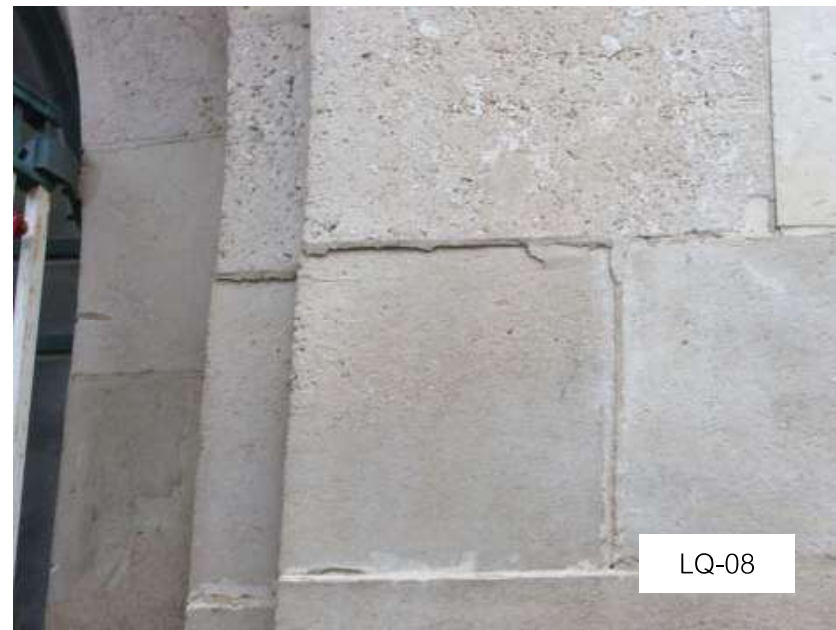
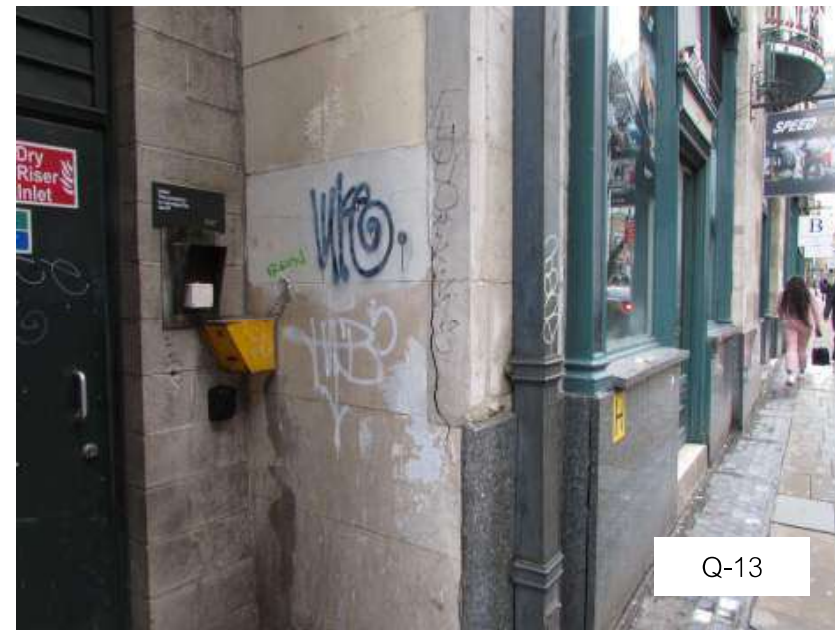
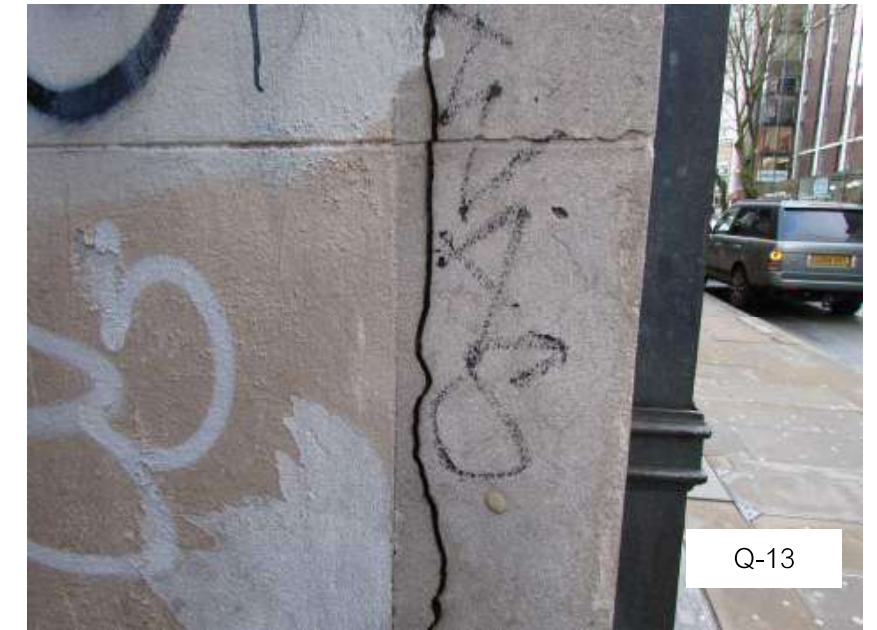
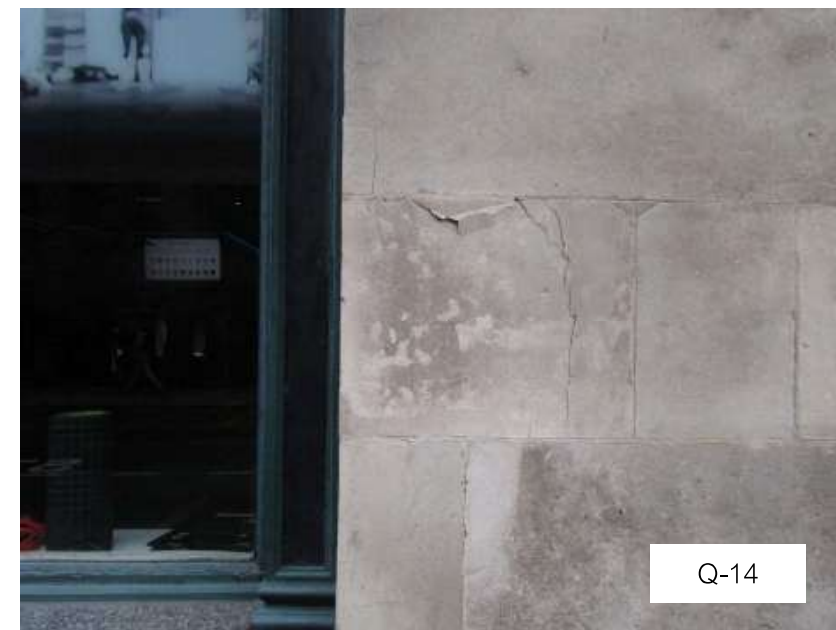
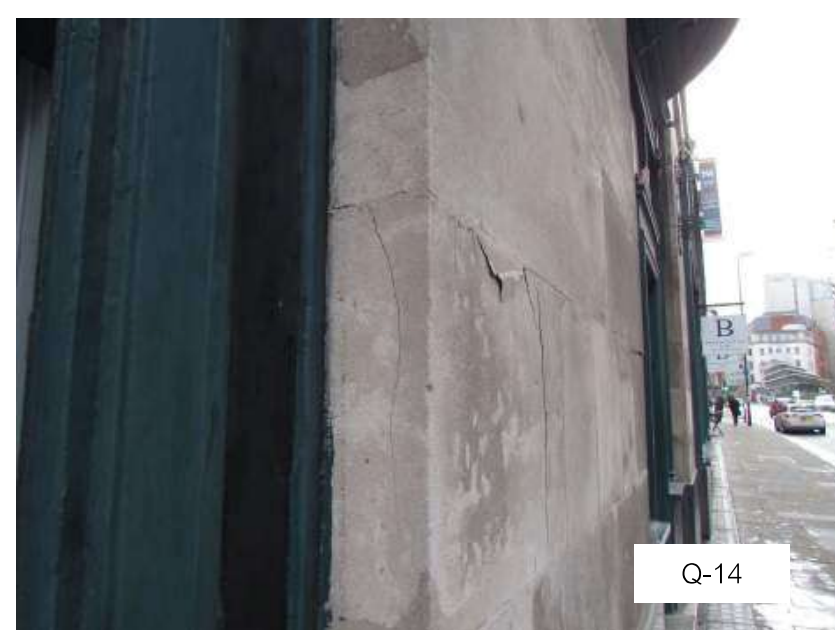
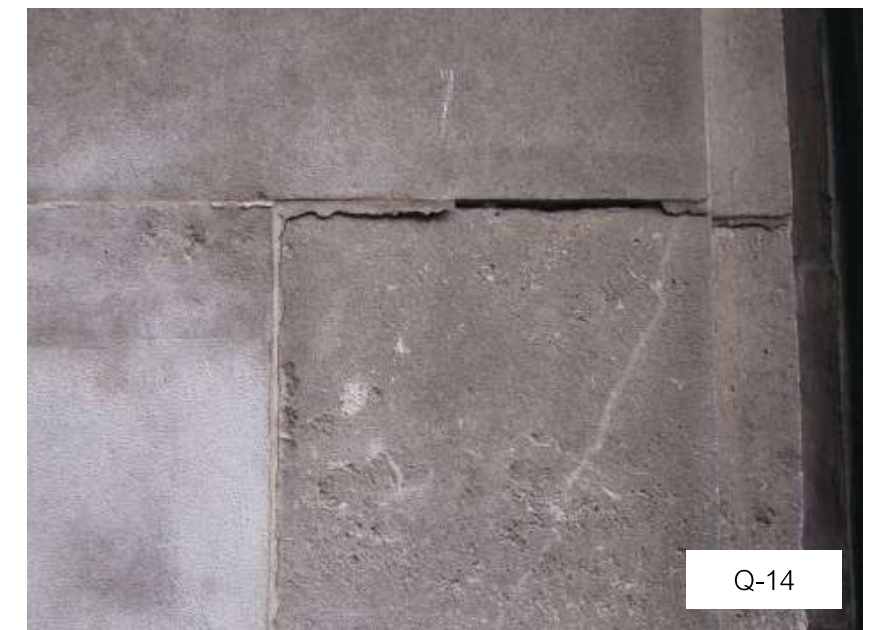
*Notable defect photograph; fractures and displacement observed through masonry to lower levels possibly caused by steel frame corrosion*

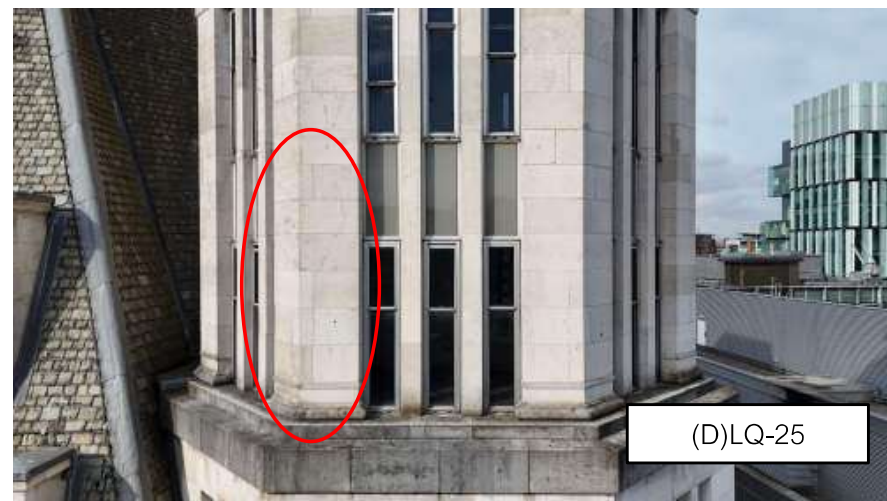
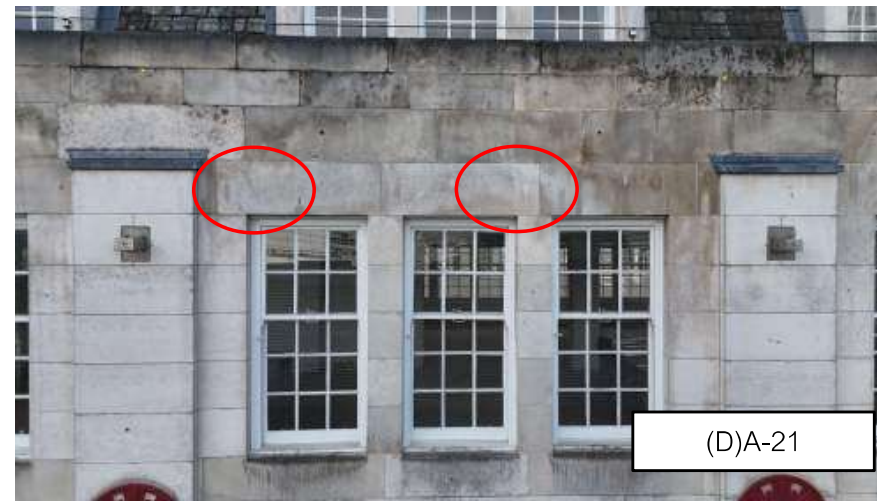
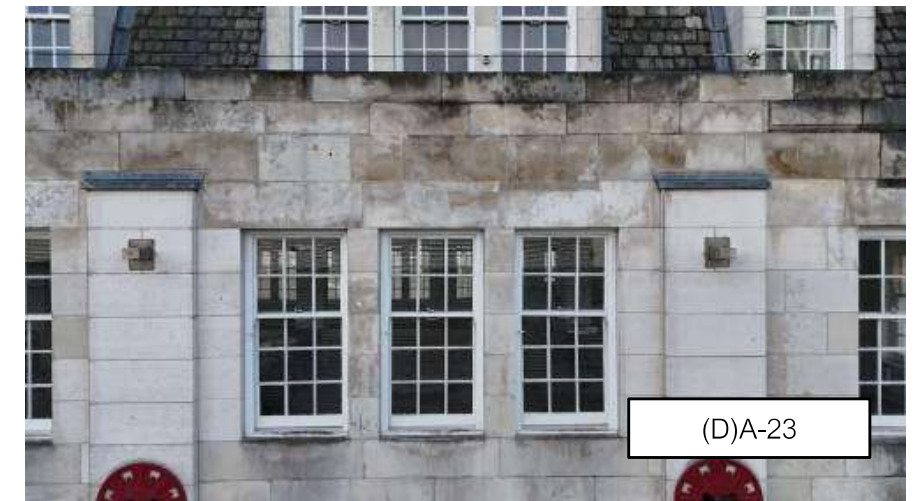
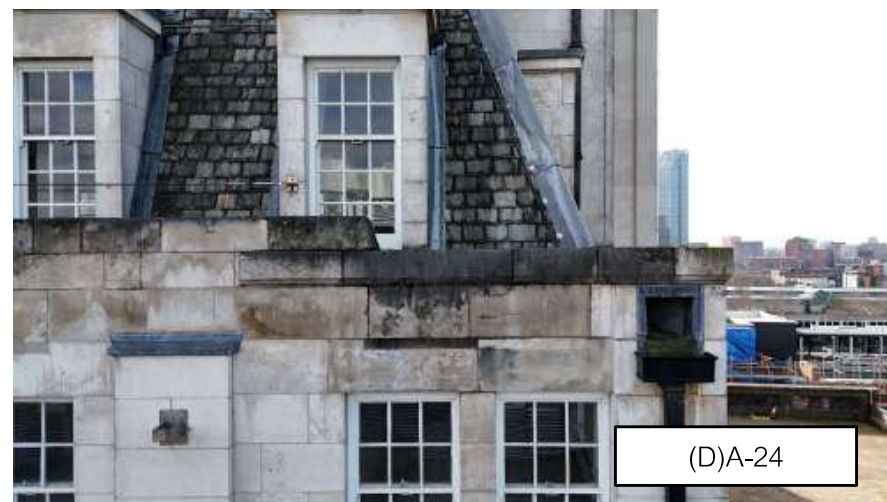
*Notable defect photograph; hairline fractures observed through masonry possibly caused by steel frame corrosion. Note the previous repairs to (D)A-23 and -24*

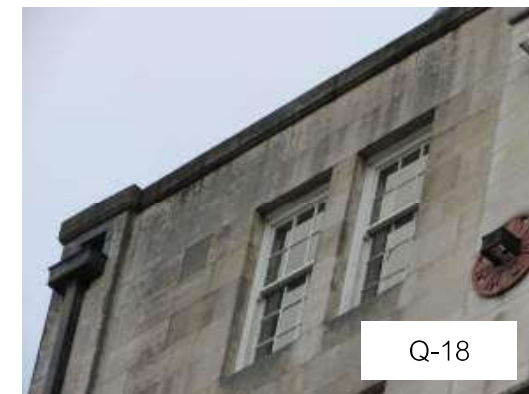
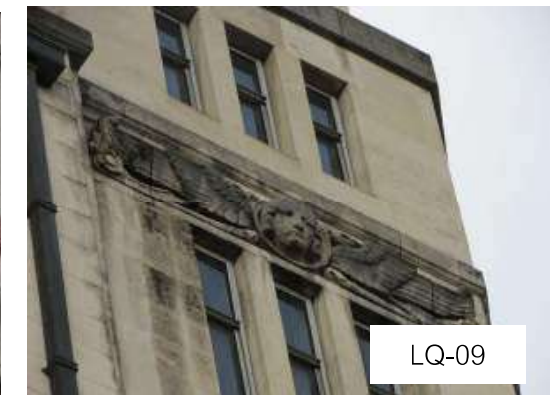
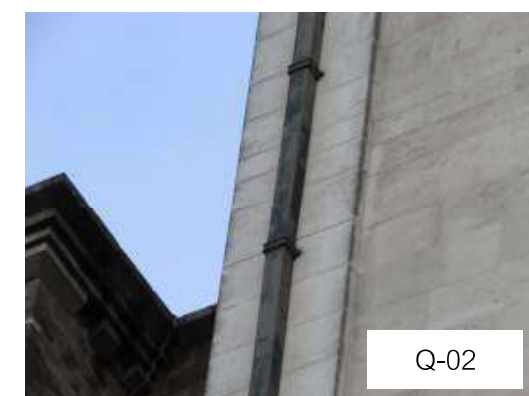
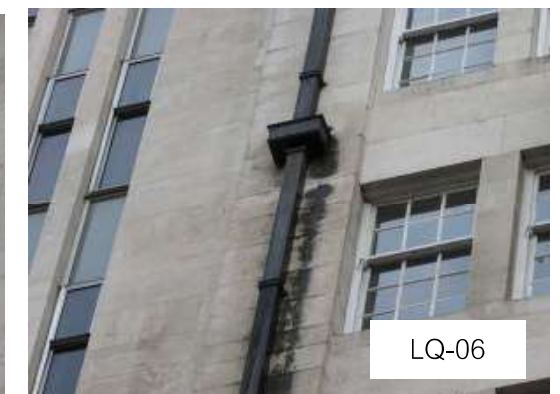
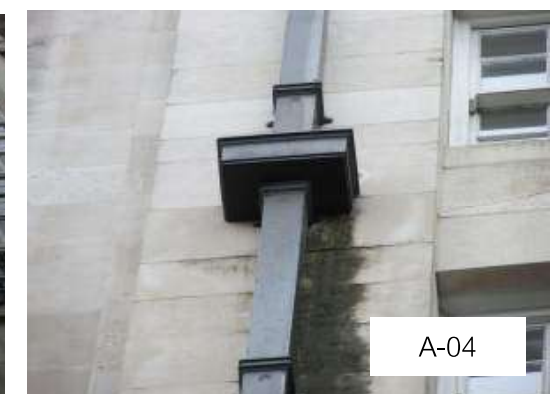
PHOTOS: Q-02, LQ-06, A-04

Vegetation growth was observed to a hidden rainwater gulley below the coping. Biological growth can root into joints, weakening the bond and creating a point of water ingress into the façade. Recommend removing all rooting buddleia and clearing all debris from gutters and rainwater outlets during periodic maintenance.

Biological staining was observed to the ninth and tenth floor copings and high-level masonry. The cause for the staining is because water is allowed to sit on the surface of the stone and allow spore growth.

The paint to the rainwater downpipes is beginning to flake in areas. To two downpipes, it appears the hoppers are blocked causing rainwater to cascade down the face of the stone, resulting in organic staining.

*Notable defect photograph; staining, staining caused by overflowing hoppers, paint flaking to rainwater downpipes*

Recommend refurbishing all rainwater downpipes and undertaking maintenance of the hoppers. Consideration should be given to how the downpipes are to be maintained in the future.

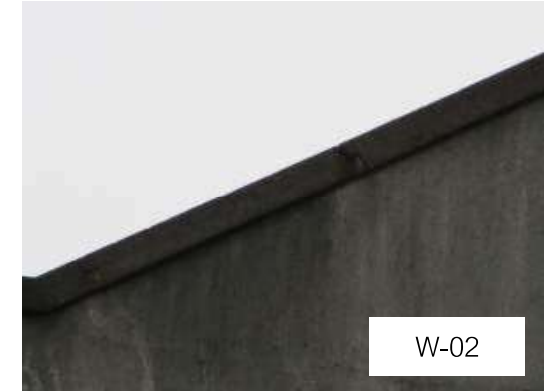
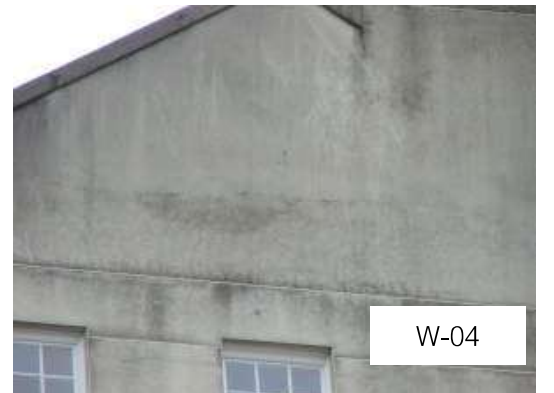
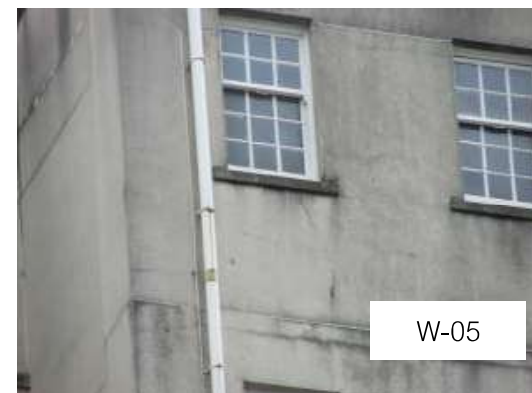
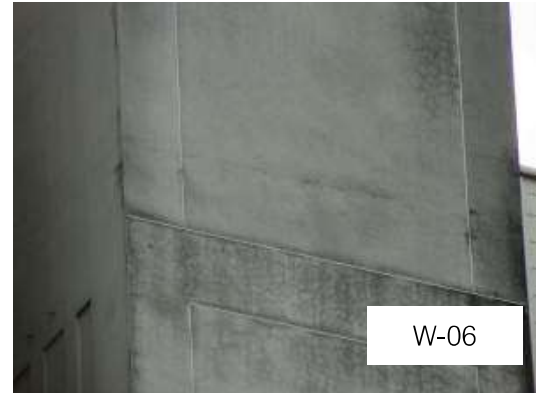
PHOTOS: (D)W-25

Medium to heavy levels of soiling was observed the copings, windowsills, and at high level. This is typical as these areas are more exposed to the weather. Low to medium levels of soiling was observed to the lower levels.

Hairline cracks (or crazing) were visible to areas of the render at high level. The cause for the cracking could be façade differential settlement or shrinkage of the render. Once scaffold access is available, all areas of render should be tap tested. Any loose or de-bonded sections of render should be removed. And a new compatible render reinstated on a stainless steel EML backing.

The copings and windowsills are pre-cast concrete and appear generally in a sound condition (if not a bit weathered). Cracks were observed to nine windowsills. The cause for the cracks is likely corrosion of embedded steel reinforcement. All windowsills should be tap-tested once scaffold access is available. Recommend replacing defective windowsills with new pre-cast concrete sills to match existing

The pointing to the copings has washed out. Recommend repointing all coping stone joints with a suitable mortar.

Cementitious render repairs has been installed to the quoin with Quay Street elevation. Recommend undertaking tap-testing to all areas of render. All loose or de-bonded render should be removed and a new compatible render installed.

Common typical defect photographs; missing pointing, staining, hairline cracks to rendered facades

Cleaning the façade will remove the biological staining. Consideration should be given to installing a lead flashing to the coping stones to shed the water away from the façade and prevent further staining.

It was not possible to confirm the condition of the silicone mastic, however, it is likely at the end of its lifespan (typically 20years). Recommend to replace all mastic with new to maintain the weathertightness of the building.

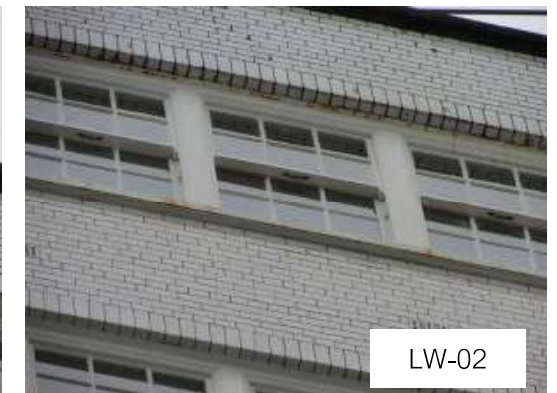
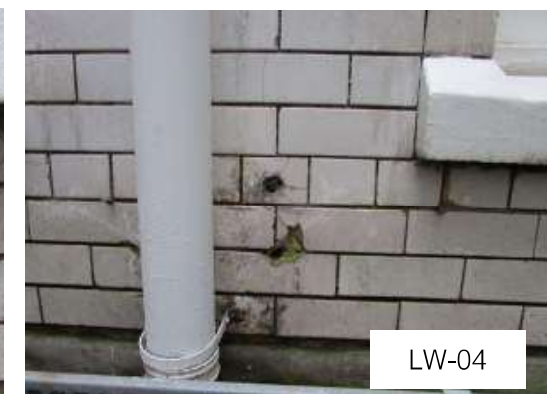
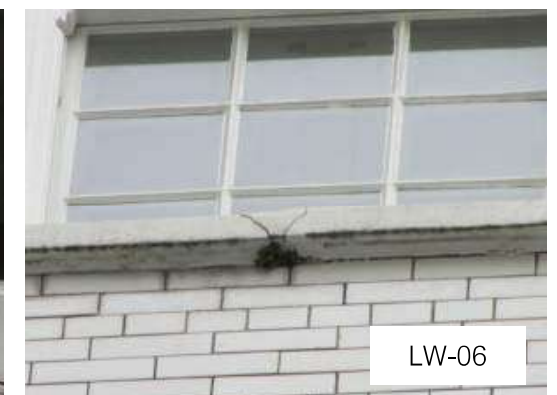
PHOTOS: (D)ROOF-14, (D)L13-09, 12-01

The lightwells are generally in a good condition. The precast concrete copings appear OK but the joints are washed out. Organic growth is observed to the brick joints at high level which suggests the pointing has washed out. Rust staining was observed to several lintel and windowsills at L13. The cause for the rust staining is likely corrosion of the steel lintels which has washed down the window to the windowsill. Recommend consultation with a structural engineer and up-close inspection once access scaffold is available.

Vegetation growth was observed to one gutter. Decay was observed to several of the timber windowsills. It is recommended to undertake a full condition survey of the timber windows and spandrels. Undertaking repairs – e.g., timber splice repairs - and re-decoration will improve the longevity of the windows.

There are redundant fixings / drill holes to the glazed brick facades which have not been repaired. Small chips were observed to the arises of individual bricks. Where the chip or fixing hole is less than 20mm it is recommended to undertake a lime-based mortar repair with Keim glaze finish to match the glazed brick texture. Where the hole is greater than 20mm it is recommended to carefully cut out the defective brick and install a new brick to match the existing.

There were several defective bricks (i.e., fracture through the full height of the brick). Recommended to carefully cut out the defective brick and install a new brick to match the existing.

All the windowsills were painted making it impossible to determine the condition of the underlying masonry. Generally, they were in a good condition. Hairline fracture or fractures were observed to several windowsill. The fractures could be to the stone sill (and possibly caused by differential settlement of the façade) or could just be flaking paint. Recommend up close inspection once scaffold is available.

Hairline fractures - originating from the windowsill – were observed to localised areas. The cause for the fractures is possibly settlement of the façades. Recommend consultation with a structural engineer and continued monitoring as part of the Pre-Planned Maintenance.

*Common typical defect photographs; vegetation growth to joints, rust staining to steel lintels and windowsills, small fixings, defective bricks, small chips, fractures observed to painted windowsill.*
