# Contaminated Land Phase Two Intrusive Investigation for proposed residential development at Land Off Chapel Street, Manchester, M19 3QB.

Burke Developments Ltd,  
Norwood,  
Greenacres,  
Oldham,  
OL4 3EX.

July 2024

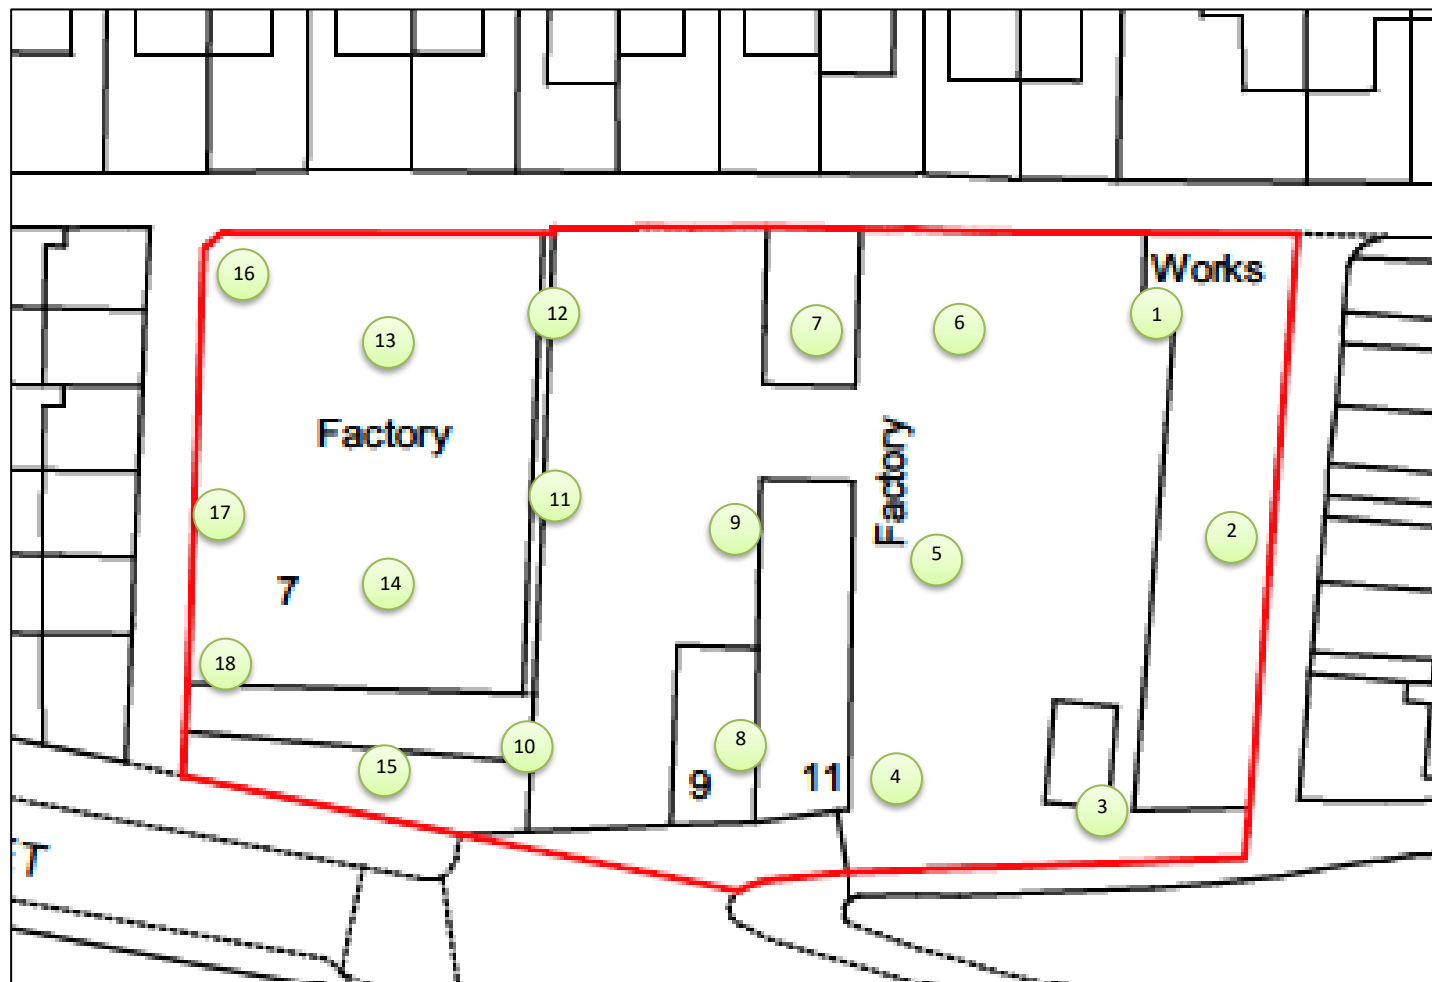
**Figure 2 – Phase II Sampling Locations**

A site visit was conducted on the 8<sup>th</sup> June 2024 to undertake an intrusive investigation. The site had been cleared at the time of the visit with previous buildings demolished. A sampling program of 18 sample locations, identified in Figure 2, spread across the site at approximately 10m centres were undertaken. Some of these were located adjacent to the previously sampled locations. Both rounds of sampling are shown on the plan in Figure 3.

The full sampling results are presented in Appendix 1, the sampling locations in Figure 2. The results have been compared against the LQM/CIEH S4UL's for a residential without homegrown produce scenario & the C4SL value for Lead. Soil organic matter varied across the site.

Elevated levels of Arsenic were identified from the second round of monitoring in TP4a and TP11a, and in the first round at TP5a and 8a. TP4 & 5 were in similar locations to the southeast of the site.

In addition, elevated lead levels were encountered across the centre of the site (front to back) in TP5, 7-12 15 & 16 during the second investigation which mirrored the first round with the exception of the northwest corner where elevated lead was found in the first round.

Elevated Total Petroleum Hydrocarbons (TPH) were identified in TP6 during the first round and TP11, 13 & 15 in the second.

Elevated Polyaromatic Hydrocarbons levels were identified in TP1B, 3A, 5A and 6A (i.e. surface levels) during the first phase of investigation. During the second-round elevated levels were encountered in TP 4, 8-13, 16 & 18. These correspond to the first round plus some additional areas. Predominantly the central strip of the site to form the roadway and the western corners.

1. Excavation and disposal of the contaminated soils across the central strip (TP 9-16 and hotspots at TP4 & 18, to depth of approx. 500mm or clean clay.
2. Test excavations on site with a PID to confirm no residual VOC's and take a series of soil samples for analysis to confirm to if residual contamination is present.
3. Back fill with clean imported material.
4. Ensure a minimum of 600mm clean material is provided in garden amenity areas, with a geotextile no dig layer below. 450mm clean material in other soft landscaping areas.
5. All services to be laid in trenches backfilled with clean imported material.
6. All mains water pipework to be of a Barrier pipework.

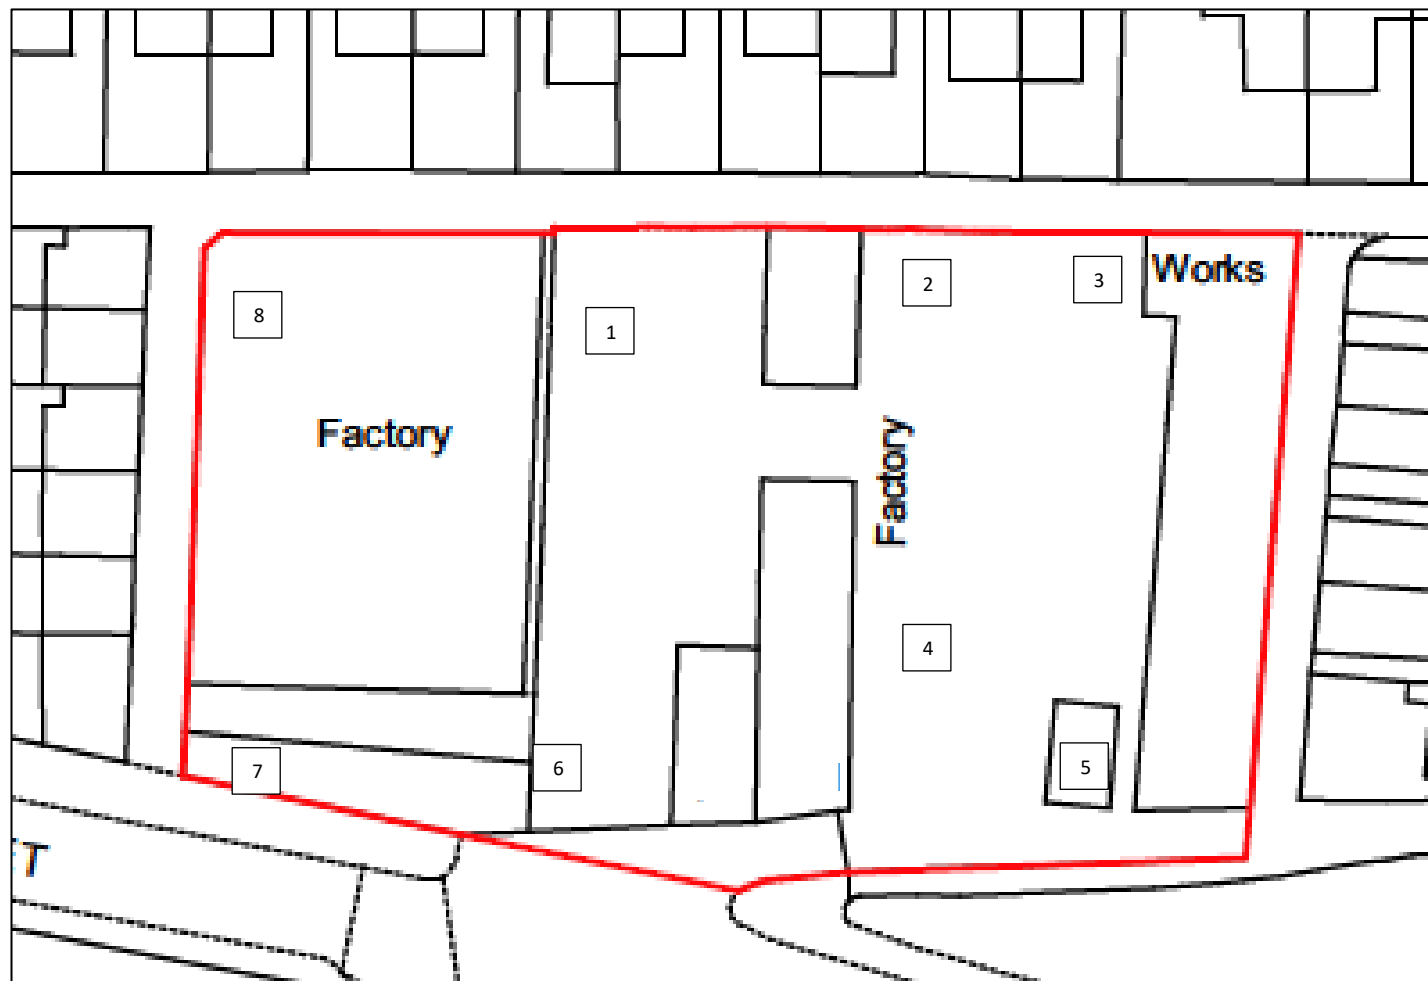
**Figure 2 – Phase 1 Intrusive Investigation Trail Pits Locations**

The initial phase II investigation consisted of a series of trial holes across the site. These identified elevated levels of contaminations in five areas as indicated in the report and the plan in figure 2.

The results of the samples identified no asbestos fibres within the site. The previous round of sampling (Phase I report) did identify some asbestos in two locations TP1b and 6a, from lagging material.
