**Approval of details reserved by a condition (discharge)**

Address: Chorlton District Library, Manchester Road, Chorlton, Manchester, M21 9PN

Reference: PP-13082579

**Condition 3**

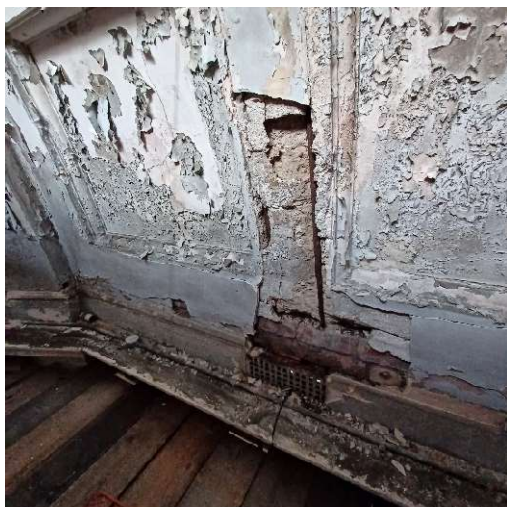
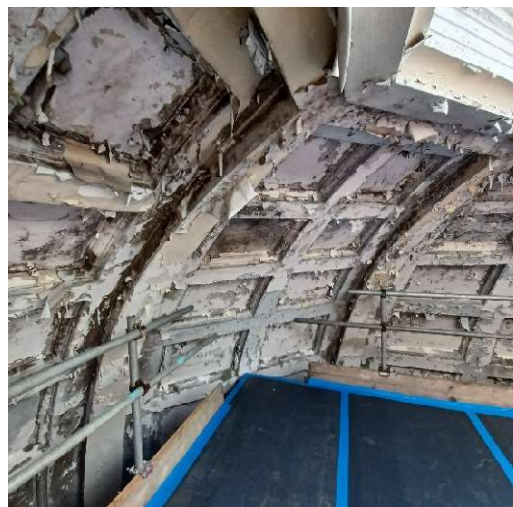
When the suspended ceiling was removed from below the rotunda, it was found to be in poor condition exhibiting structural defects and flaking finishes.

A survey found that water ingress, over a long period of time, had corroded the steel work in the reinforced concrete causing spalling, exposing the rusting steel work. As pictured below.

A test of the paint found it contained Lead. Prior to the concrete repairs the damaged and flaking paint was removed from the dome/coffering. A respirator zone was set up to prevent contamination to the rest of the building.
