| REVISIONS | |
|---|---|
| Contract | Facade Survey, Sunlight House, Manchester, M3 3HP (24008) |
| Drawing Title | Facade Condition Survey - West Elevation |
| Drawing No. | 24008-PAYE-DR-004 rev P01 |

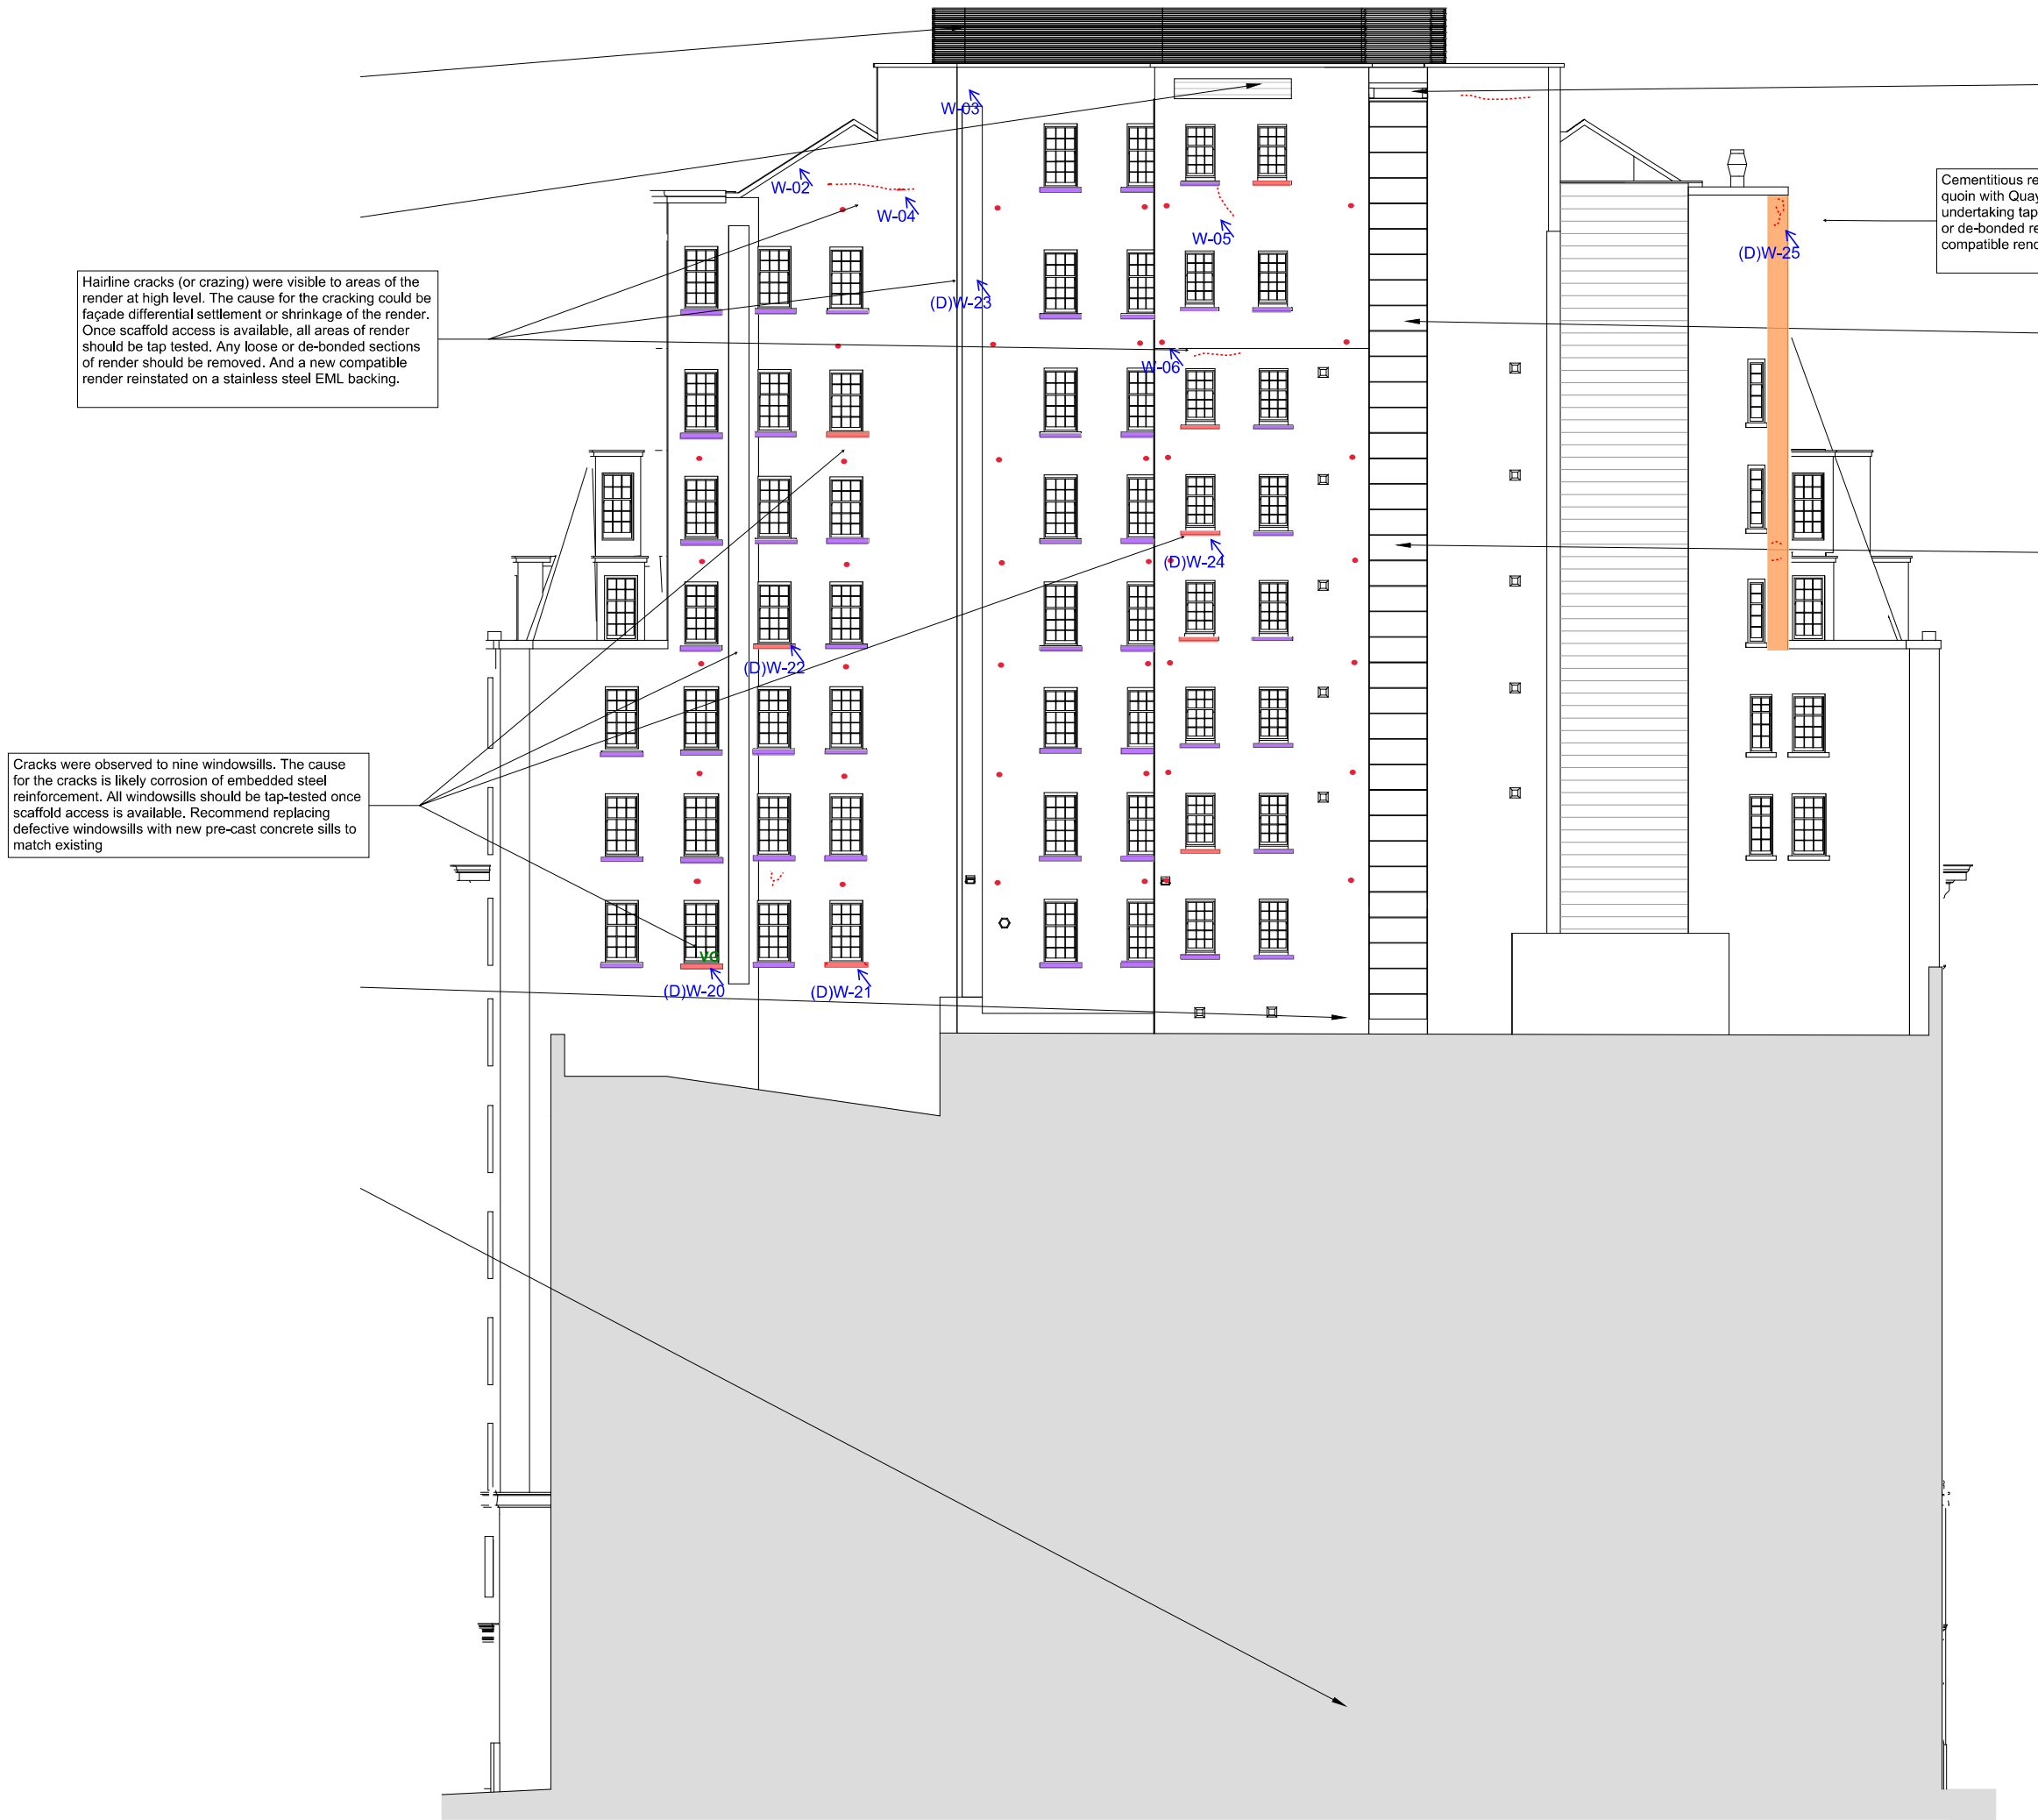
WEST ELEVATION

| KEY | |
|---|---|
| | Fractures |
| | Hairline fractures |
| | DSP Displaced stone |
| | FR Friable stone. Recommend de-frassing stone to remove all loose material. |
| | Damaged stone (notable erosion, sections spalled). Recommend de-frass / indent repair / replacement unit. |
| | Existing render coat. Recommend tap testing to confirm well bonded. |
| | Redundant scaffold tie. |
| | Staining to masonry |

| KEY | |
|---|---|
| | PIN Recommend stainless steel pin repair (subject to structural engineers recommendation) |
