# Television Post-Construction Survey Report

Mobility Hub, Manchester

Bowmer + Kirkland Limited

November 2024

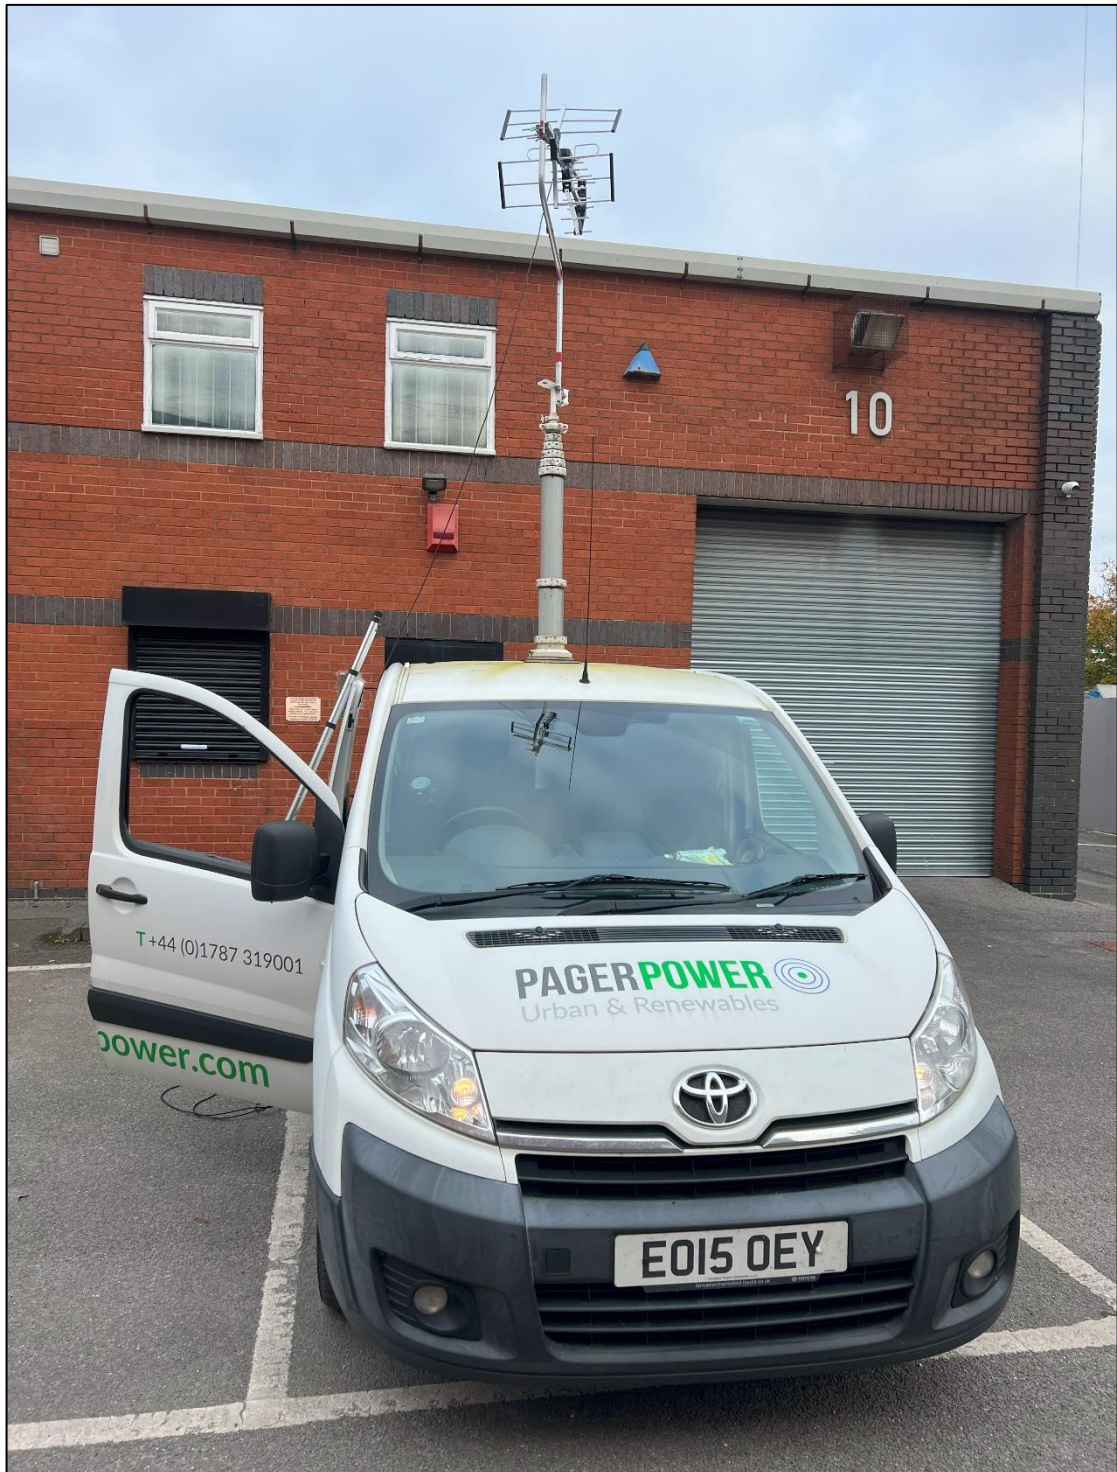
### Location 1

Notes: Elevated horizontally polarised Ultra High Frequency (UHF) aerials directed towards the Winter Hill transmitter were observed at this location.

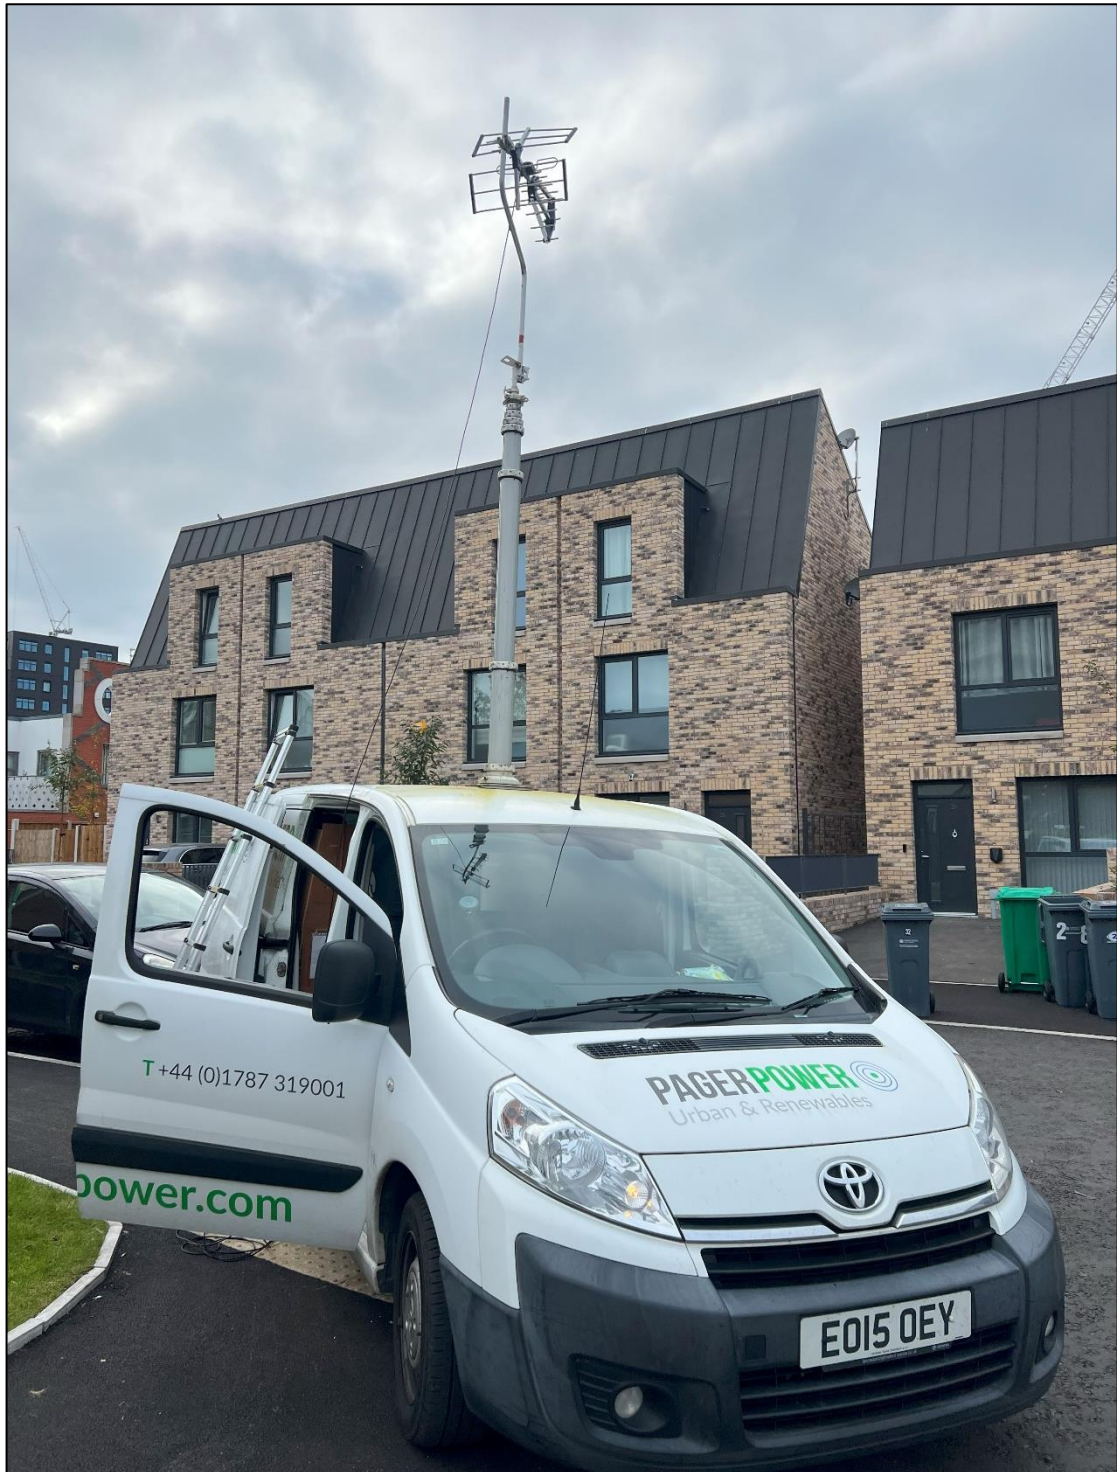
Location 2

Notes: Elevated horizontally polarised UHF aerials directed towards the Winter Hill transmitter and satellite dishes were observed at this location.

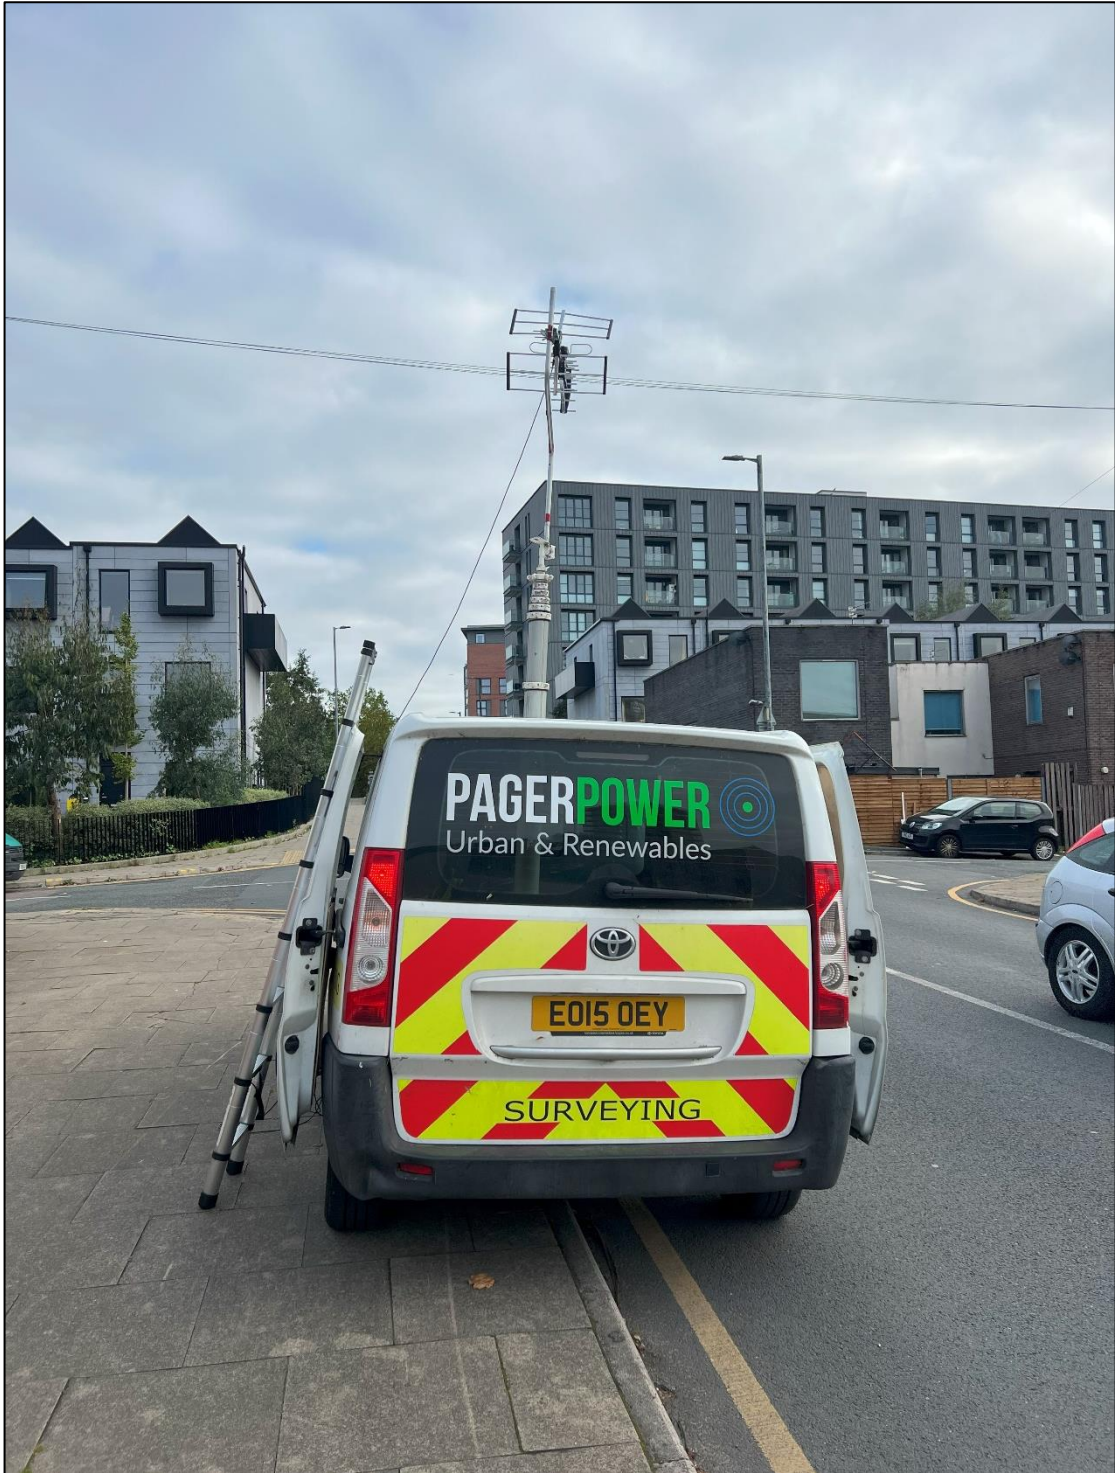
Location 3

Notes: Elevated horizontally polarised UHF aerials directed towards the Winter Hill transmitter and satellite dishes were observed at this location.

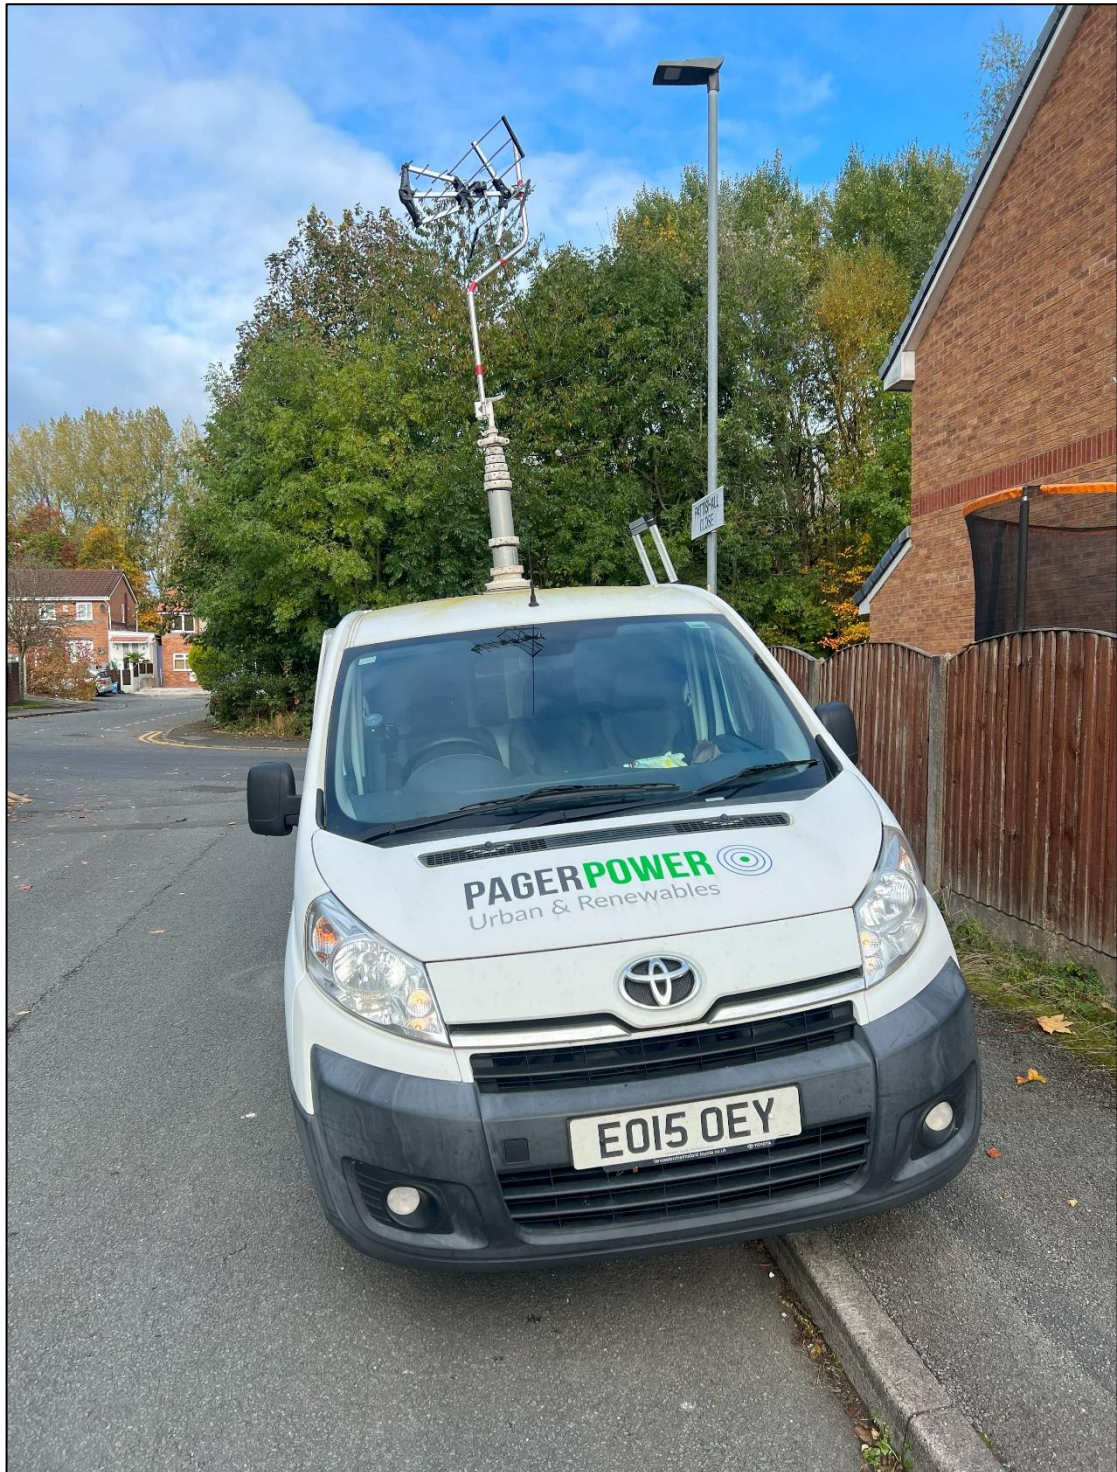
Location 4

Notes: Elevated horizontally polarised UHF aerials directed towards the Winter Hill transmitter and satellite dishes were observed at this location.

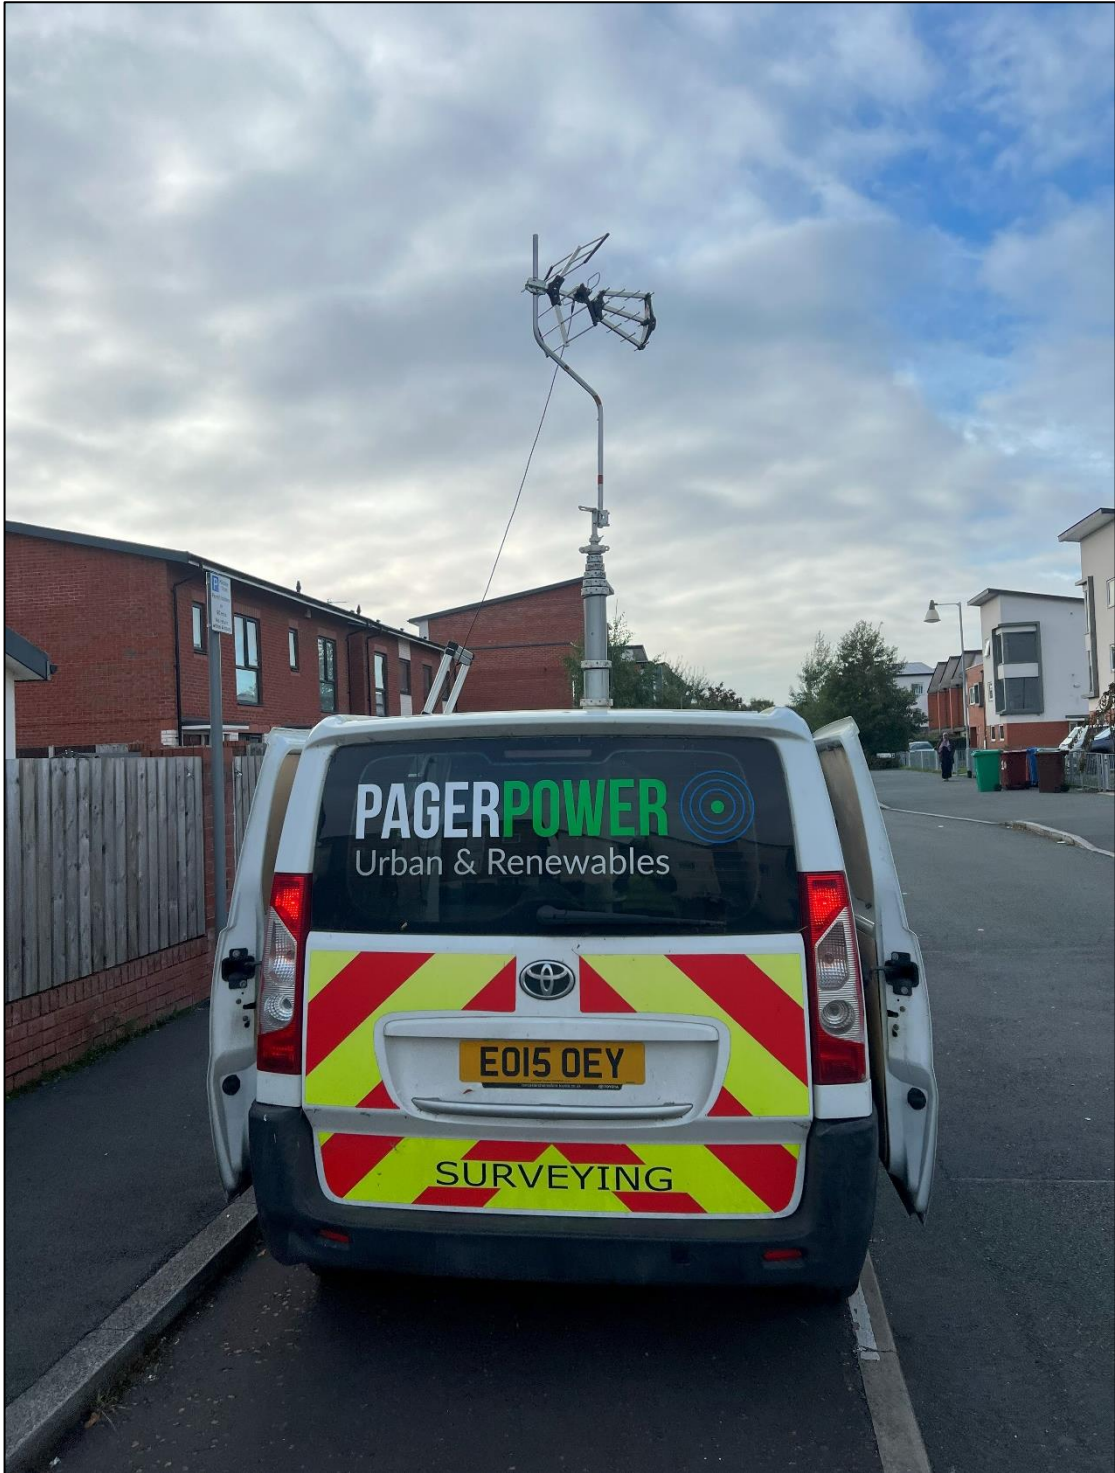
Location 5

Notes: Elevated horizontally polarised UHF aerials directed towards the Winter Hill transmitter and satellite dishes were observed at this location.

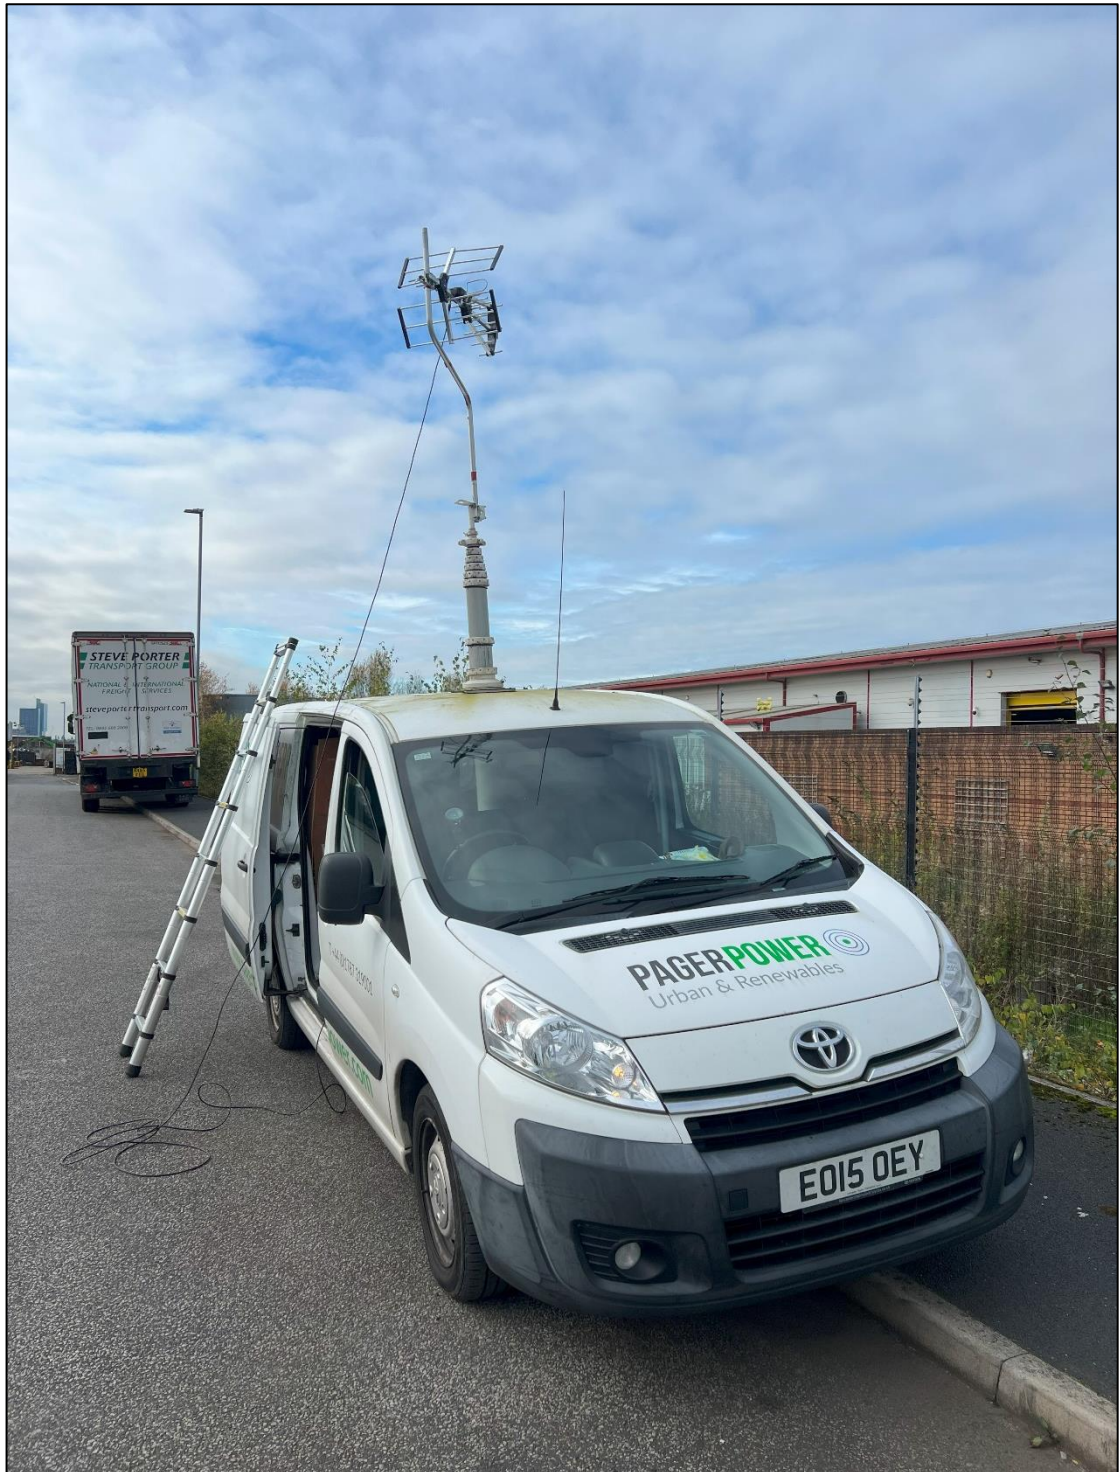
Location 6

Notes: No horizontally or vertically polarised aerials or satellite dishes were observed at this location.

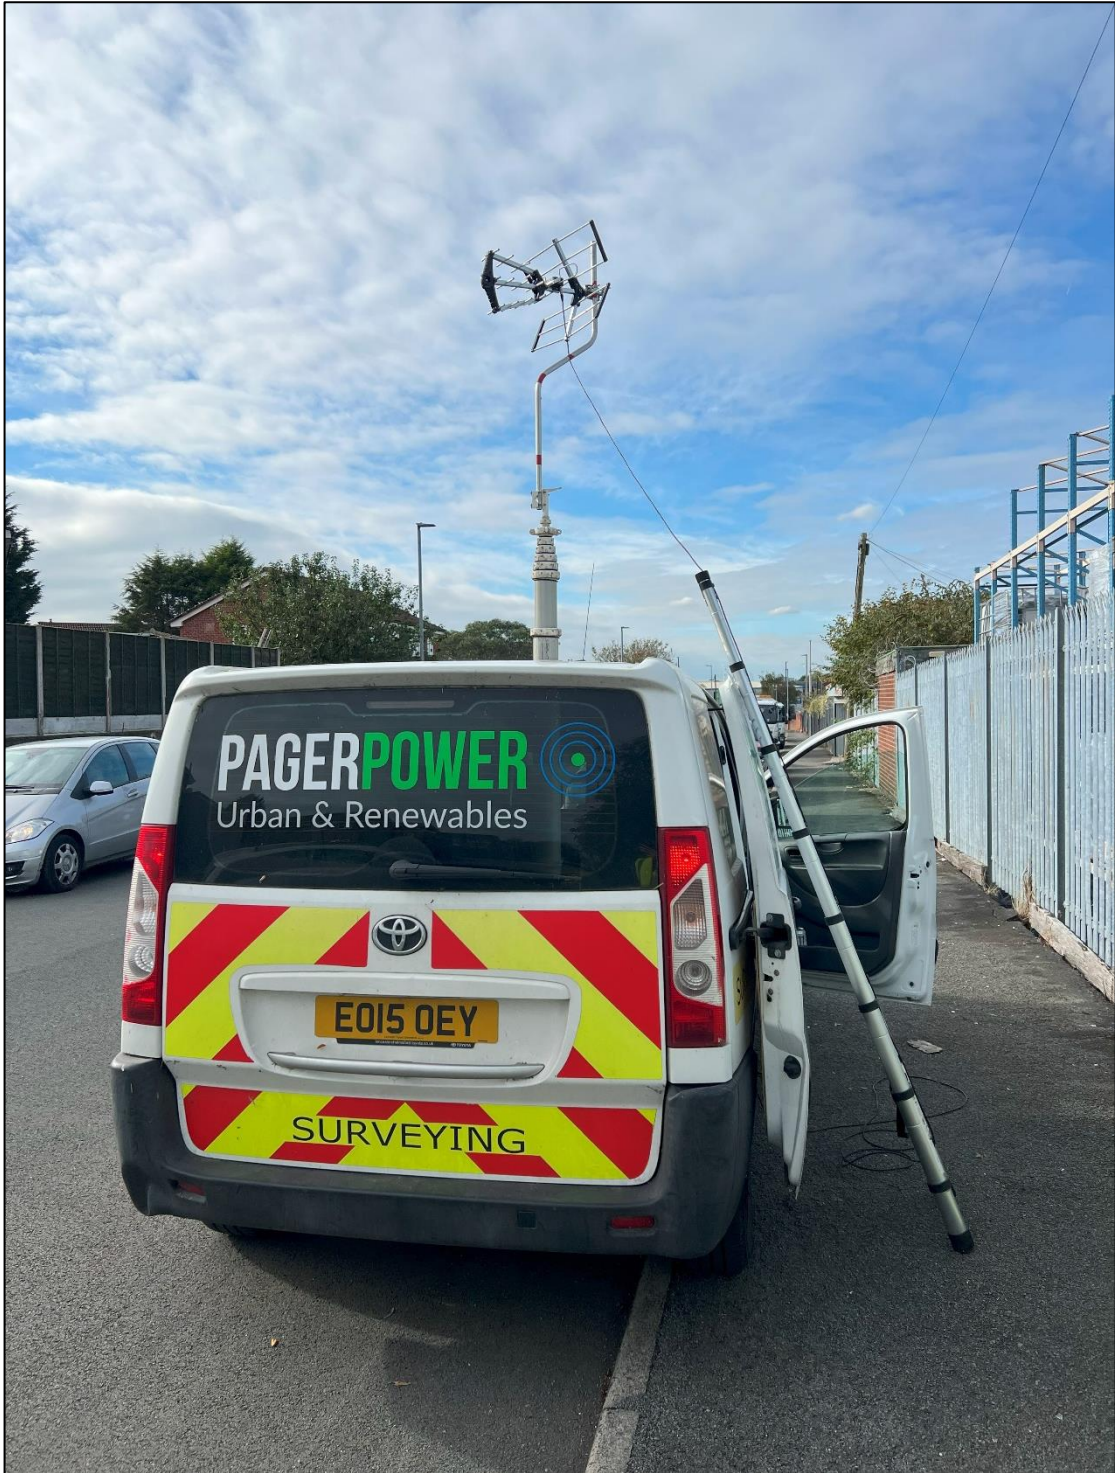
Location 7

Notes: Elevated horizontally polarised UHF aerials directed towards the Winter Hill transmitter and satellite dishes were observed at this location.

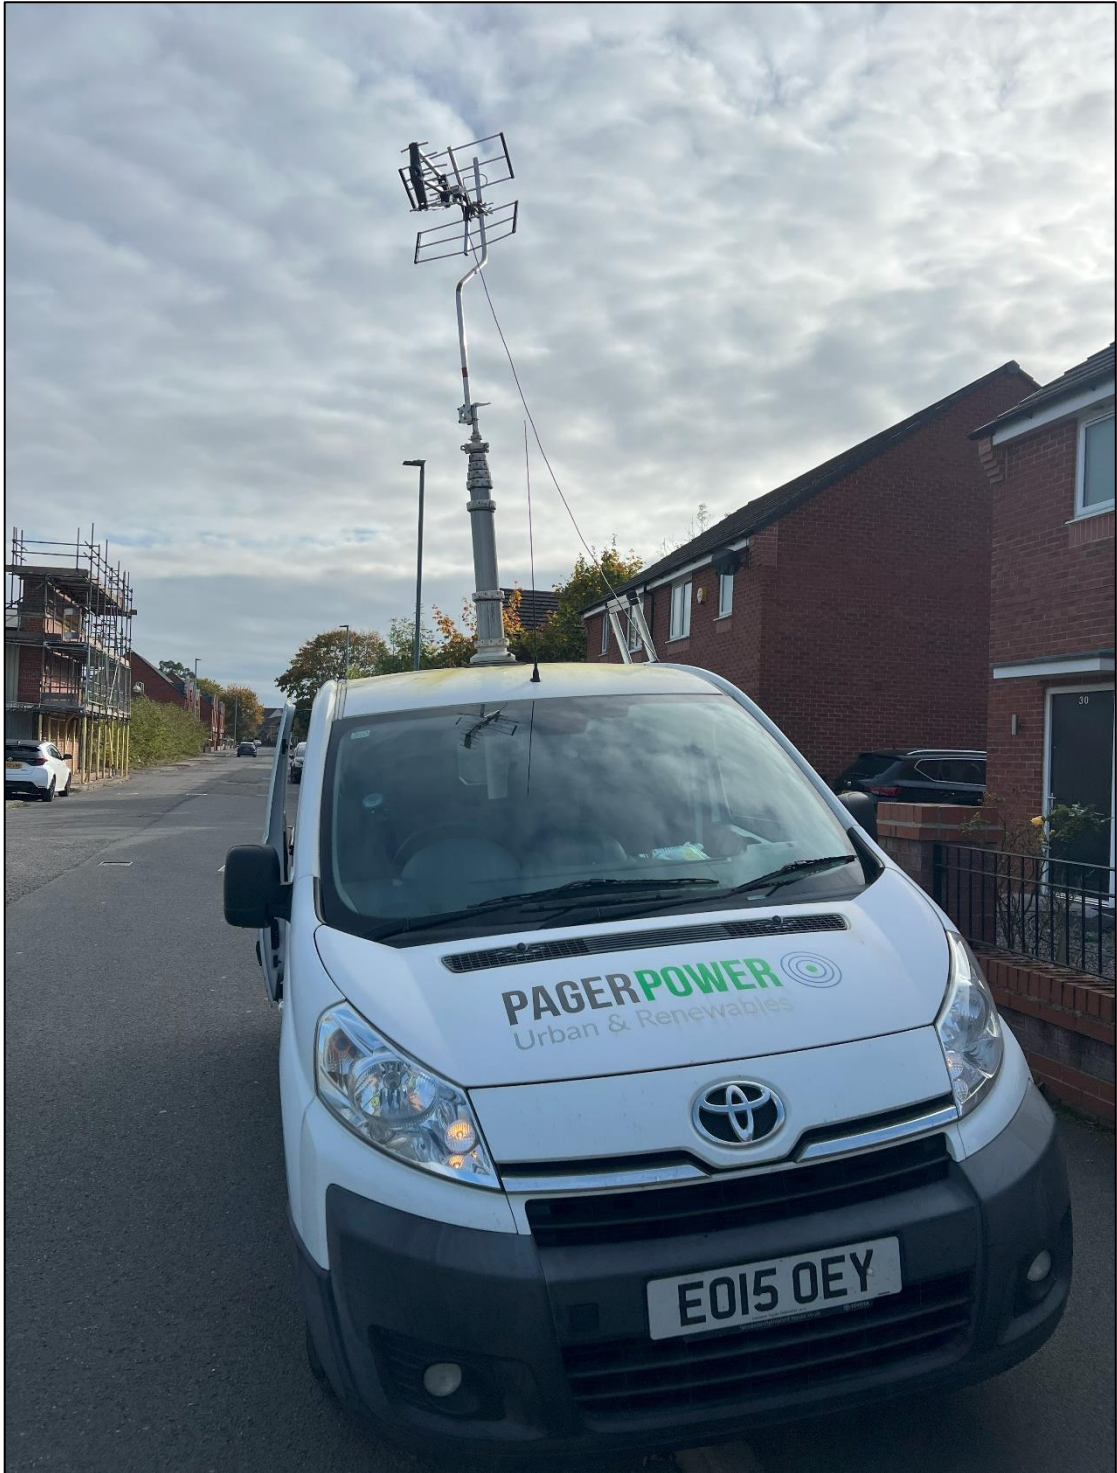
Location 8

Notes: No horizontally or vertically polarised aerials were observed, satellite dishes were observed at this location.

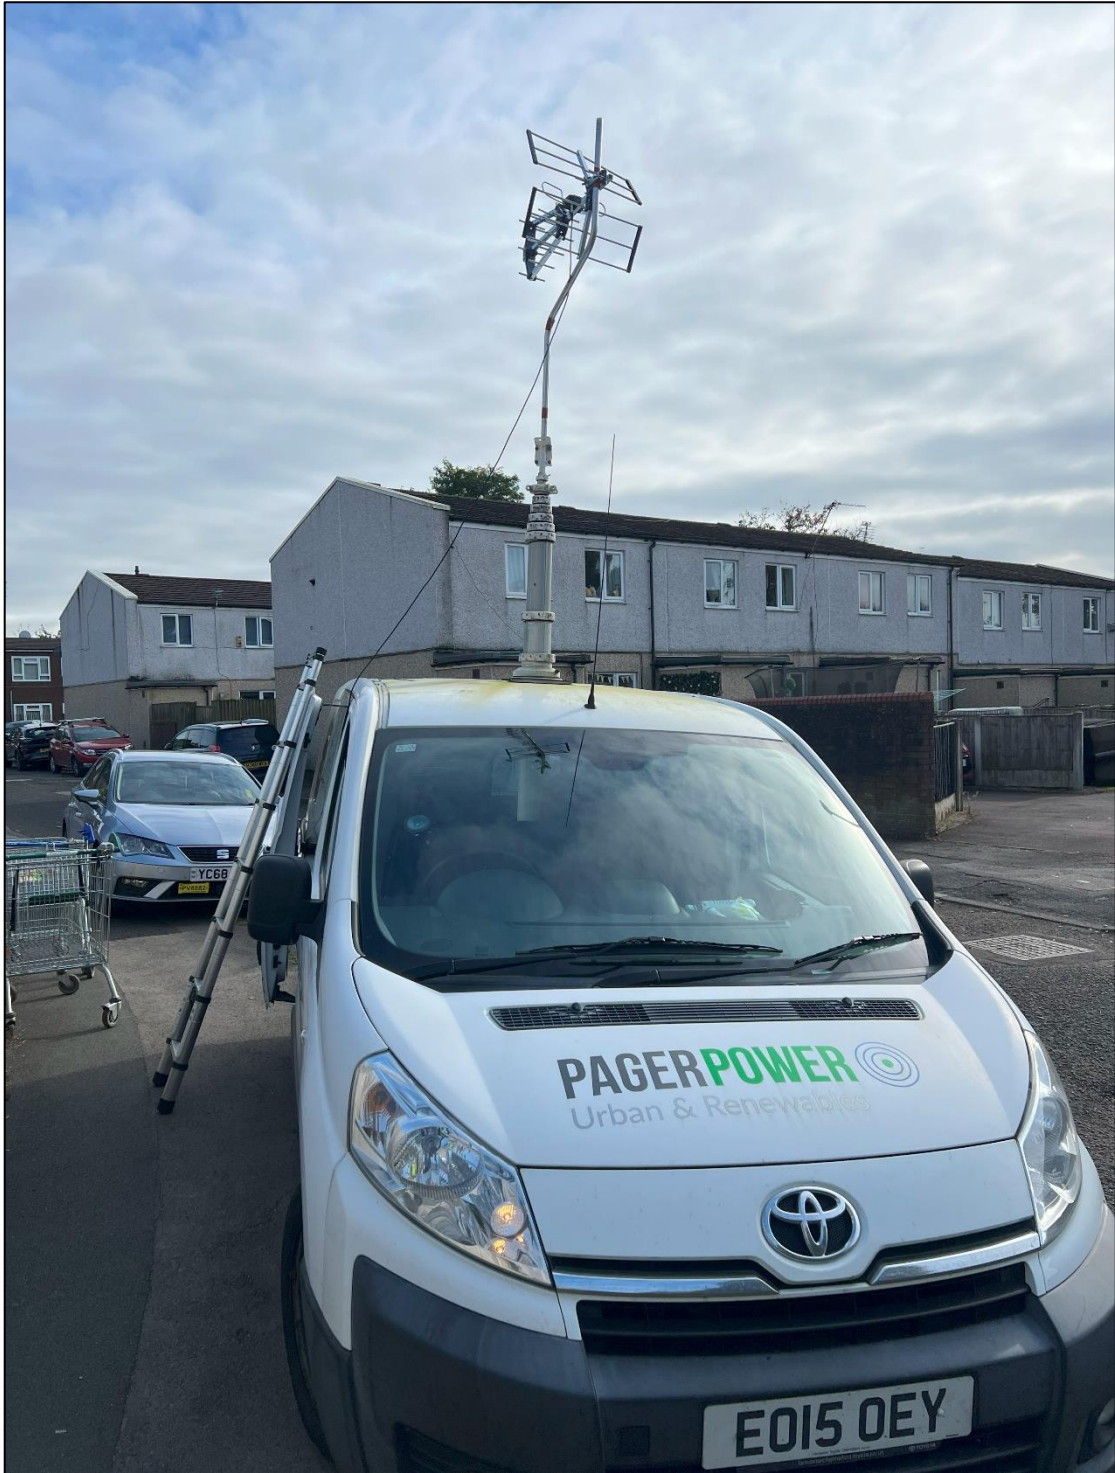
Location 9

Notes: Elevated horizontally polarised UHF aerials directed towards the Winter Hill transmitter and satellite dishes were observed at this location.

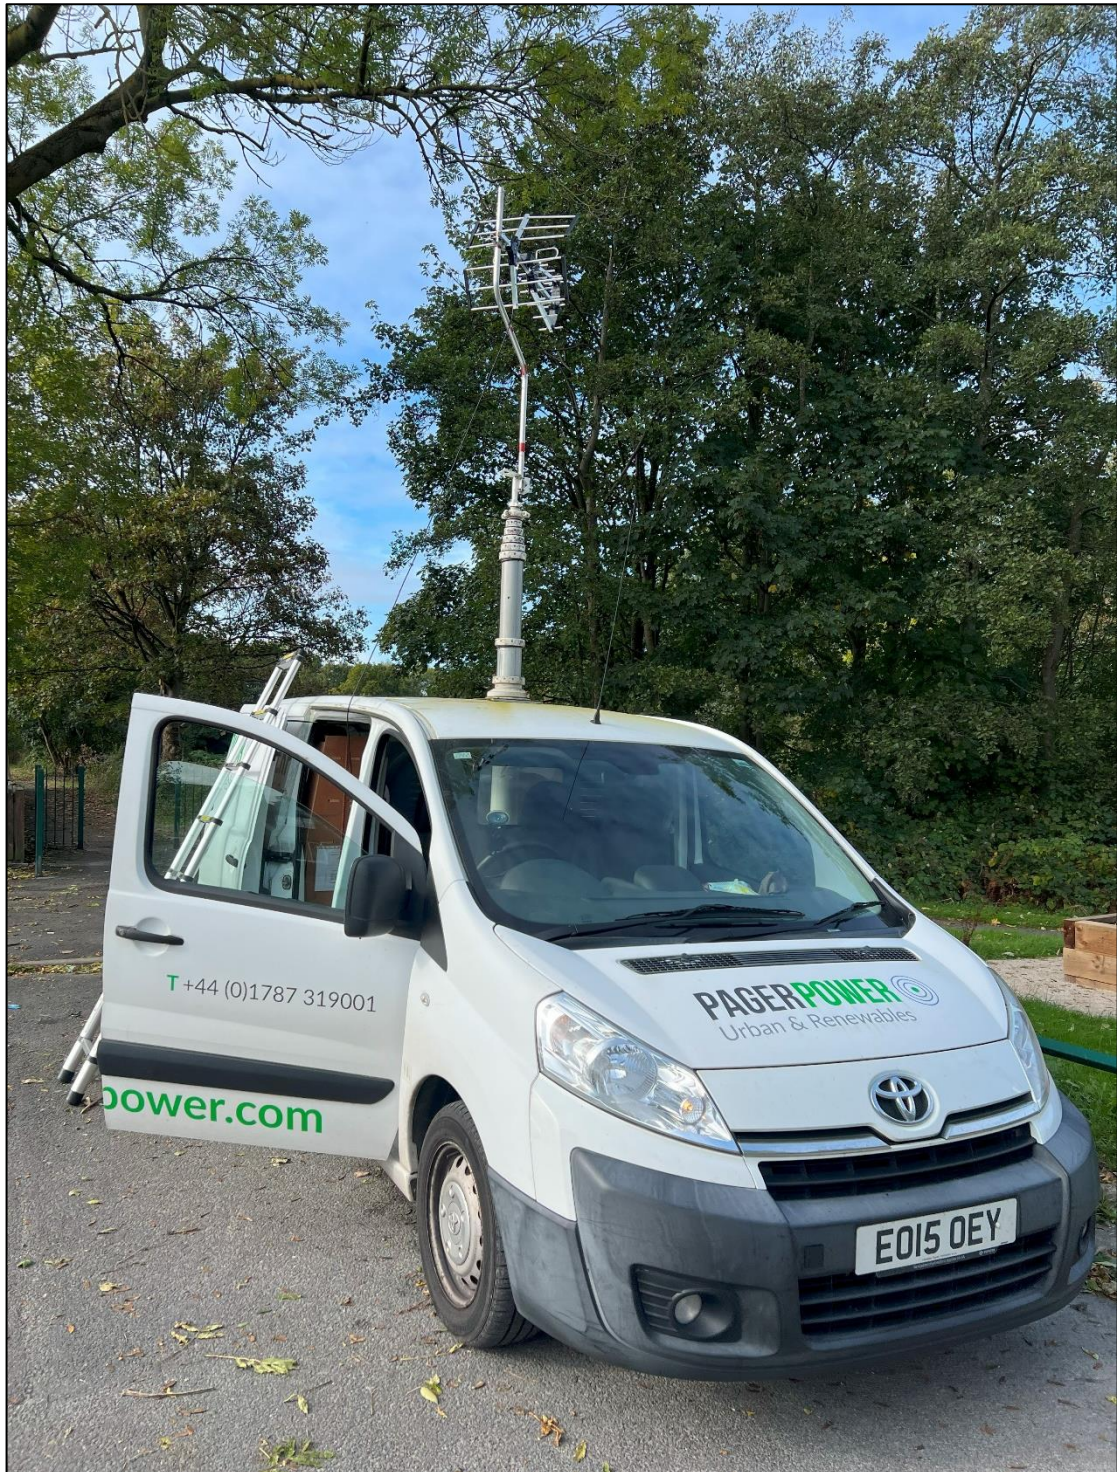
Location 10

Notes: Elevated horizontally polarised UHF aerials directed towards the Winter Hill transmitter and satellite dishes were observed at this location.

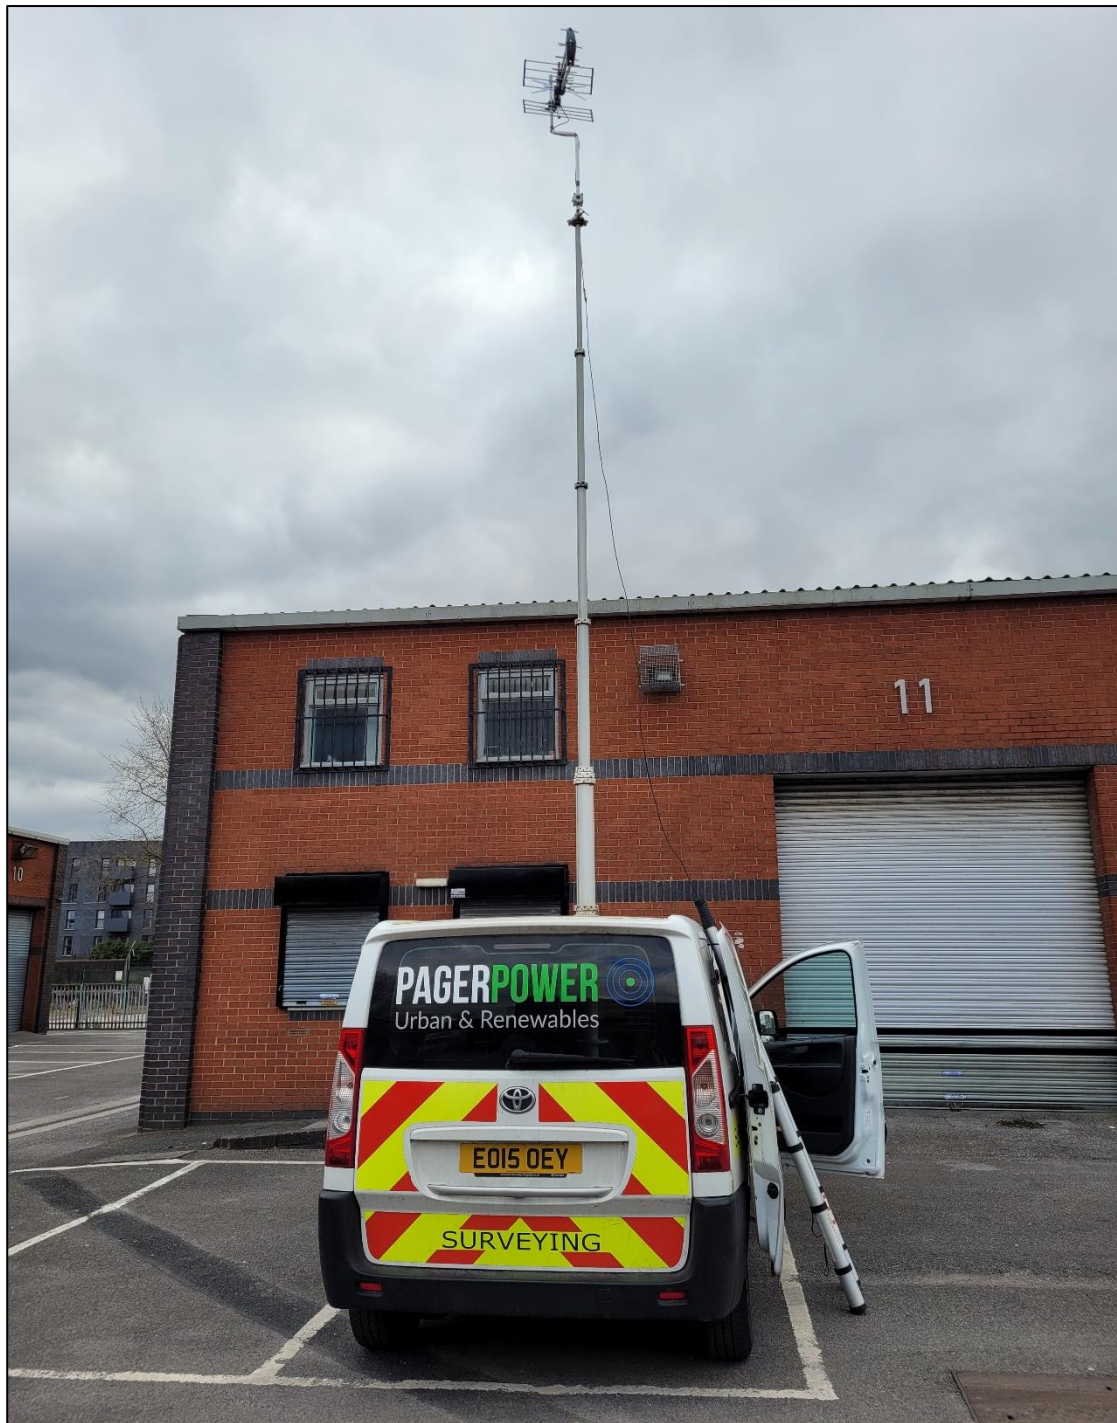
### Location 1

Notes: Elevated horizontally polarised Ultra High Frequency (UHF) aerials directed towards the Winter Hill transmitter were observed at this location.

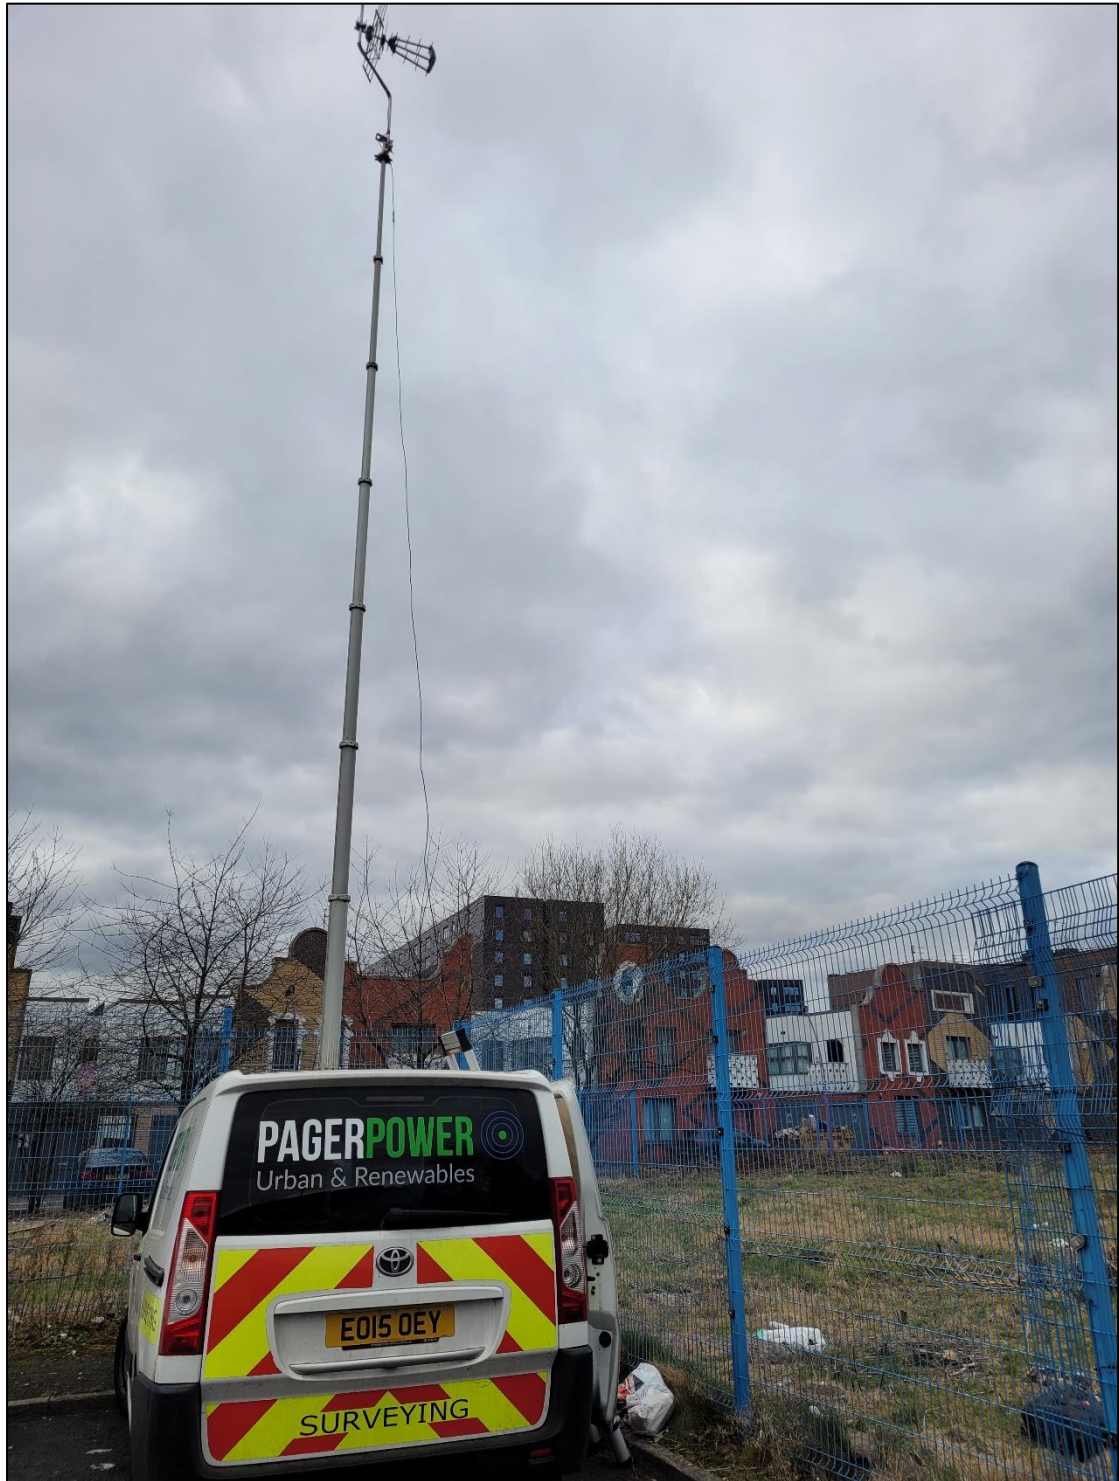
Location 2

Notes: Elevated horizontally polarised UHF aerials directed towards the Winter Hill transmitter and satellite dishes were observed at this location.

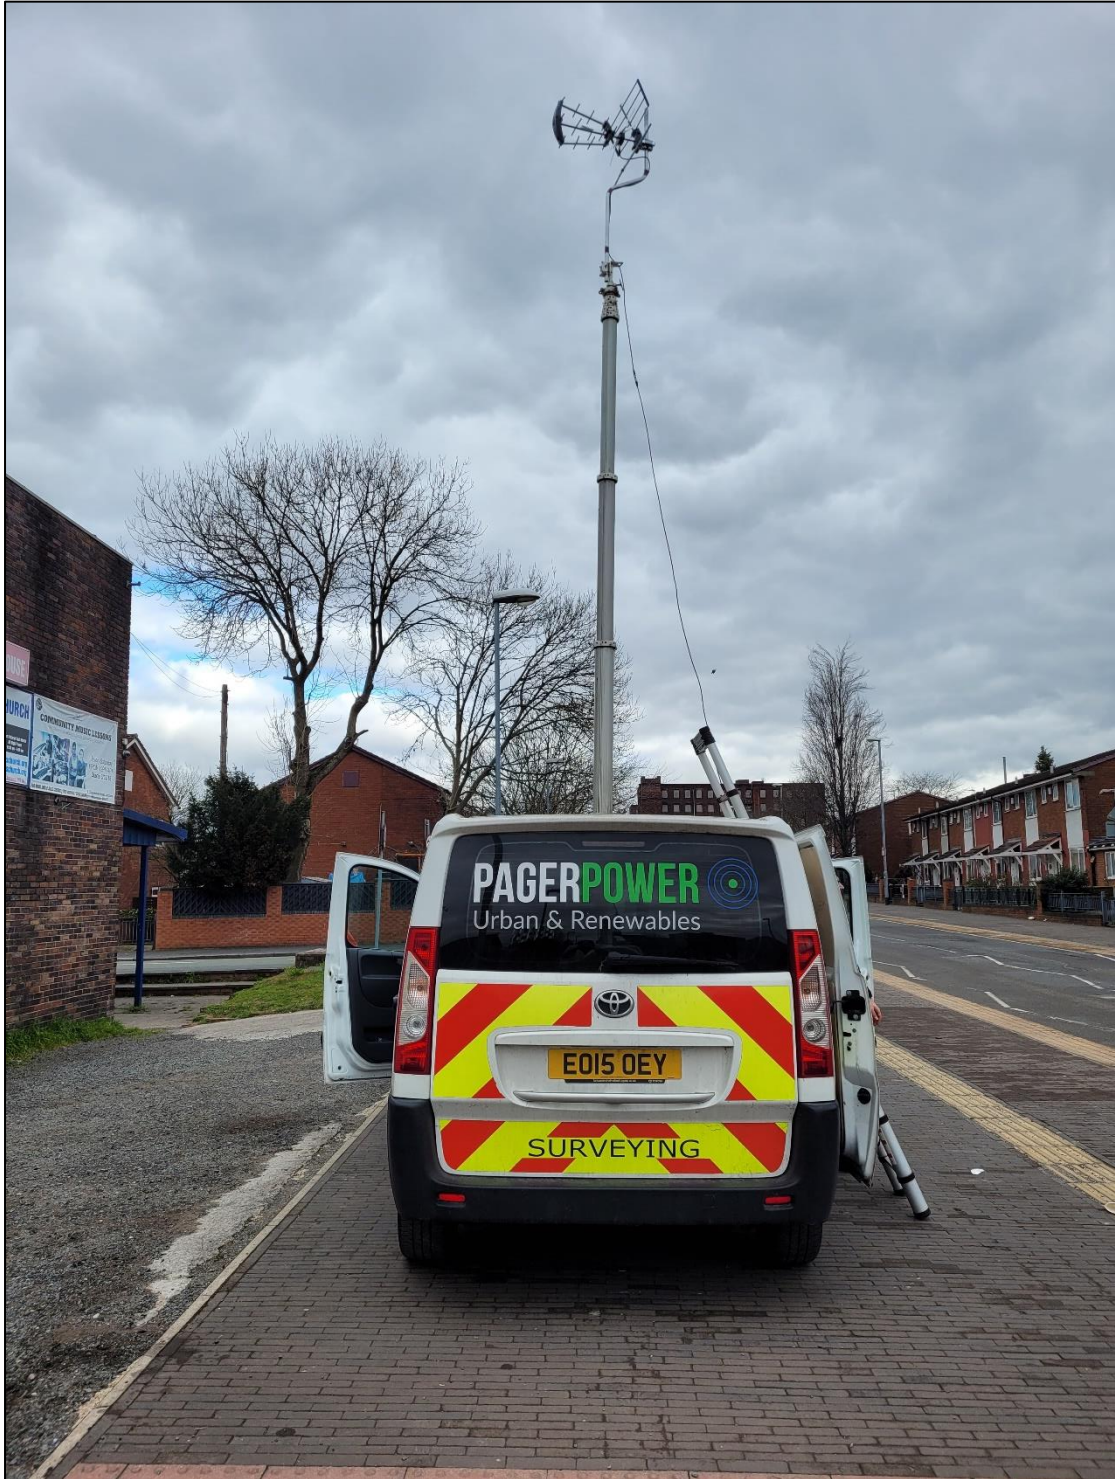
Location 3

Notes: Elevated horizontally polarised UHF aerials directed towards the Winter Hill transmitter and satellite dishes were observed at this location.
