# Television Post-Construction Survey Report

Mobility Hub, Manchester

Bowmer + Kirkland Limited

November 2024

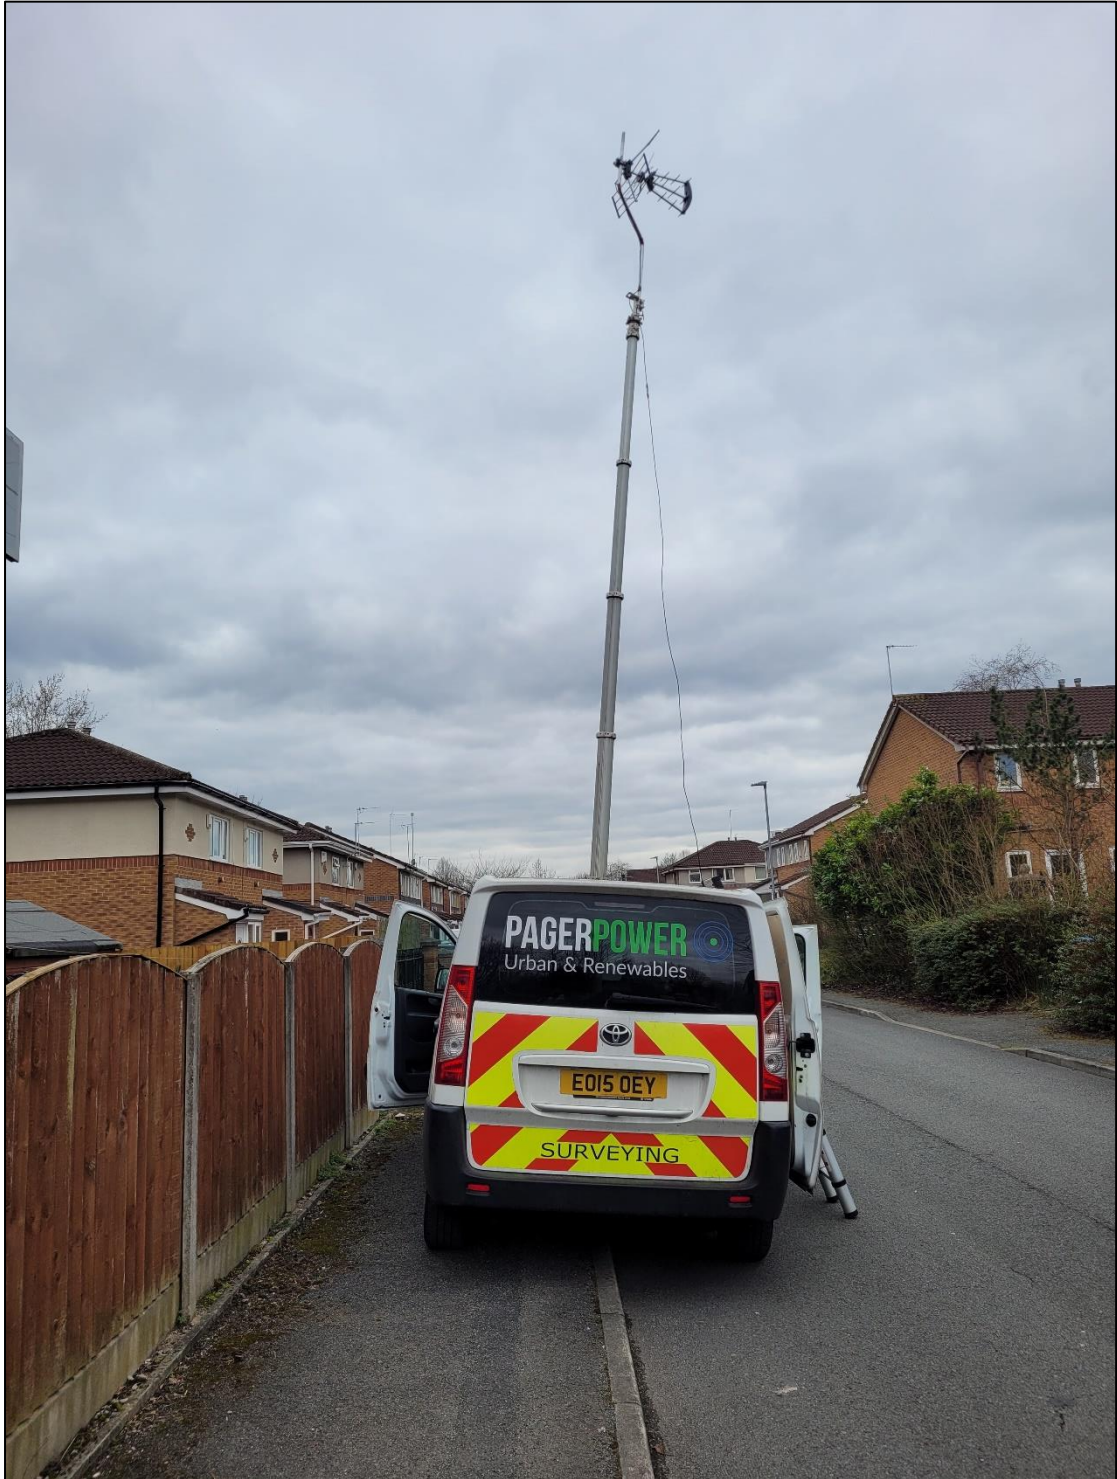
Location 4

Notes: Elevated horizontally polarised UHF aerials directed towards the Winter Hill transmitter and satellite dishes were observed at this location.

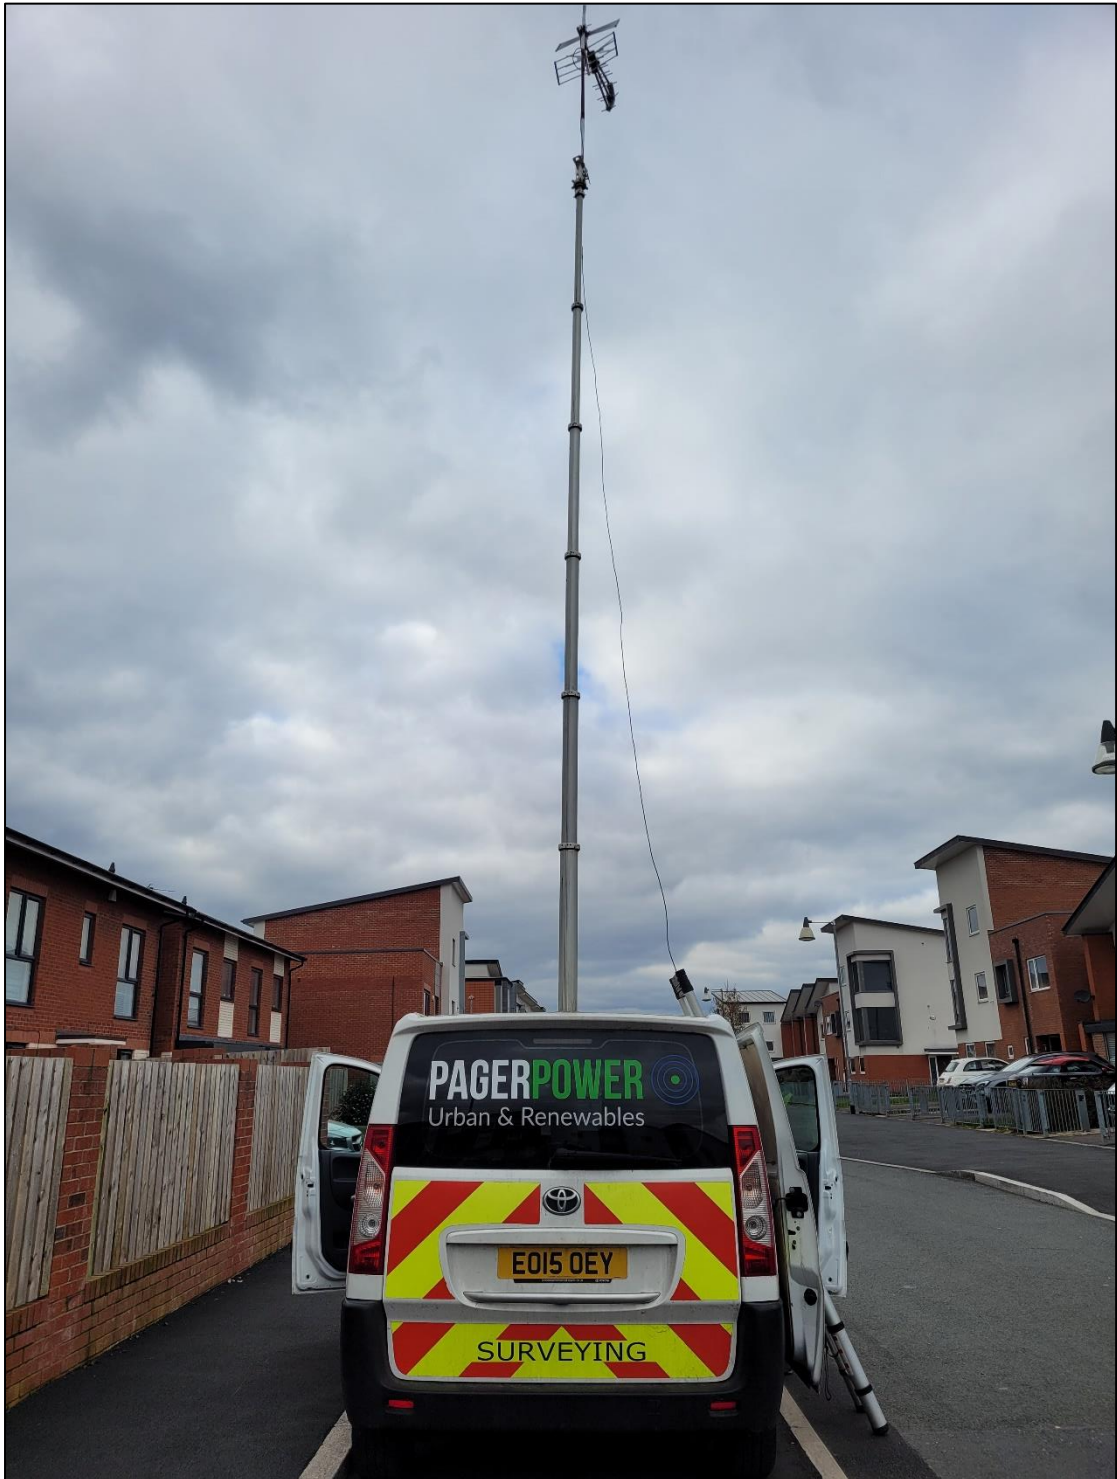
Location 5

Notes: Elevated horizontally polarised UHF aerials directed towards the Winter Hill transmitter and satellite dishes were observed at this location.

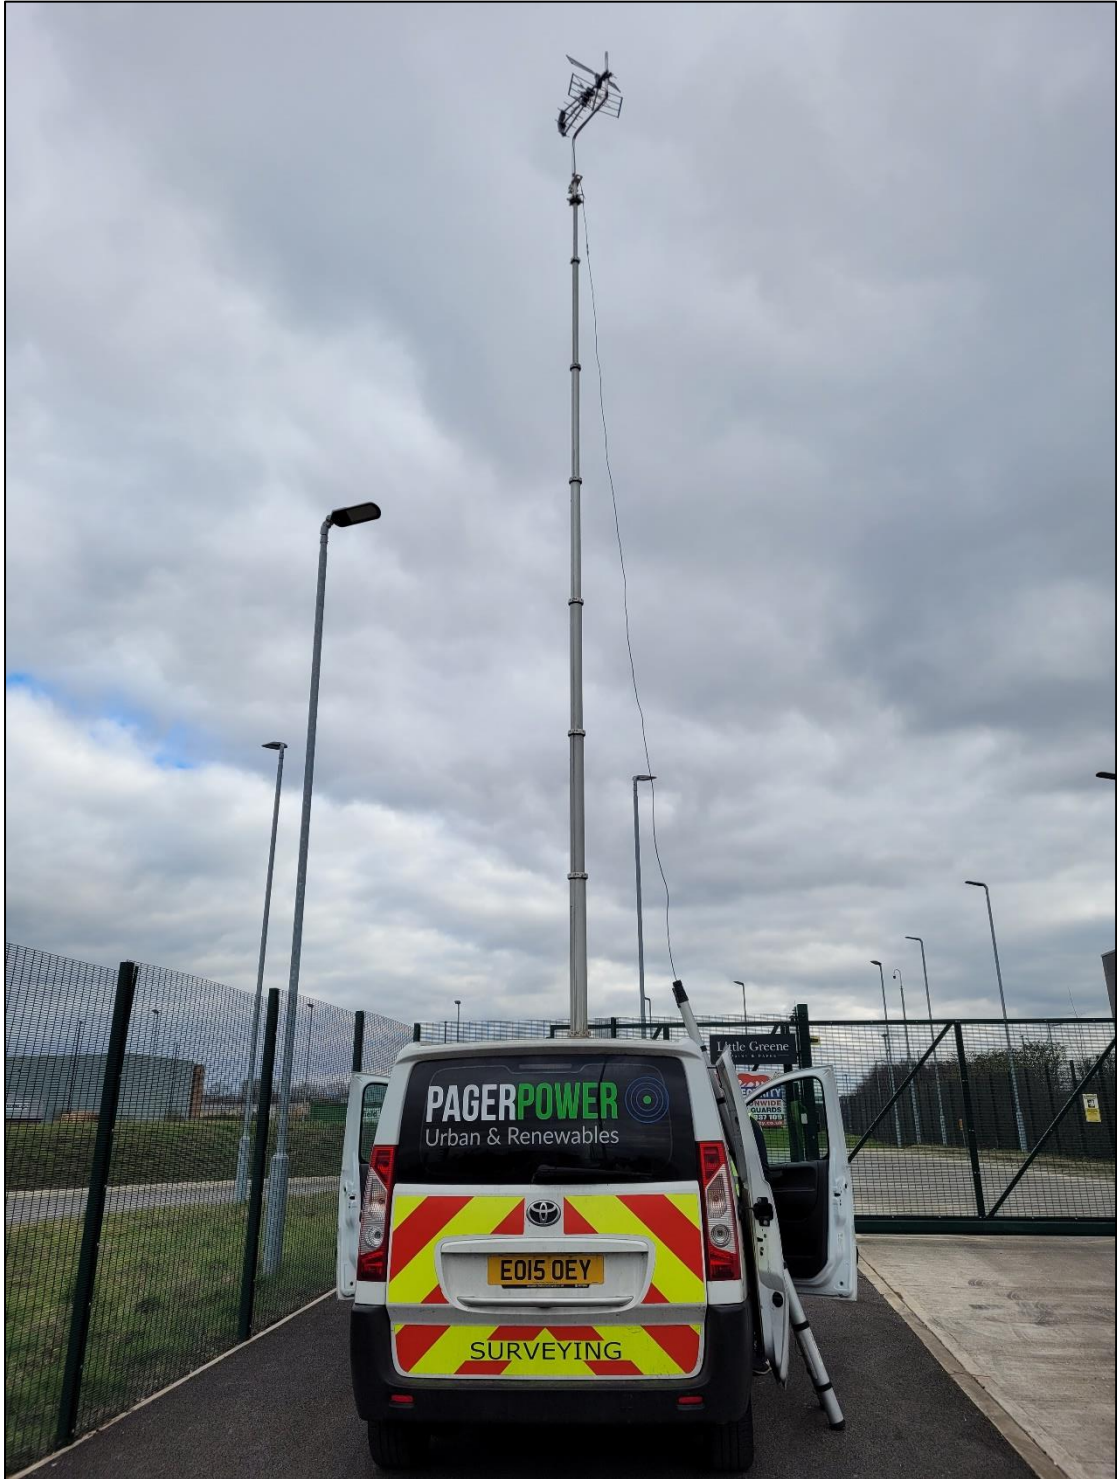
Location 6

Notes: No horizontally or vertically polarised aerials or satellite dishes were observed at this location.

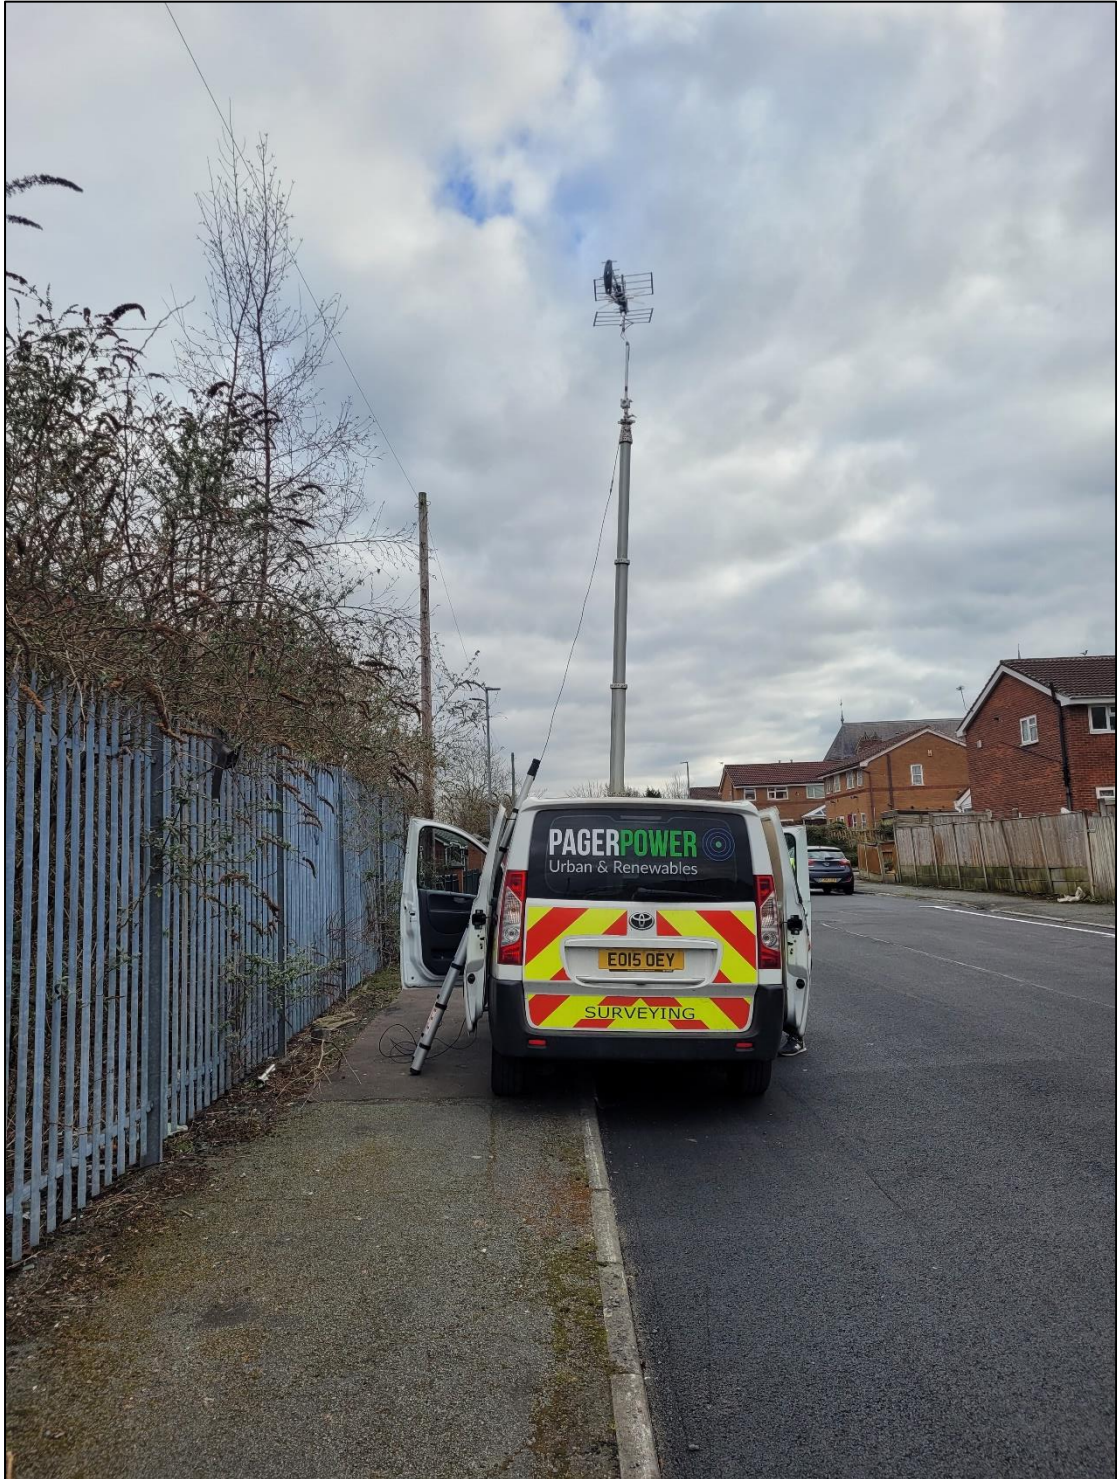
Location 7

Notes: Elevated horizontally polarised UHF aerials directed towards the Winter Hill transmitter and satellite dishes were observed at this location.

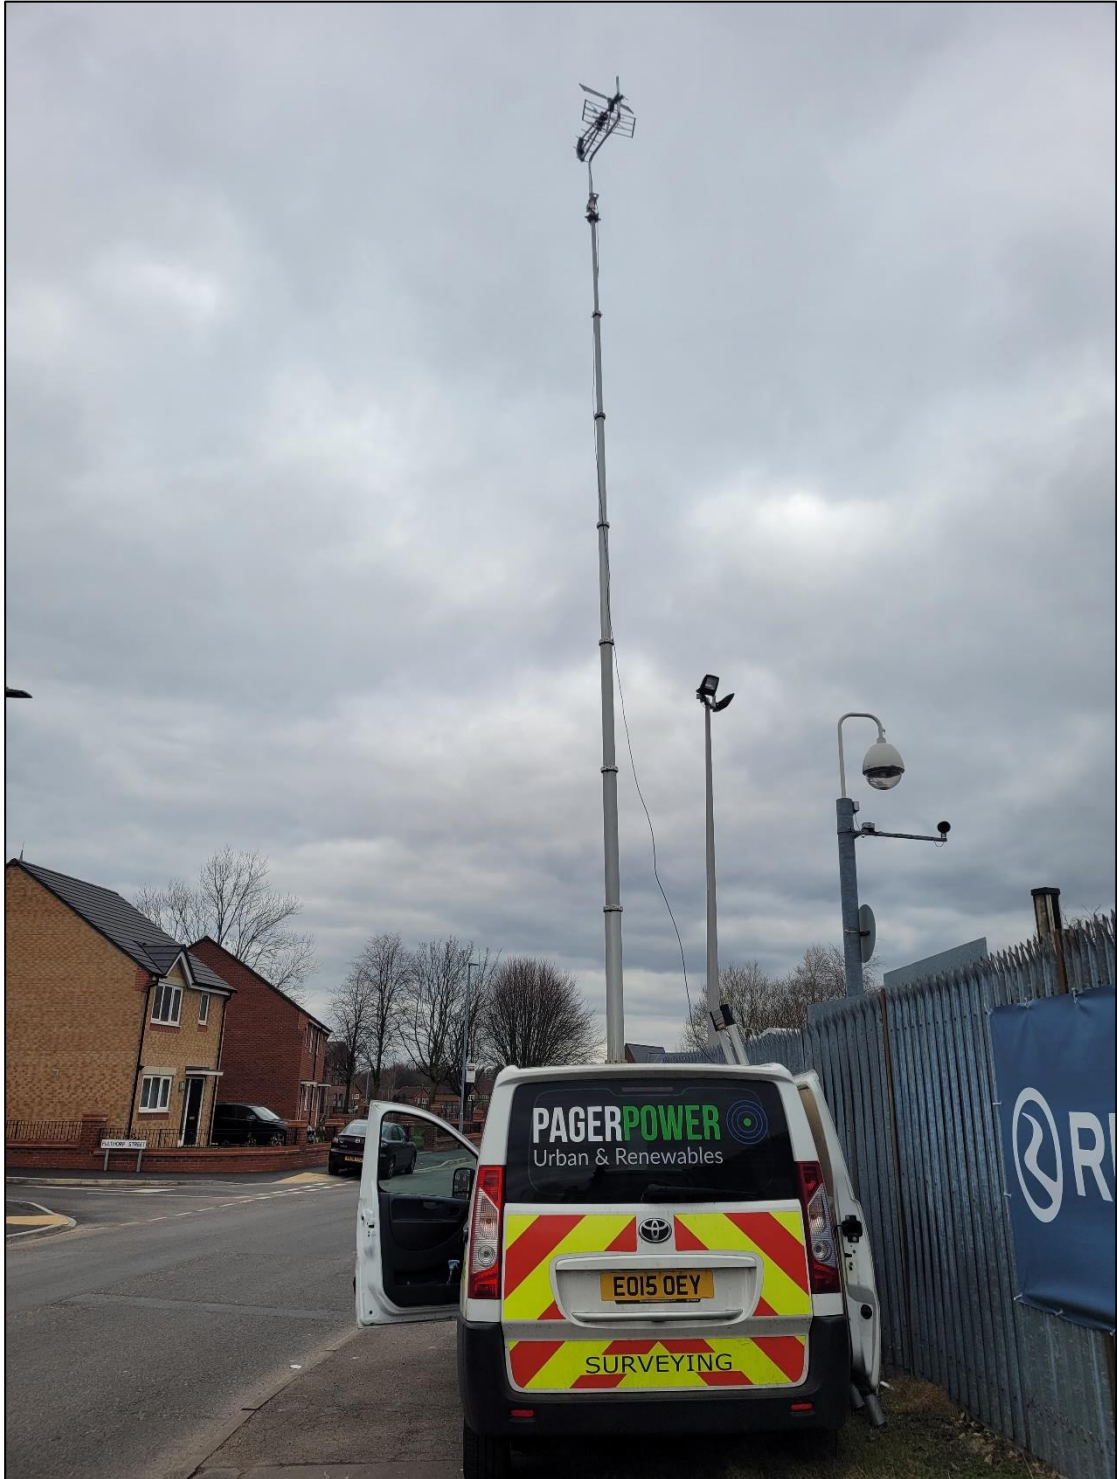
Location 8

Notes: No horizontally or vertically polarised aerials were observed, satellite dishes were observed at this location.

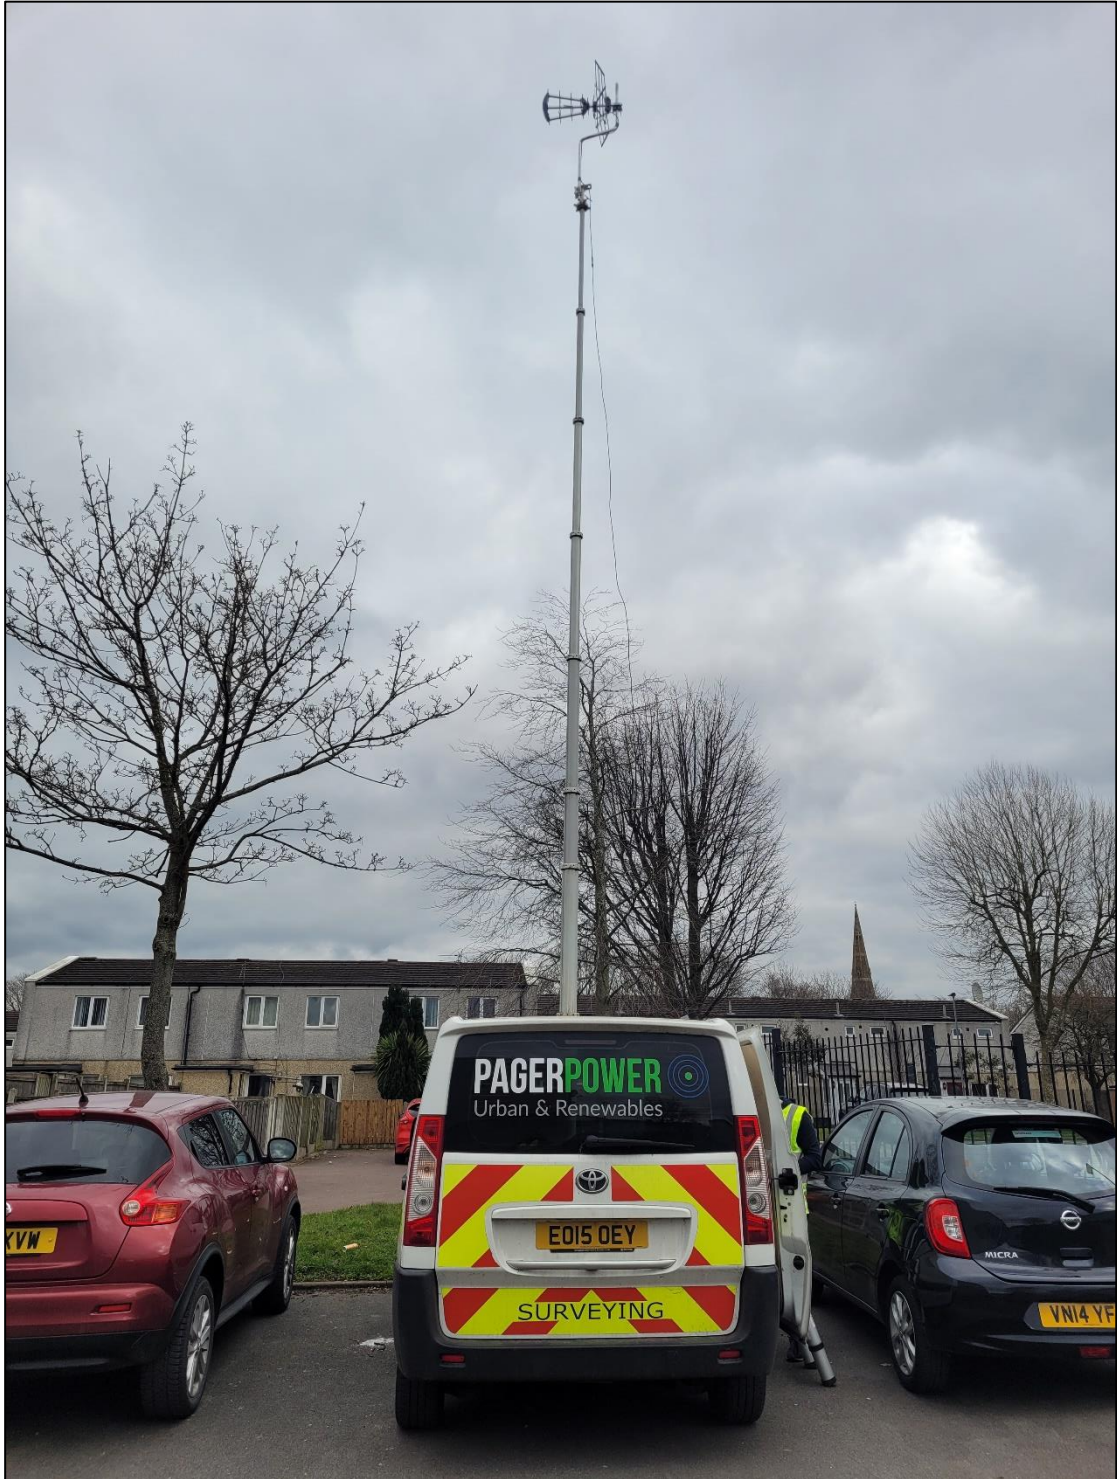
Location 9

Notes: Elevated horizontally polarised UHF aerials directed towards the Winter Hill transmitter and satellite dishes were observed at this location.

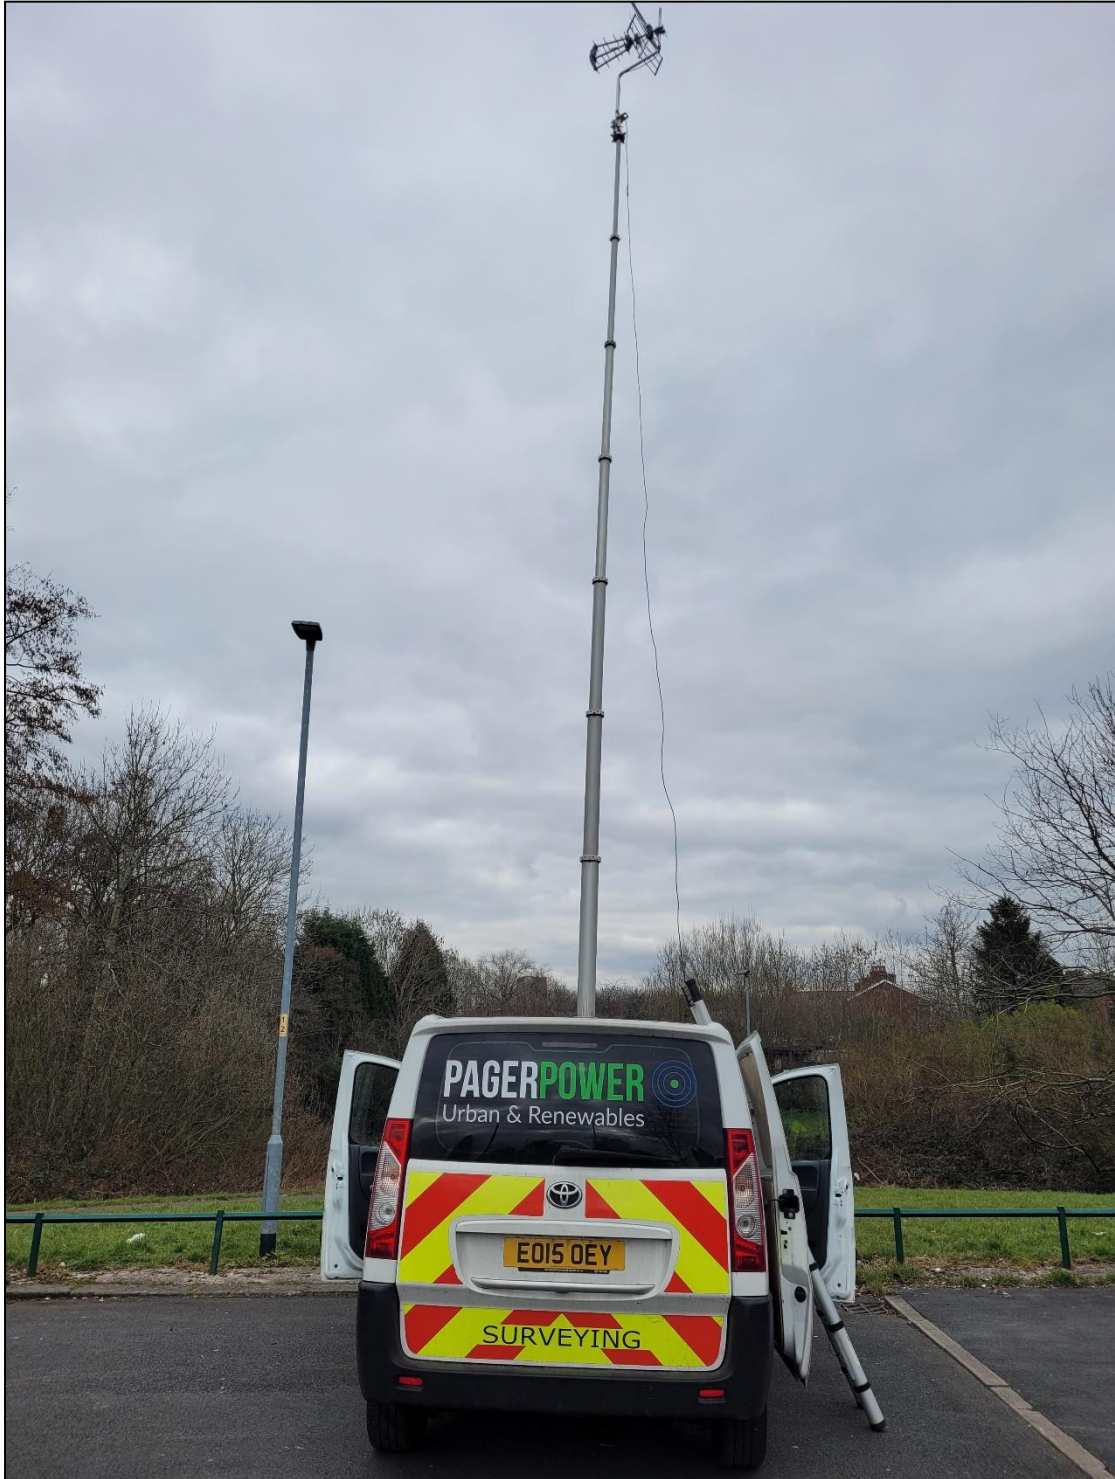
Location 10

Notes: Elevated horizontally polarised UHF aerials directed towards the Winter Hill transmitter and satellite dishes were observed at this location.
