# 35 KING STREET SASH WINDOW REPORT

Tuesday, October 29, 2024

Prepared For Portview Fitout Ltd

16 Issues Identified

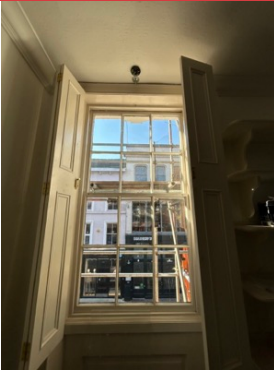
**W-08**

This also includes for hack out and reglaze of broken glass in top sash.

Full Refurbishment and draught-proofing of existing sash windows.

Existing timber sill of sash box to be cut out and replaced with Like for like replacement to eliminate rot.

Glass will be 6mm as per existing and be glazed with Toupret glazing putty

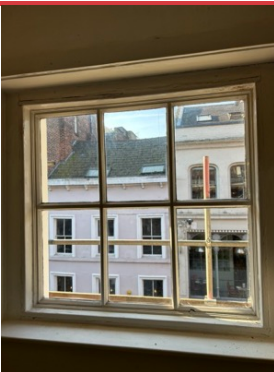
**W-21**

This is due to the fact original sashes have been removed and a fixed casement has been badly installed into existing box.

Replacement redwood top and bottom sashes to be fitted into the existing box.

New replacement sashes to be single glazed and matching existing sashes on 2nd floor as per original design.

Replacement timber sill on existing box required to eliminate rot.

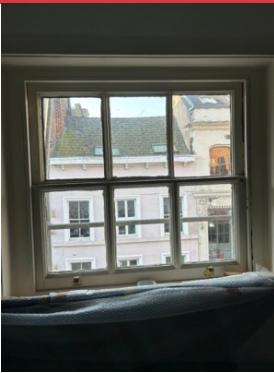
**W-22**

This is due to the fact original sashes have been removed and a fixed casement has been badly installed into existing box.

Replacement redwood top and bottom sashes to be fitted into the existing box.

New replacement sashes to be single glazed and matching existing sashes on 2nd floor as per original design.

Replacement timber sill on existing box required to eliminate rot.

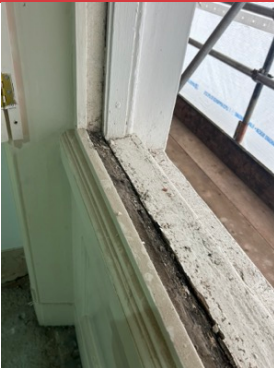
### **EXAMPLE OF ROTTEN SILL**

As pictured this is the sill from W-08

The front section has been spliced badly which has resulted in the sill still having rot present and an incorrect slope on the sill causing more problems.

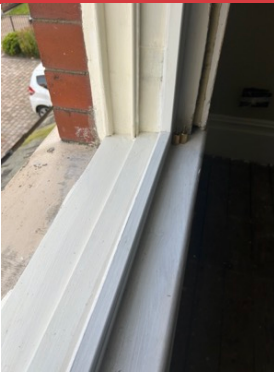
### **EXAMPLE OF FULL SILL REPLACEMENT**

As pictured this is an example of a sill replacement.

All rot has been fully eliminated, original box is unaffected and no change to look as the replacement is like for like.
