# Preliminary Roost Assessment

60a Wood Road  
Whalley Range  
Manchester  
M16 8BL

For  
Northedge Architecture

# Gritstone Ecology

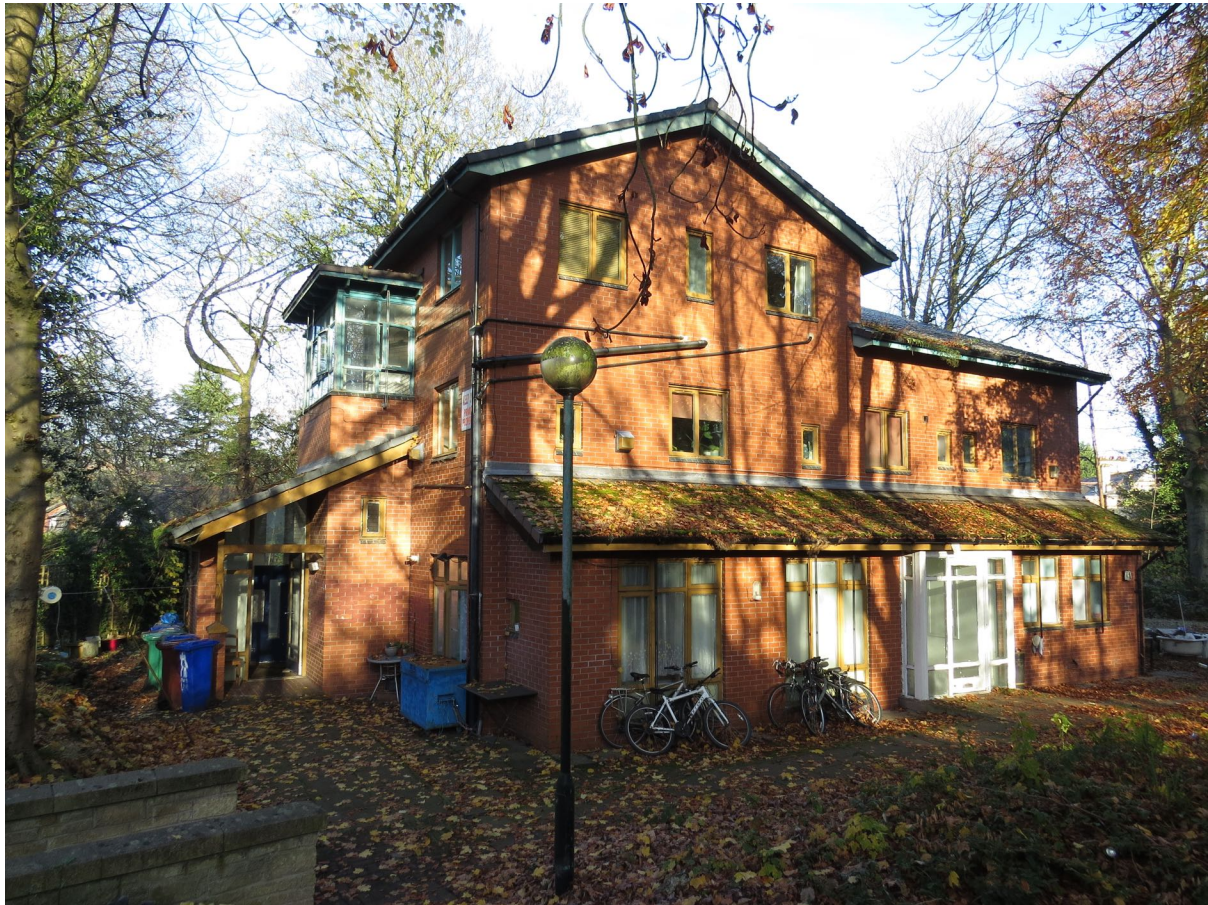
3.1a – The front of the building.

Nº60a Wood Road, Whalley Range, is a former children's home, which was converted to residential apartments, and is currently occupied and in use. It has a pitched roof, covered with Marley concrete roof tiles and vented mechanically-fixed ridge tiles. Ground floor extensions have single pitched roofs covered with Marley concrete tiles.

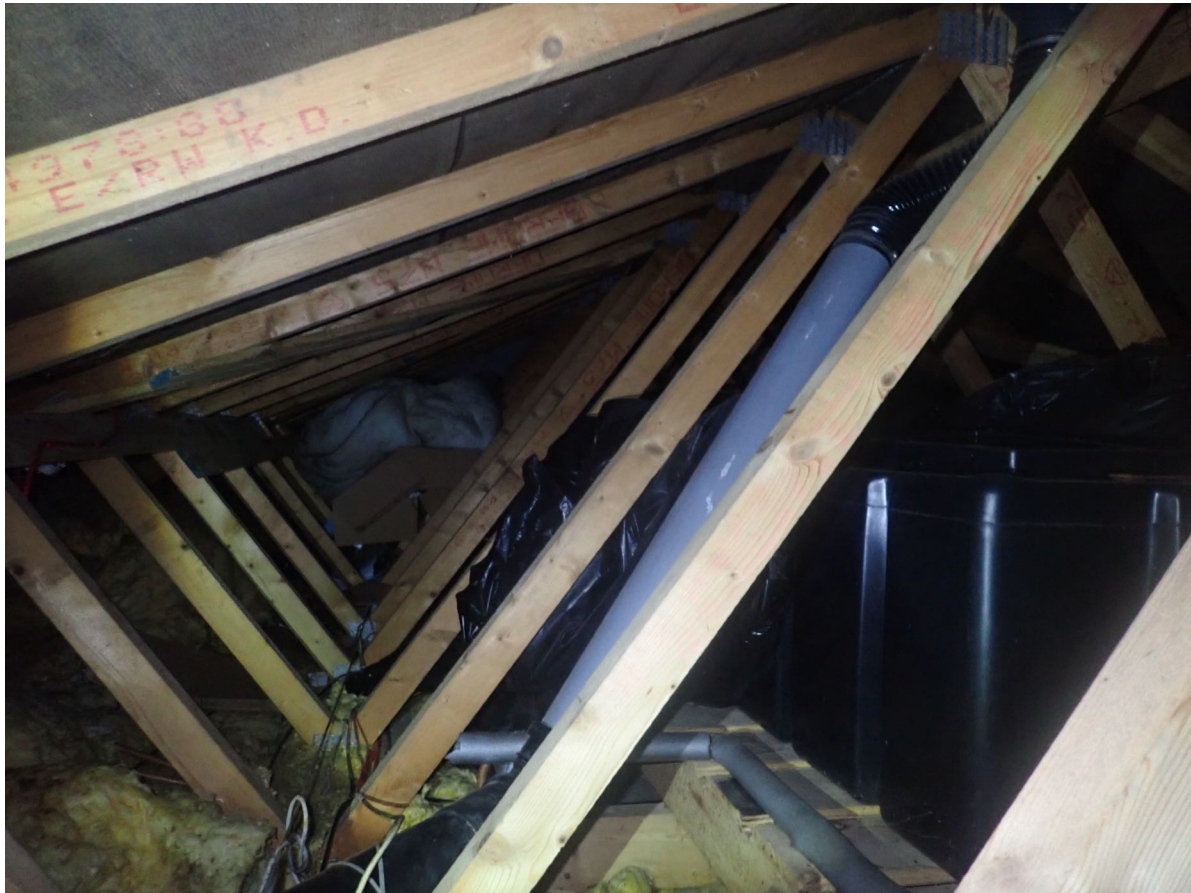
3.2a – The roof void.

The building has a single roof void, which is not used for storage, and is only accessed infrequently for essential maintenance work.

The roof has a trussed timber structure, lined with bitumen felt, and insulated with mineral wool between the ceiling joists. The roof lining is in good condition with no tears, or gaps.

The wall cavity was inspected at the wall plate using an endoscope. There are no gaps at the wall-plate; and there are no gaps which give direct access to the roof void from the outside. Boxed soffits open into the roof void and were inspected from above.

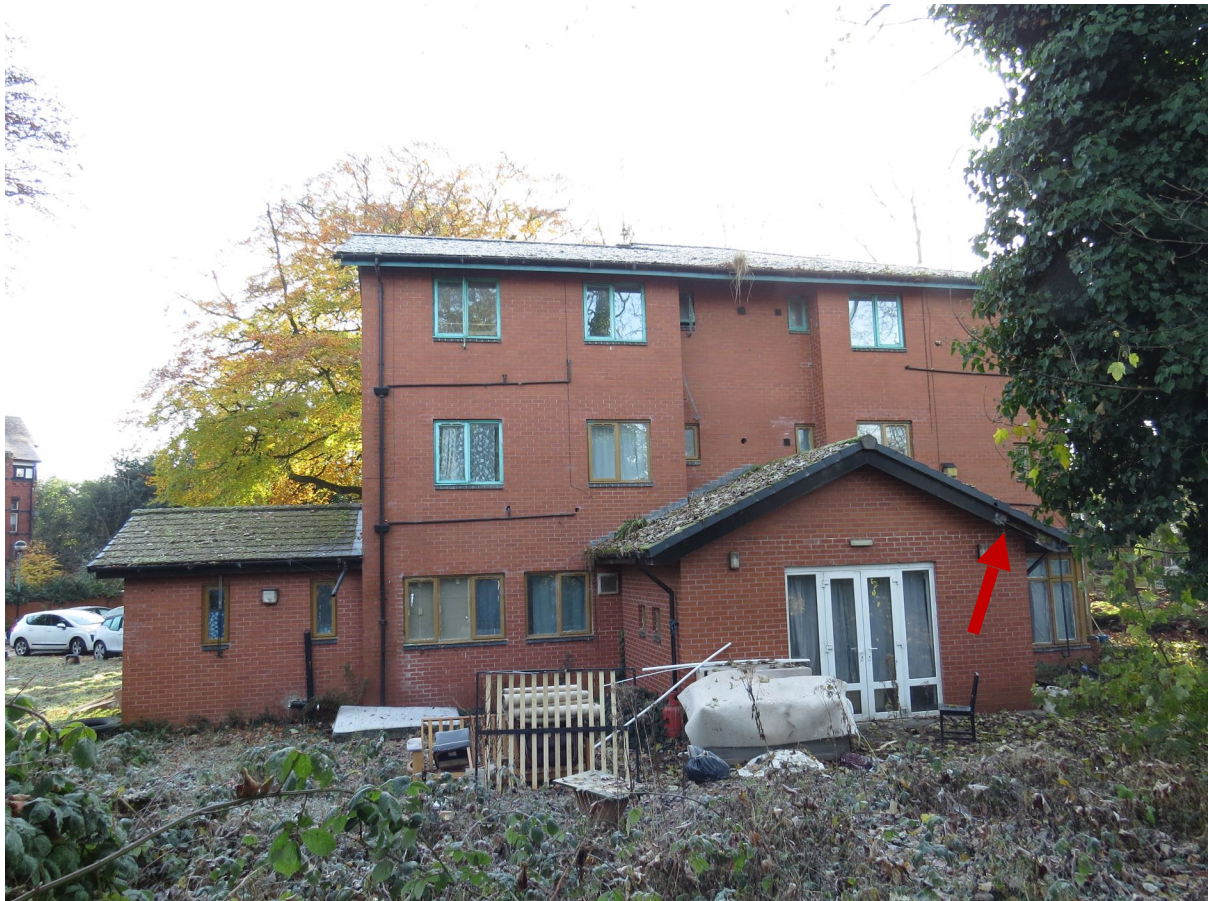
There are small areas of damaged fascia boards to the rear of the building, and a gap beneath lead flashing at the side of the building, which are potentially suitable for use by roosting bats.

There is a small section of damaged fascia board on a single storey roof to the rear of the building, and a gap beneath lead flashing to the side of the building, which could allow access to the small cavity between roof tiles and roofing felt.

2 – The rear of the building with damaged fascia indicated.

The building has a **low suitability** for use by roosting bats. A single dusk emergence survey is recommended during the active season for bats (May to August).

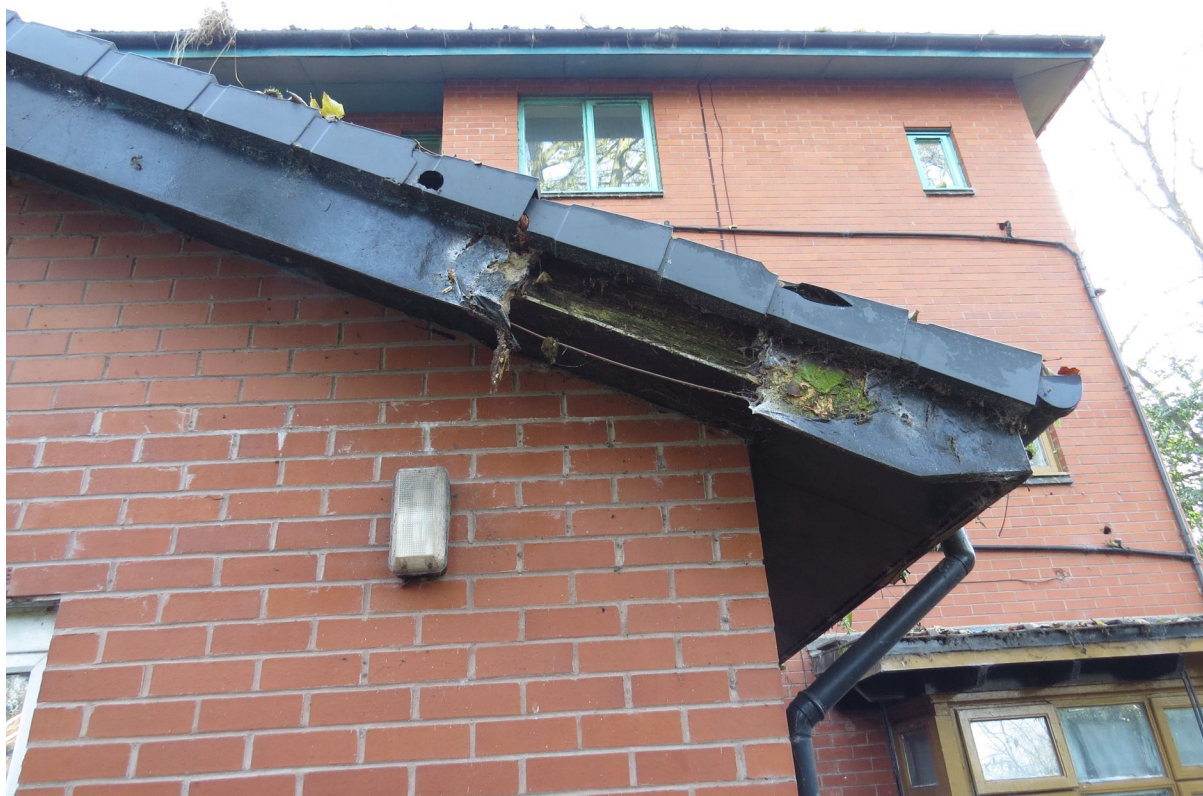
The building is well maintained, and in generally good condition. However, there are areas of damaged soffits and fascia boards which could be used by roosting bats.

The building has a low number of external features which are potentially suitable for use by roosting bats, including gaps beneath damaged fascia boards, which could lead into wall cavities, or the small crevices between roofing materials. These are features which cannot be fully inspected without a destructive search, and the presence of roosting bats, in these areas, cannot be ruled out.

3 – Damaged fascia boards and soffits.

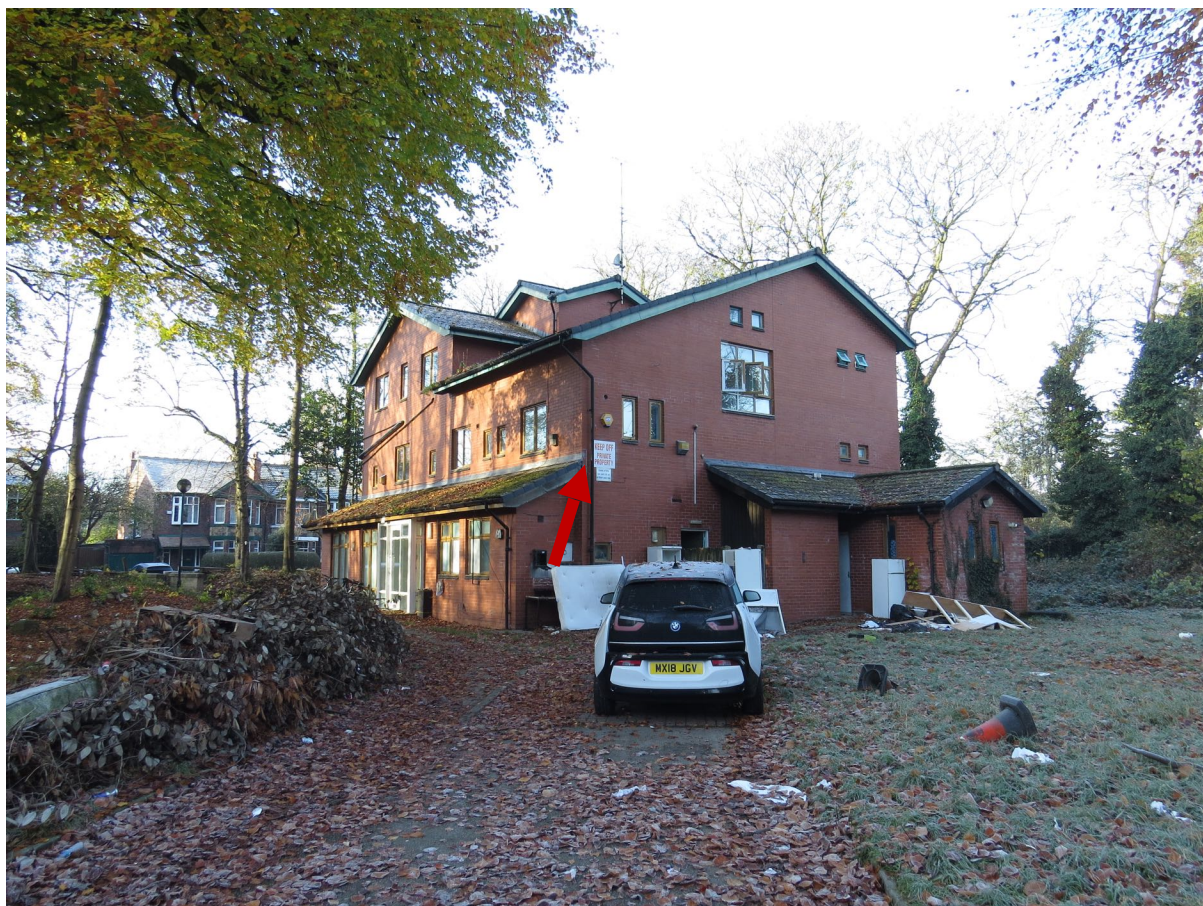
4 – Gaps behind lead flashing.

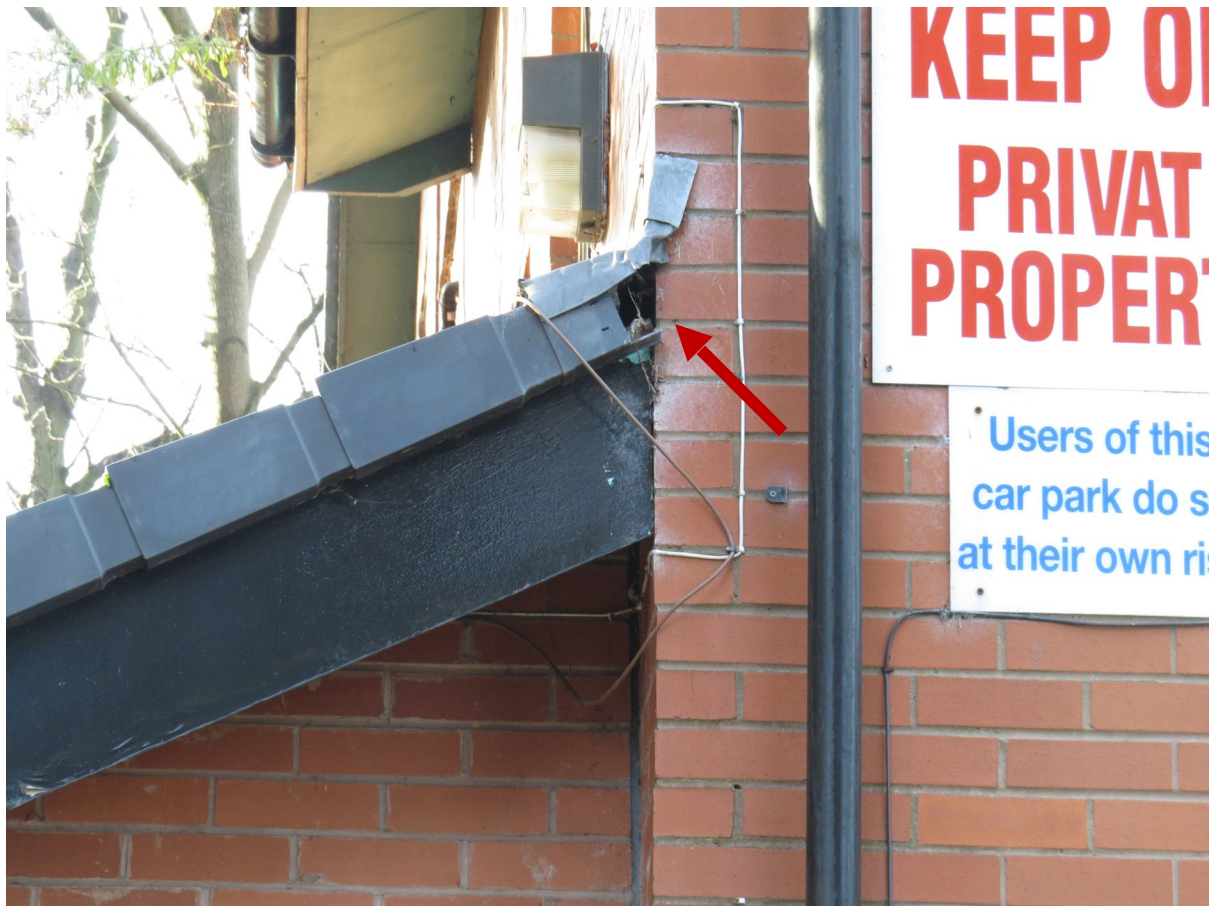
5 – Lead flashing and dry verge covers are damaged and could give access to roosting bats.

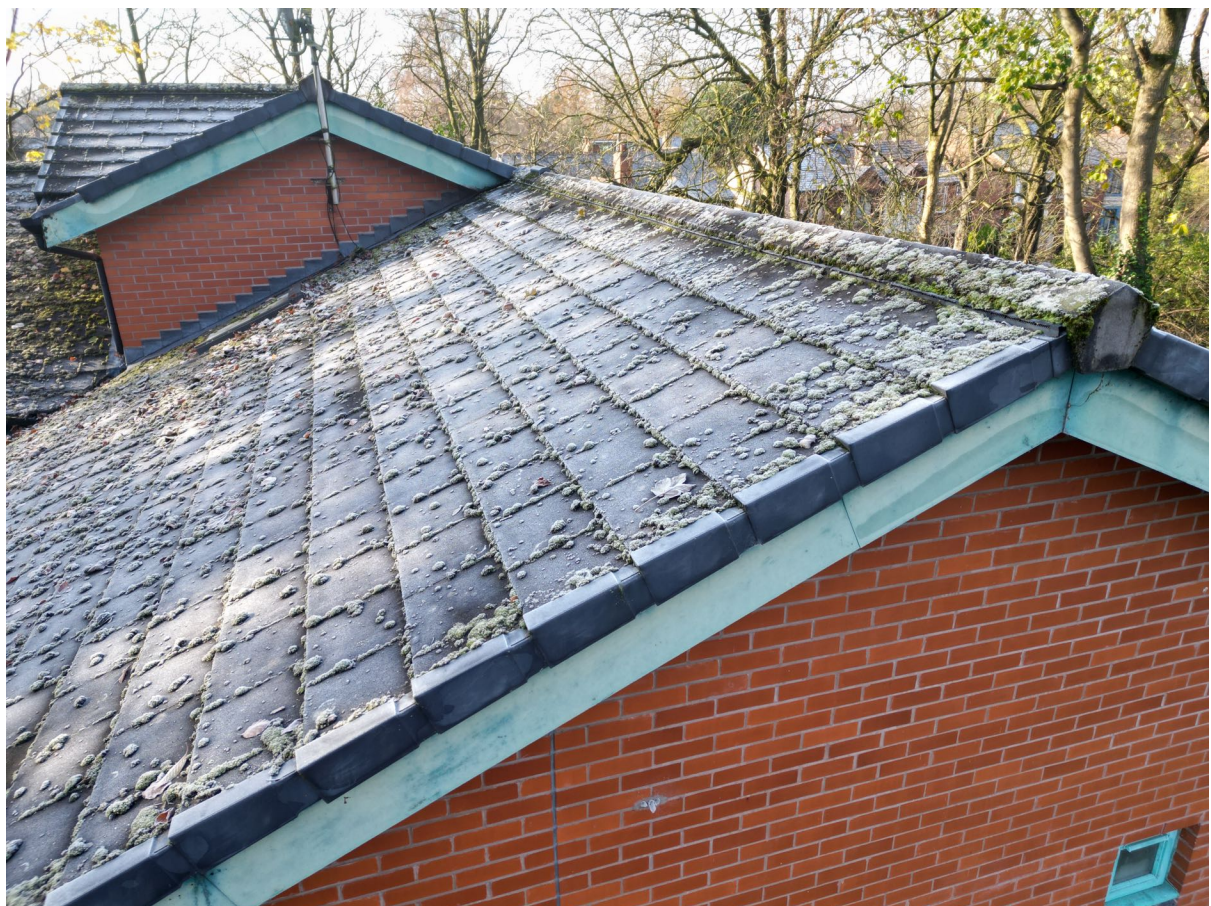
Roof and ridge tiles are in good condition; ridge tiles are vented and mechanically fixed. There are no gaps between roofing materials which could be used by roosting bats.

6 – Roof and ridge tiles are in good condition with no viable gaps.

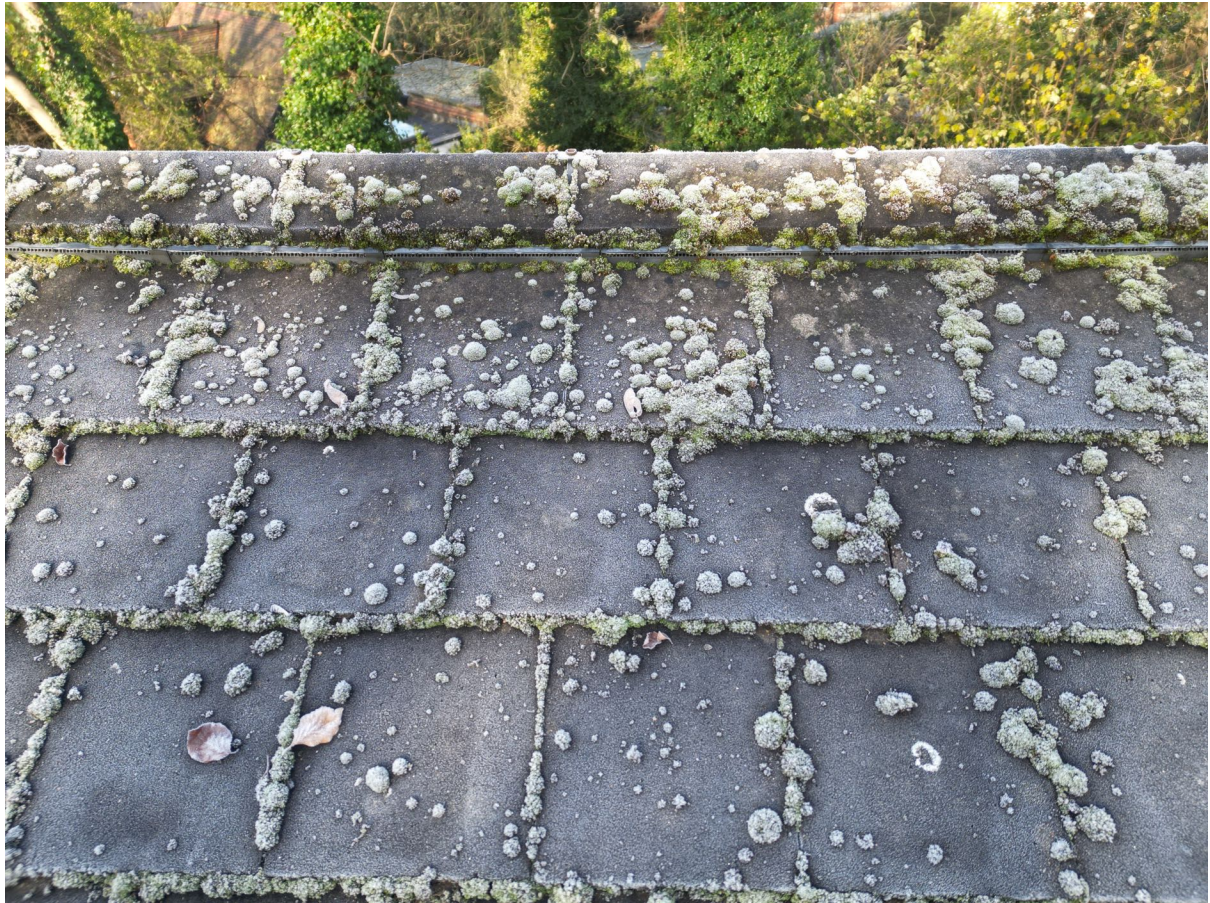
7 – Ridge tiles are mechanically fixed and vented.

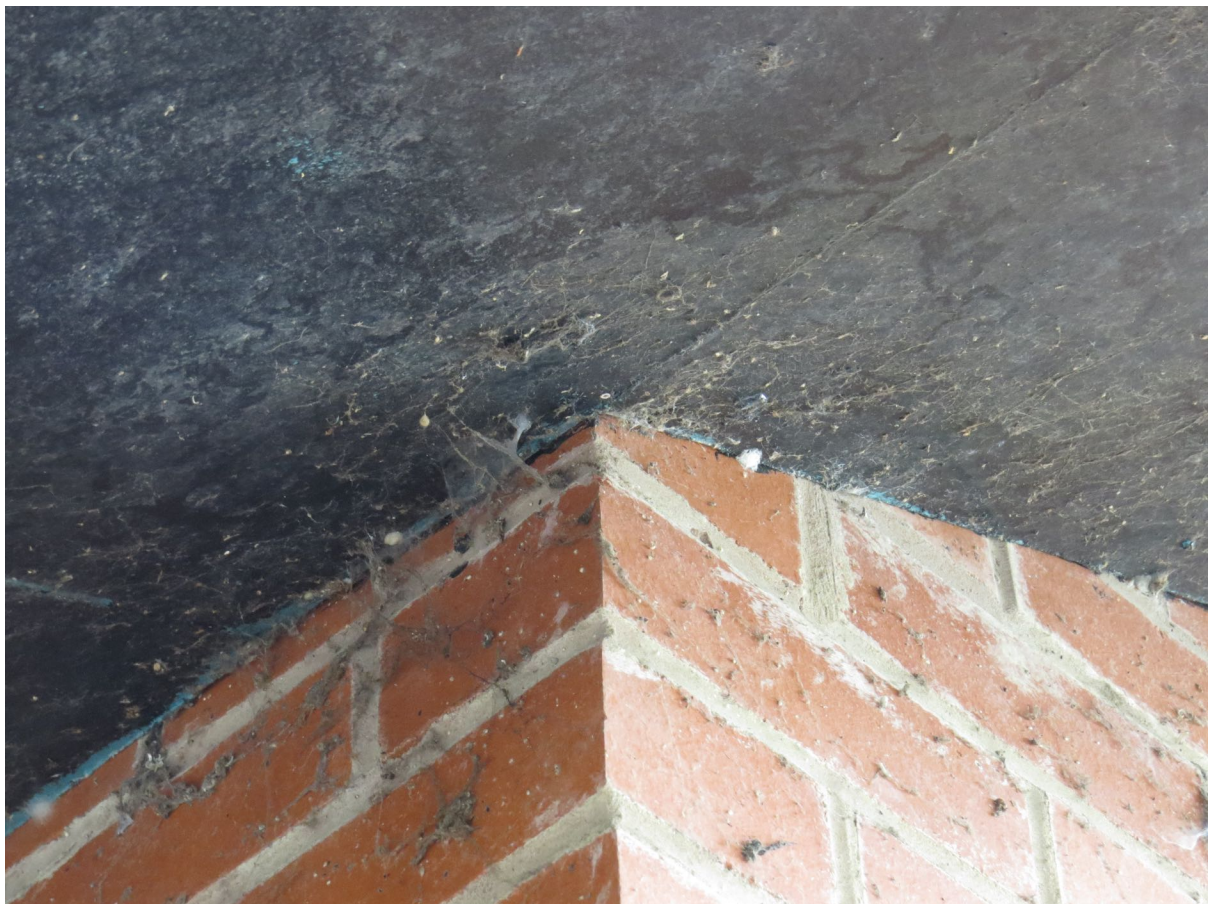
The majority of fascia boards and boxed soffits at the eaves are fixed tightly against brickwork, with no suitable gaps; wall cavities and boxed soffits open into the roof void, and were inspected from above.

8 – Fascia boards and boxed soffits are in good condition with no suitable gaps.

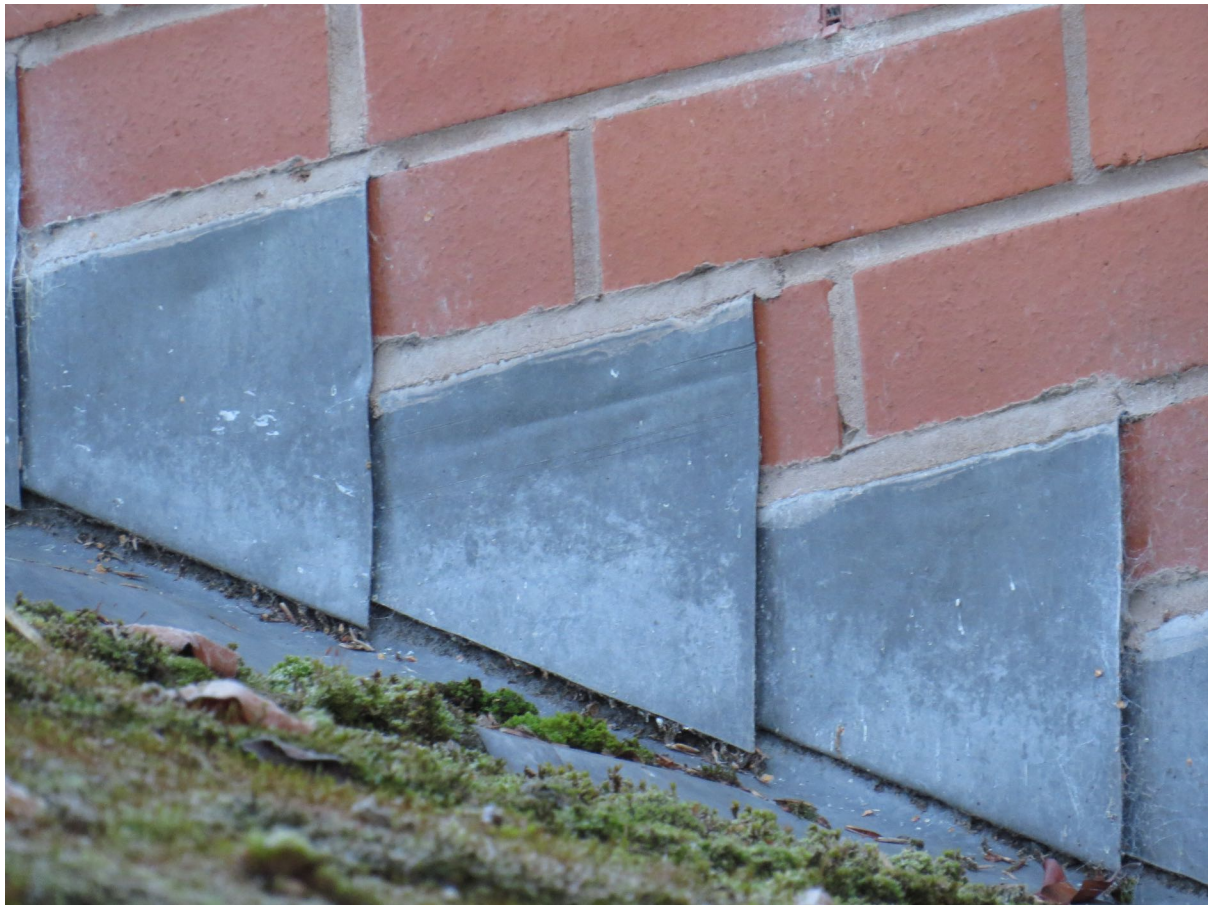
9 – Lead flashing is in good condition with no viable gaps.

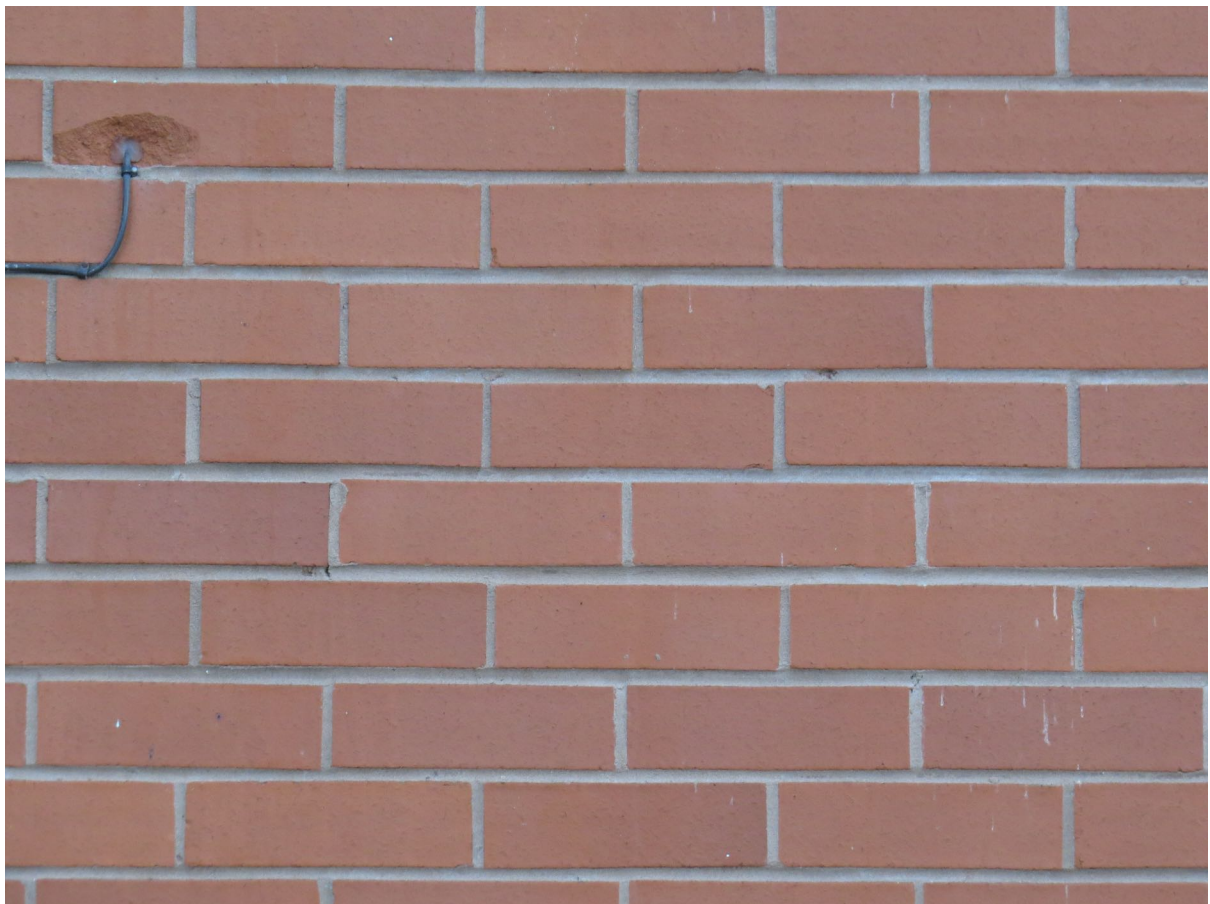
Walls are brick with an insulating cavity. Walls are in good condition, with no cracks, or missing mortar which could be used by crevice dwelling bats.

10 – Brickwork is in good condition with no cracks or missing mortar.

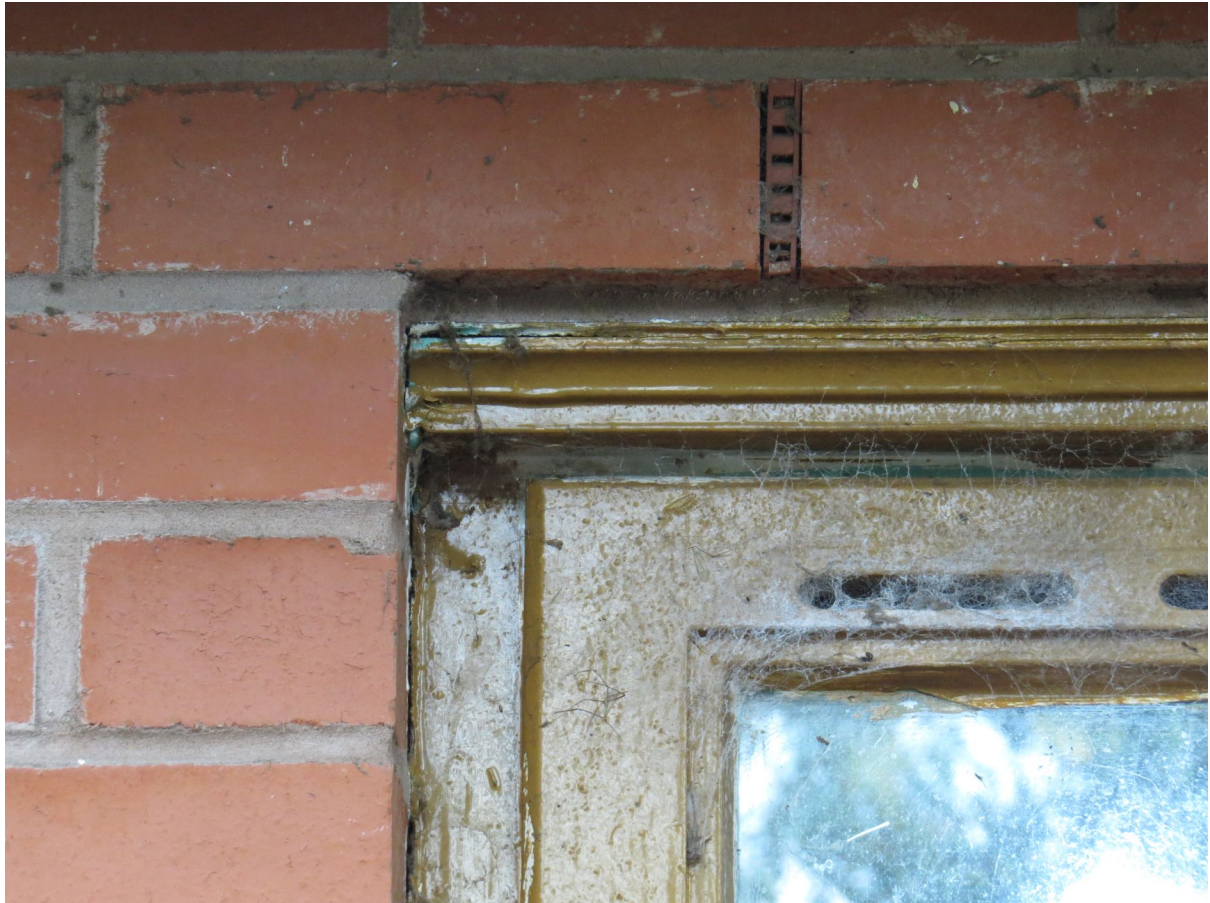
Window and door frames are fixed into the brickwork, gaps are filled with sealant, and offer no suitable roosting opportunities.

11 – Window and door frames are tightly fixed into brickwork with no viable gaps.

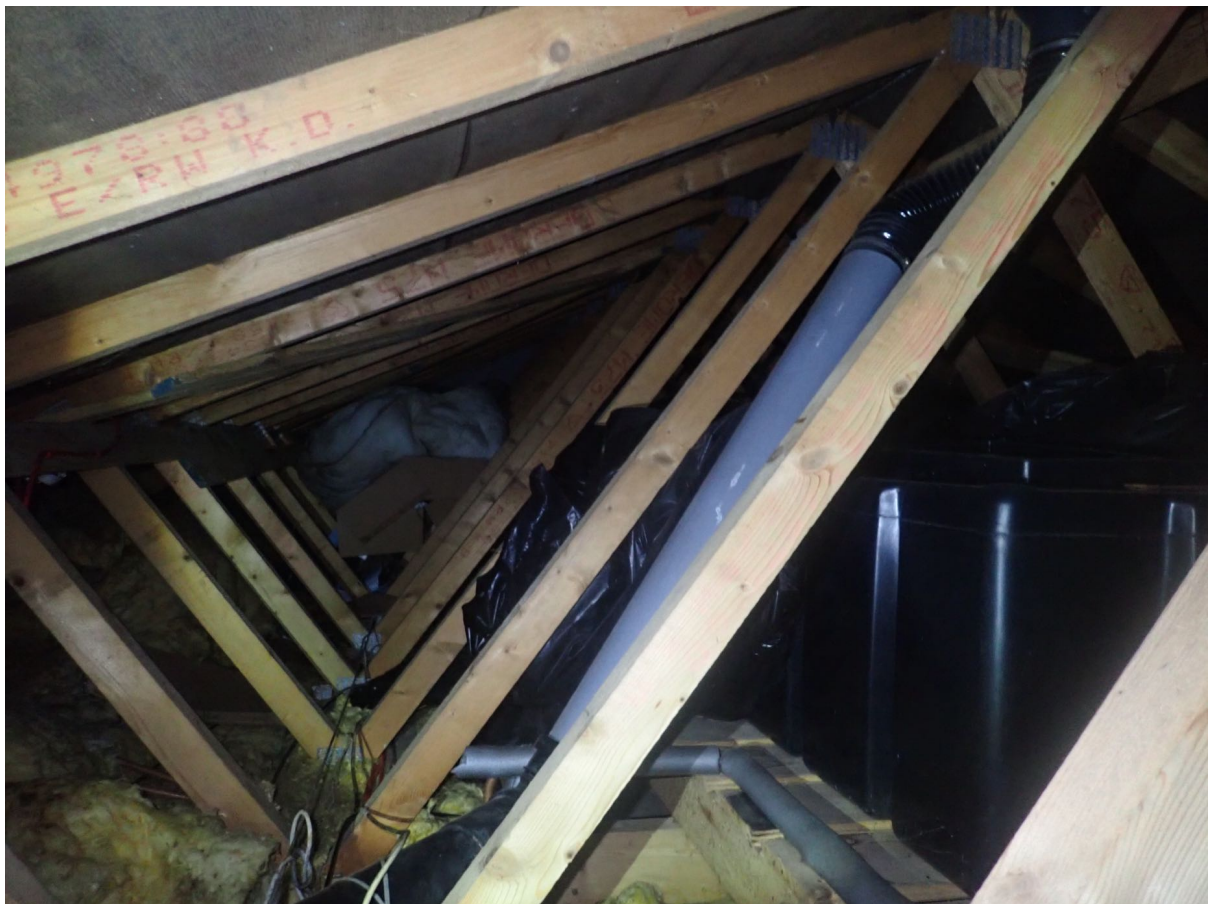
12 – The building has a single roof void.
