# Asbestos Analyst's Certificate Report

Job Ref No: **538234**, Cert Ref No: **89608**, Account Ref No: **25660**, Contract Ref No: **85664**

## First Street, Manchester City Centre, M15 4AA

**Title:** Asbestos Fibre Air Monitoring at First Street, Central Manchester

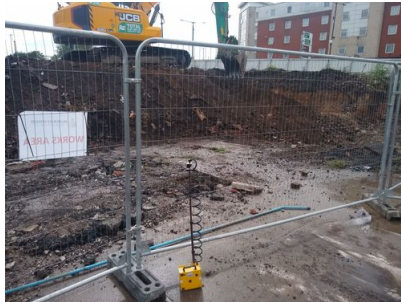
| Additional Photo 1 | <br>Image Added: 2022-09-06 14:25:11<br>Adjacent potentially contaminated spoil during removal |

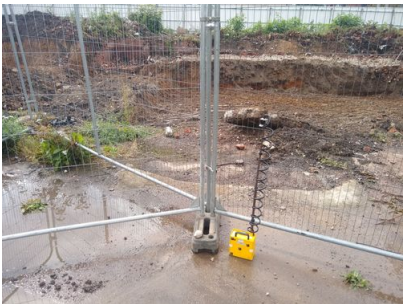
Additional Photo 2

Adjacent potentially contaminated spoil during removal

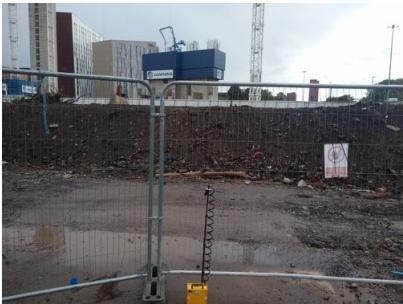
Additional Photo 3

Adjacent potentially contaminated spoil during removal

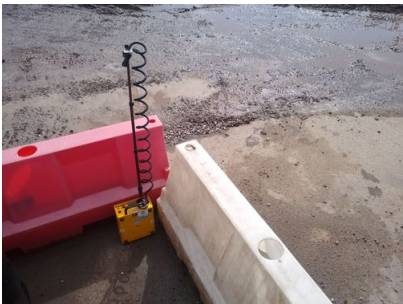
Additional Photo 4

Adjacent potentially contaminated spoil during removal

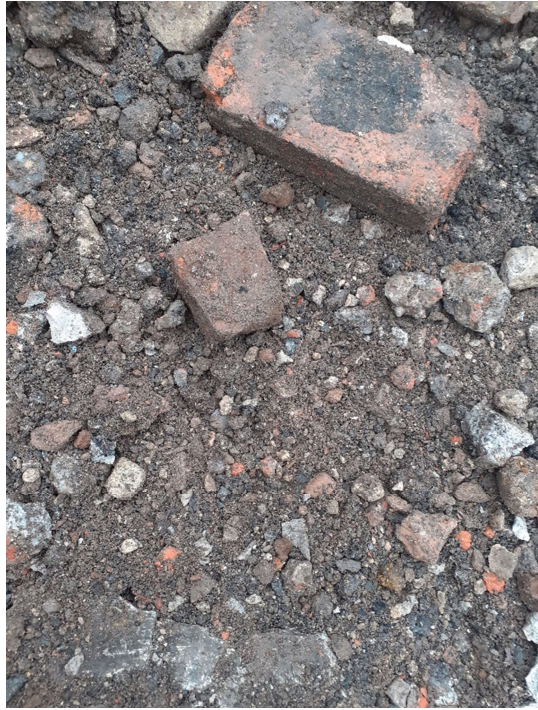
Plate 1: Friday 25<sup>th</sup> August 2022. Asbestos hotspot 1 – image of the base.

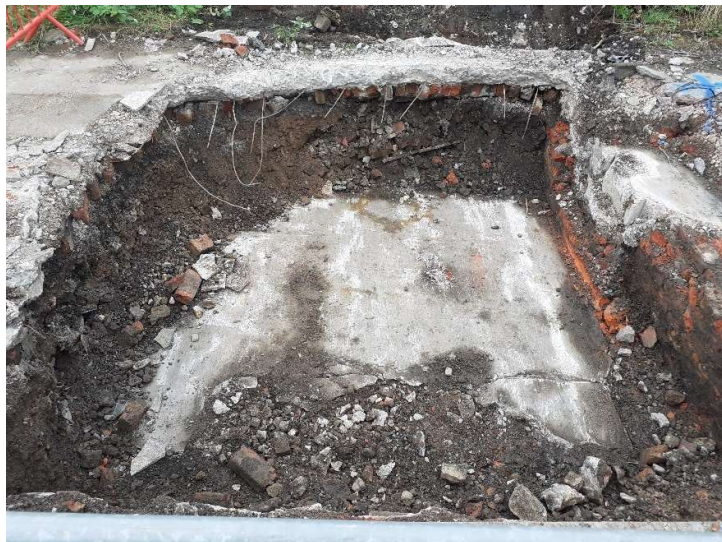
Plate 6: Friday 25<sup>th</sup> August 2022. Asbestos hotspot 1 – overview of the excavation.

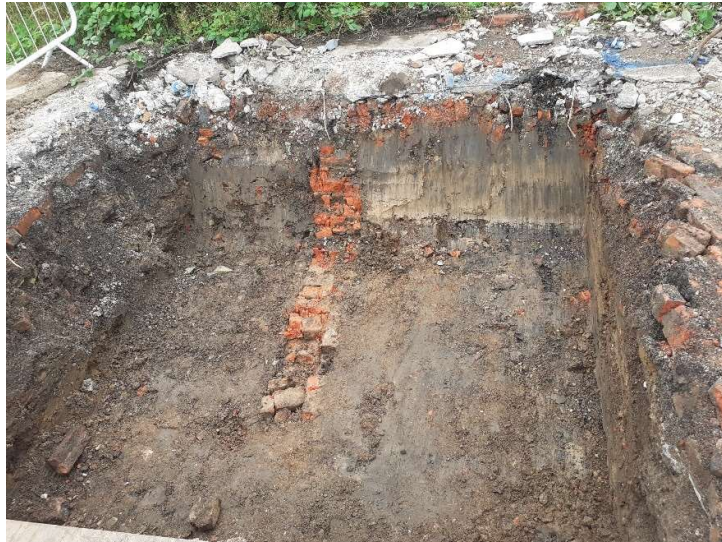
Plate 7: Friday 25<sup>th</sup> August 2022. Asbestos hotspot 2 – overview of excavation.

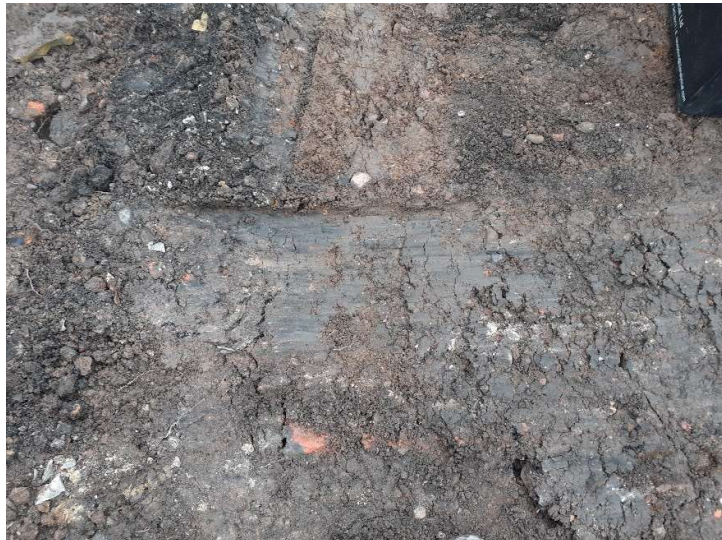
Plate 12: Friday 25<sup>th</sup> August 2022. Asbestos hotspot 3 – image of the base of the excavation.

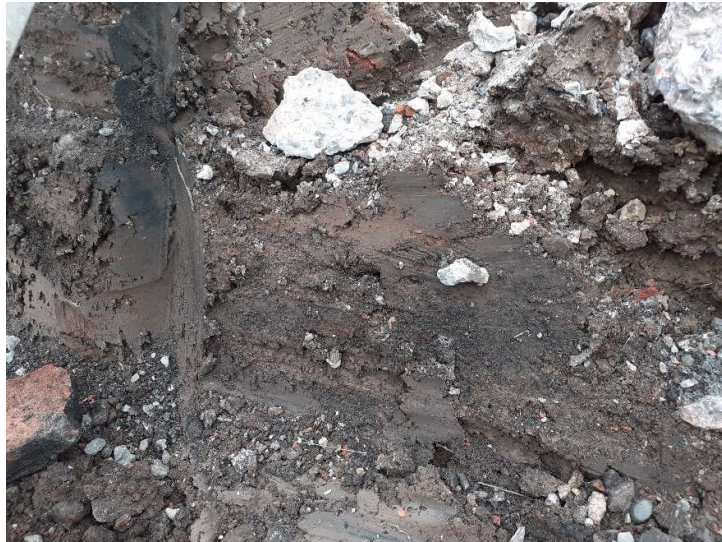
Plate 17: Friday 25<sup>th</sup> August 2022. Asbestos hotspot 3 – image of visible contamination.

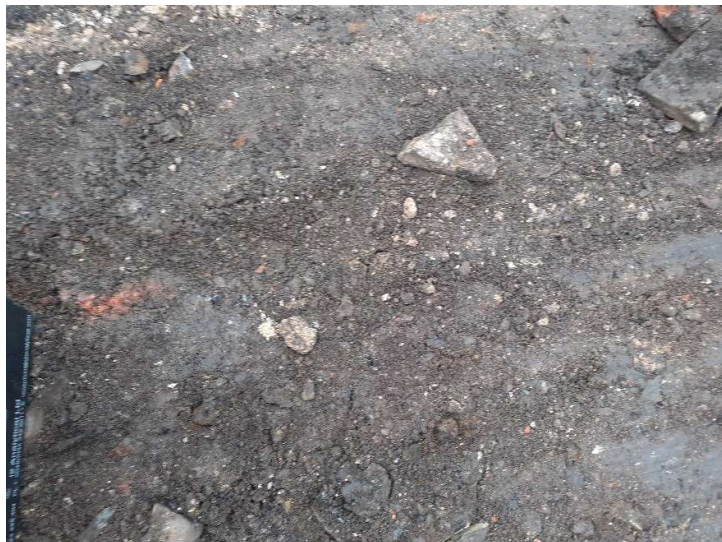
Plate 18: Friday 25<sup>th</sup> August 2022. Asbestos hotspot 4 – image of the base of the excavation.

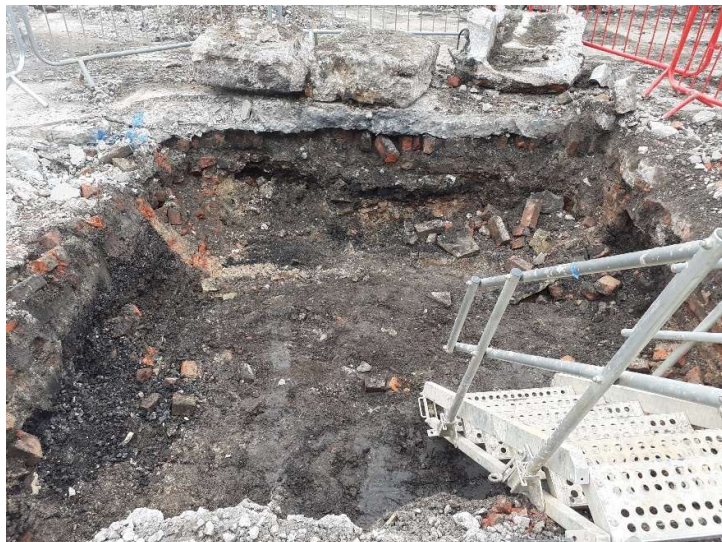
Plate 22: Friday 25<sup>th</sup> August 2022. Asbestos hotspot 4 – overview of the excavation.

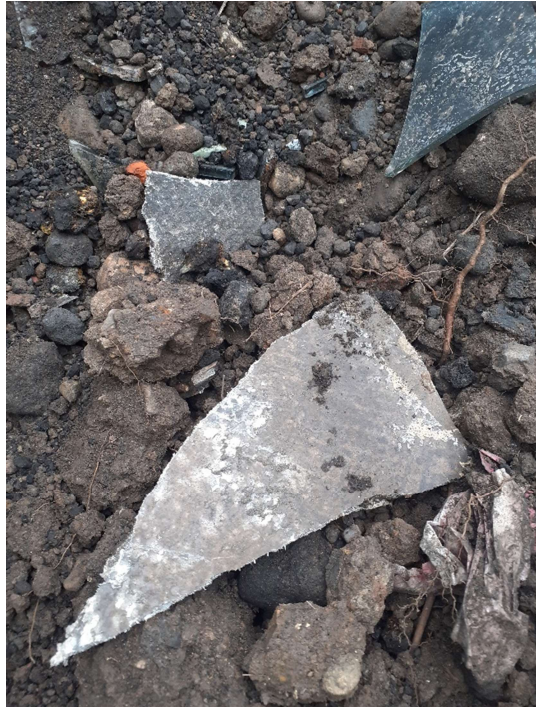
Plate 23: Friday 25<sup>th</sup> August 2022. Asbestos fragments found in made ground excavations.

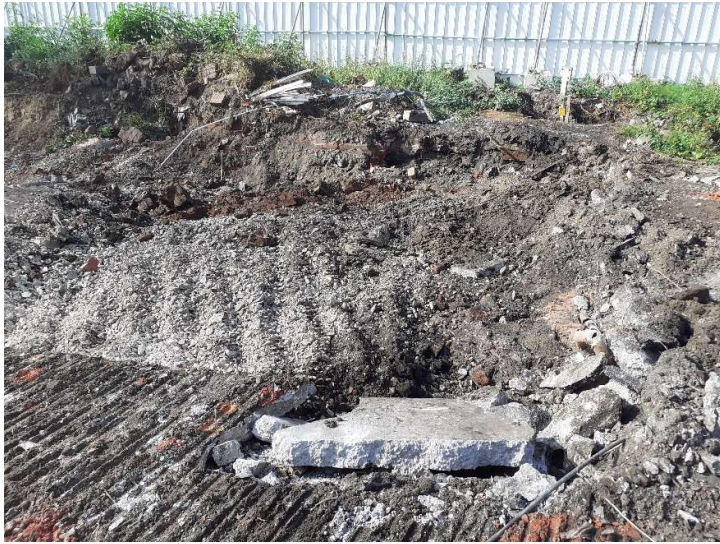
Plate 28: Monday 5<sup>th</sup> September 2022. Demolition and excavation debris on site.

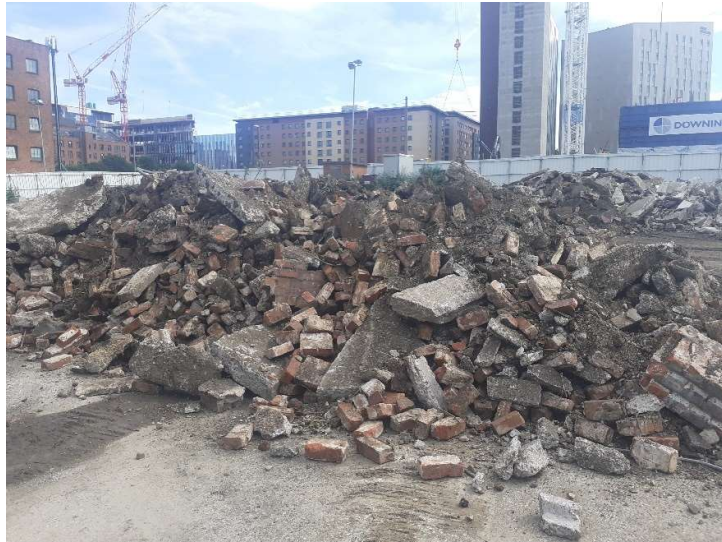
Plate 30: Monday 5<sup>th</sup> September 2022. Stockpiled debris produced from excavations.

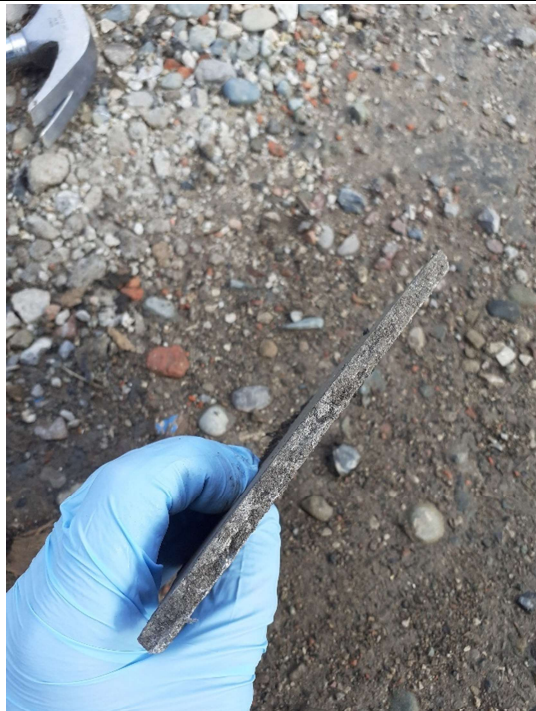
Plate 33: Monday 5<sup>th</sup> September 2022. Asbestos cement fragment from site excavations.

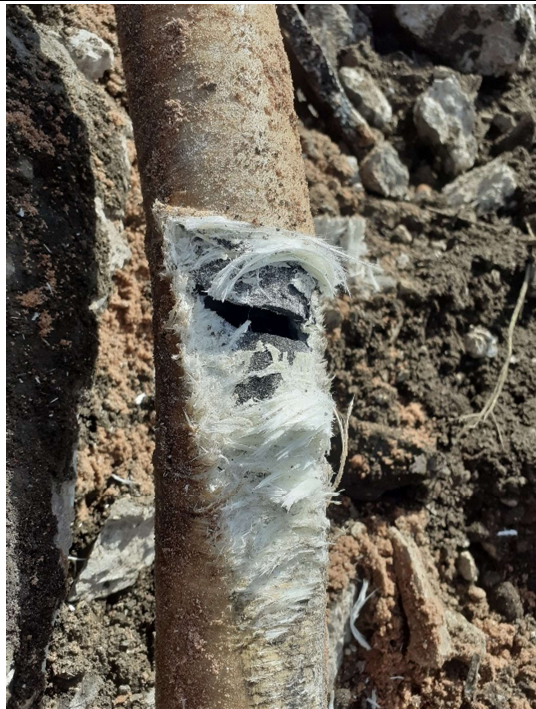
Plate 34: Monday 5<sup>th</sup> September 2022. Asbestos lagging on pipe found on site during excavations.

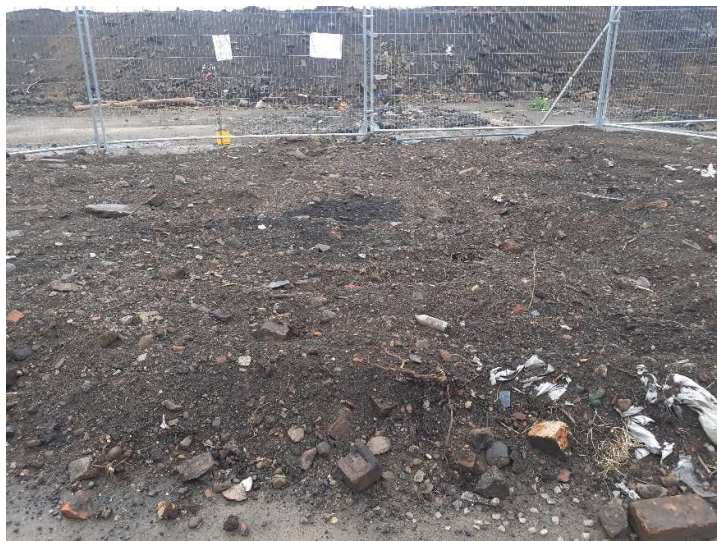
Plate 35: Tuesday 6<sup>th</sup> September 2022. Made ground in asbestos exclusion zone being hand-picked for asbestos with air monitoring location in background.
