Information Required to Discharge Outstanding Condition number 18 of Listed Building Consent Reference: CDN/23/0065 for the Adaptation of Fenton House, Higher Ardwick into Seven Apartments.

### **Details and Method statement for Condition Compliance Details for Roof Insulation**

Cross section drawing of the Urgent Insulation Works carried out at Fenton House

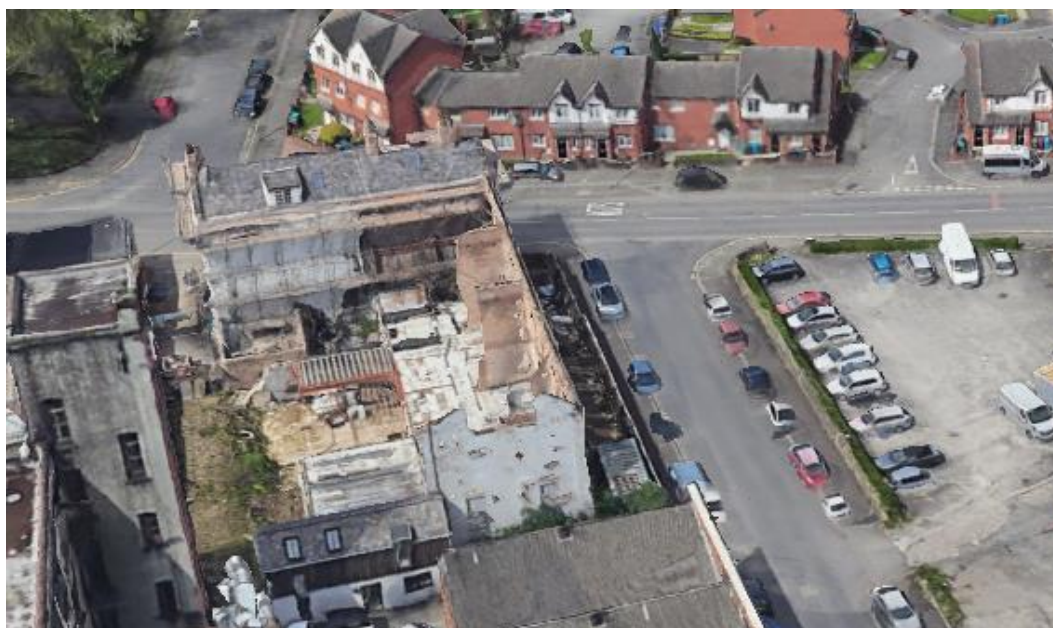
1.2 The existing roof of Fenton House was extensively damaged by a major fire that started in the adjoining connected terrace building facing Harkness Street. The fire occurred prior to the purchase of Fenton House by Mr Ahmed and before applications were submitted to adapt the listed building into seven self-contained apartments. The adjoining fire destroyed part of the roof covering and underlying roof structure including a significant area of the rafters.

*Above - Google Earth image of fire damaged property facing Harkness Street. [April 2023]*

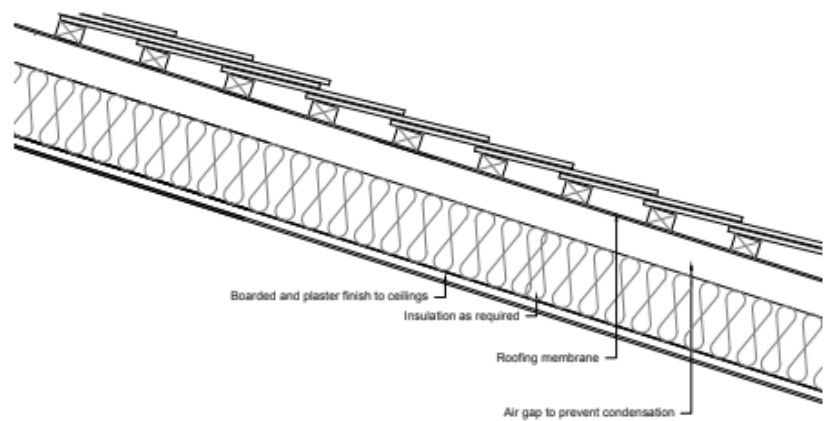
Due to the fire, the upper floors of Fenton House retain no existing ceilings or insulation. The proposals are to re-roof as specified elsewhere within the previously submitted documents. The ceilings will be insulated and boarded with a skim finish to be painted.

2.2 All roof slopes were insulated with a layer of 100mm-120mm rigid board insulation, [Depending on the precise thickness of the rafters] allowing air gap on the side of the slates to prevent condensation. Insulation was cut by hand to fit between the existing rafters and friction held in place. Overboard insulation and rafters with 12.5mm plasterboard, allow for taping each seam with plasterer mesh tape. Finished with skim plaster and then paint once fully dried

- All roof slopes to be insulated with 75mm rigid board insulation, allowing air gap on the side of the slates to prevent condensation. Insulation to be cut by hand to fit between rafters and friction held in place.
- Overboard insulation and rafters with 12.5mm plasterboard, allow for taping each seam with plasterer mesh tape.
- Finish with skim plaster and then paint once fully dried.
