**Creative Support Ltd  
Wellington House  
131 Wellington Road  
Stockport  
SK1 3TS**

## **Heritage Impact Assessment**

*July 2024*

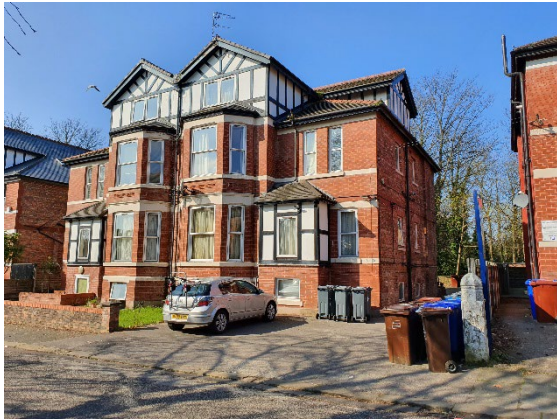
Photo 1:  
Front elevation.

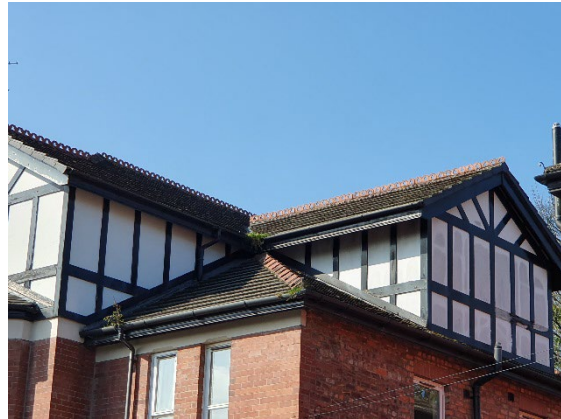
Photo 2:  
Mock Tudor to third floor.

A proposed replacement for the decaying timber Tudor panelling is with a uPVC 150 x 22mm board foiled on three sides with a wood grain. All fixings are to be hidden with a layout and colour to match the existing.

Replacement of the decaying timber soffit, fascia's and Mock Tudor panelling with a uPVC alternative is to provide a low maintenance product which maintains the aesthetics of the property. This will not impact the contrasting surfaces between the roofline joinery and brick façade.

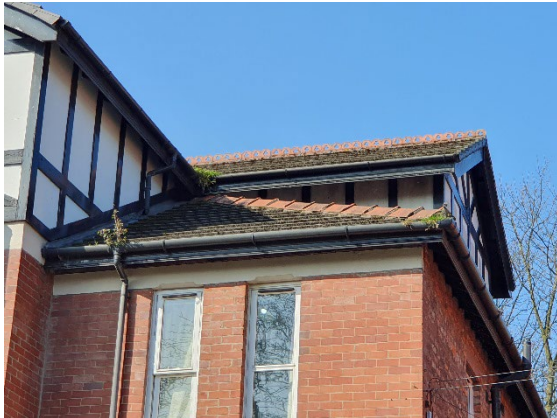
Photo 3:  
Interlocking concrete tiles to high level roofs.

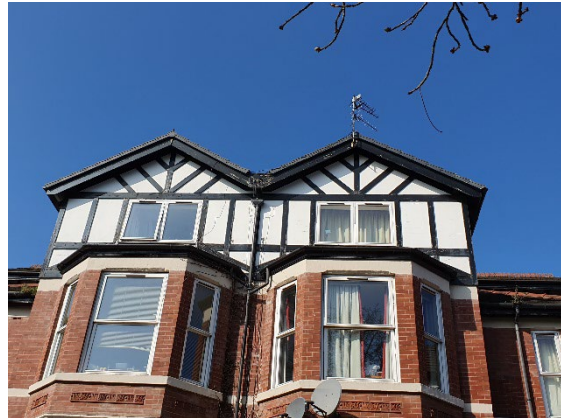
Photo 4:  
Mock Tudor to third floor.

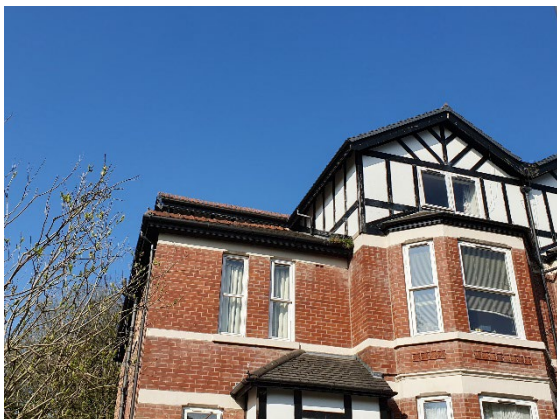
Photo 5:  
Mock Tudor to third floor.

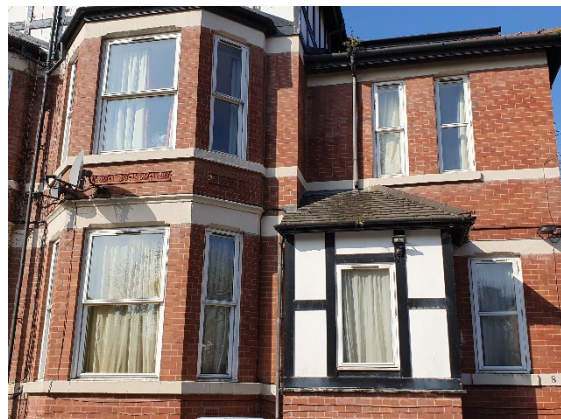
Photo 6:  
Double glazed timber windows.

The proposed specification for the replacement of 54 No. windows and 1 No. door as identified on drawings 002, 004, 006 and 008. This is summarised within drawing 011 with a full specification outlined within the REHAU Specification. The window layout will be identical to the existing utilising a white uPVC 63mm flush casement sash. All of the fenestration will be glazed with an inner pane of toughened 4mm soft coat low emissivity glass and an outer pane of 6.8mm laminated glass with a 28mm cavity filled with argon. A satin finish is to be installed to all bathroom and WC windows. All windows are to be restricted with a Pro-5 Jackloc Key-Locking Cable Window Restrictor. Opening directions are to be a mixture of top hung or side hung. Each window is to be fitted with a minimum of two 5000EA background ventilators where possible.

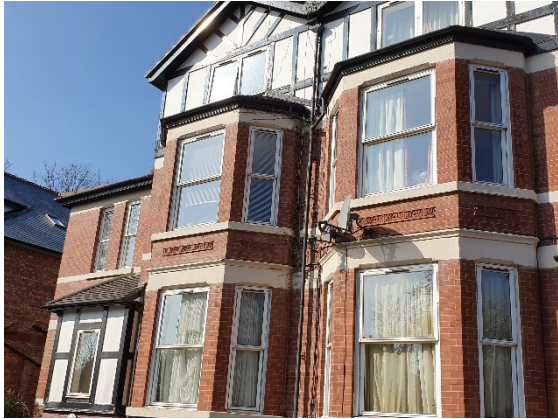
Photo 7:  
Bay windows with sandstone detailing.

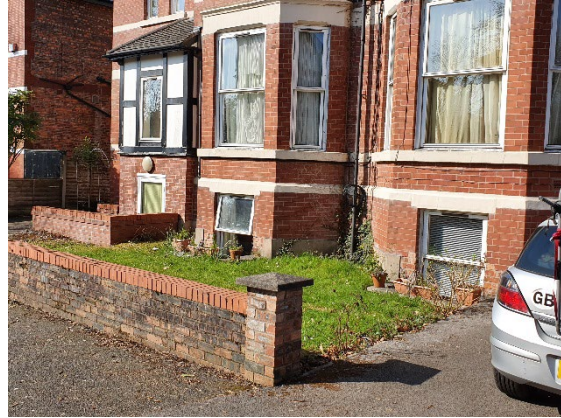
Photo 8:  
Low-level wall to site boundary.

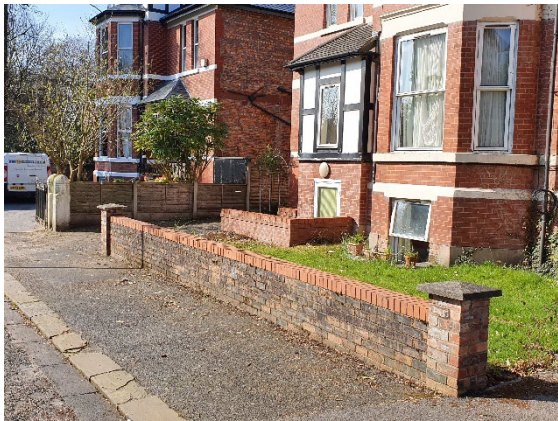
Photo 9:  
Small lawn to front elevation.

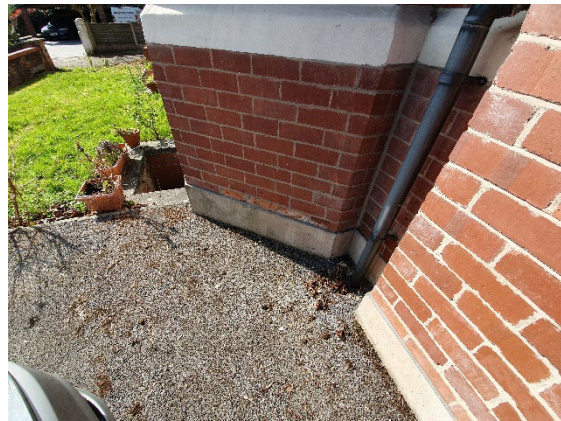
Photo 10:  
Cavity wall construction with stone detailing

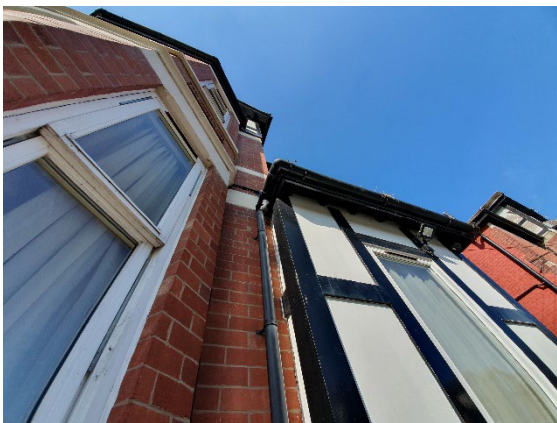
Photo 11:  
Gutters overflowing with debris.

Existing black uPVC half round rainwater goods are to be replaced with a FloPlast uPVC 112mm black half round guttering and black uPVC 68mm round downpipes. Locations of all outlets are to match the existing layout with falls no less than 1:350. Gutter brackets are to be spaced a maximum of 1000mm centres.

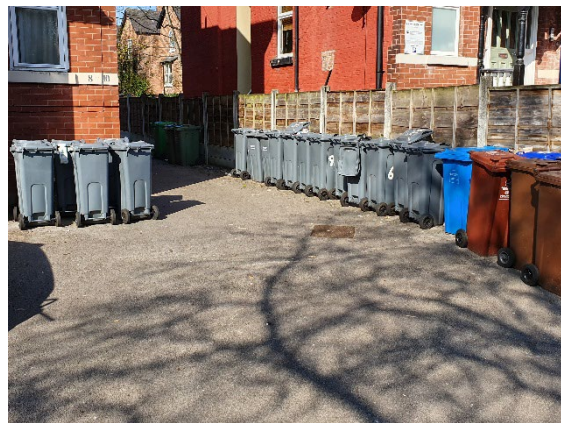
Photo 12:  
Bins stored to RHS fence.

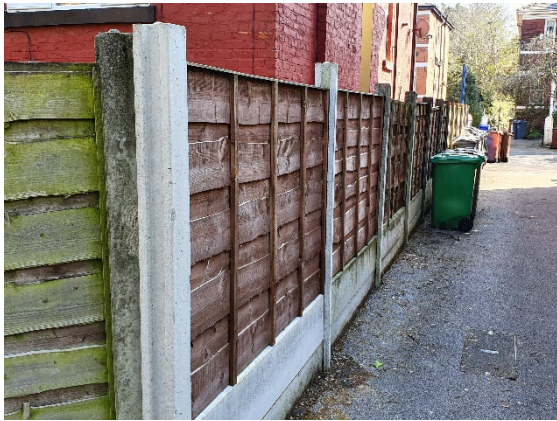
Photo 13:  
RHS timber panel and concrete post fence.

Replacement of the dilapidated timber fence panels is to be with Waneylap fence panels to match the existing layout and height. New thermoplastic bay markings are to be applied to the front and rear elevation. Localised areas of the tarmacadam renewal to the front elevation driveways will be undertaken. Ensuring hollow areas of binder course and sub-base are filled and compacted prior to laying the finishing wearing coat.

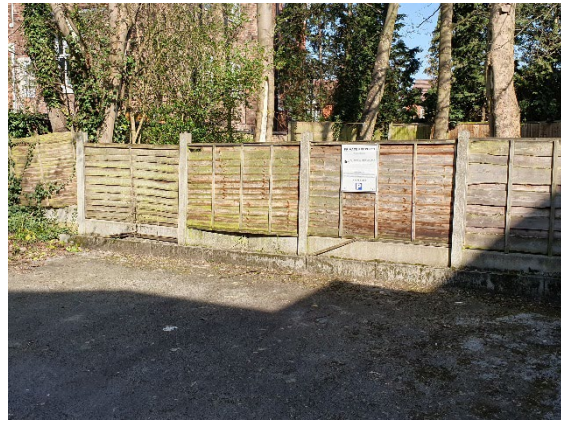
Photo 14:  
RHS timber panel and concrete post fence.

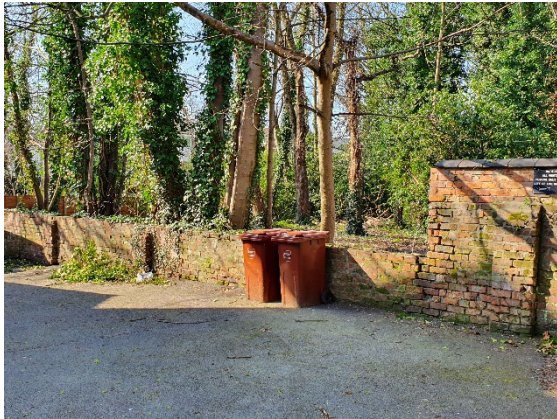
Photo 15:  
Rear brickwork garden wall.

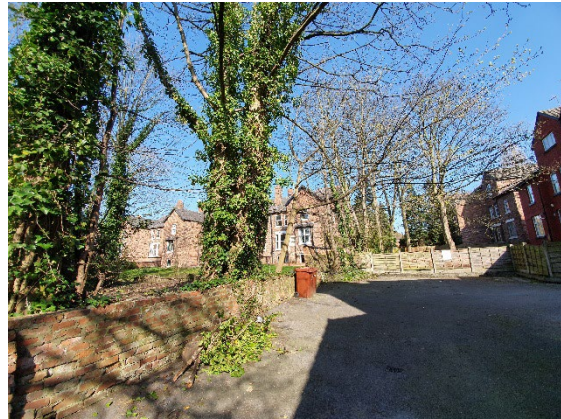
Photo 16:  
Rear brickwork garden wall.

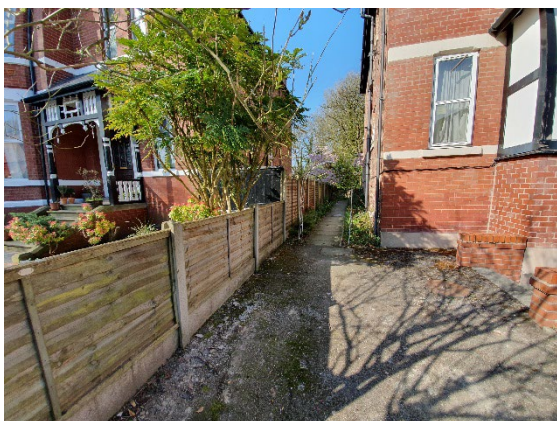
Photo 17:  
LHS timber panel and concrete post fence.

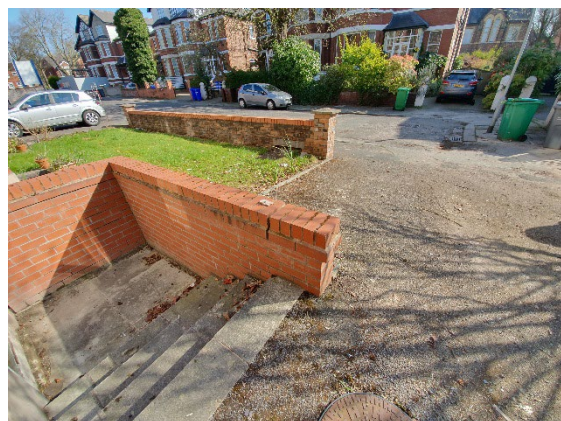
Photo 18:  
Low-level brick wall to front elevation.

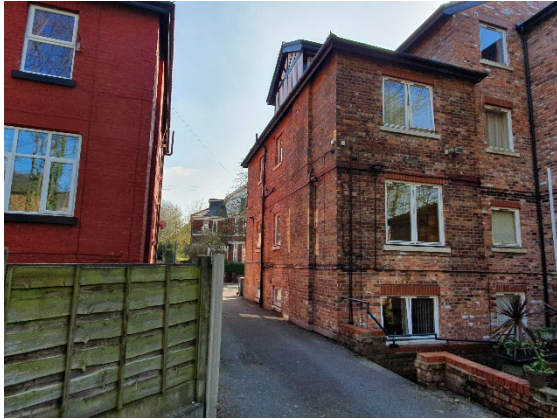
Photo 19:  
RHS gable end of building.

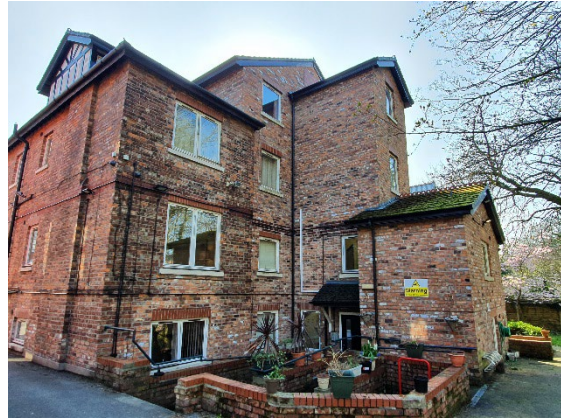
Photo 20:  
Rear elevation and additions.

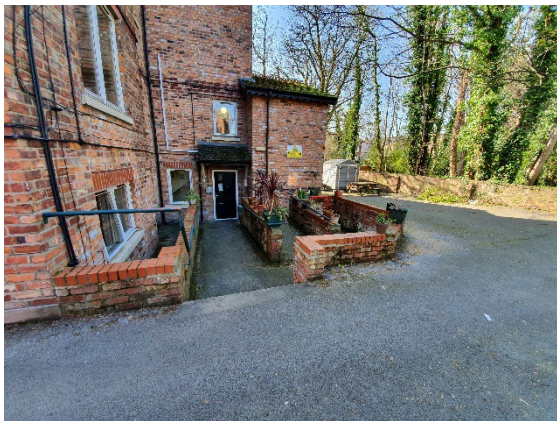
Photo 21:  
Main building access to rear.

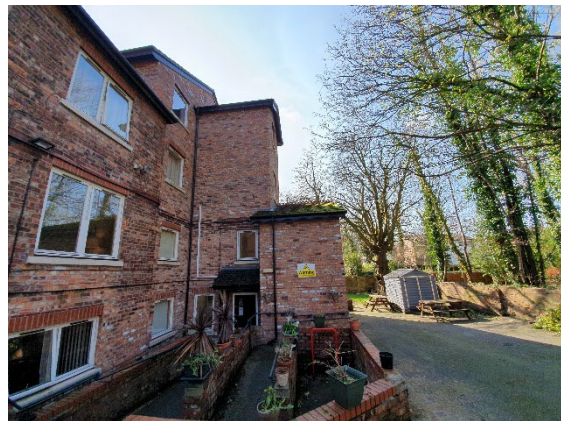
Photo 22:  
Rear elevation and additions.

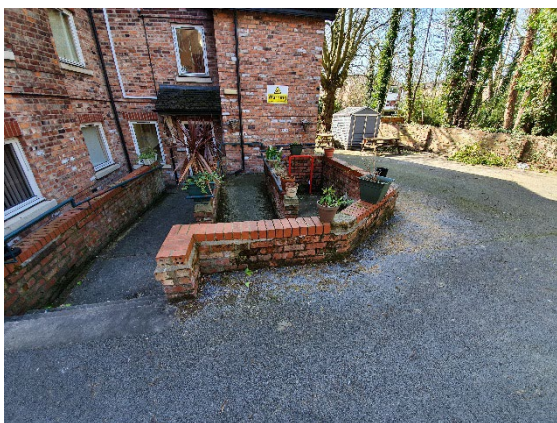
Photo 23:  
Ramp to main entrance at rear.

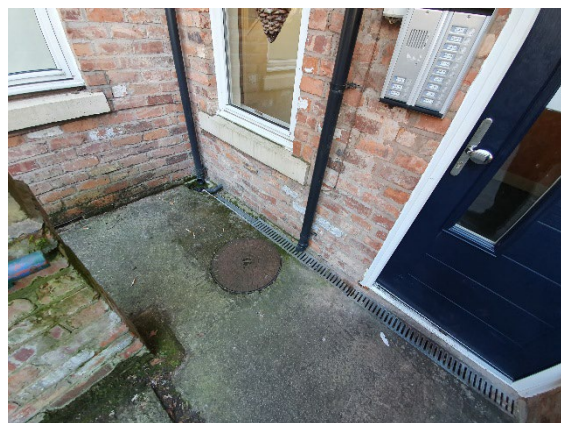
Photo 24:  
Drainage near main entrance door.

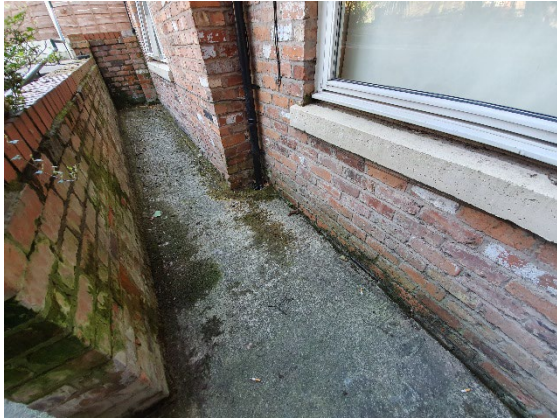
Photo 25:  
Moss covered concrete.

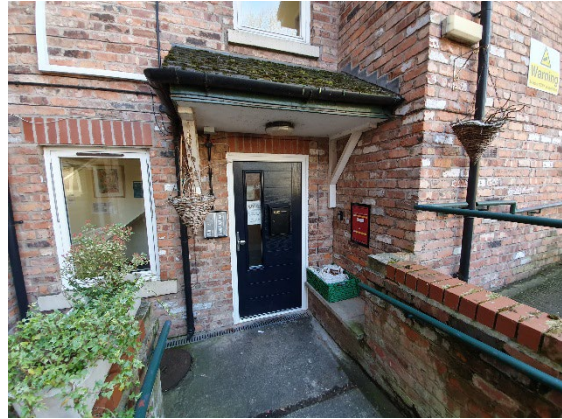
Photo 26:  
Main entrance door at rear.
