Contract  
Facade Survey,  
Sunlight House, Manchester, M3  
3HP  
(24008)

Drawing Title  
Facade Condition Survey - Internal  
Light well Elevations 5 to 8

Drawing No.  
24008-PAYE-DR-006 rev P01

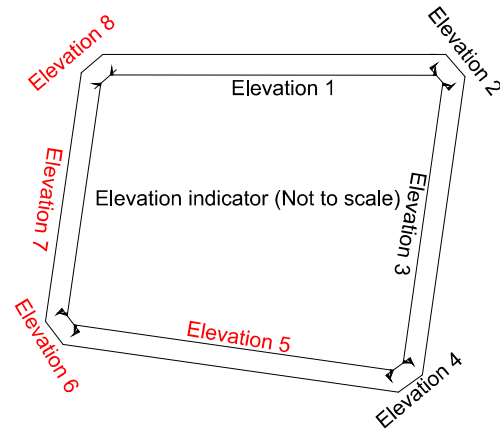
VEGETATION GROWTH OBSERVED TO THE BED JOINTS.  
RECOMMEND 100% RAKING OUT AND REPOINTING

Hairline fractures were observed to localised areas. The cause for the fractures is possibly settlement of the facades. Recommend consultation with a structural engineer and continued monitoring as part of the Pre-Planned Maintenance.

Rust staining was observed to several lintel and windowsills at L13. The cause for the rust staining is likely corrosion of the steel lintels which has washed down the window to the windowsill. Recommend consultation with a structural engineer and up-close inspection once access scaffold is available.

Vegetation growth was observed to one gutter.

Hairline fracture or fractures were observed to several windowsill. The fractures could be to the stone sill (and possibly caused by differential settlement of the façade) or could just be flaking paint. Recommend up close inspection once scaffold is available.

Hairline fractures - originating from the windowsill - were observed to localised areas. The cause for the fractures is possibly settlement of the facades. Recommend consultation with a structural engineer and continued monitoring as part of the Pre-Planned Maintenance.

RECOMMEND 100% RAKING OUT AND REPOINTING
