# Preliminary Roost Assessment

Alpha House, Wythenshawe  
Reference: 81-876-R1  
Date: August 24

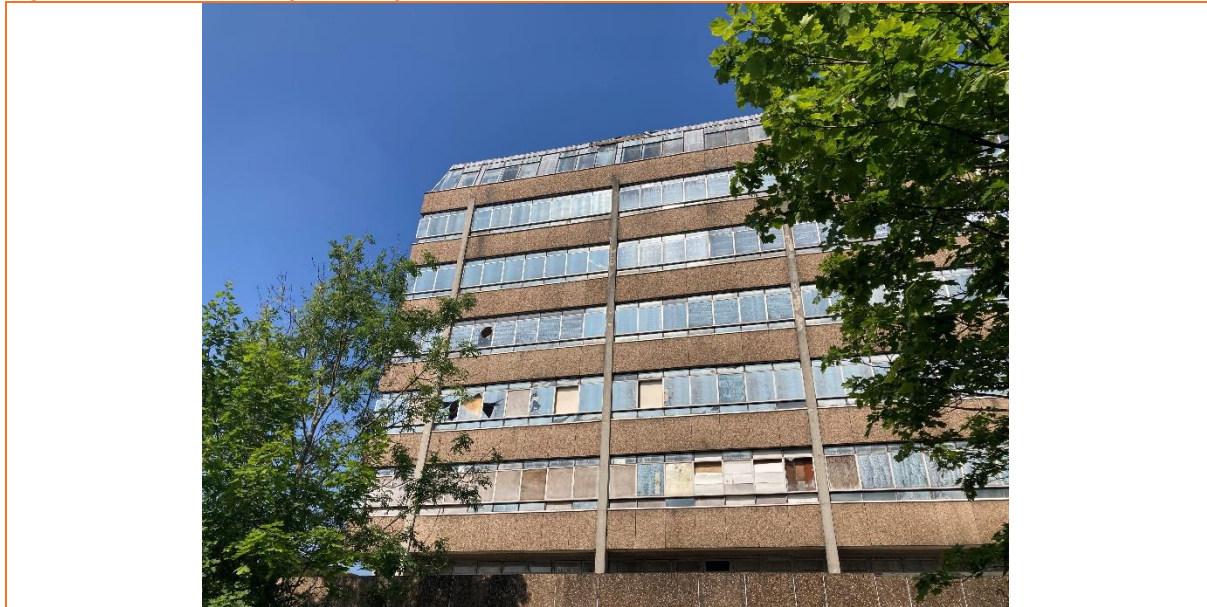
**Figure 2**      **Showing Building Exterior**

The building comprised an eight-floor commercial unit. The building was vacant at the time of the survey. The building was constructed with concrete with pebble dash cladding and large glass windows on all aspects. The building had a flat roof that was covered in lead cladding and gravel. The concrete and pebble dash cladding covering the building was in good condition providing limited roosting opportunities for local bats. However, many smashed windows were present, some providing access inside the building.

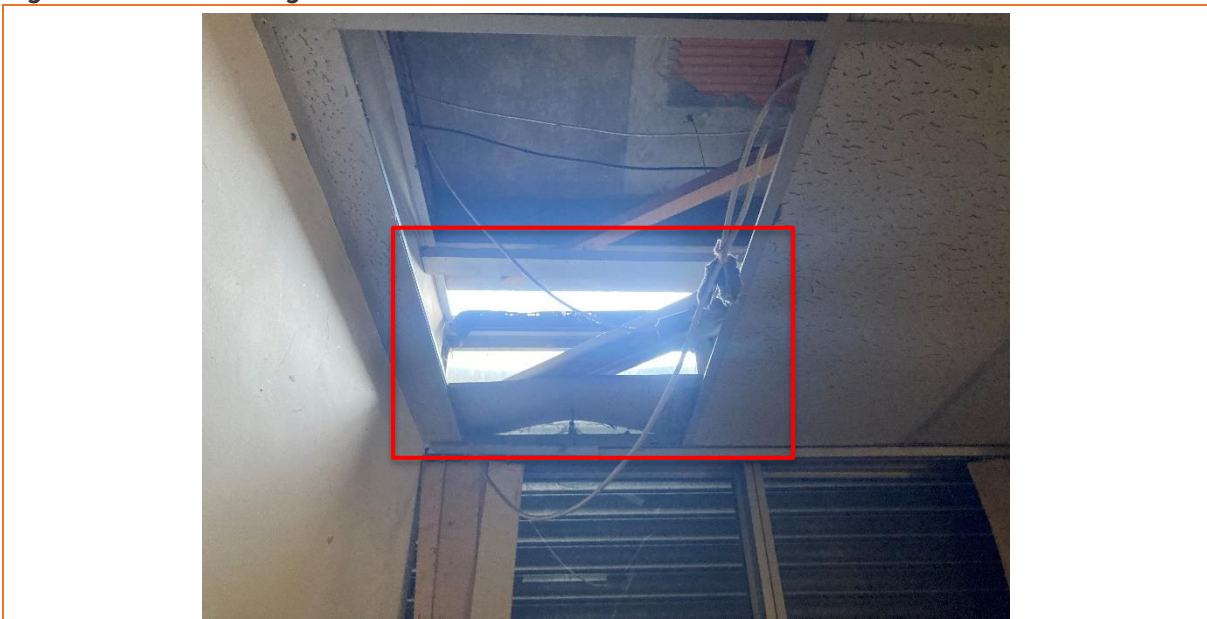
**Figure 3**      **Showing AP1**

The ground floor was generally in good condition. However, two broken windows were present within the north east section of the building. Access Point 1 (AP1) and AP2 was a broken window that allowed access into the building. However, during the survey no features with roosting potential were identified within the section of building these access points were identified within. No bat droppings or field signs were identified on the ground floor.

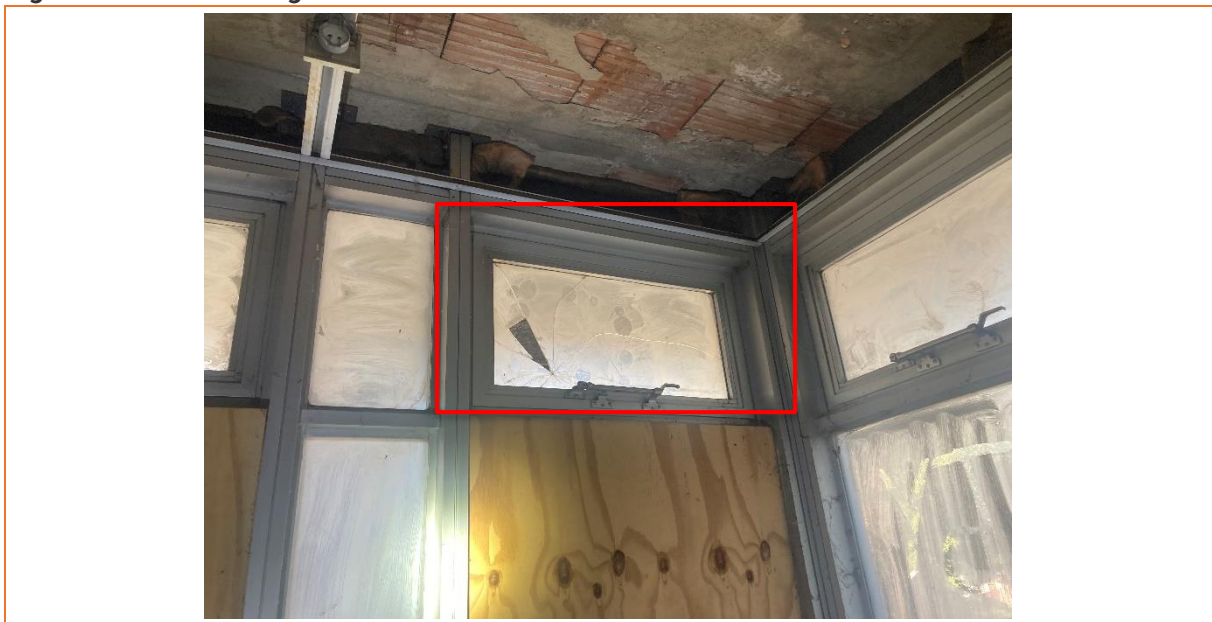
**Figure 5**      **Showing AP3**

The first floor was in a state of disrepair with three smashed windows providing access into the building (AP3, AP4 and AP5). Multiple potential bat features were located on the first floor. The ceiling contained many crevices (Potential Roost Feature 1 (PRF1) that could be utilised by crevice-dwelling bat species, such as common pipistrelle. The crevices had the potential to be used by a small number of bats on a more regular basis. Multiple brickwork crevices were located within the walls on the first floor (PRF2, PRF3 and PRF4) located within close proximity to the access points. These brickwork crevices had the potential to be utilised by opportunistic crevice-dwelling bats on an occasional basis. No field signs of bats were identified during the survey on this floor. No bat droppings or field signs of bats were identified on the first floor.

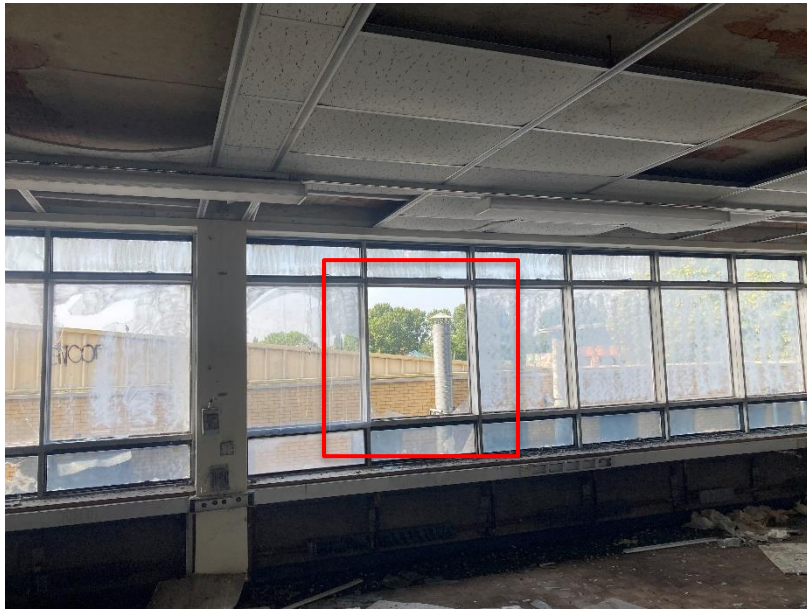
**Figure 10**      **Showing AP6**

The second floor was in a state of disrepair and was being occupied by feral pigeons (*Columba livia*). Two access points were identified into the second floor through smashed windows (AP6 and AP7). Multiple crevices were identified within the ceiling of the second floor (PRF5), these crevices were identified throughout the whole floor. The crevices within the ceiling are likely to support a small number of crevice-dwelling bats on a more regular basis. No bat droppings or field signs of bats were identified on the second floor.

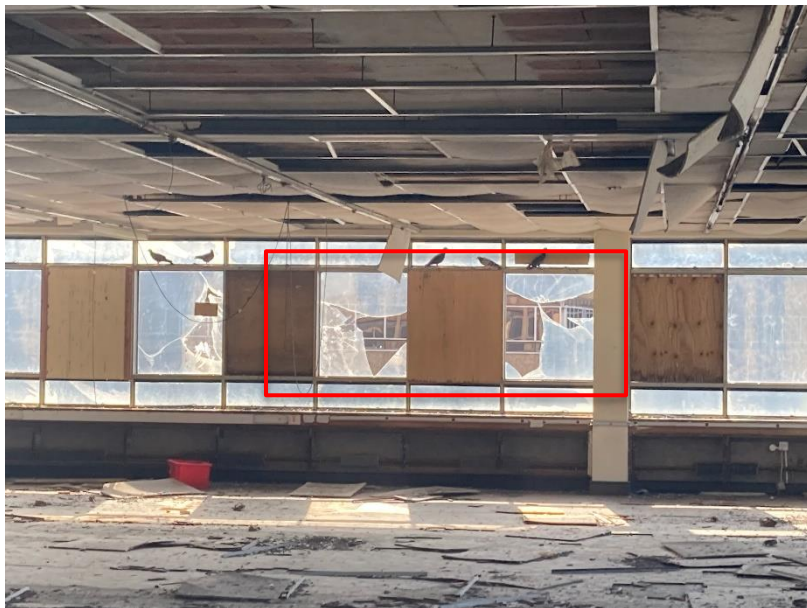
**Figure 13**      **Showing AP8**

The third floor was in a state of disrepair and was being occupied by feral pigeons. One access point was identified on the third floor through a smashed window (AP8). Multiple crevices were identified within the ceiling of the third floor (PRF6), these crevices were identified throughout the whole floor. The crevices within the ceiling are likely to support a small number of crevice-dwelling bats on a more regular basis. No bat droppings or field signs of bats were identified on the third floor.

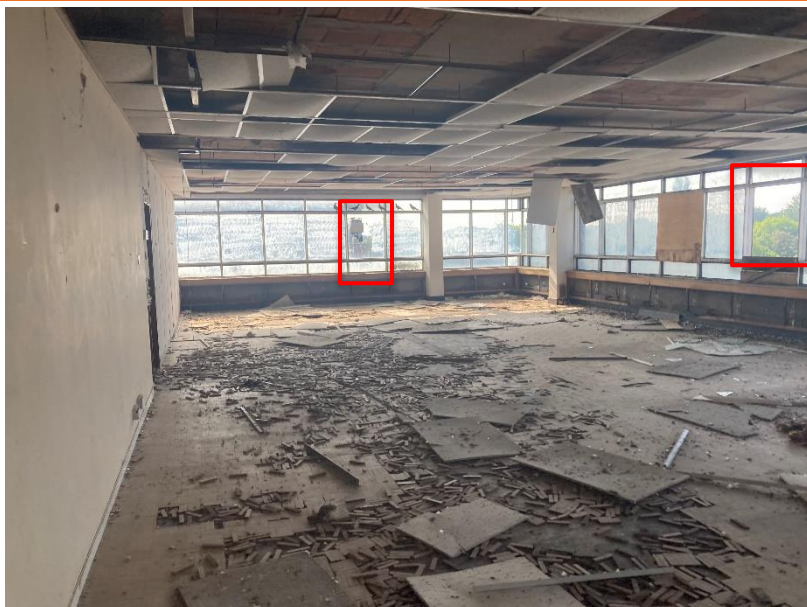
**Figure 15**      **Showing AP9 and AP10**

The fourth floor was in a state of disrepair and was being occupied by feral pigeons. Two access points were identified on the fourth floor through smashed windows (AP9 and AP10). Multiple crevices were identified within the ceiling of the fourth floor (PRF7), these crevices were identified throughout the whole floor. The crevices within the ceiling are likely to support a small number of crevice-dwelling bats on a more regular basis. No bat droppings or field signs of bats were identified on the fourth floor

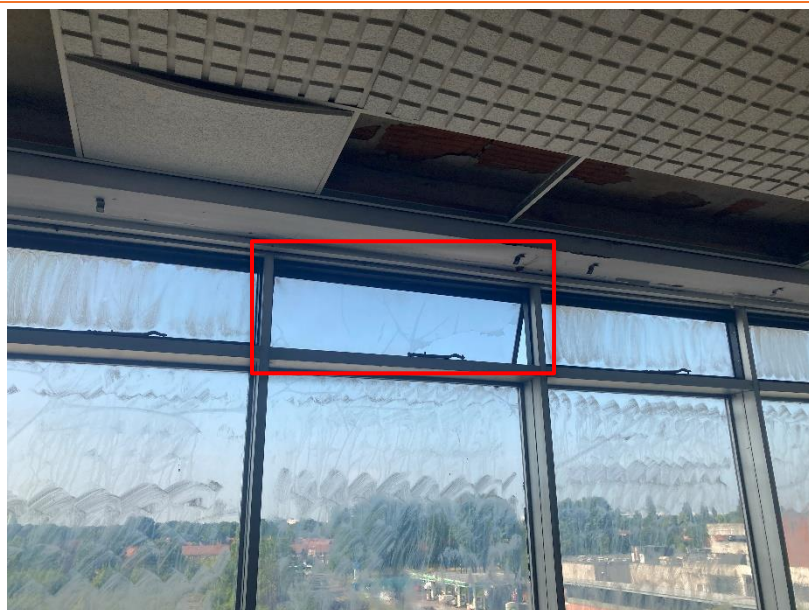
**Figure 17**      **Showing AP11**

The fifth floor was in a state of disrepair and was being occupied by feral pigeons. One access point was identified on the fifth floor through an open window (AP11). Multiple crevices were identified within the ceiling of the fifth floor (PRF8), these crevices were identified throughout the whole floor. The crevices within the ceiling are likely to support a small number of crevice-dwelling bats on a more regular basis. Crevices were identified within the plasterboard (PRF9), these crevices had the potential to support opportunistic bats on an occasion basis. No bat droppings or field signs of bats were identified on the fifth floor.

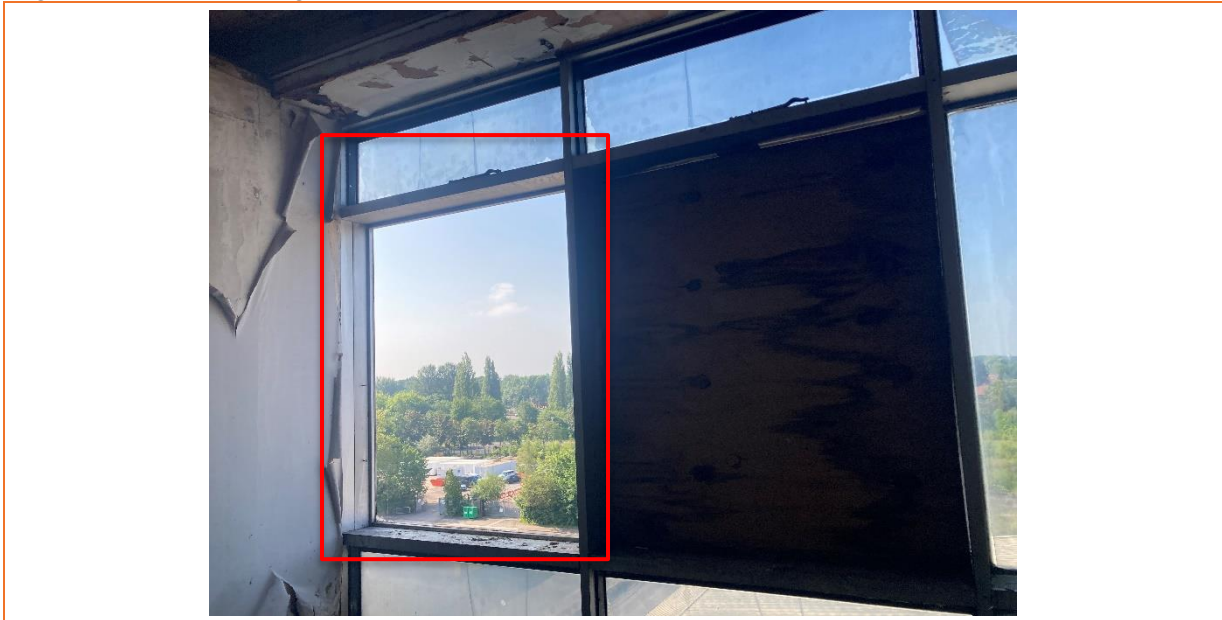
**Figure 20**      **Showing AP12**

The sixth floor was in a state of disrepair and was being occupied by feral pigeons. One access point was identified on the sixth floor through a missing window (AP12). Multiple crevices were identified within the ceiling of the sixth floor (PRF10), these crevices were identified throughout the whole floor. The crevices within the ceiling are likely to support a small number of crevice-dwelling bats on a more regular basis. No bat droppings or field signs of bats were identified on the sixth floor.

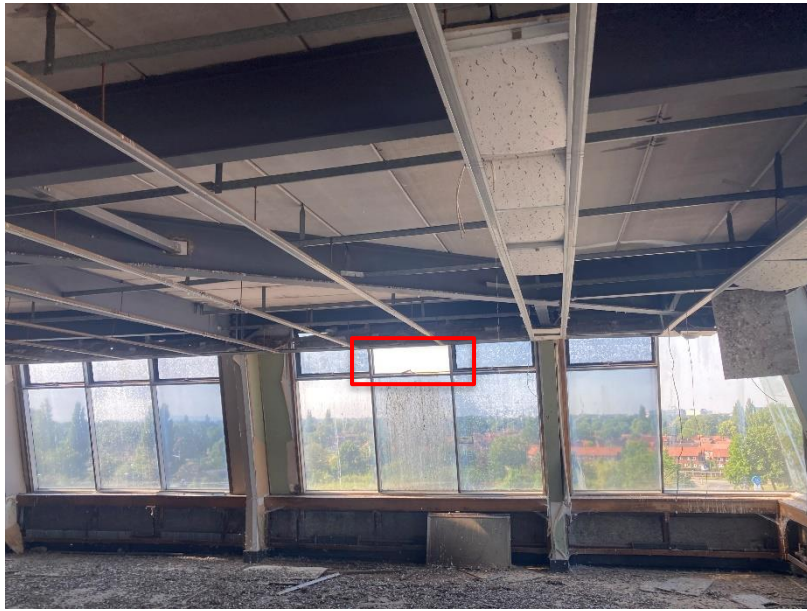
**Figure 22**      **Showing AP13**

The seventh floor was in a state of disrepair and was being occupied by feral pigeons. One access point was identified on the sixth floor through a smashed window (AP13). The ceiling on this floor was in good condition and was constructed with concrete. Three crevices within the plasterboard on this floor were identified (PRF11, PRF12 and PRF13). These crevices are likely to provide roosting opportunities to opportunistic crevice-dwelling bats on an occasional basis. No bat droppings or field signs of bats were identified on the seventh floor .

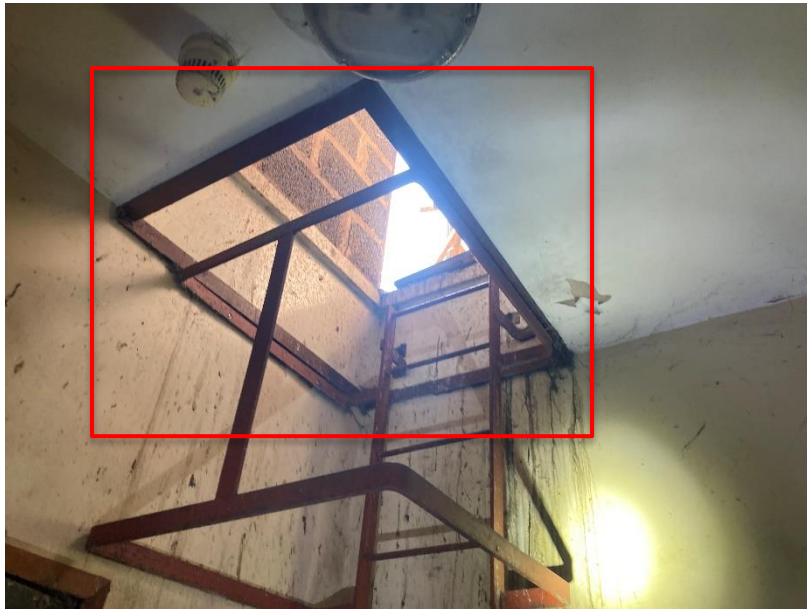
**Figure 24**      **Showing AP14**

The roof was in a good condition, and no potential roost features were present during the survey. An access point was present from an open fire escape (AP14). This access point allowed access into the seventh floor of the building.
