## Phase 1 GeoEnvironmental Desk Study

Hulme Primary

Manchester

**Report No. A6339/24/FDS**

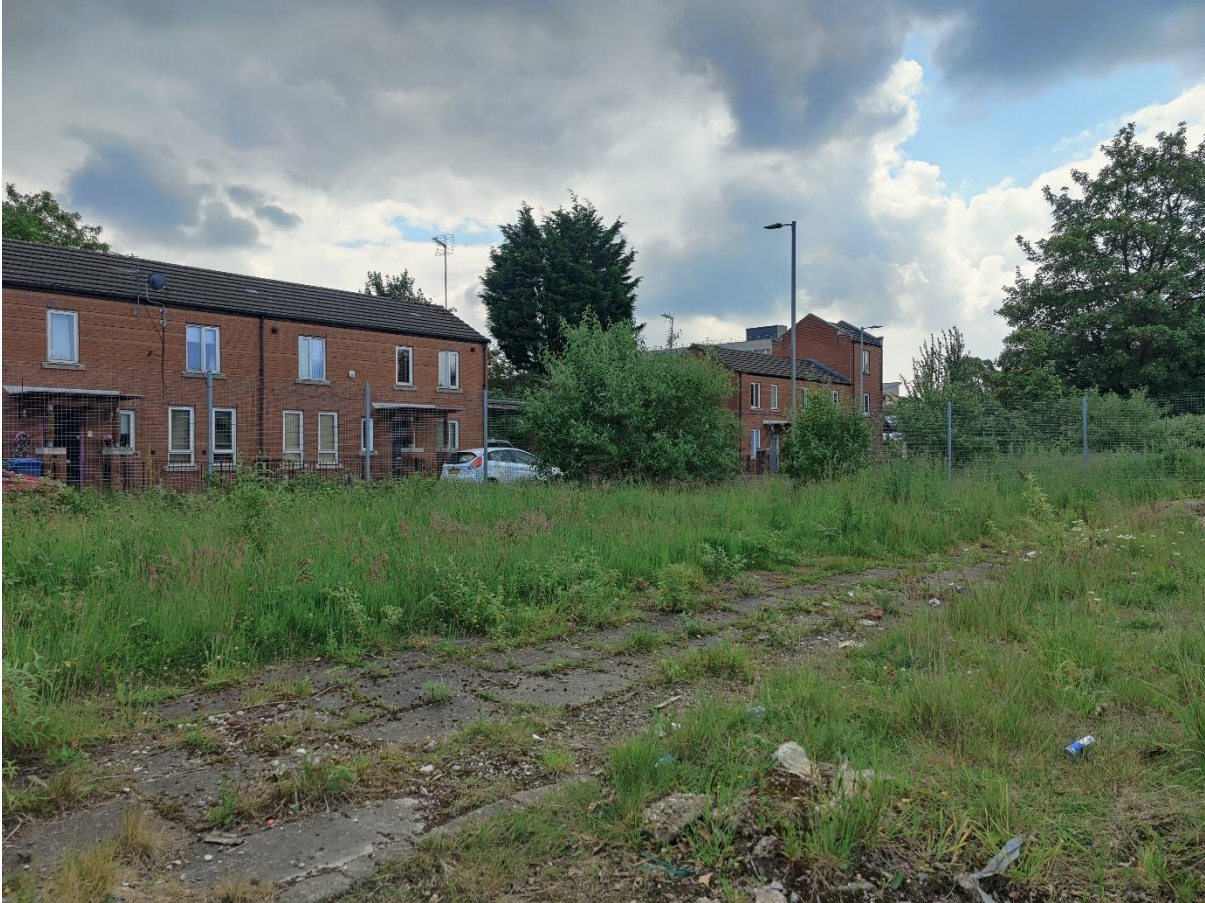
**Figure 3 Site Photograph**

- 2.4 The site is a rectangular shaped parcel of land with access via Upper Medlock Street to the east of the site.
- 2.5 The site is a vacant plot of disused land comprising overgrown vegetation in the western site section. No buildings are present on site.

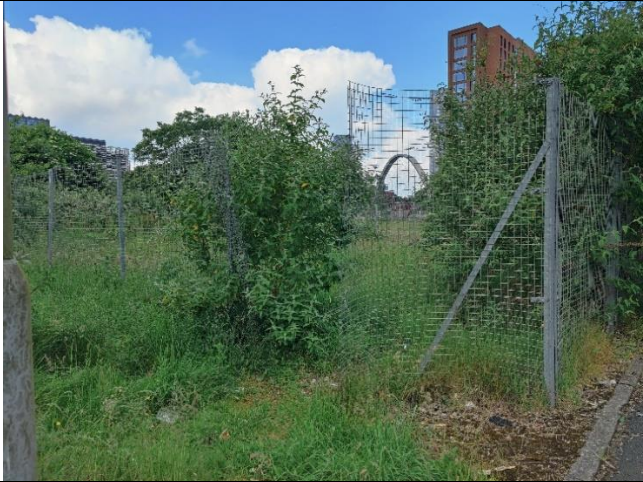
| <p><b>Plate 1</b> Site access via Upper Medlock Street, facing northwest</p> | <p><b>Plate 2</b> Paving slabs and gravel underfoot, facing west</p> |

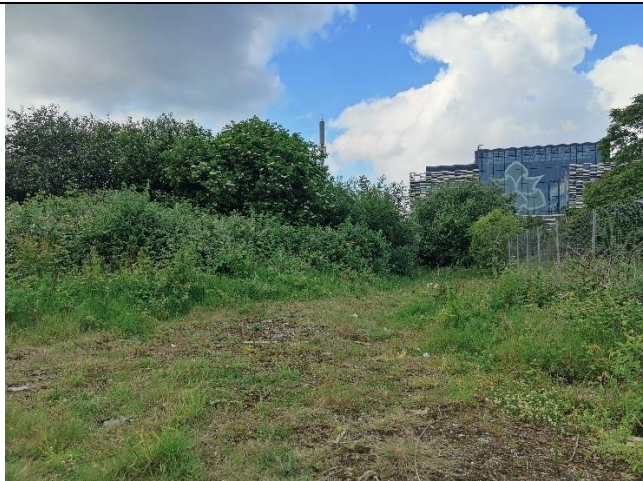
| <p><b>Plate 3</b> Overgrown vegetation and semi-mature trees in the southwestern site section, facing west</p> | <p><b>Plate 4</b> Central site section, facing south</p> |

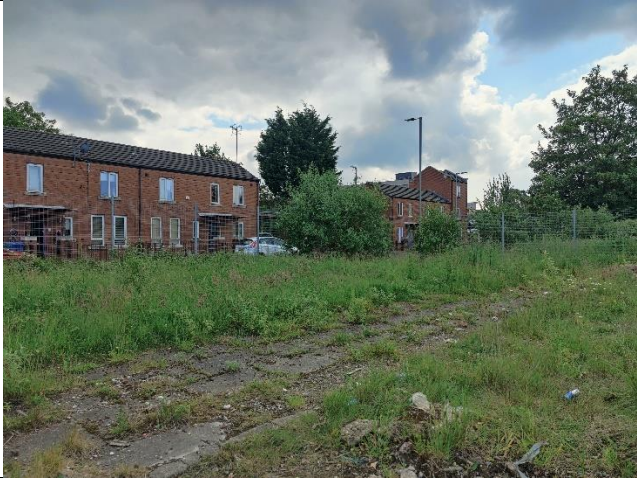
| <p><b>Plate 5</b> Paving slabs underfoot facing southwest at Upper Medlock Street.</p> | <p><b>Plate 6</b> Semi-mature trees in the southwestern site section, facing southwest.</p> |

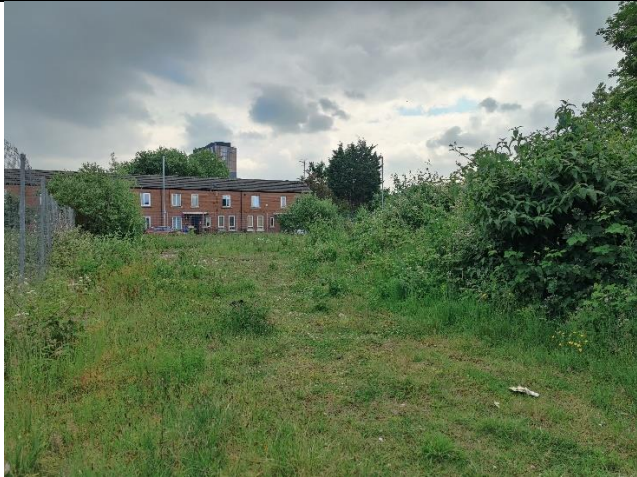
| <p><b>Plate 7</b> Facing east along the northern boundary</p> | <p><b>Plate 8</b> Facing north at the former road (Poynton Close)</p> |

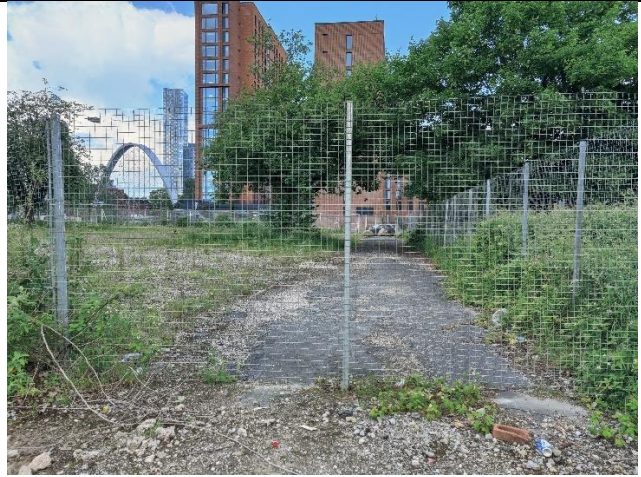
| <b>Geohazards:</b> | |
|---|---|
| Existing Buildings/Obstructions | <p>There are currently no existing buildings on site. However, the remnants of a historical road runs through the eastern section of the site. This may present challenges with 'breaking out' if an intrusive ground investigation takes place.</p> <p>Also, the foundations of former terraced houses may present obstructions in the shallow subsurface. Furthermore, it is unknown whether these houses also had basements. If so, this would present a further challenge, especially if they have been infilled with demolition materials from the former houses.</p> <p>An intrusive ground investigation is recommended prior to any construction works taking place to discover the depth and extent of any possible on-site basements.</p> |

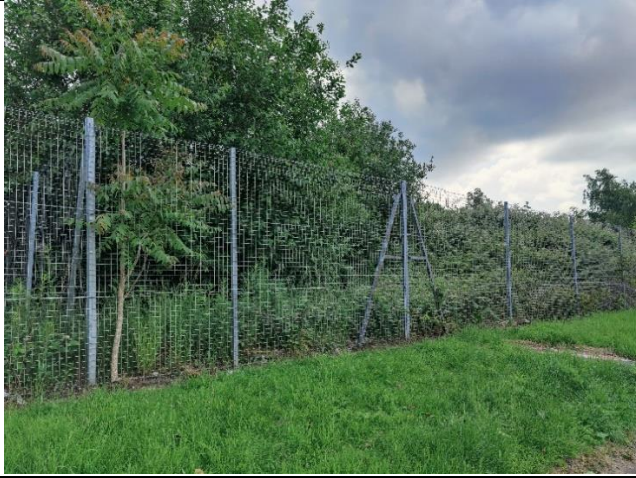
| <p><b>Plate 9</b> Metal fencing along the western boundary, facing southeast</p> | <p><b>Plate 10</b> Manhole cover just west of the western boundary, possible drainage services crossing the site</p> |

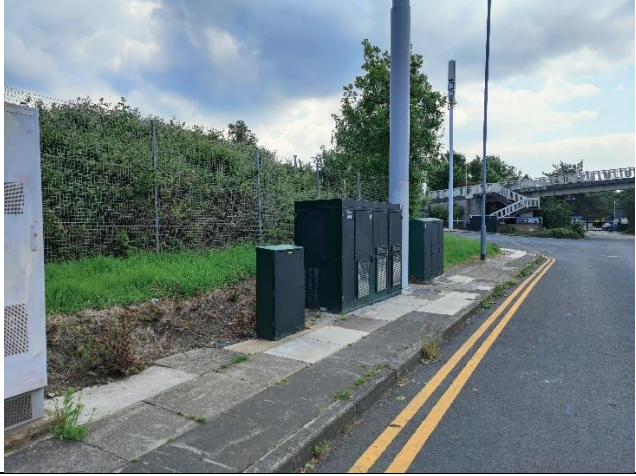
| <p><b>Plate 11</b> Electrical services along the western boundary with Birchall Lane, facing southeast</p> | <p><b>Plate 12</b> Possible site access off Bonsall Street to the north of the site, facing southeast</p> |
