| Contract | Facade Survey, Sunlight House, Manchester, M3 3HP (24008) |
| Drawing Title | Facade Condition Survey - Little Quay Street Elevation (East) |
| Drawing No. | 24008-PAYE-DR-002 rev P02 |

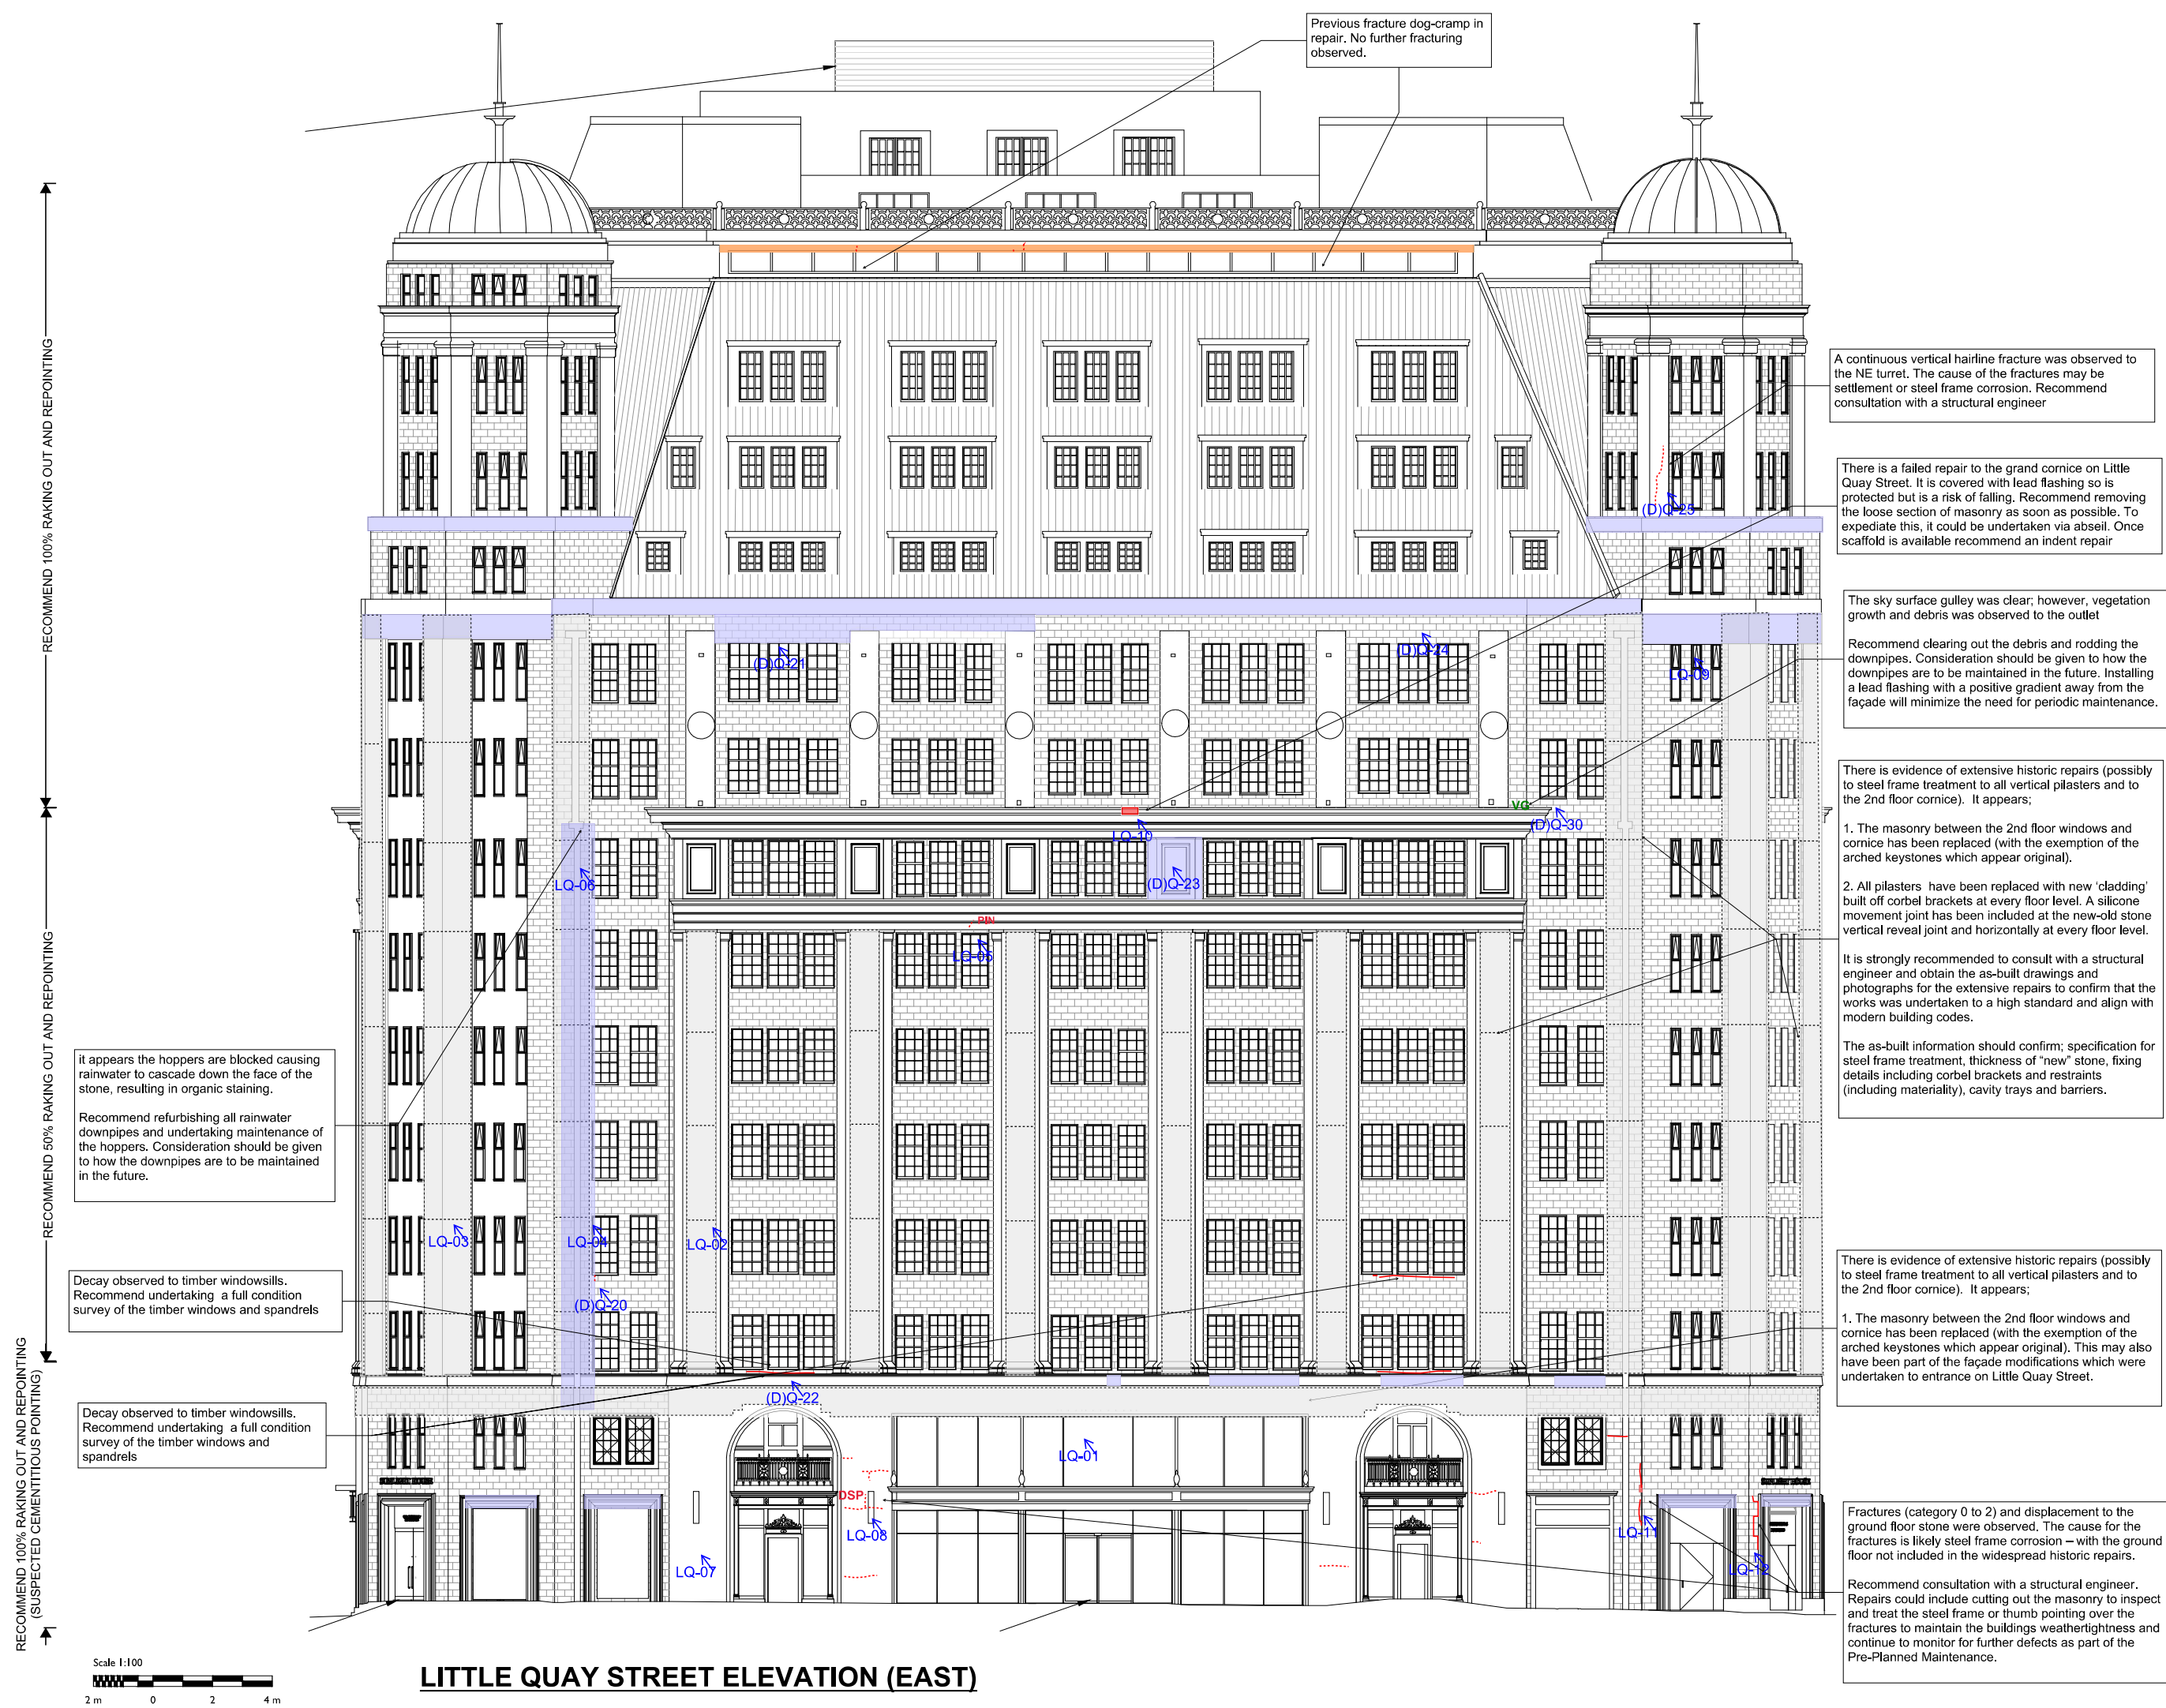
- Viewpoint
- Fractures
- Hairline fractures
- PIN** Recommend stainless steel pin repair (subject to structural engineers recommendation)
- DSP** Displaced stone
- FR** Friable stone. Recommend de-frassing stone to remove all loose material.
- Damaged stone (notable erosion, sections spalled). Recommend de-frass / indent repair / replacement unit.
- Existing render coat. Recommend tap testing to confirm well bonded.
- Redundant scaffold tie.
- FX** Street furniture (e.g. CCTV, alarm etc.).
- Staining to masonry
- No access (excluded from the survey)
