Information Required to Discharge Outstanding Condition number of Planning Listed Building Consent Reference: CDN/23/0065 for the Adaptation of Fenton House, Higher Ardwick into Seven Apartments.

**Document 5**  
**Latest Timber Inspection and Condition Survey Report**

**RE: Fenton House, Grade 11 Listed Georgian Town House, 4 Higher Ardwick, Manchester, M12 6BT,**

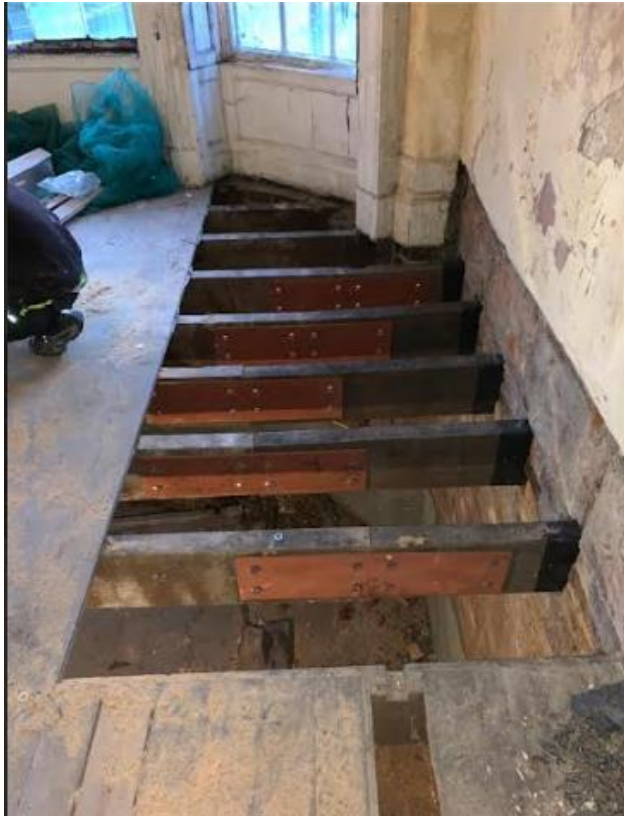
**Left:** East side of upper ground floor room with front bay extension. **Right:** North west corner of first floor front bedroom.

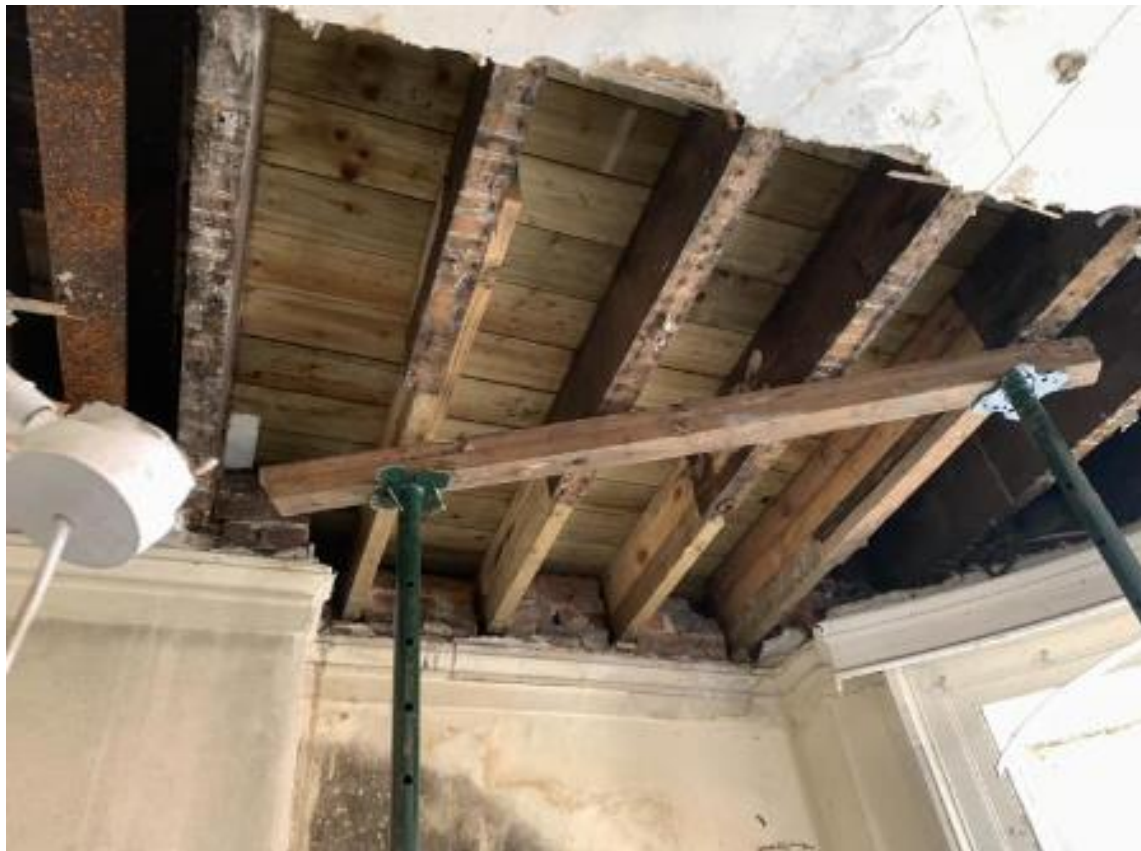
**Above:** Upper ground floor room with front bay extension. North west corner of ceiling.
