World Mission Agency - Winners Chapel International.

Chain Road Blackley Manchester M9 6GN

## CCTV Survey Review and Remedial Requirements

Ref: 24360-ROS-XX-XX-T-C-00002

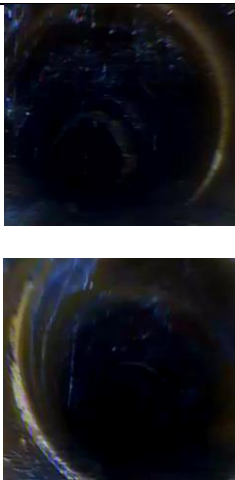
| MH18A > MH18B (B1 OUTFALL) Pipe Run | Survey<br>1. Scale at the joints of the system throughout the run.<br>2. Radial crack at 2.0m.<br>CCTV<br>3. Moderate joint displacement throughout the run. | 1. <br><br>2. <br>3. | Jetting and cleaning of debris are required.<br>Cracks and displacement appear minor and could possibly be left as current.<br>If deemed required, pipe lining required to fix defects throughout pipe. |
