| REVISIONS | |
|---|---|
| Contract | Facade Survey, Sunlight House, Manchester, M3 3HP (24008) |
| Drawing Title | Facade Condition Survey - Quay Street Elevation (South) |
| Drawing No. | 24008-PAYE-DR-001 rev P02 |

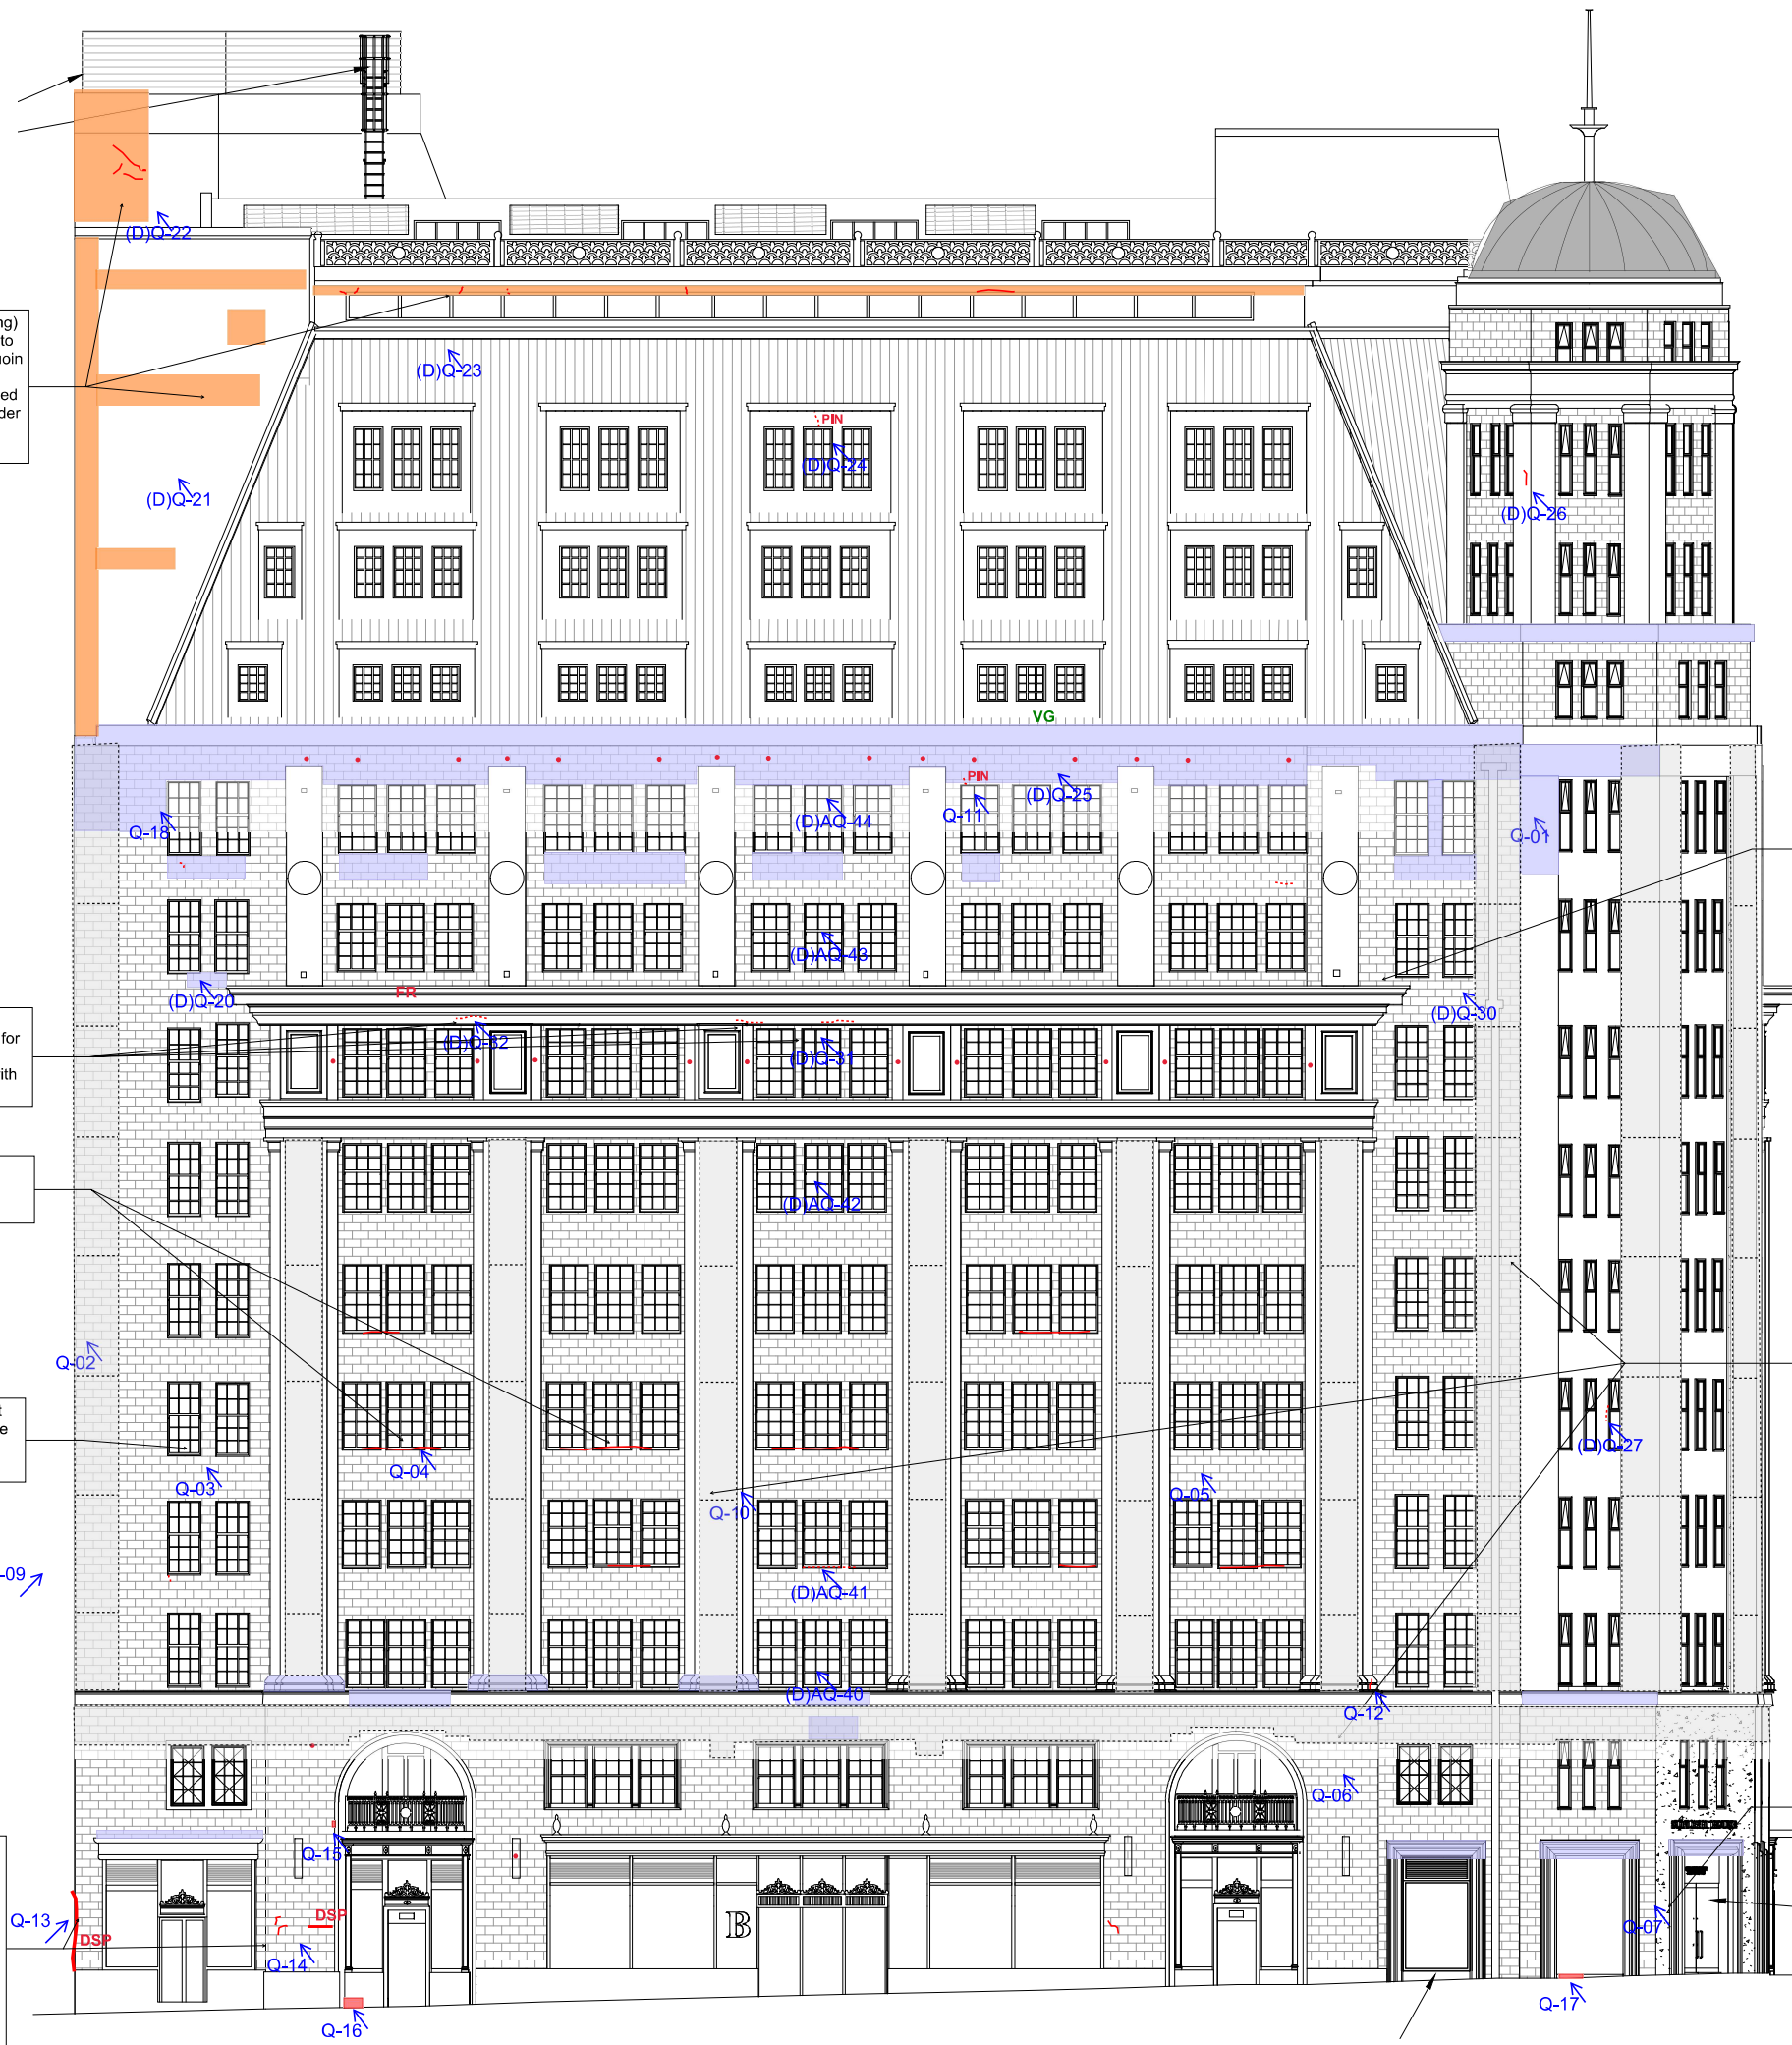
Cementitious render (both repairs and original detailing) has been installed to the setback areas at high level (to the lintel band just below the balustrade and at the quoin with the rear elevation). Recommend undertaking tap-testing to all areas of render. All loose or de-bonded render should be removed and a new compatible render installed.

Hairline fractures (category 0) was observed to the decorative frieze band below the cornice. The cause for the fractures may be steel frame corrosion. Strongly recommend consultation with a structural engineer with further investigations undertaken.

Decay observed to timber windowsills. Recommend undertaking a full condition survey of the timber windows and spandrels

Some windowsills have had a cementitious slurry coat applied to the sky surface which has run down the face of the façade. This likely installed as it was thought to improve weatherproofing ability

Fractures (category 0 to 2) and displacement to the ground floor stone were observed. The cause for the fractures is likely steel frame corrosion – with the ground floor not included in the widespread historic repairs.

Water-pooling was observed to the grand cornice on Quay Street. The cornice directs the rainwater to a back gully channel which then likely drains through a rainwater downpipe built with the build-up of the wall to the external downpipe hopper. The outlet on Quay Street is likely blocked with debris, preventing the rainwater from draining.

There is evidence of extensive historic repairs (possibly to steel frame treatment to all vertical pilasters and to the 2nd floor cornice). It appears;

1. The masonry between the 2nd floor windows and cornice has been replaced (with the exemption of the arched keystones which appear original).
2. All pilasters have been replaced with new 'cladding' built off corbel brackets at every floor level. A silicone movement joint has been included at the new-old stone vertical reveal joint and horizontally at every floor level.

At ground floor it is suspected that a cementitious pointing has been used to re-point the façade. The type of pointing to the upper levels is unknown. Cementitious pointing is impervious to water and will cause degradation to the facing Portland stone. Recommend to make an allowance to rake out all joints to the ground and first floor and repoint with a lime-base mortar

RECOMMEND 100% RAKING OUT AND REPOINTING (SUSPECTED CEMENTITIOUS POINTING)

RECOMMEND 50% RAKING OUT AND REPOINTING

RECOMMEND 100% RAKING OUT AND REPOINTING

Recommend consultation with a structural engineer. Repairs could include cutting out the masonry to inspect and treat the steel frame or thumb pointing over the fractures to maintain the buildings weathertightness and continue to monitor for further defects as part of the Pre-Planned Maintenance.

Recommend clearing out the debris and rodding the downpipes. Consideration should be given to how the downpipes are to be maintained in the future. Installing a lead flashing with a positive gradient away from the façade will minimize the need for periodic maintenance.

It is strongly recommended to consult with a structural engineer and obtain the as-built drawings and photographs for the extensive repairs to confirm that the works was undertaken to a high standard and align with modern building codes.

The as-built information should confirm; specification for steel frame treatment, thickness of "new" stone, fixing details including corbel brackets and restraints (including materiality), cavity trays and barriers.
