ATKINSON STREET ELEVATION (NORTH)

| Contract | Facade Survey, Sunlight House, Manchester, M3 3HP (24008) |

Drawing Title  
Facade Condition Survey - Atkinson Street Elevation

Drawing No.  
24008-PAYE-DR-003 rev P02

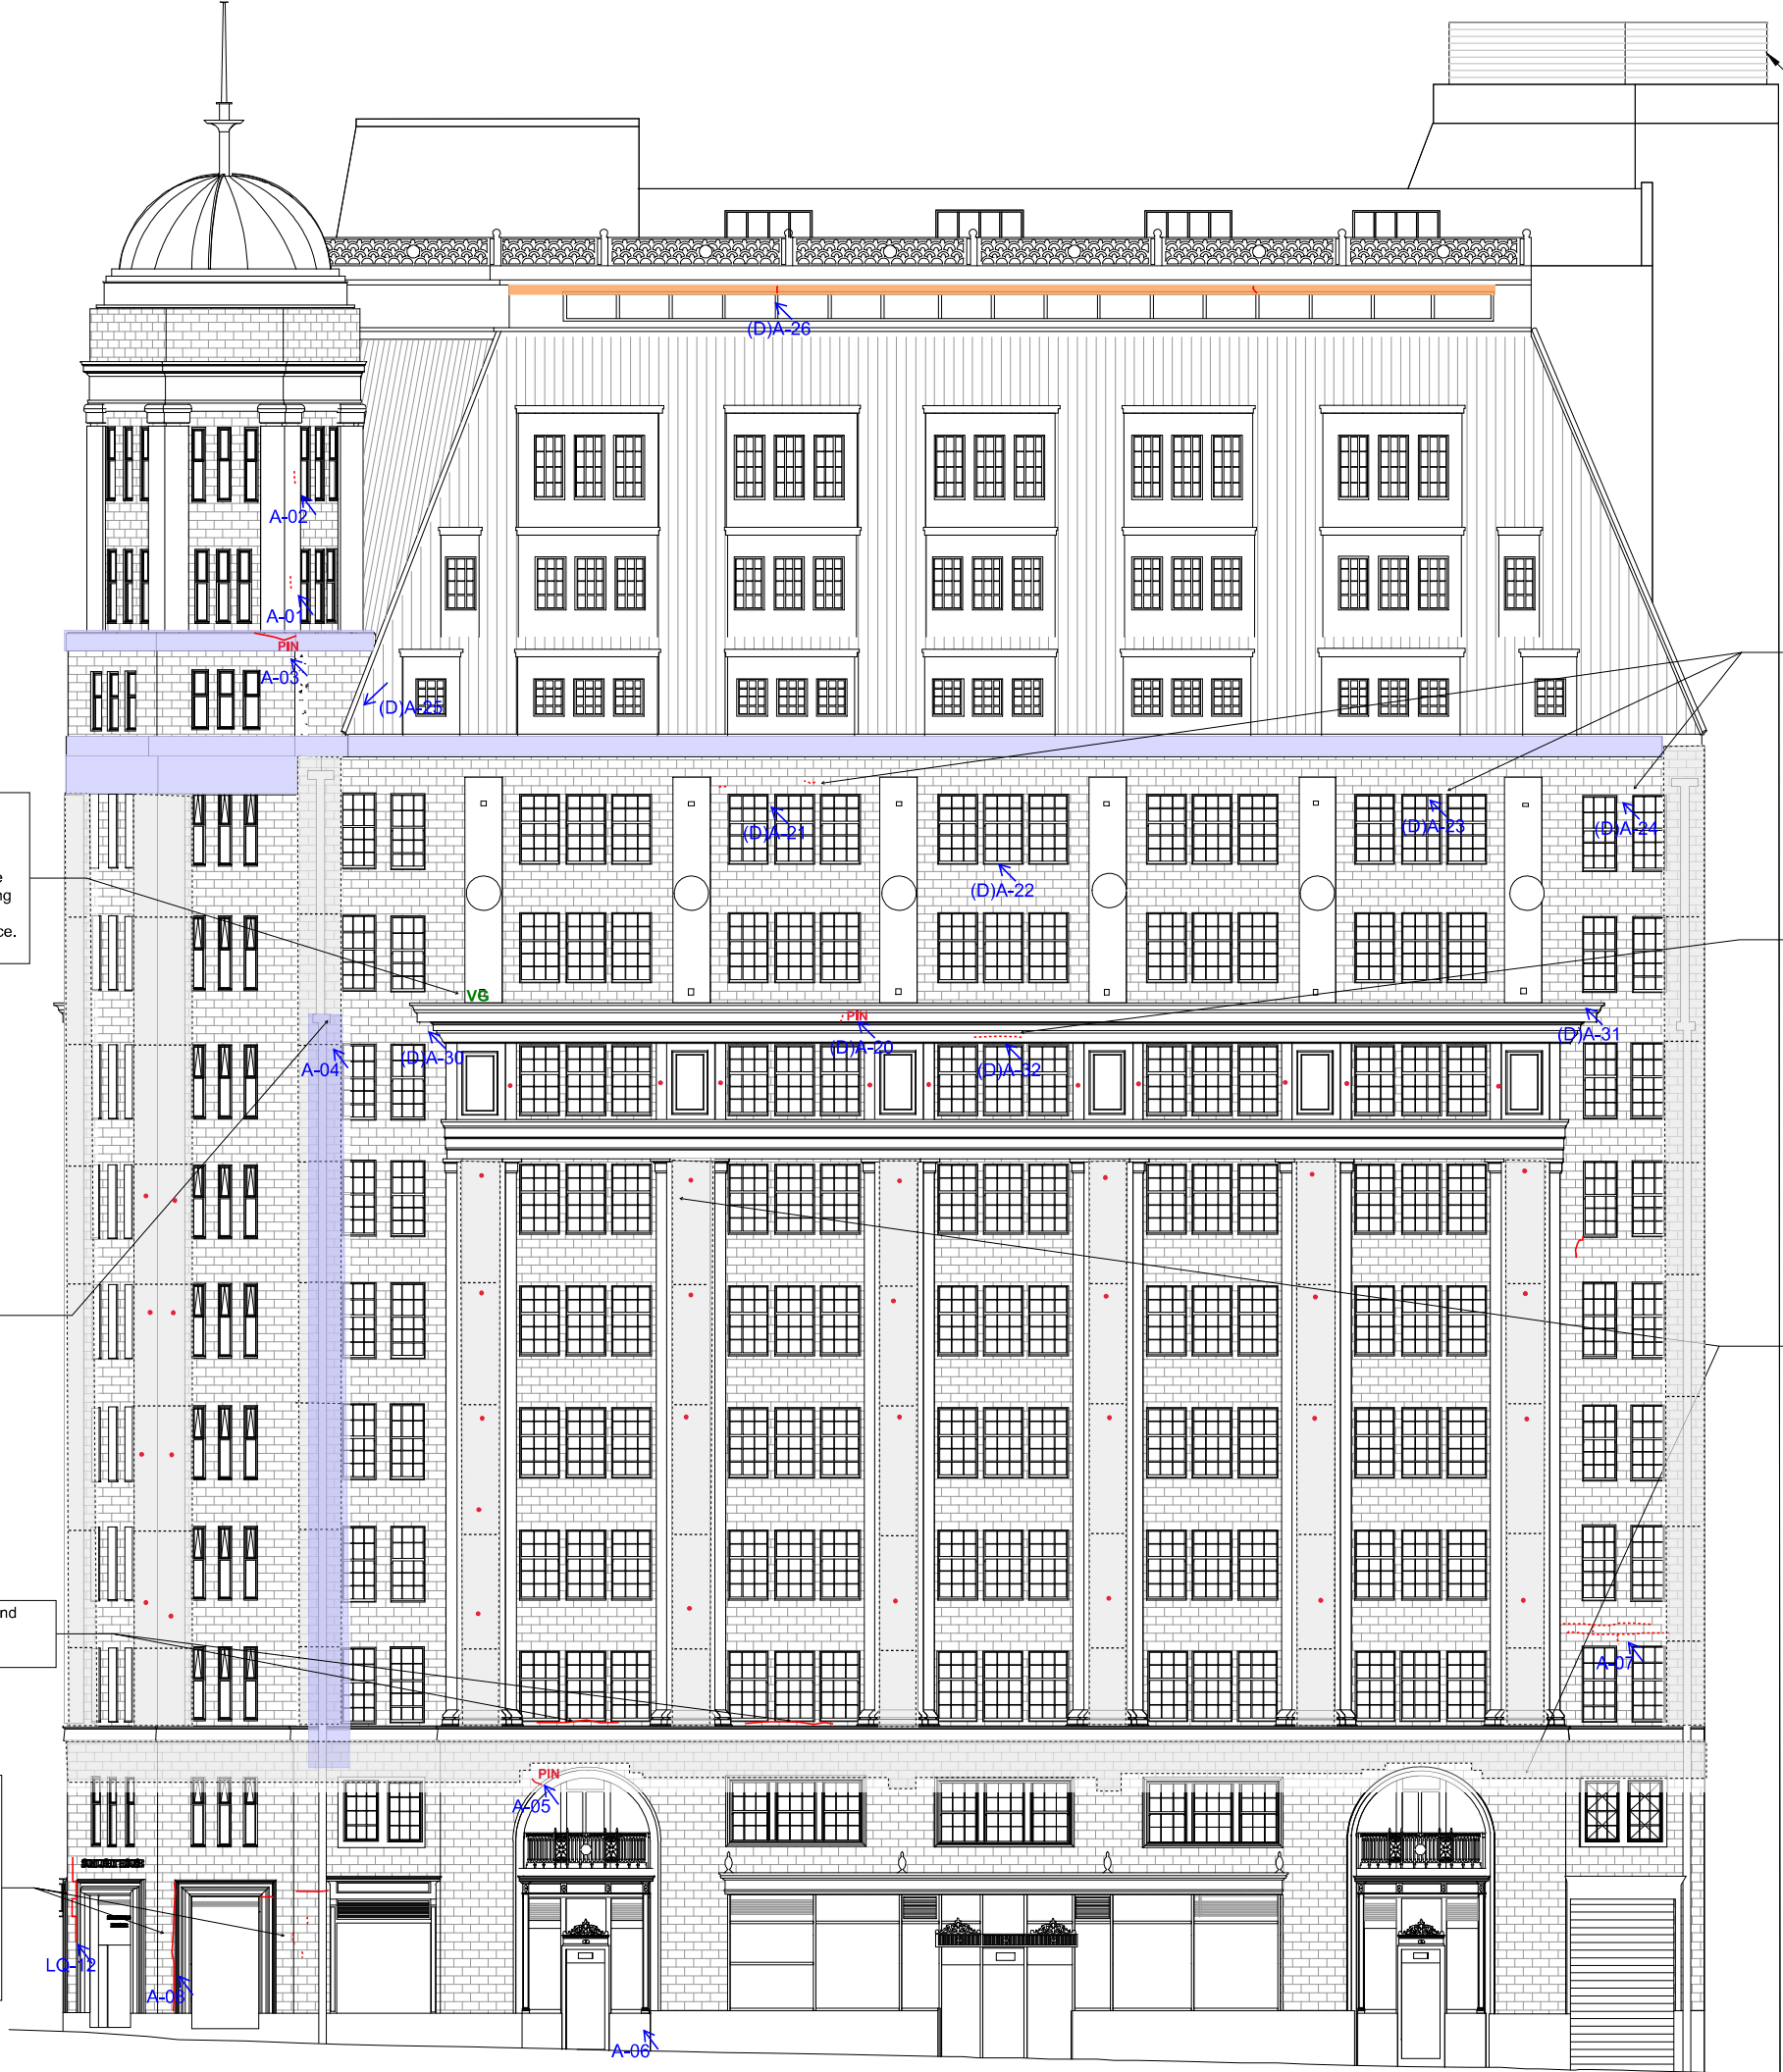
Horizontal hairline fractures were observed to a ninth-floor window lintel on Atkinson Street. The stone joint arrangement suggests the likelihood of a steel beam behind. The cause for the fractures may be steel frame corrosion. Although in its infancy, there is a risk that if left untreated it could deteriorate (especially due to the proximity the parapet hidden gutter). Historic mortar repairs were observed to the same bed joint three bays over (see (D/A)-23, 02, which suggest there may have been a historic issue

Hairline fractures (category 0-1) was observed to the decorative frieze band below the cornice. The cause for the fractures may be steel frame corrosion. Strongly recommend consultation with a structural engineer with further investigations undertaken.

There is evidence of extensive historic repairs (possibly to steel frame treatment to all vertical pilasters and to the 2nd floor cornice). It appears;

1. The masonry between the 2nd floor windows and cornice has been replaced (with the exemption of the arched keystones which appear original).
2. All pilasters have been replaced with new 'cladding' built off corbel brackets at every floor level. A silicone movement joint has been included at the new-old stone vertical reveal joint and horizontally at every floor level.

RECOMMEND 100% RAKING OUT AND REPOINTING (SUSPECTED CEMENTITIOUS POINTING)

RECOMMEND 50% RAKING OUT AND REPOINTING

RECOMMEND 100% RAKING OUT AND REPOINTING

It is strongly recommended to consult with a structural engineer and obtain the as-built drawings and photographs for the extensive repairs to confirm that the works was undertaken to a high standard and align with modern building codes.

The as-built information should confirm; specification for steel frame treatment, thickness of "new" stone, fixing details including corbel brackets and restraints (including materiality), cavity trays and barriers.
