| Contract | Facade Survey, Sunlight House, Manchester, M3 3HP (24008) |
| Drawing Title | Facade Condition Survey - Internal Light well Elevations 4 to 7 |
| Drawing No. | 24008-PAYE-DR-005 rev P01 |

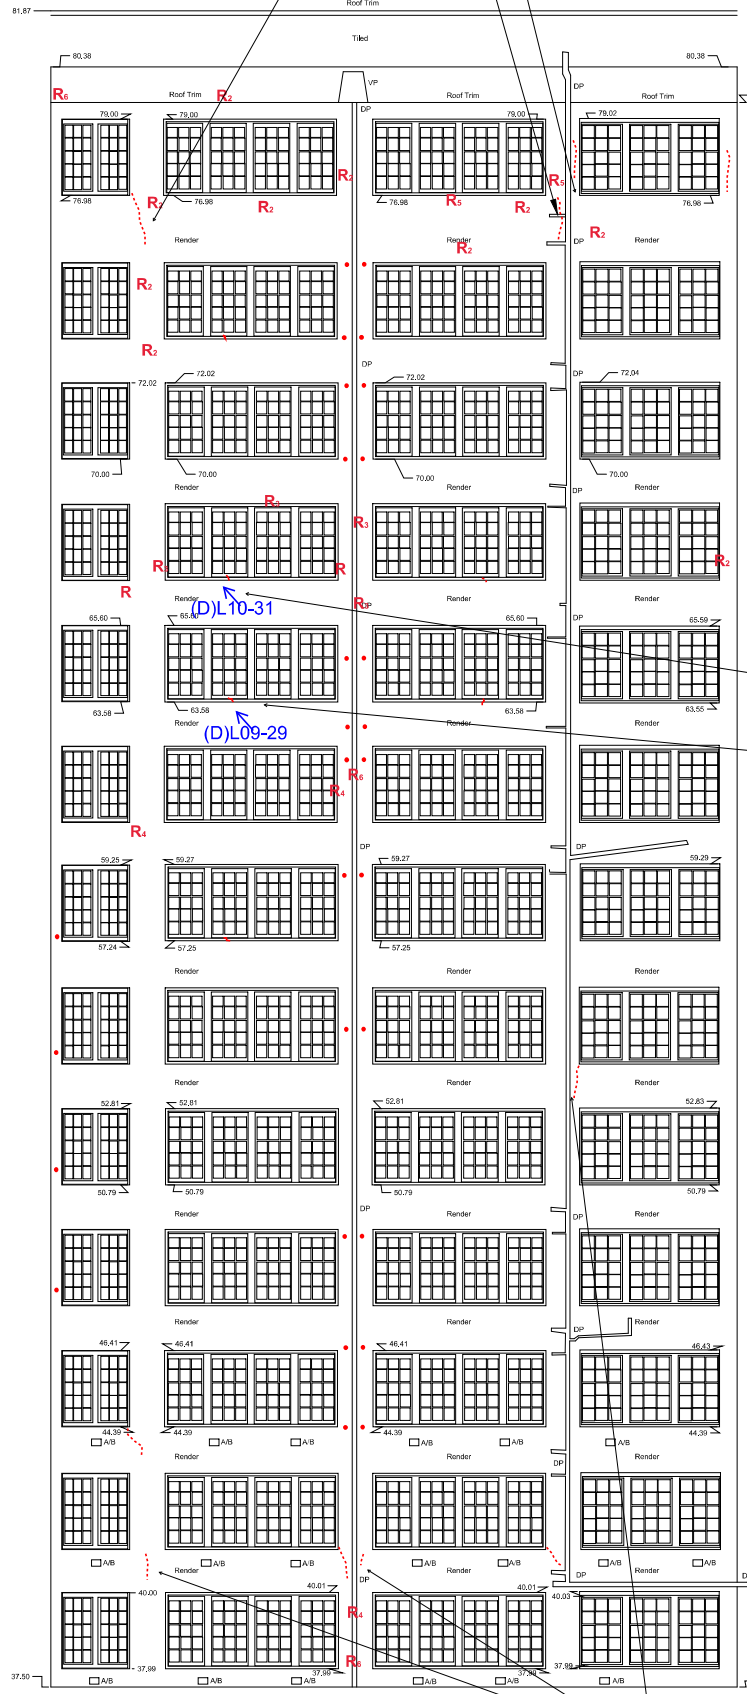
VEGETATION GROWTH OBSERVED TO THE BED JOINTS.  
RECOMMEND 100% RAKING OUT AND REPOINTING

Hairline fractures - originating from the windowsill - were observed to localised areas. The cause for the fractures is possibly settlement of the facades. Recommend consultation with a structural engineer and continued monitoring as part of the Pre-Planned Maintenance.

Rust staining was observed to several lintel and windowsills at L13. The cause for the rust staining is likely corrosion of the steel lintels which has washed down the window to the windowsill. Recommend consultation with a structural engineer and up-close inspection once access scaffold is available.

Hairline fracture or fractures were observed to several windowsill. The fractures could be to the stone sill (and possibly caused by differential settlement of the façade) or could just be flaking paint. Recommend up close inspection once scaffold is available.

RECOMMEND 100% RAKING OUT AND REPOINTING
