| Location/Beam | Dimensions | Decay viewed from<br>bearing side | Cross plan view | Photographs | Confirmed agreed repairs with<br>Structural engineer comment in bold |

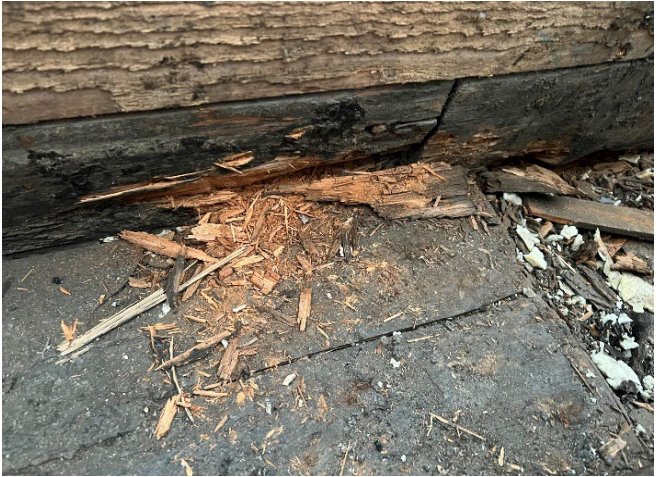
| Location/Beam | Dimensions | Decay viewed from<br>bearing side | Cross plan view | Photographs | Confirmed agreed repairs with<br>Structural engineer comment in bold |
|---|---|---|---|---|---|
| <b>E/VB/3</b><br><br>Full length<br>of the<br>beam | <div><div>95mm</div><div>275mm</div></div> | | <div><div><div>← 2500mm →</div><div>60mm Deep</div><div>30-40mm Deep</div><div>+ 300+ mm</div><div>Cross plan View</div><div>Decayed section</div></div></div> | <div>Decay to both bearing ends. The end opposite VB1, 300mm</div> <div>wide and 60mm deep</div> <div>The opposite end decay full height with decay extending 2500mm along the beam 30-40mm deep</div> | <div></div> <div><b>Recommendations</b><br/>Allow to fully renew the beam with C24<br/><br/>treated Douglas Fir<br/><br/><b>Buro Happold agreed to replacement in email dated 25/10/24</b></div> |

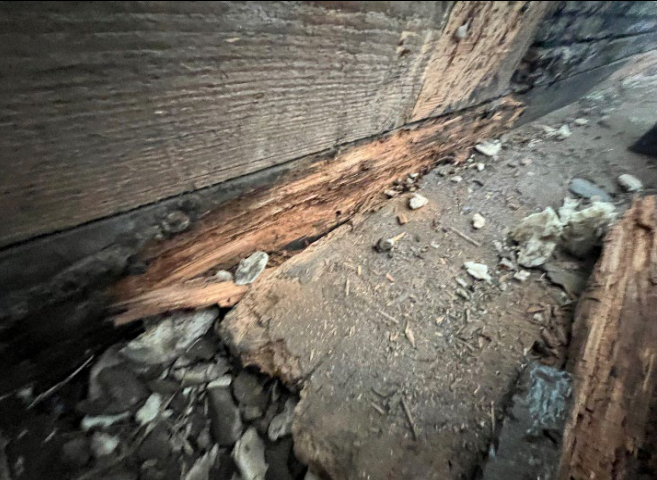
| Location/Beam | Dimensions | Decay viewed from<br>bearing side | Cross plan view | Photographs | Confirmed agreed repairs with<br>Structural engineer comment in bold |
|---|---|---|---|---|---|
| <b>E/VB/4</b><br><br>Bearing<br>end<br>opposite<br>VB2 | <div><div>95mm</div><div>275mm</div></div> | | <div><div><div>600mm</div><div>20mm Deep</div><div>+ 200 mm</div><div>Cross plan View</div><div>Decayed section</div></div></div> | <div>Superficial rot to face of valley beam opposite VB2 20mm deep to a section 600x100mm in section</div> | <div></div> <div><b>Recommendations</b><br/>Defrass the beam of all decay back<br/><br/>to sound timber and treat with Wykamol 10.1 fungicide gel<br/><br/><b>Buro Happold agreed to defrass and treat in email dated 25/10/24. Commented that section is adequate for shear at bearing end.</b></div> |

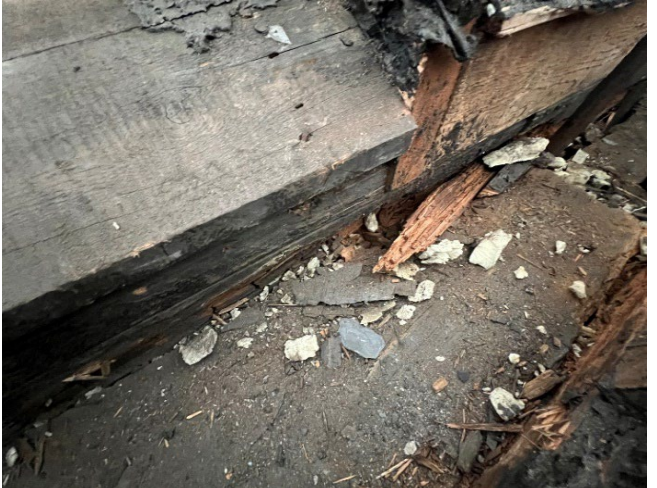
| Location/Beam | Dimensions | Decay viewed from<br>bearing side | Cross plan view | Photographs | Confirmed agreed repairs with<br>Structural engineer comment in bold |
|---|---|---|---|---|---|
| <b>E/VB/5</b><br><br>Bearing end<br>opposite | <div><div>95mm</div><div>275mm</div></div> | | <div><div><div>← 800 mm →</div><div>60mm Deep</div><div>+ 300+ mm</div><div>Cross plan View</div><div>Decayed section</div></div></div> | <div>Wet rot to bearing end opposite VB5. The decay affected 300mm of bearing end to depth of 60mm. The rot extension for a further 800mm</div> | <div></div> <div><b>Recommendations</b><br/>Flitch beam plate repair as per drawings and calculation provided by WMI Consulting<br/><br/>drawing no 1179R<br/><br/><b>Buro Happold agreed to flitch plate repair as per agreed detail in email dated 25/10/24</b></div> |

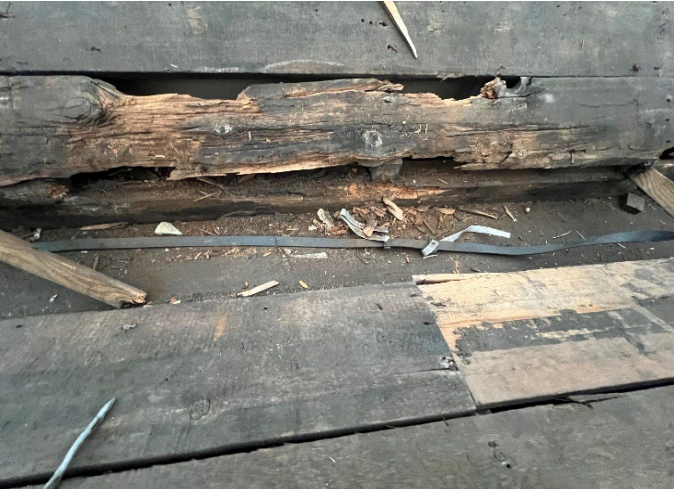
| Location/Beam | Dimensions | Decay viewed from<br>bearing side | Cross plan view | Photographs | Confirmed agreed repairs with<br>Structural engineer comment in bold |
|---|---|---|---|---|---|
| <b>E/VB/12</b><br><br>Middle section of<br>beam | <div><div>95mm</div><div>275mm</div></div> | | <div><div><div>← 800 mm →</div><div>20-30mm Deep</div><div>Cross plan View</div><div>Decayed section</div></div></div> | <div>Section to top face of beam at mid section 20-30mm deep spanning 800mm</div> | <div></div> <div><b>Recommendations</b><br/><br/>Timber to timber scarfed infill to midspan required. To be installed as per BHE drawing VB12 intent. Repair to consist of a wedge fixed with structural adhesive, we will ensure the moisture content of the new piece matches the existing beam to avoid shrinkage to the repair. The wood would be cut back as a minimum, as detailed previous 50x50mm 800mm long is the maximum size of the wedge.<br/><br/><b>Buro Happold agreed to the repair as per agreed detail in email dated 05/11/24</b></div> |

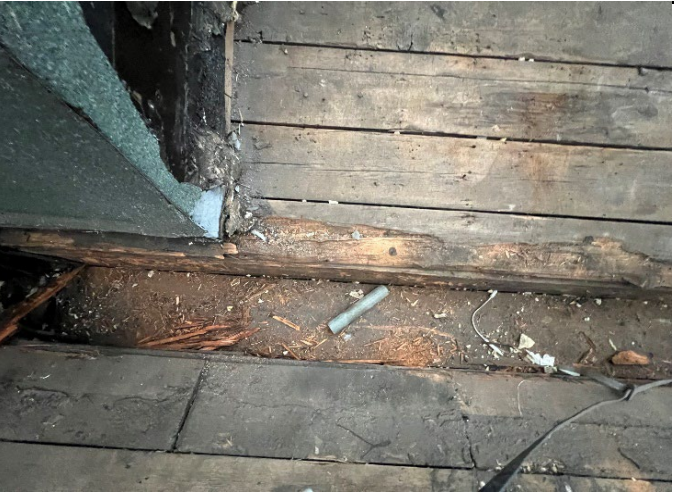
| <div>E/VB/13</div> <div>Bearing end into external wall</div> | <div><div><div>95mm</div><div>440mm</div><div>Bearing end</div></div><div><div>2000mm</div><div>15-20mm Deep</div><div>Cross plan View</div><div>Decayed section</div></div></div> | <div>Wet rot to the bearing end nearest the external wall with decay to the inner face towards the valley 15-20mm in depth</div> | <div></div> | <div>Recommendations</div> <div>Defrass the beam of all decay back to sound timber and treat with Wykamol 10.1 fungicide gel</div> <div>Buro Happold Comment</div> <div>Buro Happold agreed to defrass and treat in email dated 25/10/24. Commented that section is adequate for shear at bearing end.</div> |

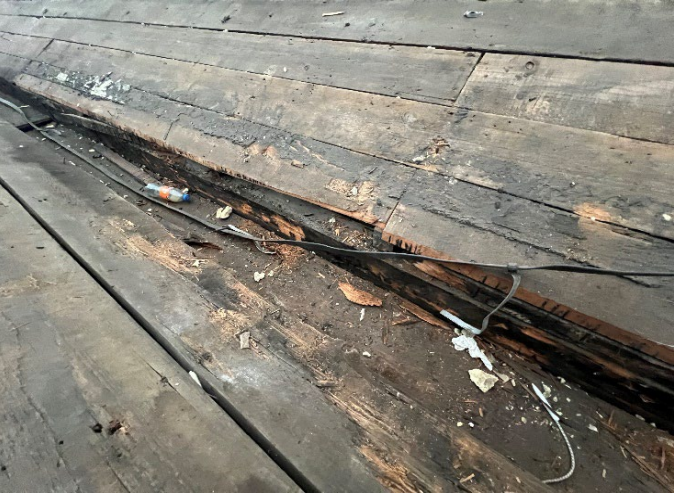
| <div>E/VB/14</div> <div>Full length of the beam</div> | <div><div><div>95mm</div><div>440mm</div><div>Bearing end</div></div><div><div>10-15mm Deep</div><div>3000mm</div><div>30-50mm Deep</div><div>2000mm</div><div>Cross plan View</div><div>Decayed section</div></div></div> | <div>Rot to the inner face to the valley</div> <div>The first 2 metres from the external wall the decay 30 to 50mm to the upper 175mm of exposed beam. Superficial decay to the remaining 3 metres 10 to 15mm deep to upper 175mm of beam</div> | <div></div> | <div>Recommendations</div> <div>Beam to be replaced with C24 douglas fir to match existing section</div> <div>Buro Happold confirmed replacement rquired with the following comments:</div> <div>15mm deep decay leaves enough section, but 50mm deep does not - shear OK, but bending towards middle of beam is not. Repair at midspan is not feasible. As such, replacement is beam is required - section to match existing, C24 douglas fir.</div> |
