## REFURBISHMENT / DEMOLITION ASBESTOS SURVEY

Units 1, 2, 3, 4, 5, 6, 7 & 8 Ambrose Street,  
Gorton, Manchester, M12 5DD

| <b>Project Reference:</b> | PEC1483 |
| <b>Project date:</b> | Tuesday 7 <sup>th</sup> May 2024 |

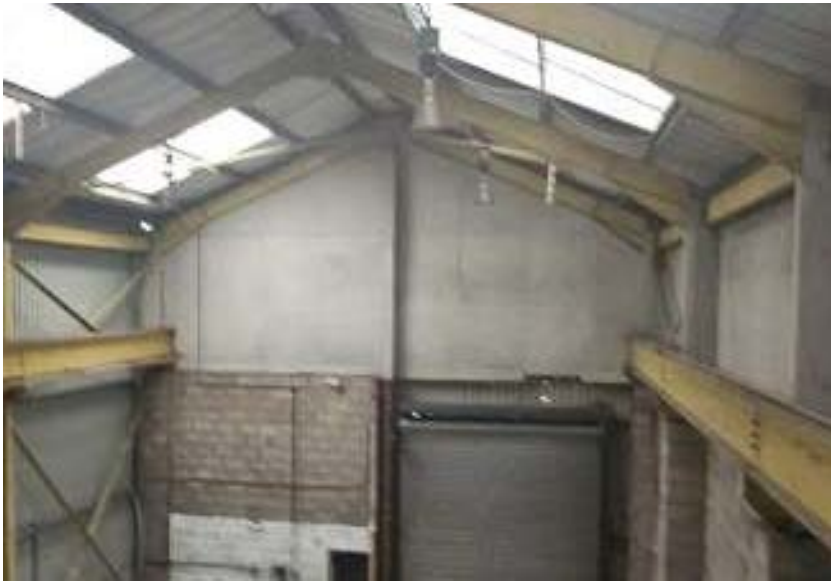
| Sample position | Lining panels to walls and vertical steels at high level | | |
| Extent / Quantity of material | 170m <sup>2</sup> | | |
| <b>RISK BAND SCORE</b> - The risk band score assigned to this sample based on the surveyor's assessment of the materials condition / location and possibility of exposure to any occupants of the site | | <b>2</b> | |

| <b>Recommendations</b> | Remedial works to damaged areas or displaced boards, Encapsulate, label and monitor the material with regular and pre planned inspection. Prior to any demolition or refurbishment work involving the material it should be removed under full conditions using a licensed contractor in accordance with the Control of Asbestos Regulations 2012 | | |

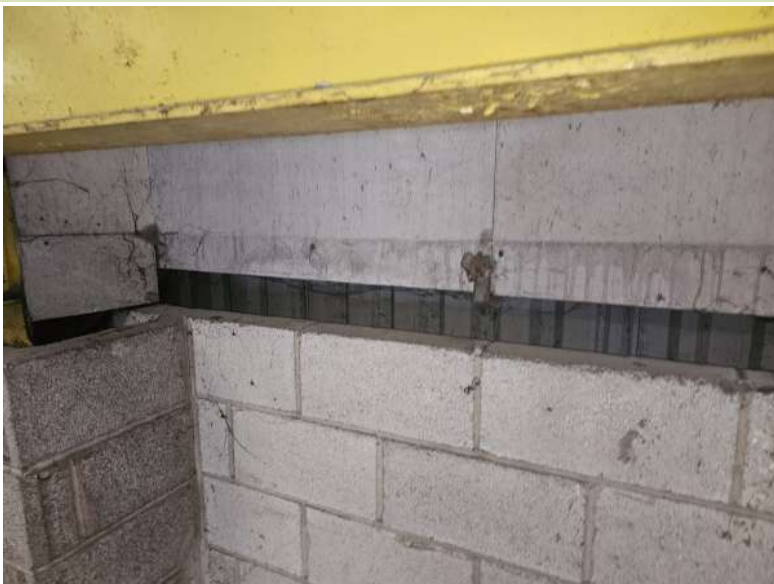
| Sample position | Lining panels to walls and vertical steels at high level | | |
| <b>RISK BAND SCORE</b> - The risk band score assigned to this sample based on the surveyor's assessment of the materials condition / location and possibility of exposure to any occupants of the site | | | <b>2</b> |

| <b>Recommendations</b> | Remedial works to damaged areas or displaced boards, Encapsulate, label and monitor the material with regular and pre planned inspection. Prior to any demolition or refurbishment work involving the material it should be removed under full conditions using a licensed contractor in accordance with the Control of Asbestos Regulations 2012 | | |

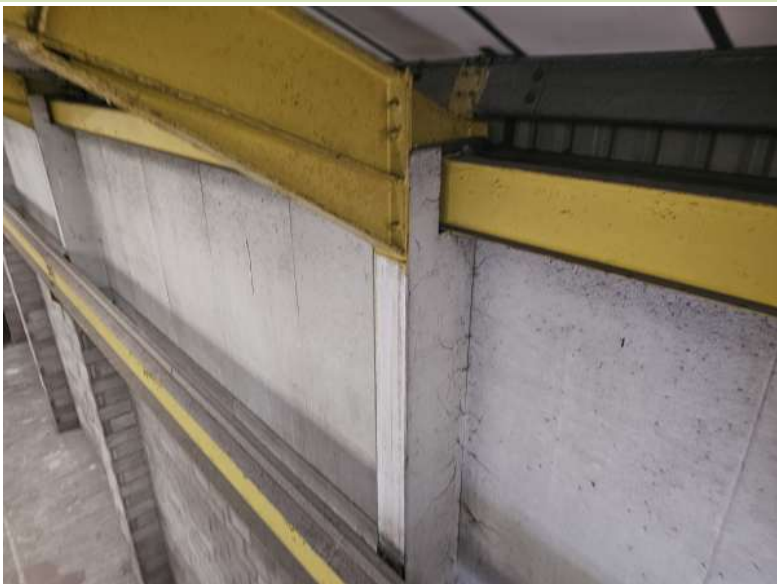
| Sample position | Lining panels to walls and vertical steels at high level | | |
| <b>RISK BAND SCORE</b> - The risk band score assigned to this sample based on the surveyor's assessment of the materials condition / location and possibility of exposure to any occupants of the site | | | 2 |

| <b>Recommendations</b> | Remedial works to damaged areas or displaced boards, Encapsulate, label and monitor the material with regular and pre planned inspection. Prior to any demolition or refurbishment work involving the material it should be removed under full conditions using a licensed contractor in accordance with the Control of Asbestos Regulations 2012 | | |

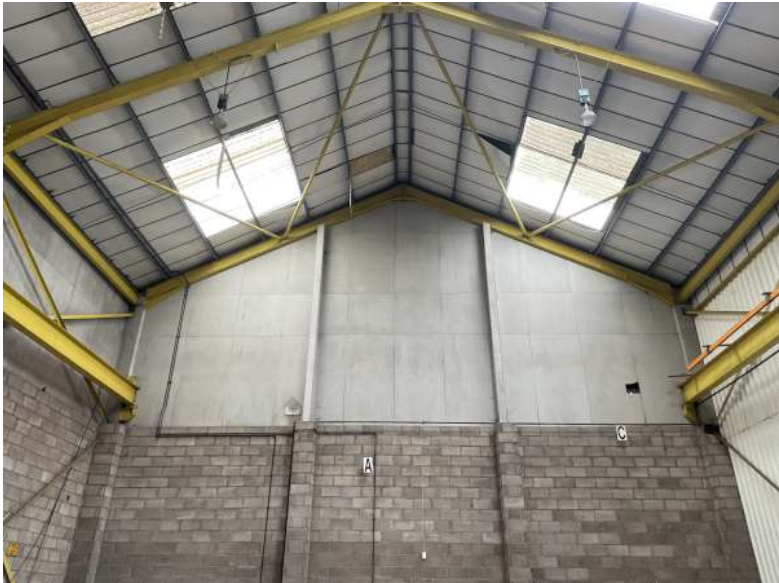
| Sample position | Lining panels to walls and vertical steels at high level | | |
| Extent / Quantity of material | 250m <sup>2</sup> | | |
| <b>RISK BAND SCORE</b> - The risk band score assigned to this sample based on the surveyor's assessment of the materials condition / location and possibility of exposure to any occupants of the site | | | <b>2</b> |

| <b>Recommendations</b> | Remedial works to damaged areas or displaced boards, Encapsulate, label and monitor the material with regular and pre planned inspection. Prior to any demolition or refurbishment work involving the material it should be removed under full conditions using a licensed contractor in accordance with the Control of Asbestos Regulations 2012 | | |

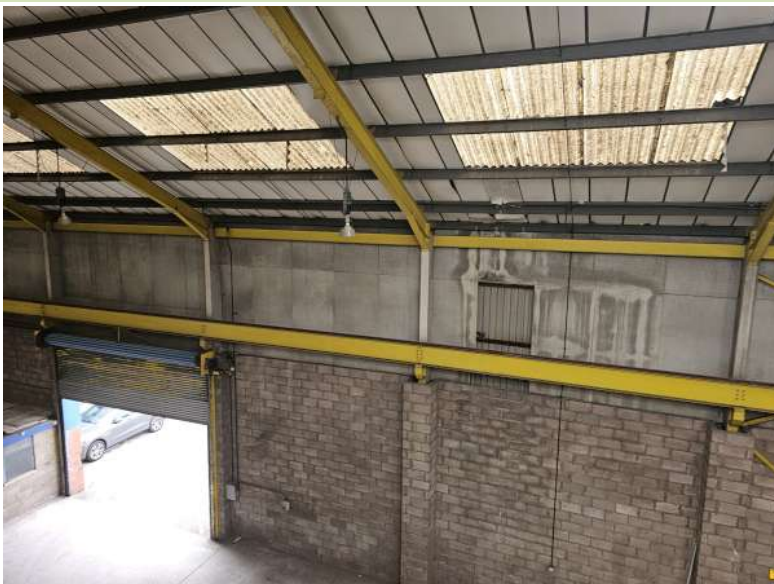
| Sample position | Lining panels to walls and vertical steels at high level | | |
| <b>RISK BAND SCORE</b> - The risk band score assigned to this sample based on the surveyor's assessment of the materials condition / location and possibility of exposure to any occupants of the site | | | <b>2</b> |

| <b>Recommendations</b> | Remedial works to damaged areas or displaced boards, Encapsulate, label and monitor the material with regular and pre planned inspection. Prior to any demolition or refurbishment work involving the material it should be removed under full conditions using a licensed contractor in accordance with the Control of Asbestos Regulations 2012 | | |

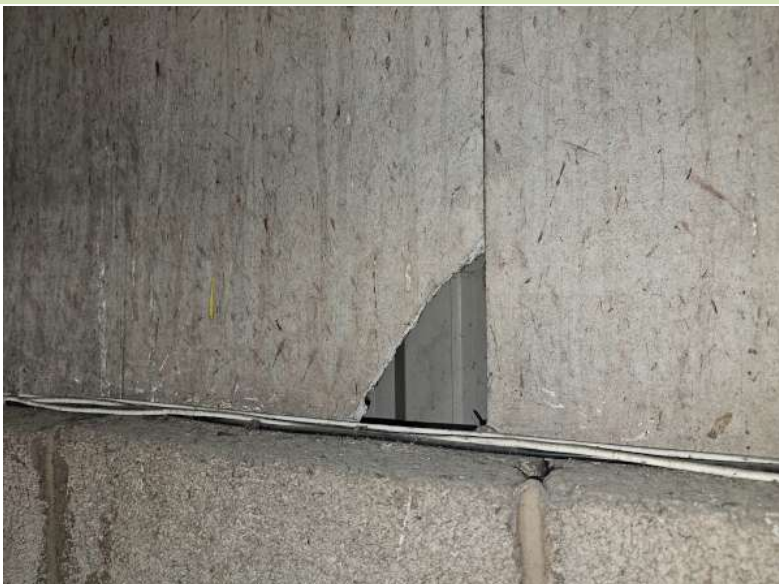
| Sample position | Lining panels to walls and vertical steels at high level | | |
| <b>RISK BAND SCORE</b> - The risk band score assigned to this sample based on the surveyor's assessment of the materials condition / location and possibility of exposure to any occupants of the site | | | <b>2</b> |

| <b>Recommendations</b> | Remedial works to damaged areas or displaced boards, Encapsulate, label and monitor the material with regular and pre planned inspection. Prior to any demolition or refurbishment work involving the material it should be removed under full conditions using a licensed contractor in accordance with the Control of Asbestos Regulations 2012 | | |

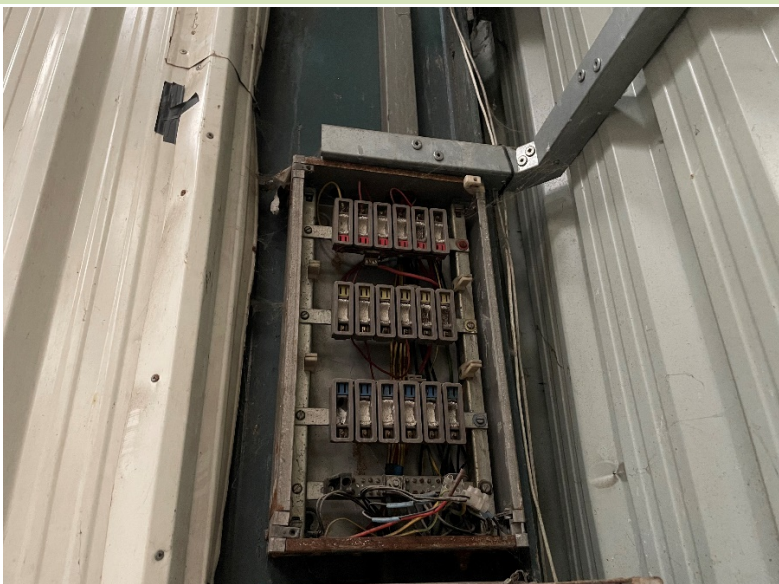
| Sample position | Textile pad within fuse holders | | |
| Extent / Quantity of material | 6 x boxes throughout units inspected | | |
| <b>RISK BAND SCORE</b> - The risk band score assigned to this sample based on the surveyor's assessment of the materials condition / location and possibility of exposure to any occupants of the site | | | <b>3</b> |

| <b>Recommendations</b> | Label, monitor & review the material with regular and pre planned inspection. Prior to any demolition or refurbishment works involving the material it should be removed in accordance with the Control of Asbestos Regulations 2012 | | |

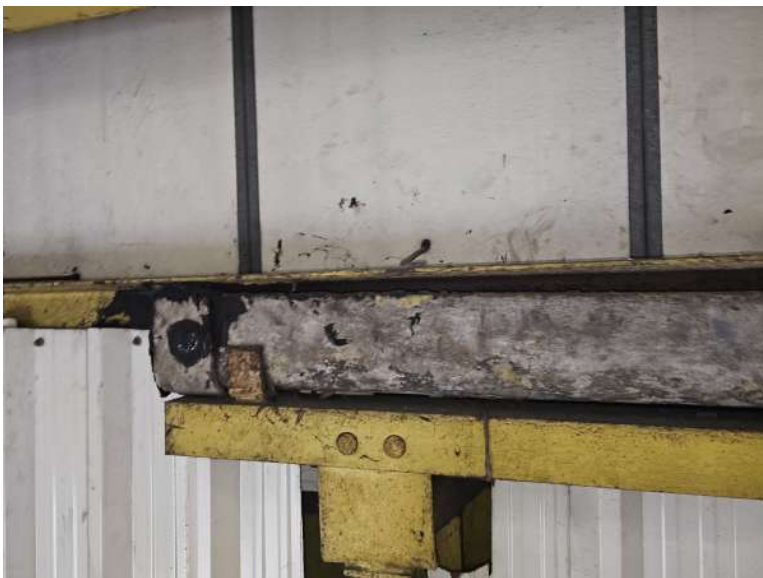
| Sample position | Gutter trough at high level between units | | |
| Extent / Quantity of material | 85 linear metres | | |
| <b>RISK BAND SCORE</b> - The risk band score assigned to this sample based on the surveyor's assessment of the materials condition / location and possibility of exposure to any occupants of the site | | | <b>3</b> |

| <b>Recommendations</b> | Monitor & review the material with regular and pre planned inspection. Prior to any demolition or refurbishment works involving the material it should be removed in accordance with the Control of Asbestos Regulations 2012 | | |

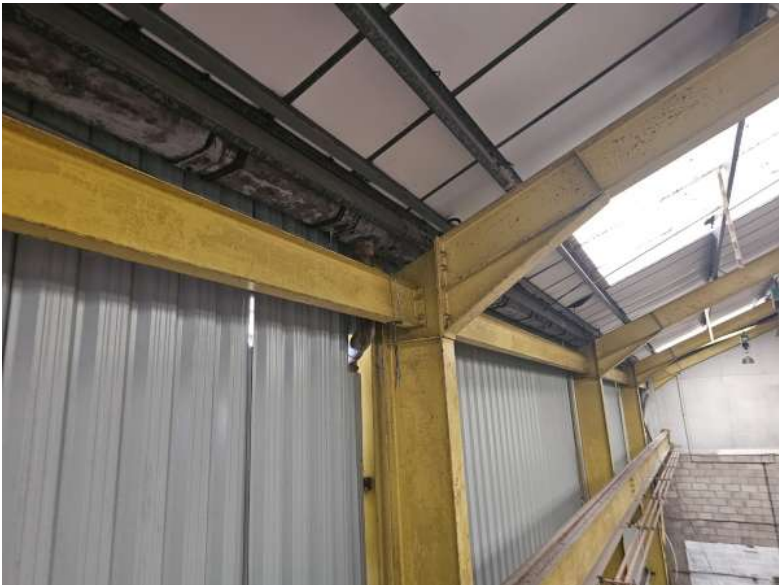
| Sample position | Gutter trough at high level between units | | |
| <b>RISK BAND SCORE</b> - The risk band score assigned to this sample based on the surveyor's assessment of the materials condition / location and possibility of exposure to any occupants of the site | | | <b>3</b> |

| <b>Recommendations</b> | Monitor & review the material with regular and pre planned inspection. Prior to any demolition or refurbishment works involving the material it should be removed in accordance with the Control of Asbestos Regulations 2012 | | |

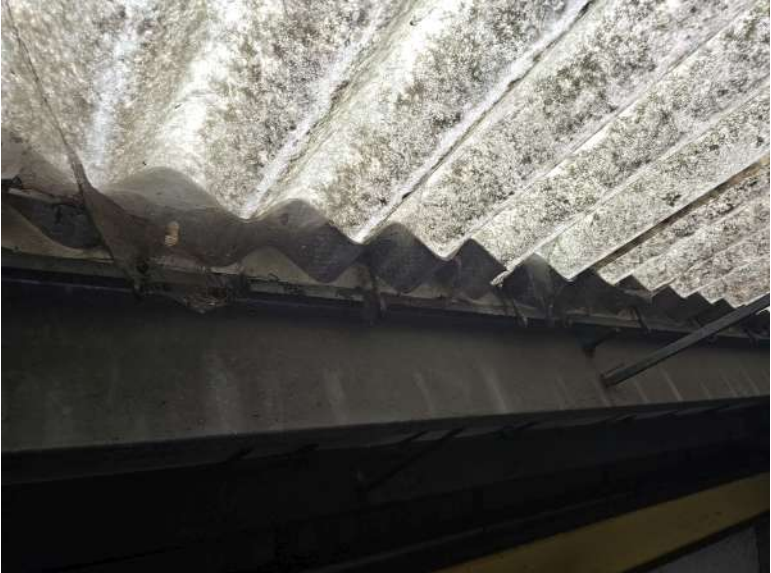
| Sample position | Corrugated sheets to external of roof | | |
| Extent / Quantity of material | 330m <sup>2</sup> | | |
| <b>RISK BAND SCORE</b> - The risk band score assigned to this sample based on the surveyor's assessment of the materials condition / location and possibility of exposure to any occupants of the site | | | <b>3</b> |

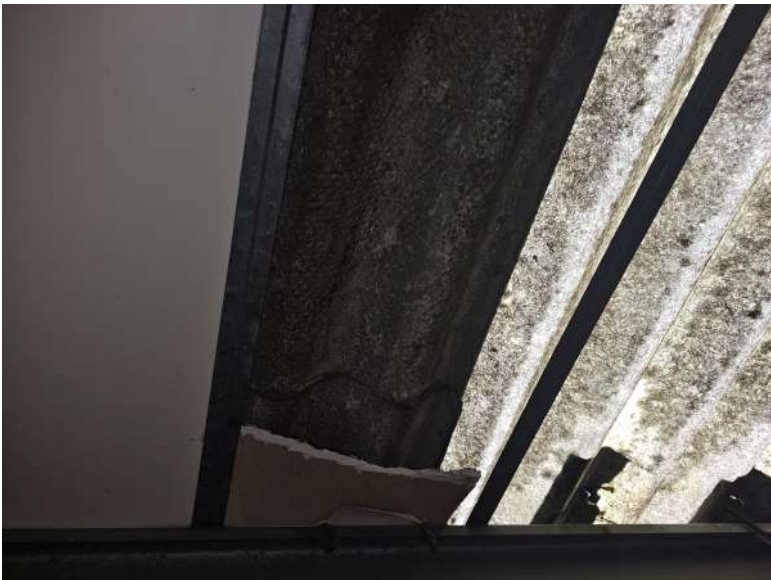
| Sample position | Corrugated sheets to external of roof | | |

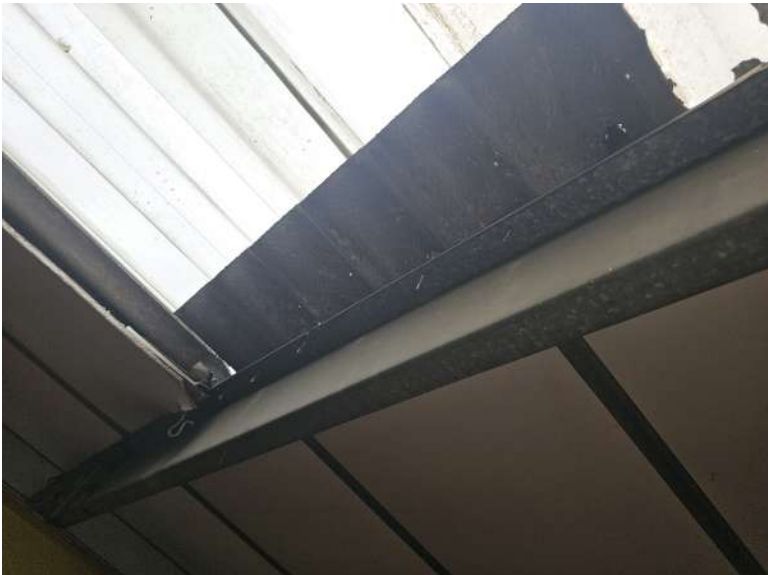
| Sample position | Corrugated sheets to external of roof | | |
| Extent / Quantity of material | 460m <sup>2</sup> | | |

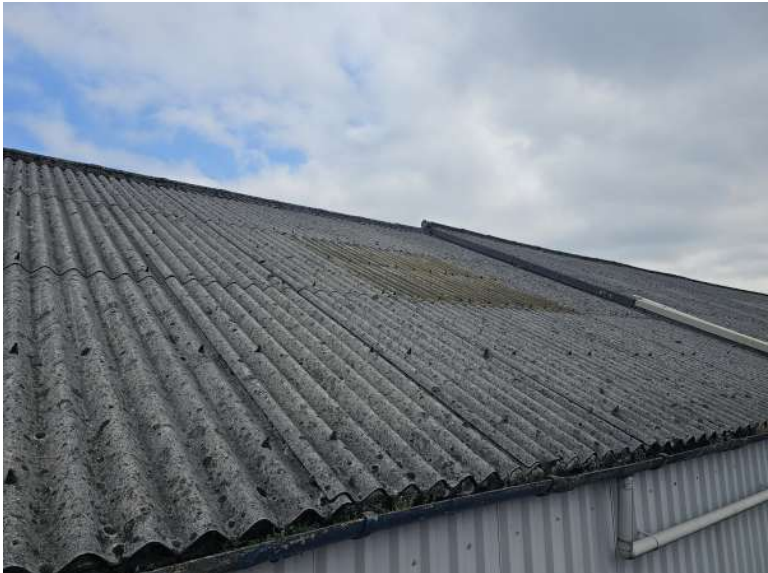
| Sample position | Corrugated sheets to external of roof | | |

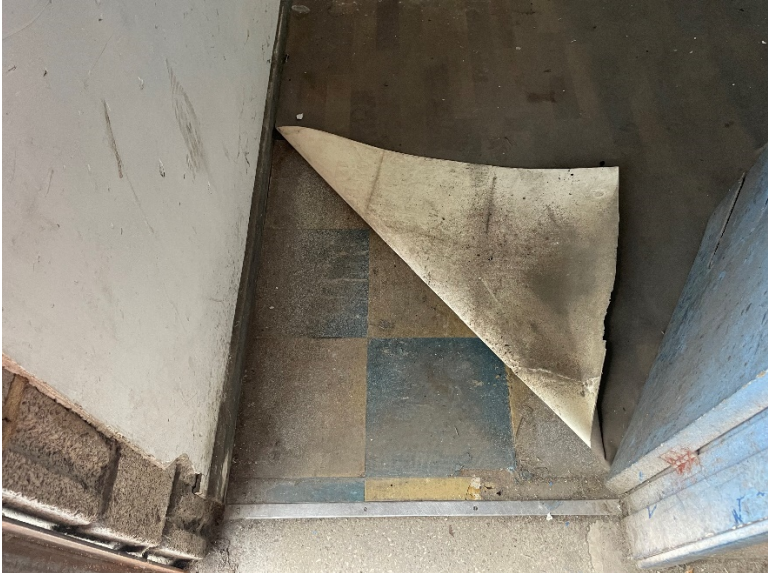
| Sample position | To floor throughout room beneath floor coverings | | |
| Extent / Quantity of material | 10m <sup>2</sup> | | |

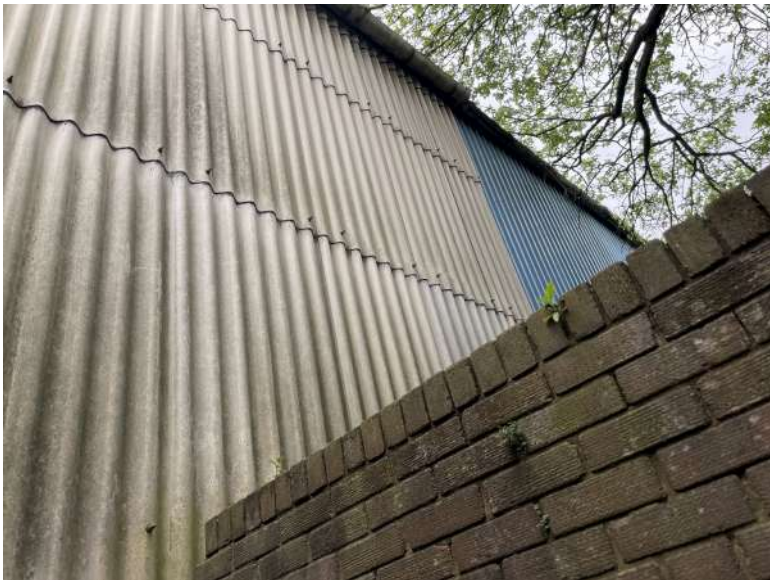
| Sample position | Corrugated sheets to external wall | | |
| Extent / Quantity of material | 240m <sup>2</sup> | | |

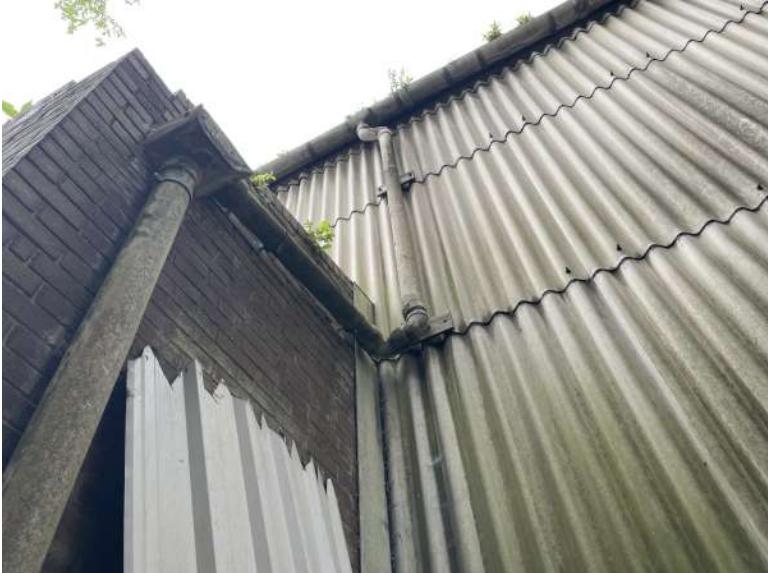
| Sample position | Cement downspouts and gutter troughs to rear of unit | | |
| Extent / Quantity of material | 40 linear metres | | |

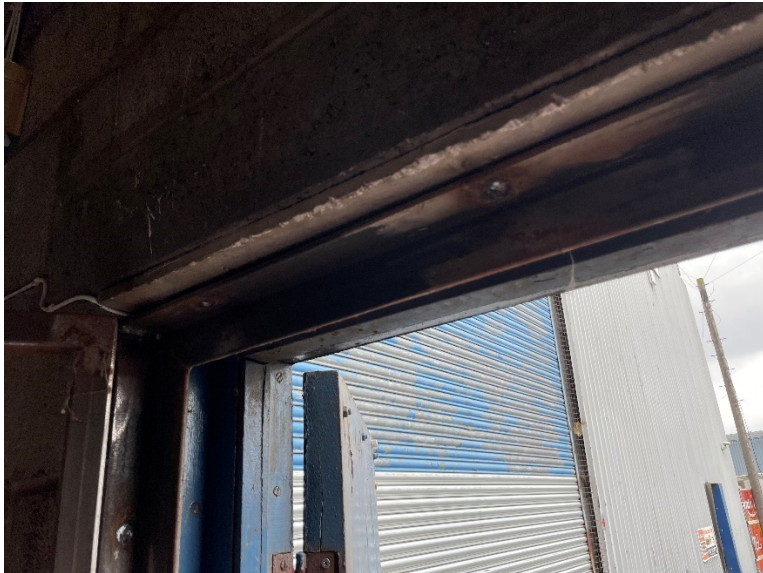
| Sample position | Board above door frame to entrance | | |
| Extent / Quantity of material | 1m <sup>2</sup> | | |

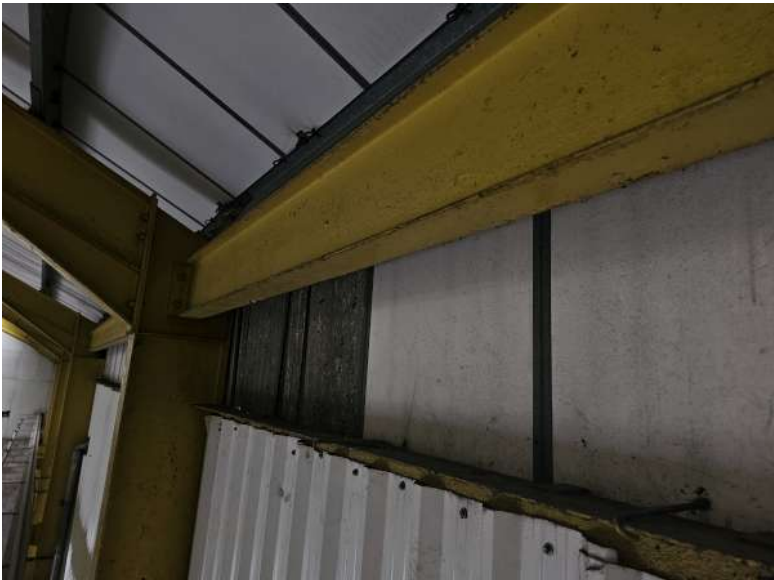
| Sample position | Corrugated sheets to wall at high level | | |
| Extent / Quantity of material | 40m <sup>2</sup> | | |

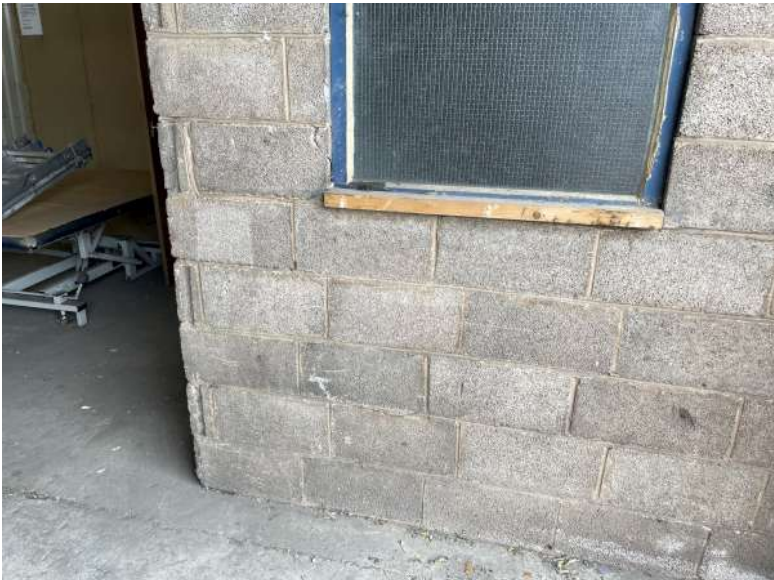
| Sample position | To seal of office windows | | |
| Extent / Quantity of material | 7 linear metres | | |

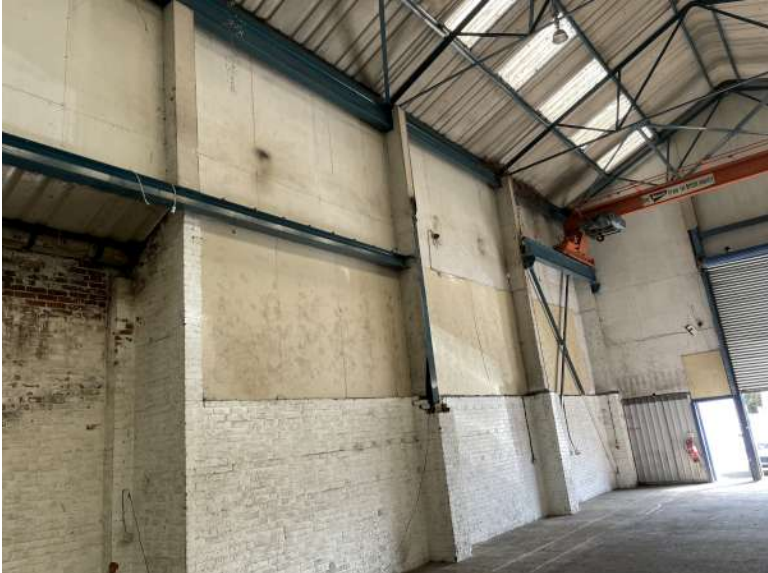
| Sample position | Lining panels to walls at high level | | |

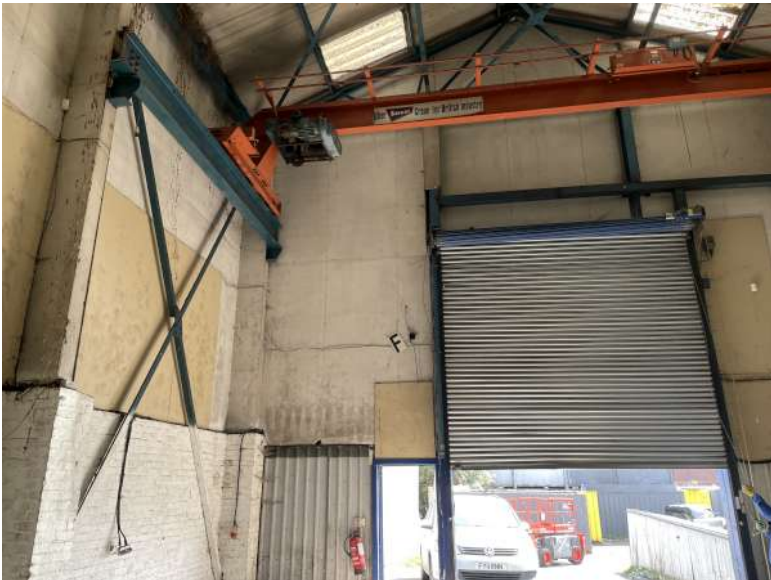
| Sample position | Lining panels to walls at high level | | |

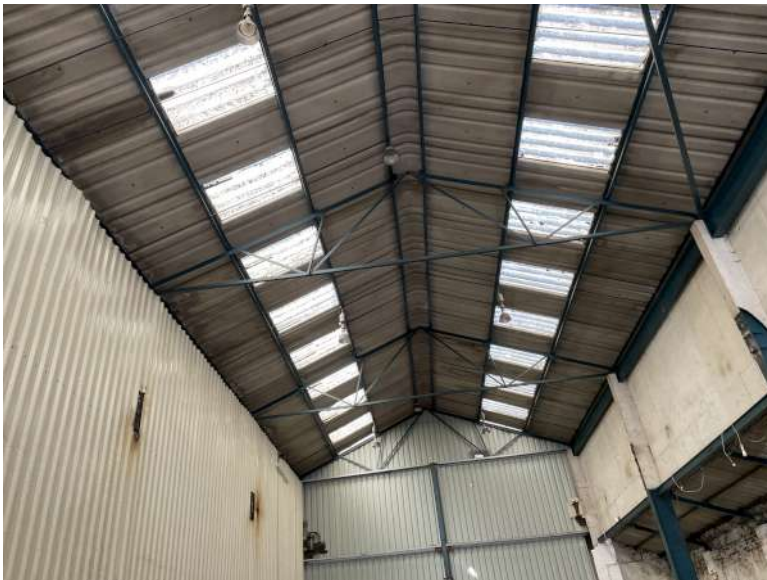
| Sample position | Lining panels to internal of roof | | |
| Extent / Quantity of material | 320m <sup>2</sup> | | |

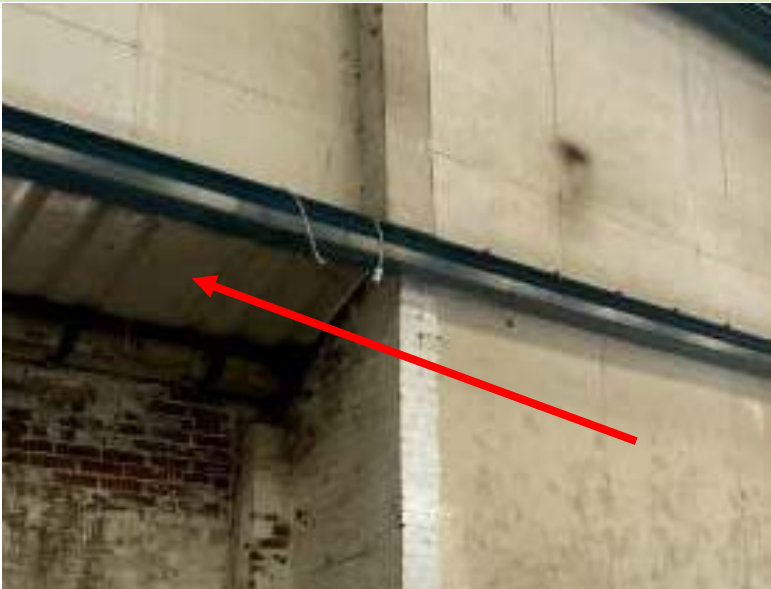
| Sample position | Lining panels to internal of roof at low level | | |
| Extent / Quantity of material | 50m <sup>2</sup> | | |

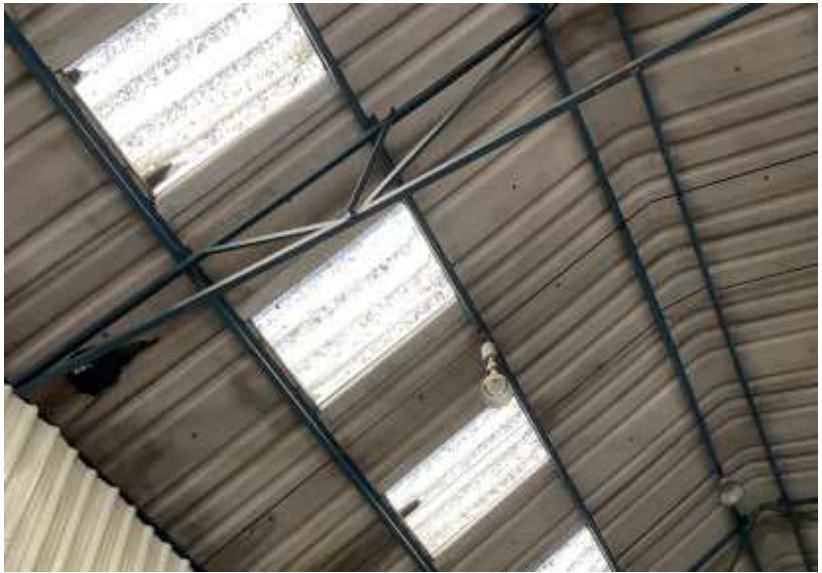
| Sample position | Lining panels to internal of roof | | |

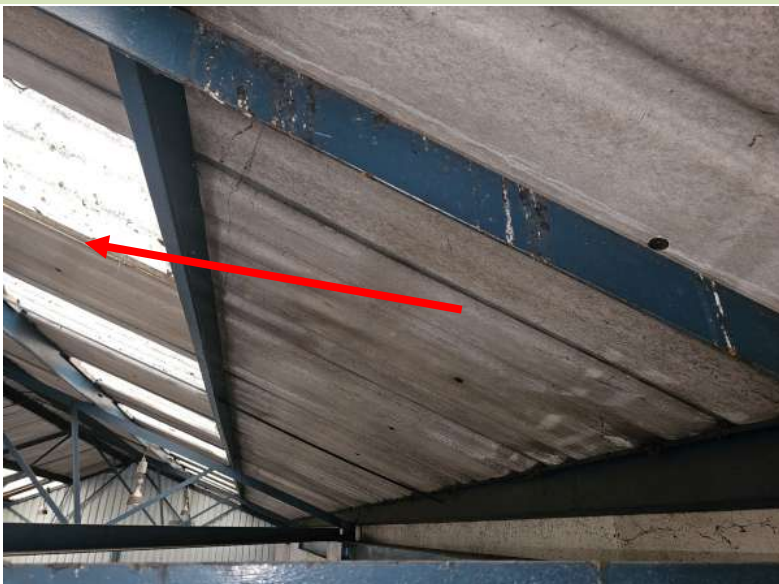
| Sample position | Corrugated sheets to external of roof | | |
| Extent / Quantity of material | 320m <sup>2</sup> | | |

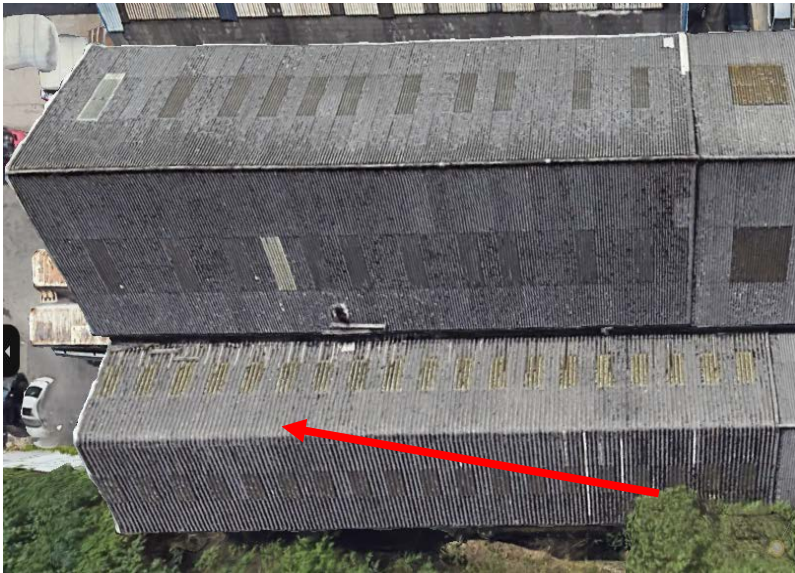
| Sample position | Corrugated sheets to external of roof | | |

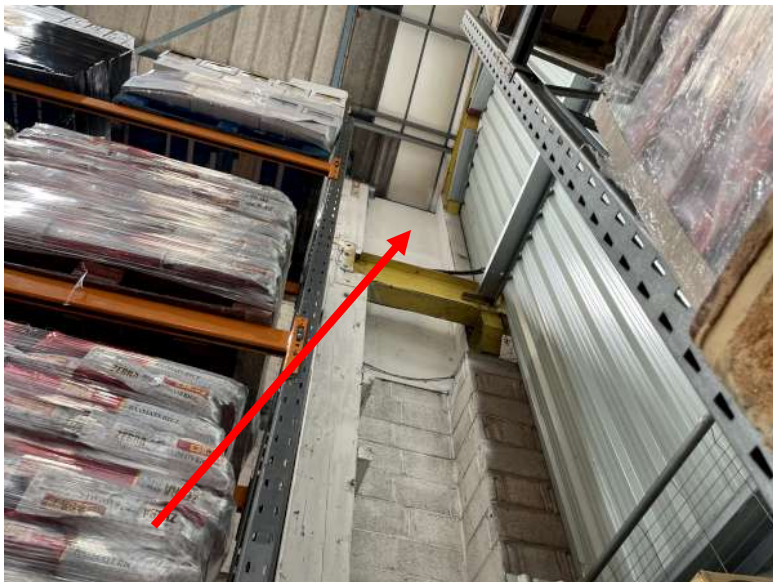
| Sample position | To cladding of columns at high level | | |
| Extent / Quantity of material | 20m <sup>2</sup> | | |

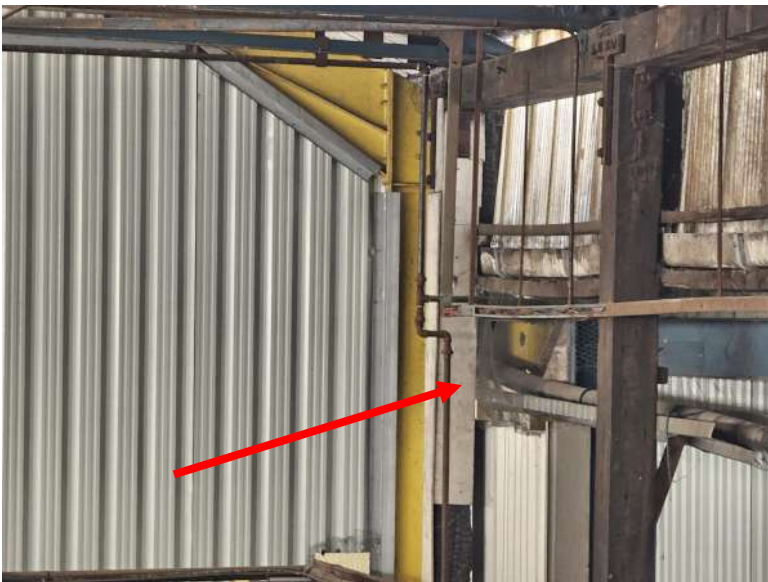
| Sample position | To cladding of columns at high level | | |
| Extent / Quantity of material | 20m <sup>2</sup> | | |

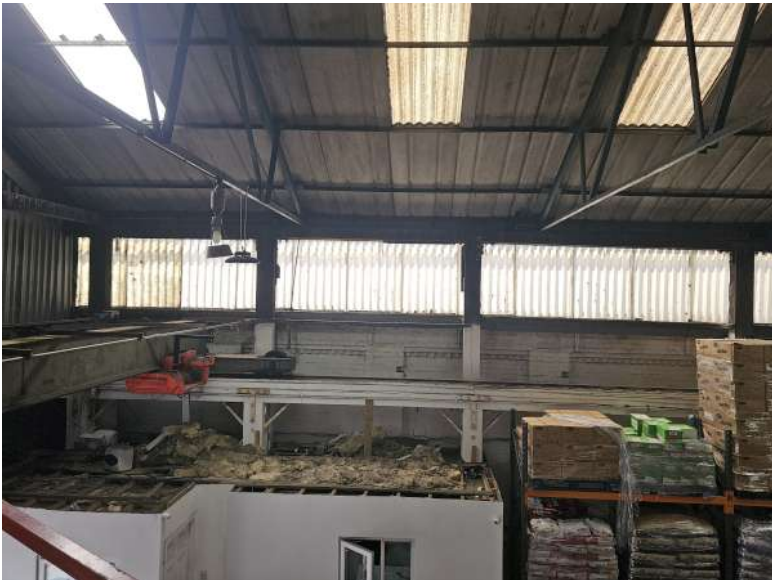
| Sample position | Lining panels to internal of roof | | |
| Extent / Quantity of material | 630m <sup>2</sup> | | |

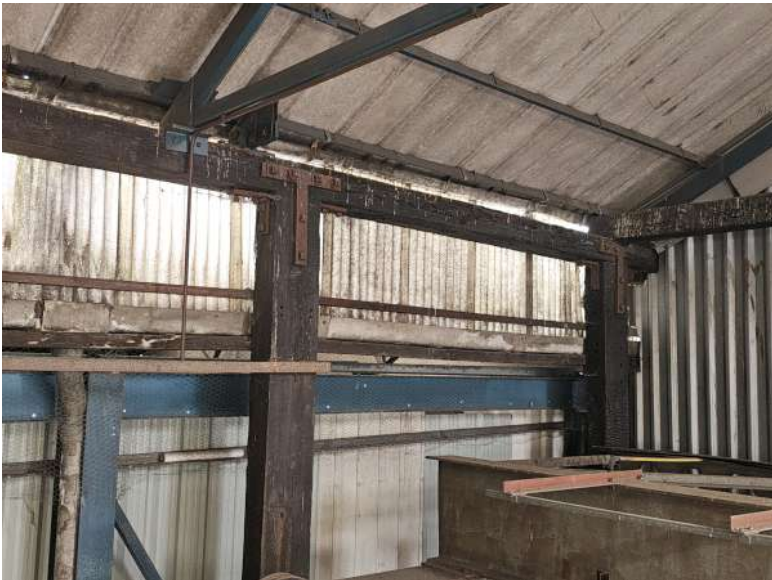
| Sample position | Lining panels to internal of roof | | |

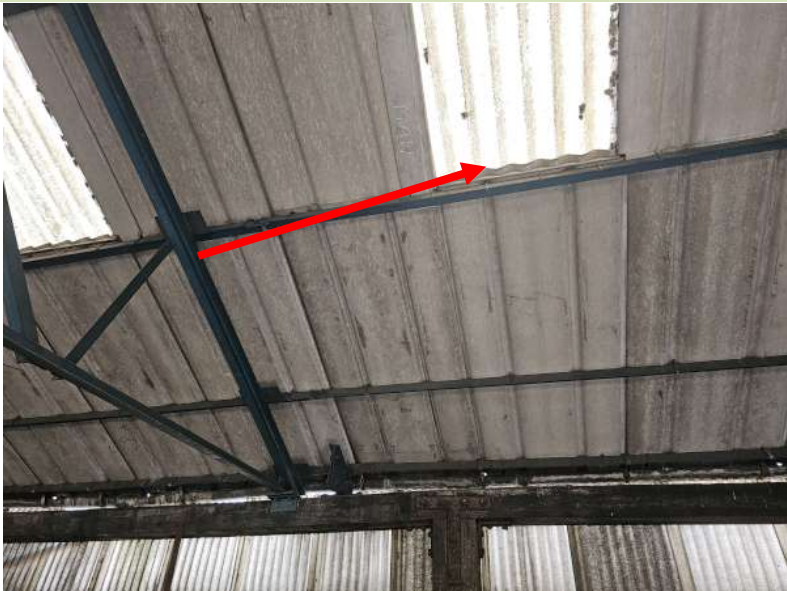
| Sample position | Corrugated sheets to external of roof | | |
| Extent / Quantity of material | 630m <sup>2</sup> | | |

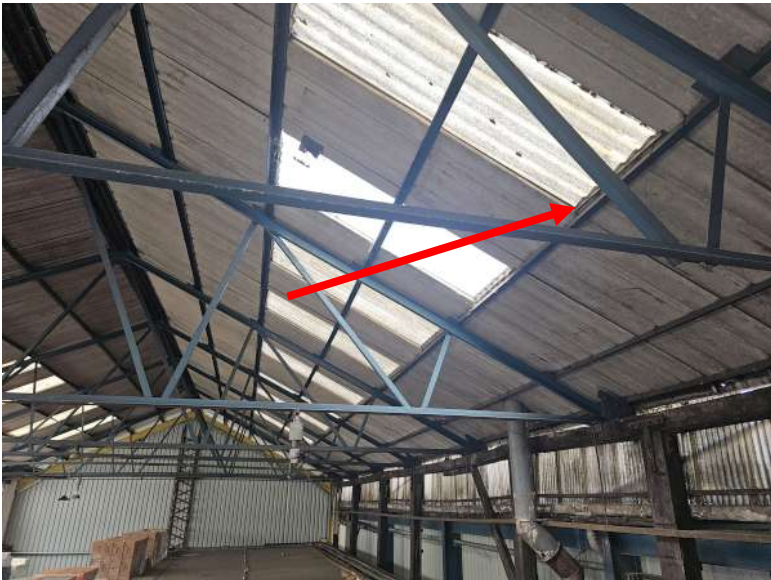
| Sample position | Corrugated sheets to external of roof | | |

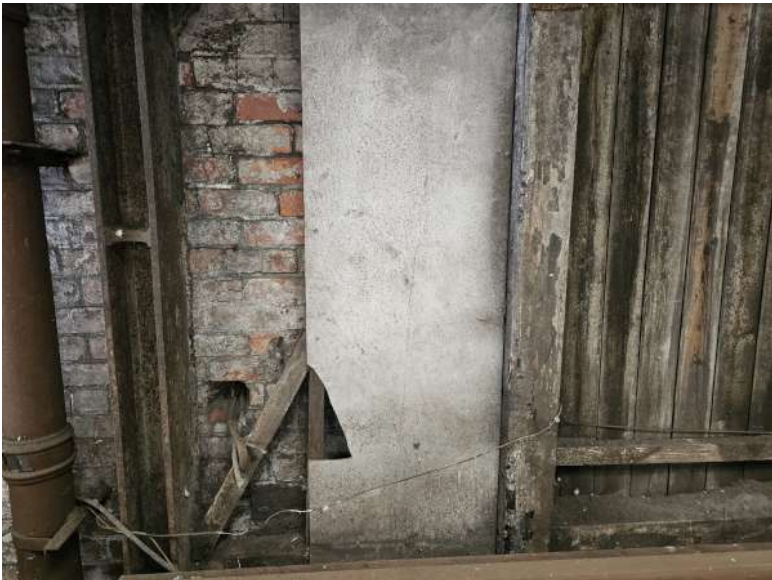
| Sample position | Boarding to side of rear shutter at high level | | |
| Extent / Quantity of material | 2m <sup>2</sup> | | |

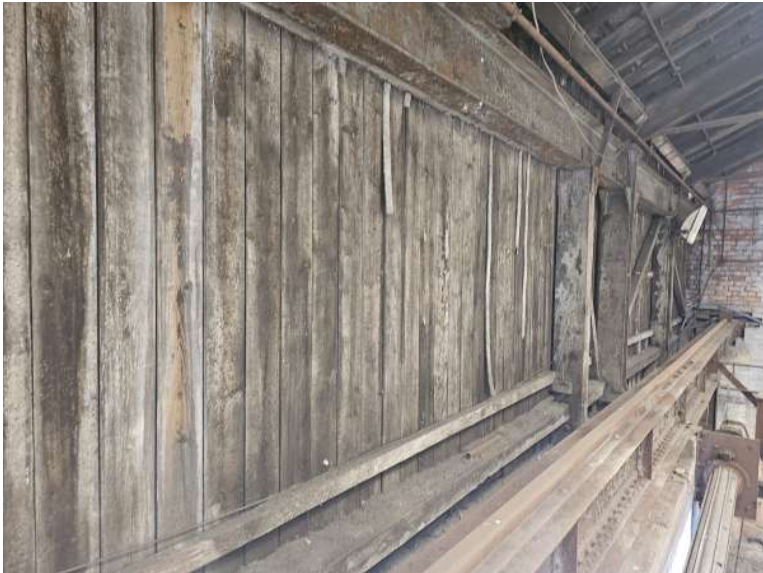
| Sample position | Debris to timber and ledges above rear shutter at high level | | |
| Extent / Quantity of material | 10m <sup>2</sup> | | |

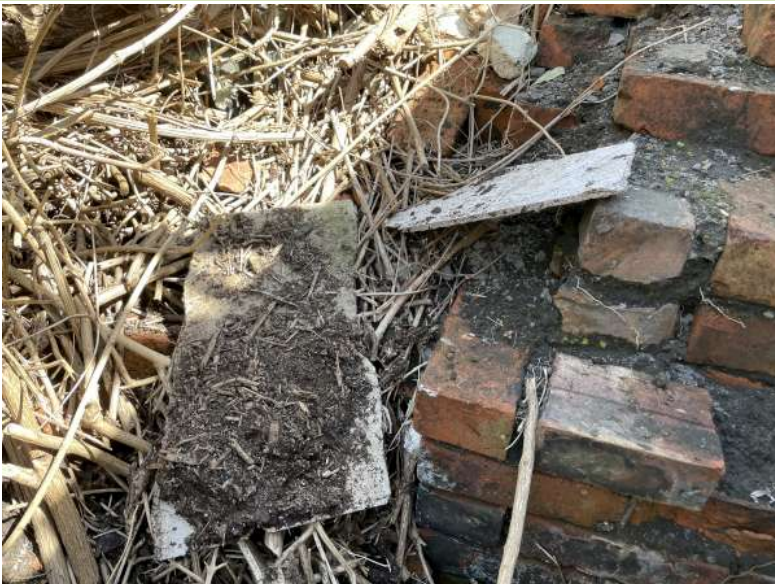
| Unique Sample reference | Asbestos Present? | Type of material | Asbestos Content (s) | Location | Position | Extent / Quantity | Material Score | Risk Band Score |
|---|---|---|---|---|---|---|---|---|
| PEC1483 / 34 | Yes | Asbestos Insulating board | Amosite / Chrysotile | Unit 8, external | Boarding debris within embankment from damaged lining panels of the unit | 6m <sup>2</sup> visible | 9 | 1 |

| Sample position | Boarding debris within embankment from damaged lining panels of the unit | | |
| Extent / Quantity of material | 6m <sup>2</sup> visible | | |

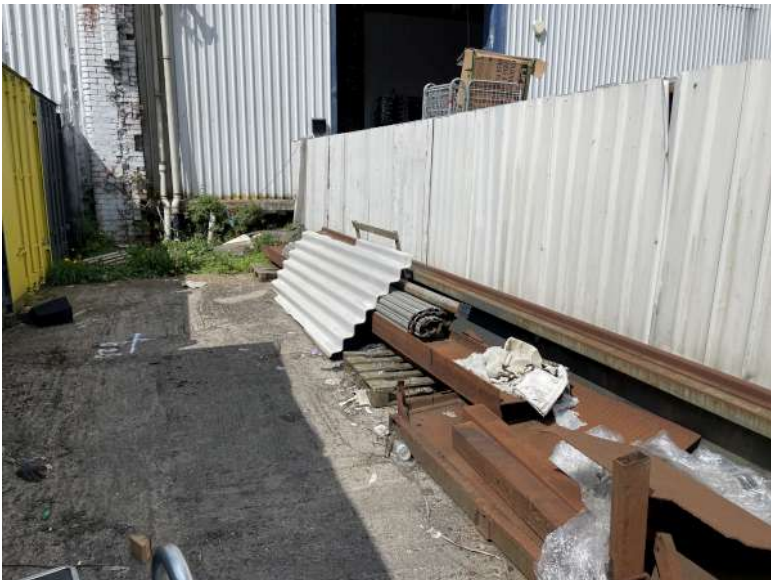
| Unique Sample reference | Asbestos Present? | Type of material | Asbestos Content (s) | Location | Position | Extent / Quantity | Material Score | Risk Band Score |
|---|---|---|---|---|---|---|---|---|
| PEC1483 / 35 | No | Cement product | NAD | Unit 3 | Loose corrugated sheet to front of unit | 2m <sup>2</sup> | N/A | N/A |

| Sample position | Loose corrugated sheet to front of unit | | |
| Extent / Quantity of material | 2m <sup>2</sup> | | |

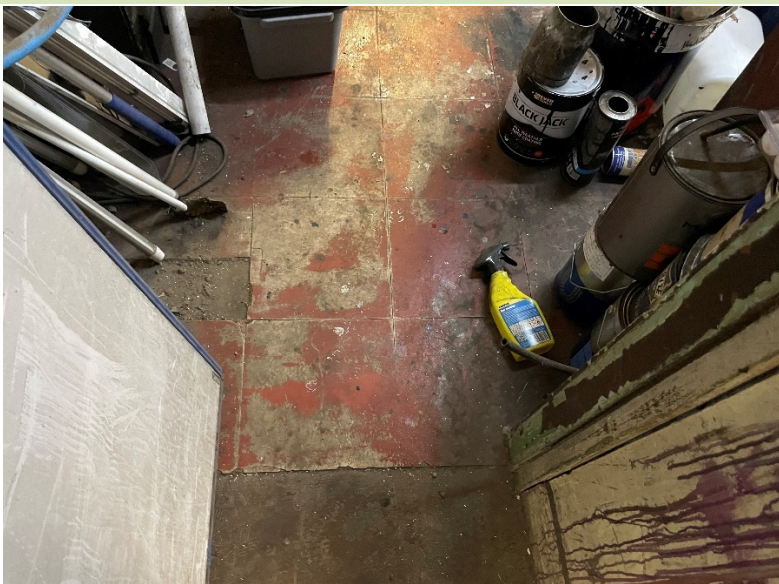
| Sample position | To floor throughout room | | |
| Extent / Quantity of material | 55m <sup>2</sup> | | |

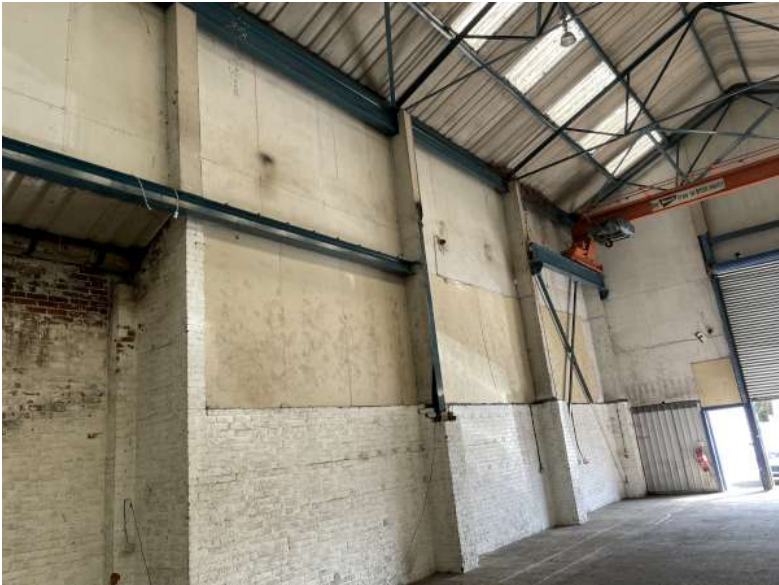
| item not accessed | Rooms / areas the item not accessed relates to | Reason for not accessed. If client restriction, please state | Example Picture(s) showing item for reference |
|---|---|---|---|
| Within brick wall voids / column voids at low level | Units 1, 2, 7, 8 | No access due to restrictions by highlighted ACM's. due to slipped and damaged boards identified throughout the units it cannot be ruled out that AIB debris have fallen within the confines of the columns / block wall voids. This should be reinspected when removal works are taking place and access is achievable | |

| Unique Sample reference | Asbestos Present? | Type of material | Asbestos Content (s) | Location | Position | Extent / Quantity | Material Score | Risk Band Score |
|---|---|---|---|---|---|---|---|---|
| PEC1483 / SP001 | Yes | Asbestos Insulating board debris | Amosite / Chrysotile | Units 1, 2, 7, 8 | Potential insulating board debris within brick wall and column voids at low level from damaged / slipped boards above | Not quantified presumed throughout | 9 | 1 |

| Sample position | Potential insulating board debris within brick wall and column voids at low level from damaged / slipped boards above | | |
| Extent / Quantity of material | Not quantified presumed throughout | | |

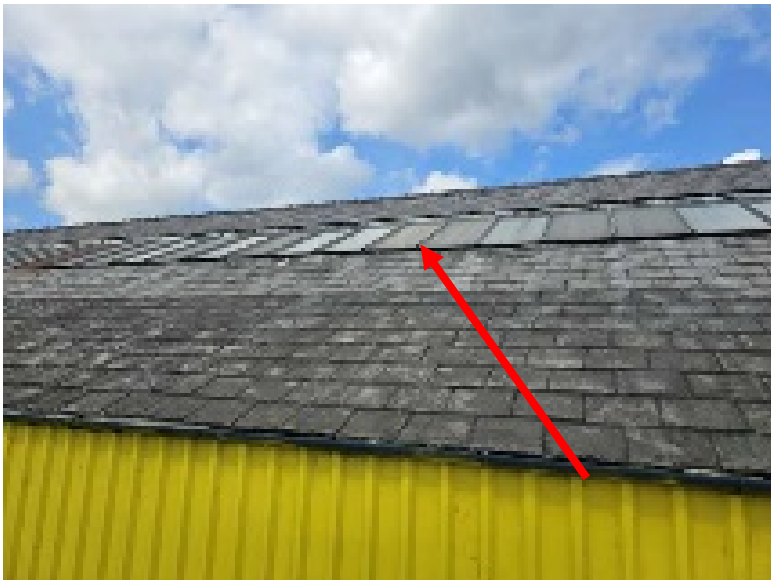
| Sample position | Rope seal to northern light windows within roof | | |
| Extent / Quantity of material | Up to 500 linear metres | | |
