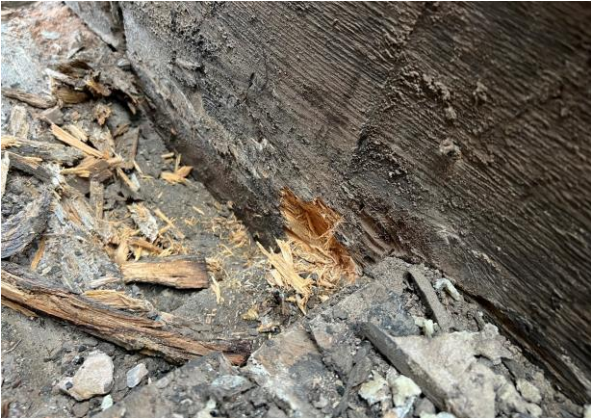
| Location/Beam | Dimensions | Decay viewed from<br>bearing side | Cross plan view | Photographs | Confirmed agreed repairs with<br>Structural engineer comment in bold |
|---|---|---|---|---|---|
| Q/GB/1<br><br>Bearing end into<br>external wall | 95mm<br><br>270mm<br><br>Bearing end<br><br>Decayed section | | <br><br>Cross plan view | Small pocket of wet rot 25mm<br>deep approx. 25x25mm in<br>section<br> | <b>Recommendations</b><br>Defrass the beam of all decay back<br>to sound timber and treat with<br>Wykamol 10.1 fungicide gel<br><br>Confirmed repairs/treatments in email<br>from Buro Happold dated 4-09-2024 |

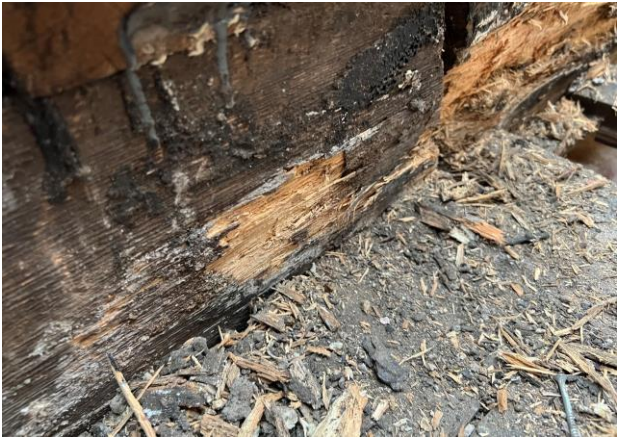
| Location/Beam | Dimensions | Decay viewed from<br>bearing side | Cross plan view | Photographs | Confirmed agreed repairs with<br>Structural engineer comment in bold |
|---|---|---|---|---|---|
| Q/GB/1<br><br>Bearing end opposite<br>GB2 | 95mm<br><br>270mm<br><br>Bearing end<br><br>Decayed section | | <br><br>Cross plan view | Superficial rot to face of<br>gutter beam<br> | <b>Recommendations</b><br>Defrass the beam of all decay back<br>to sound timber and treat with<br>Wykamol 10.1 fungicide gel<br><br>Confirmed repairs/treatments in email<br>from Buro Happold dated 4-09-2024 |

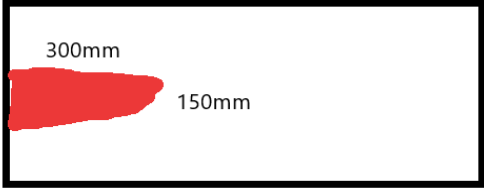
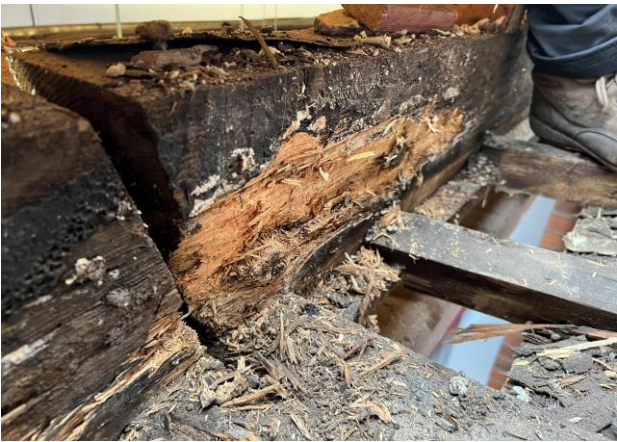
| Location/Beam | Dimensions | Decay viewed from<br>bearing side | Cross plan view | Photographs | Confirmed agreed repairs with<br>Structural engineer comment in bold |
|---|---|---|---|---|---|
| Q/GB/2<br><br>Bearing end opposite<br>GB1 | 95mm<br><br>270mm<br><br>Bearing end<br><br>Decayed section | | <br><br>Cross plan view | Wet rot to bearing end<br>opposite GB1. Pocket of<br>decay 150mm x300mm<br>to depth of 25mm<br> | <b>Recommendations</b><br>Defrass the beam of all decay back<br>to sound timber and treat with<br>Wykamol 10.1 fungicide gel<br><br>Confirmed repairs/treatments in email<br>from Buro Happold dated 4-09-2024<br><br><b><i>Defrass and treat is Ok. Section is<br/>adequate for shear at affected<br/>bearing end</i></b> |

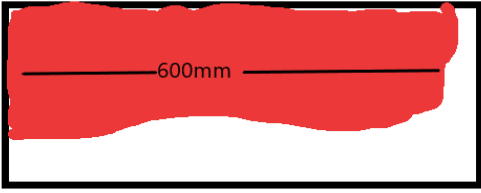
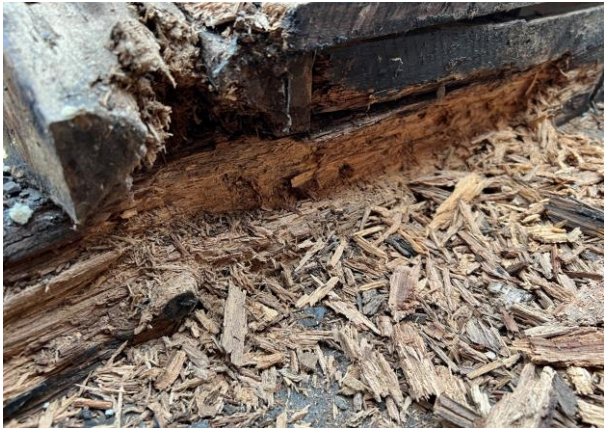
| Location/Beam | Dimensions | Decay viewed from<br>bearing side | Cross plan view | Photographs | Confirmed agreed repairs with<br>Structural engineer comment in bold |
|---|---|---|---|---|---|
| Q/GB/3<br><br>Bearing end opposite<br>GB2 | 95mm<br><br>270mm<br><br>Bearing end<br><br>Decayed section | | <br><br>Cross plan view | Decay 2/3 depth of beam<br>to 600mm bearing .<br> | <b>Recommendations</b><br>Flitch beam plate repair as per<br>drawings and calculation<br>provided by WMI Consulting<br>drawing no 1179R<br><br>Confirmed acceptance of repair in email<br>dated 27-09-2024 from Buro Happold |

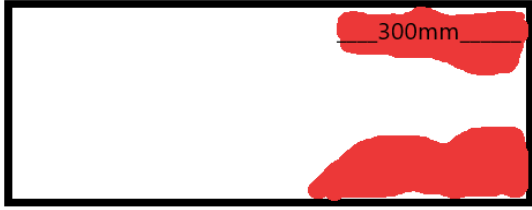
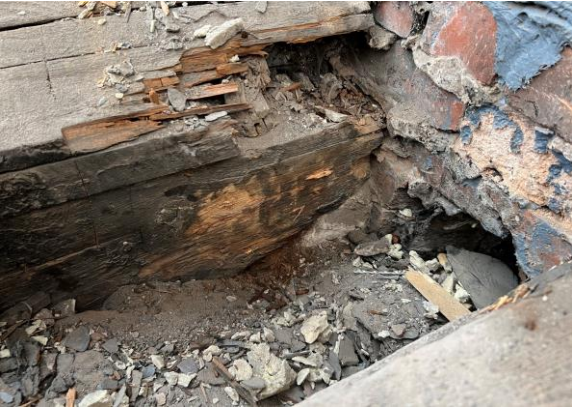
| <div>P/VB/1</div> <div>Bearing end into external wall</div> | <div><div>100mm</div><div></div><div>425mm</div><div>Bearing end</div></div> <div><div></div><div>Cross plan view</div></div> <div><div>Decayed section</div></div> | <div>Wet rot 2/3 to full depth of beam to 300mm bearing end</div> <div></div> | <div>Query from Buro Happold</div> <div><i>external wall- the extent of decay looks like this needs an end repair due to loss of section and shear capacity</i></div> <div><b>Recommendation</b></div> <div>Robinsons cut back the decayed ends back to sound timber with over 100mm of bearing still present with no end repair required</div> |

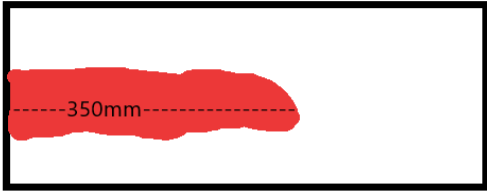
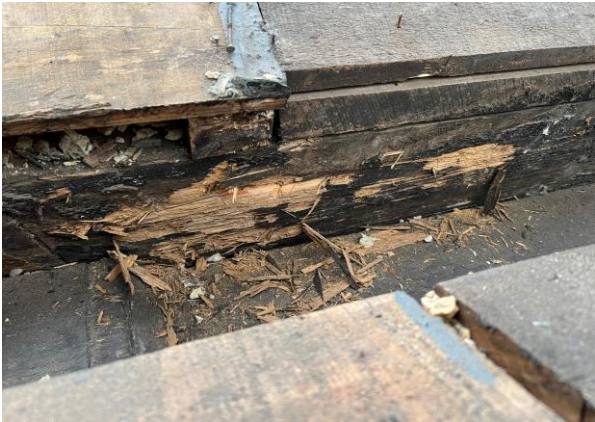
| <div>P/VB/1</div> <div>Bearing end opposite VB4</div> | <div><div>100mm</div><div></div><div>275m</div><div>Bearing end</div></div> <div><div></div><div>Cross plan view</div></div> <div><div>Decayed section</div></div> | <div>Superficial rot to face of gutter beam 10-15mm deep to 350mm bearing</div> <div></div> | <div><b>Recommendations</b></div> <div>Defrass the beam of all decay back to sound timber and treat with Wykamol 10.1 fungicide gel</div> <div>Confirmed repairs/treatments in email from Buro Happold dated 4-09-2024</div> |

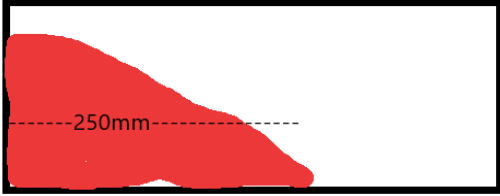
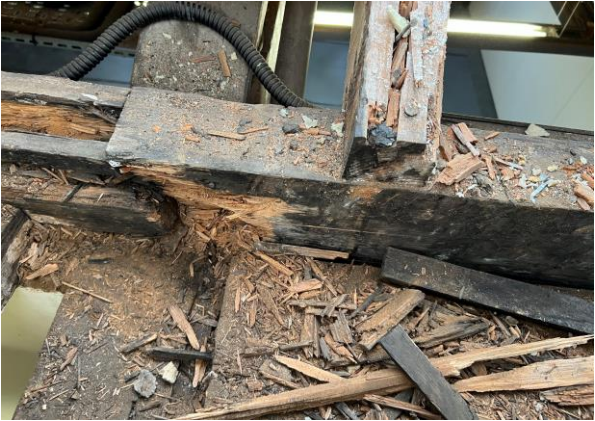
| <div>P/VB4</div> <div>Bearing end opposite VB6</div> | <div><div>100mm</div><div></div><div>275m</div><div>Bearing end</div></div> <div><div></div><div>Cross plan view</div></div> <div><div>Decayed section</div></div> | <div>decay 2/3 depth of the beam to approx. 250mm bearing onto truss</div> <div></div> | <div>Confirmed repairs/treatments in email from Buro Happold dated 27-09-2024</div> <div><i>Agree with repair loads as stated</i></div> <div><b>Recommendations</b></div> <div>Flitch beam plate repair as per drawings and calculation provided by WML Consulting drawing no 1179R</div> <div>Confirmed acceptance of repair in email dated 27-09-2024</div> |

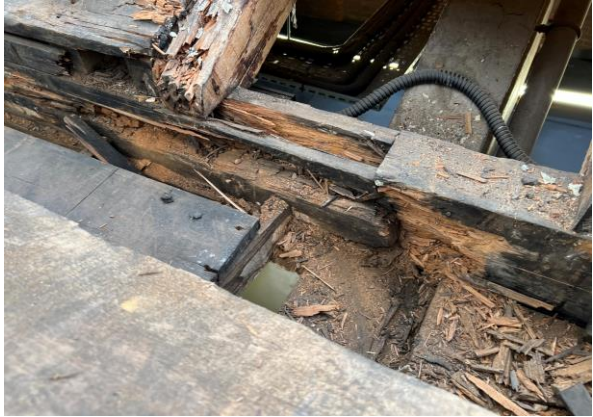
| <div>P/VB/6</div> <div>Bearing end opposite VB4</div> | <div><div>100mm</div><div></div><div>275m</div><div>Bearing end</div></div> <div><div></div><div>Cross plan view</div></div> <div><div>Decayed section</div></div> | <div>Wet rot to full depth of beam to 900mm bearing</div> <div></div> | <div>Confirmed repairs/treatments in email from Buro Happold dated 27-09-2024</div> <div><i>Agree with repair loads as stated</i></div> <div><b>Recommendations</b></div> <div>Flitch beam plate repair as per drawings and calculation provided by WML Consulting drawing no 1179R</div> <div>Confirmed acceptance of repair in email dated 27-09-2024</div> |

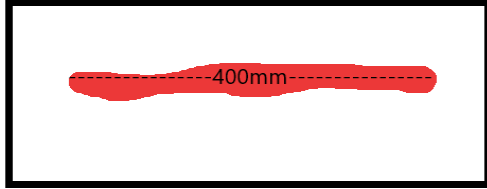
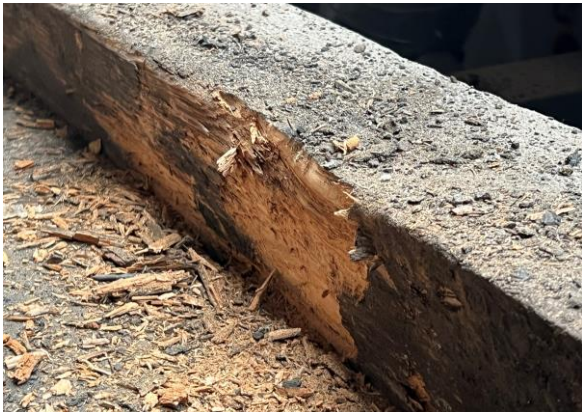
| Location/Beam | Dimensions | Decay viewed from bearing side | Cross plan view | Photographs | Confirmed agreed repairs with Structural engineer comment in bold |
|---|---|---|---|---|---|
| P/GB/2<br><br>Mid section | <div>95mm</div> <div></div> <div>270mm</div> <div>Bearing end</div> <div> Decayed section</div> <div></div> <div>400mm</div> <div>Cross plan view</div> | Superficial rot to face of gutter beam 15-20 mm deep to 400mm at midsection<br><br> | <b>Recommendations</b><br>Defrass the beam of all decay back to sound timber and treat with Wykamol 10.1 fungicide gel<br><br>Confirmed repairs/treatments in email from Buro Happold dated 4-09-2024<br><br><b>de-frass and treat is Ok. Section is adequate for bending at midspan</b> | | |

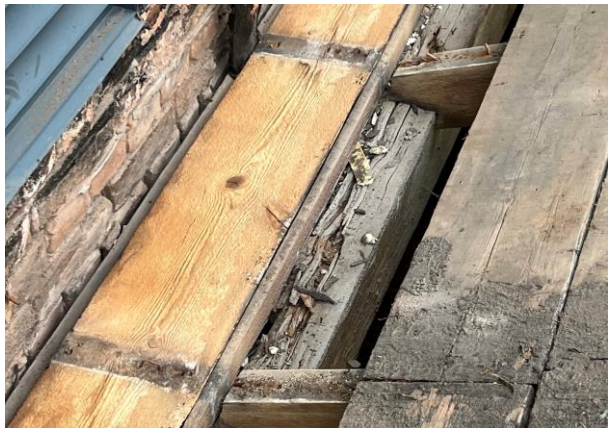
| Location/Beam | Dimensions | Decay viewed from bearing side | Cross plan view | Photographs | Confirmed agreed repairs with Structural engineer comment in bold |
|---|---|---|---|---|---|
| P/GB/1<br><br>Full length of beam | <div>95mm</div> <div></div> <div>270mm</div> <div>Bearing end</div> <div> Decayed section</div> <div>--Decay full length of beam 30-40mm top edge--<div></div></div> <div>Cross plan view</div> | Wet rot to top face the full length of beam 30 to 40mm deep<br><br> | Buro Happold<br><b>The loss of 40mm from the top edge of beam means that this doesn't have adequate capacity . Requires full length like-for-like replacement w C24 Douglas Fir</b><br><b>Recommendations</b><br>Proposed treatments to be replaced with full replacement by Robinsons | | |

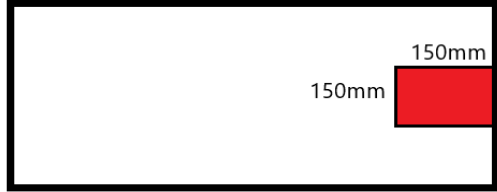
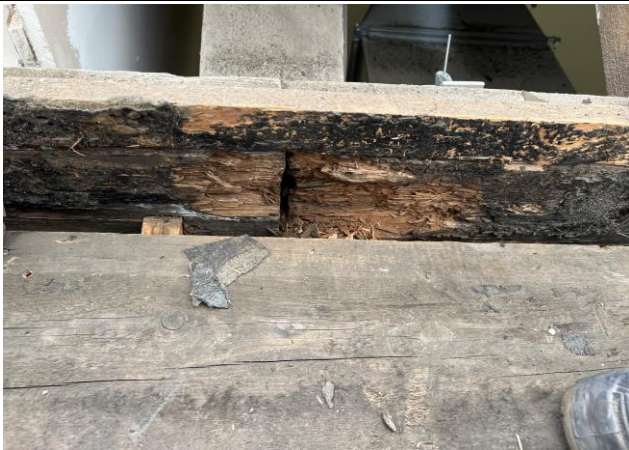
| Location/Beam | Dimensions | Decay viewed from bearing side | Cross plan view | Photographs | Confirmed agreed repairs with Structural engineer comment in bold |
|---|---|---|---|---|---|
| M/VB/10<br><br>Bearing end opposite VB12 | <div>95mm</div> <div></div> <div>270mm</div> <div>Bearing end</div> <div> Decayed section</div> <div></div> <div>150mm</div> <div>Cross plan view</div> | 150x150mm pocket of rot to a depth of 30 to 40mm<br><br> | <b>Recommendations</b><br>Defrass the beam of all decay back to sound timber and treat with Wykamol 10.1 fungicide gel<br><br>Confirmed repairs/treatments in email from Buro Happold dated 4-09-2024<br><br><b>Defrass and treat is Ok. Section is adequate for shear at affected bearing end</b> | | |

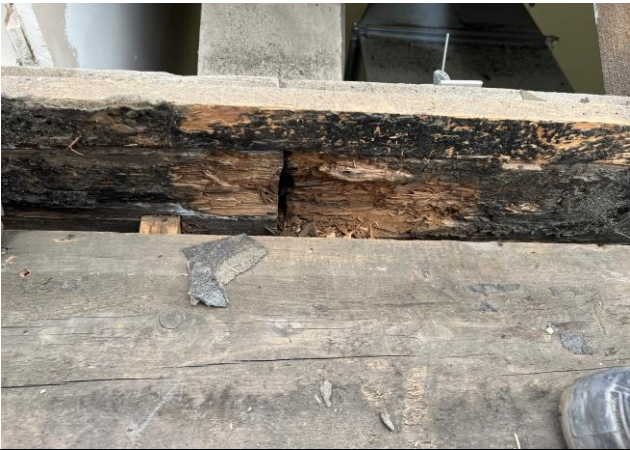
| Location/Beam | Dimensions | Decay viewed from bearing side | Cross plan view | Photographs | Confirmed agreed repairs with Structural engineer comment in bold |
|---|---|---|---|---|---|
| M/VB/12<br><br>Bearing end opposite VB10 | <div>95mm</div> <div><div></div><div>270mm</div></div> | <div>300mm</div> <div>120mm</div> | rot to the heath of beam<br>50% depth 300x120mm | | Query from Buro Happold<br><br><b>The bearing end is probably ok in shear. An alternative here is probably to remove the decayed material and infill with a timber packer</b><br><b>Recommendations</b><br>Robinsons substituted 1/2 lap repair for splicing in a new section after removal of decayed material |

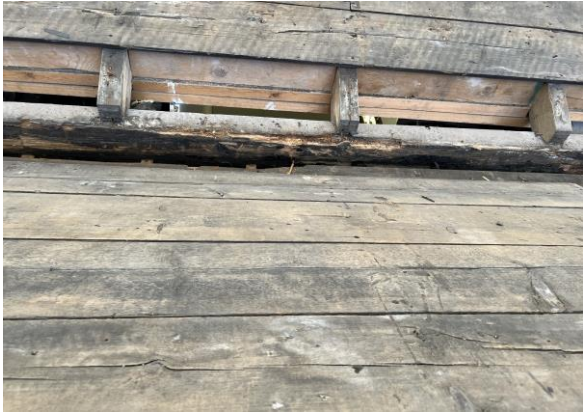
| Location/Beam | Dimensions | Decay viewed from bearing side | Cross plan view | Photographs | Confirmed agreed repairs with Structural engineer comment in bold |
|---|---|---|---|---|---|
| M/VB/11 | <div>100mm</div> <div><div></div><div>275mm</div></div> | <div>Full beam length and depth of decay</div> <div>30mm 50-60mm 50mm 20mm 15mm 10mm 40mm</div> | Wet rot to varying depth the full length of beam | | <b>Recommendations</b><br>Proposed treatments to be replaced with full replacement by Robinsons<br><br>Confirmed repairs/treatments in email from Buro Happold dated 4-09-2024<br><br><b>Agree with replacement</b> |

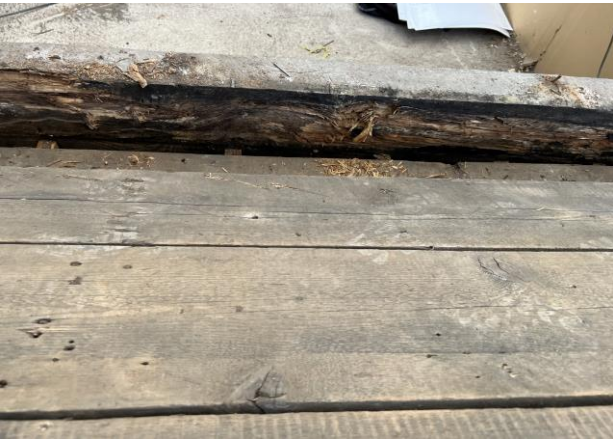
| Location/Beam | Dimensions | Decay viewed from bearing side | Cross plan view | Photographs | Confirmed agreed repairs with Structural engineer comment in bold |
|---|---|---|---|---|---|
| M/VB/13 | <div>100mm</div> <div><div></div><div>430mm</div></div> | <div>decay full length of beam to varying depth</div> <div>20-50mm 30mm Plus 50mm 20mm 50mm</div> | Wet rot to varying depth the full length of beam | | <b>Recommendations</b><br>Proposed treatments to be replaced with full replacement by Robinsons<br><br>Confirmed repairs/treatments in email from Buro Happold dated 4-09-2024<br><br><b>Agree with replacement</b> |

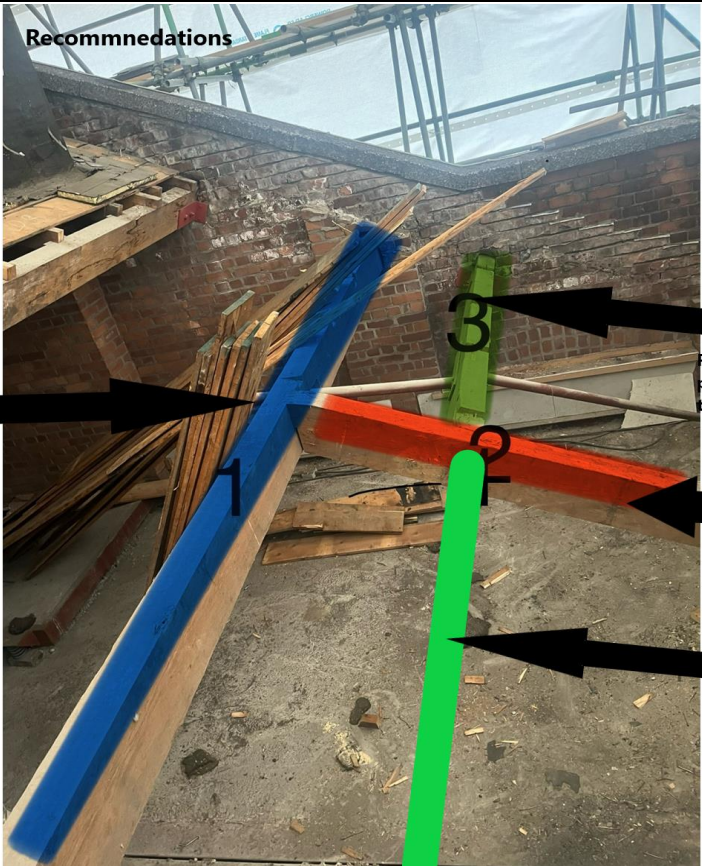
| <p>Notched purlin between gridline P&amp;Q</p> | <p>Further to the removal of the former roof access between Gridline locations P . and Q, this has given a better understanding of how the roof was constructed</p> <p>This is the location of the notched purlin (see attached drawing and photo) . This section of roof was previously modified to accommodate the roof access. To provide the access, the original purlin (timber no 3) was cut at midspan onto a new trimmer (timber no 2) , a new bearer was installed which appears as a purlin from below (timber no 1) to support the trimmer and cut purlin.</p> <p>The new bearer (no1) was notched over the metal tie which was inset and already bolt plated to the upper purlin and lower purlin (no3)</p> <p>Half of the GB4 is missing after the installation of the roof access. A new section will be installed supported off the truss and steel beam</p> | <p><b>Recommnedations</b></p> <p>Beam to remain in situ</p> <p>1</p> <p>2</p> <p>3</p> <p>Remove original purlin and save timber</p> <p>Remove trimmer</p> <p>Install new purlin C24 full width of bay</p> | <p>Further to meeting with Buro Happold verbal agreement was made on the proposed works. The SE required additional post supports below the the existing GB4 and the new section of GB4</p> <p><b>Recommendations</b></p> <p>Remove the former roof access roof and beam no 1. Install new purlin to match existing section using C24 timber, fixed to outer wall with steel brackets. Infix the metal tie to the new and existing purlins. Allow to replace 1/2 of the missing gutter beam with C24 100x275mm treated timber with additional post support provided by C16 50x150mm timber coached screws to the gutter beam. Cover the new roof structure with 60x120mm common rafters</p> |
