# NXQ

## Lever Street, Manchester

**Structural Statement**

**Revision 01: 17.09.2024**

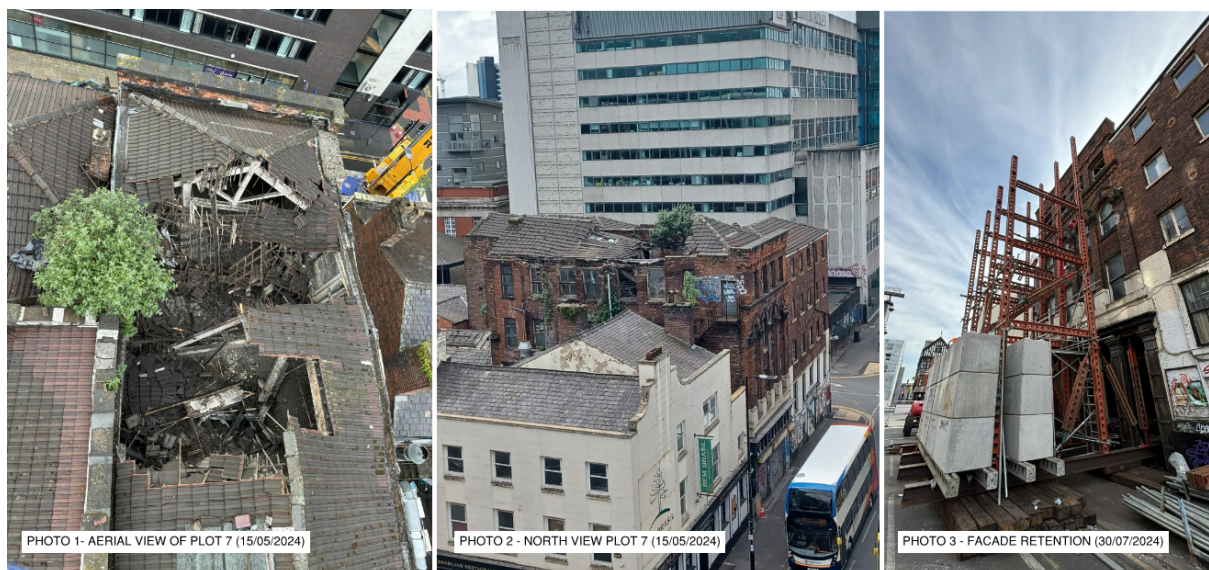
The high-risk status of Plots 6, 7 and 8 has been evidenced by a partial collapse of Plot 7 that occurred on 15/05/2024. It is suspected that water ingress to the timber roof structure over several years had caused a primary roof truss bearing to decay and fail, which appears to have resulted in the collapse of a large portion of the roof. The failed truss appears to have pushed the supporting wall, adjacent to little Lever Street, outwards leading to the collapse of the 3<sup>rd</sup> floor façade wall.

The loss of structural integrity of the roof resulted in a lack of restraint to the northwest façade wall of Plot 7 along Lever Street. In addition, the internal structures are exposed to the elements which could likely lead to further decay if left unprotected. The internal floors restrain the façade walls and loss of floor structural integrity could ultimately result in progressive, total collapse of the building. The details of the collapse and associated risks were immediately made clear to the client and local authority.

**Figure 3 - PHOTOS OF THE COLLAPSE AND FACADE RETENTION WORKS TO PLOT 7**

Subsequent intervention from the client and council occurred in an emergency stabilisation works capacity. A façade retention scheme for the northwest façade of Plot 7 has been installed, this is to prevent collapse into Lever Street and to retain the façade which is a non-designated heritage asset (NDHA) and forms part of the planning submission.

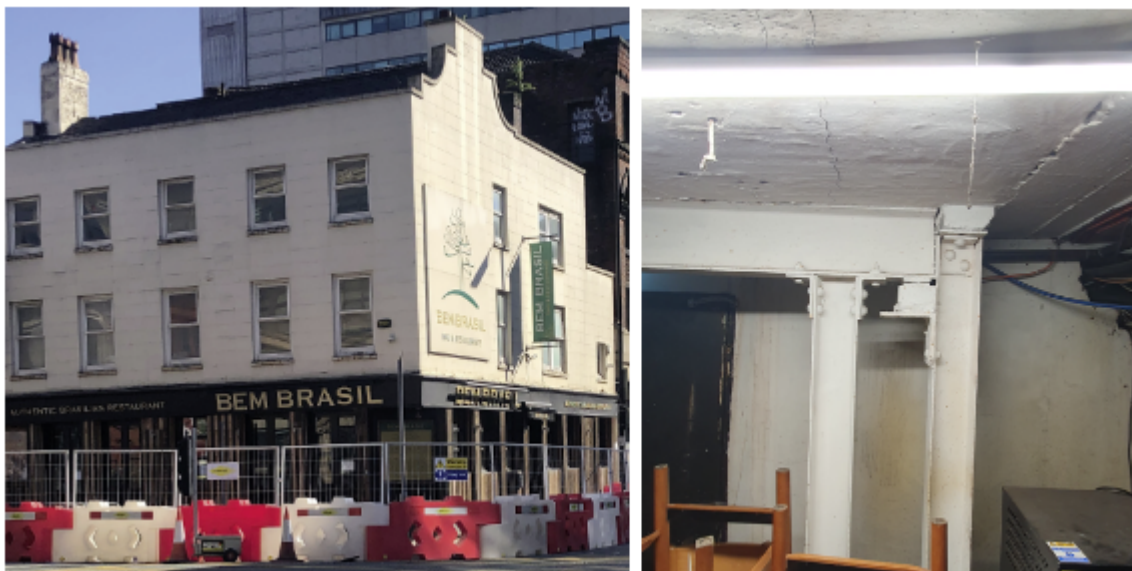
Local brickwork defects were observed with localised cracking and a patters plate at 2<sup>nd</sup> floor. Evidence of water ingress to upper floors was observed in the recent visit possibly due to blocked drains along Great Ancoats street parapet wall.

The fire escape to the rear is unsafe with several failed steps. It is understood that this may affect the current occupier's safe egress from the building. Finishes concealed the upper floor structure and therefore it is recommended that further surveys are instructed post strip out when the structure can be exposed. However, it is assumed that this building is in generally sound condition with localised repairs required.

Figure 5 - Bem Brasil and basement structures

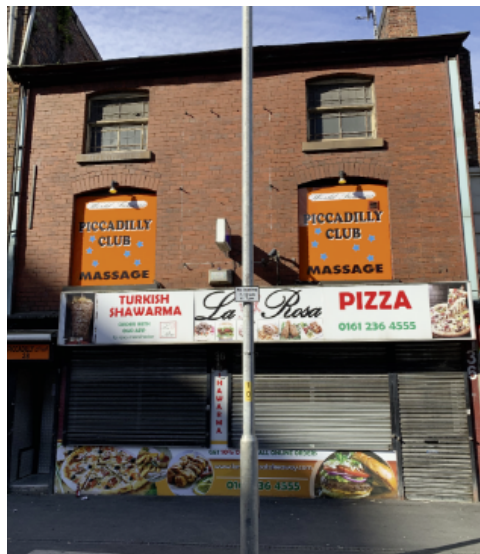
La Rosa consists of a 3-storey traditional load bearing masonry structure. Internal structures were concealed by finishes but no visible signs of distress were observed. External brickwork appeared in good condition, and it is assumed that no remedial works are required to this plot. No access was available during either site visit, therefore conclusions are limited to the visible external elevations and further internal surveys will be required to confirm the condition.

Figure 6 - La Rosa

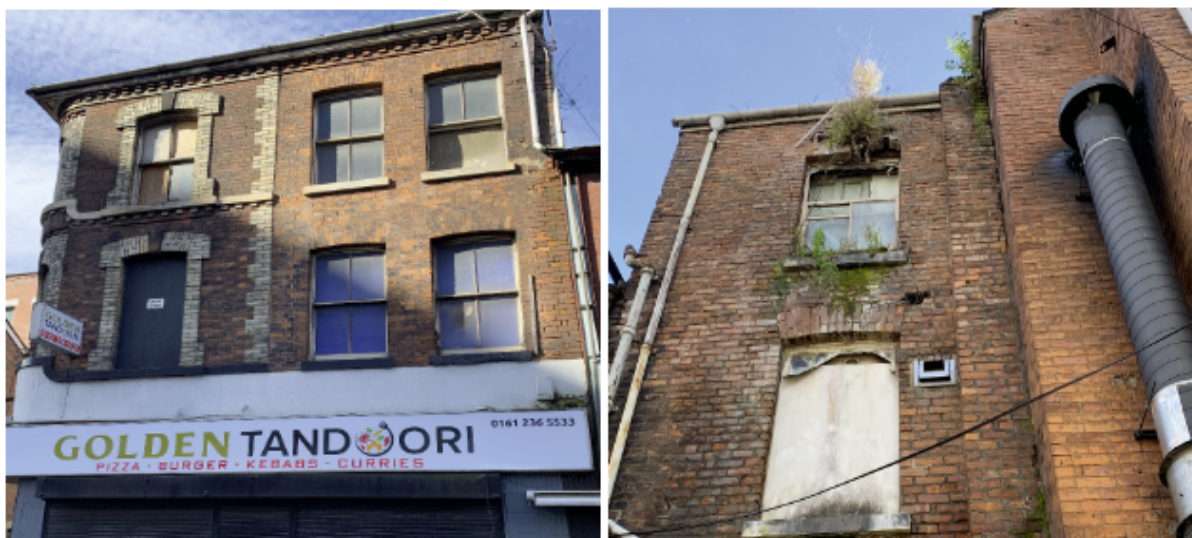
This building consists of a 3-storey traditional load bearing masonry construction. The northern portion appears to be a later addition given the change in brickwork architecture along the façade. This newer addition has cracking and spalling brickwork present.

The elevation along Little Ancoats St shows signs of significant leaking of gutters and downpipes with presence of vegetation and collapsed window lintels. No access to the internal areas of this plot were granted during both site visits therefore the internal condition is unknown. Given the extent of vegetation and leaking gutters there is a risk of water ingress to the roof and upper floors.

Figure 7 - Golden Tandori facades

Access to the interior should be prioritised to understand the condition of roof trusses and confirm any defects to upper-level floor structures.

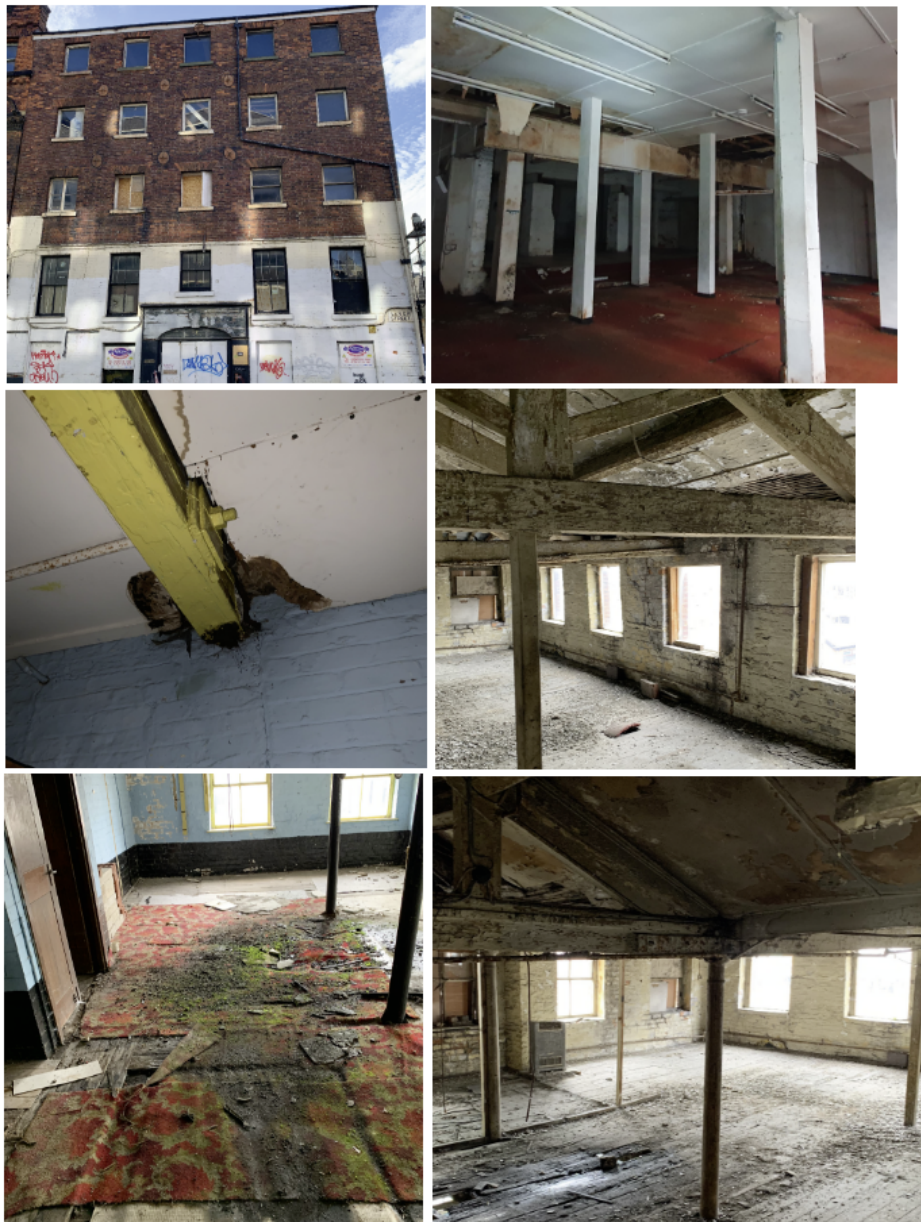
In the recent 2023 survey, access was granted to the ground floor spaces only, stairs to the upper floors were safe but no access to the floor plate was gained by AKT due to locked doors as a result of the unsafe structure. There are serious signs of degradation throughout the visible parts of the building with substantial water ingress stemming from holes in the roof being left open.

During the inspection carried out in 2020, full access to the internal spaces was achieved. Superficial cleaning had been carried out since the original survey in 2017 which had exposed more of the internal structure for inspection. Several props were present supporting failed primary beams which are still currently present suggesting this interim measure has been left insitu. Varying eras of structural alteration were observed with cast iron, mild steel and tublar steel propping.

Significant damage due to water ingress is present to all floors with staining, collapsed ceilings and floor structures. Cast-iron tie restraints are fixed back to primary timber beams on the upper floors. These were found to be defective in some areas with loss of tension due to rotten timber beams allowing slip of the ties. This is a key risk as the façade has lost restraint and is susceptible to further bowing. Roof truss have compromised bearings due to rot and are supported on columns or temporary props where bearings have failed.

Visual survey of the external elevations both in 2020 and 2023 have seen severe defects to the brickwork with spalling bricks, cracking to the masonry and vegetation growing on the Little Ancoats St elevation.

Figure 8 - Plot 6 defects

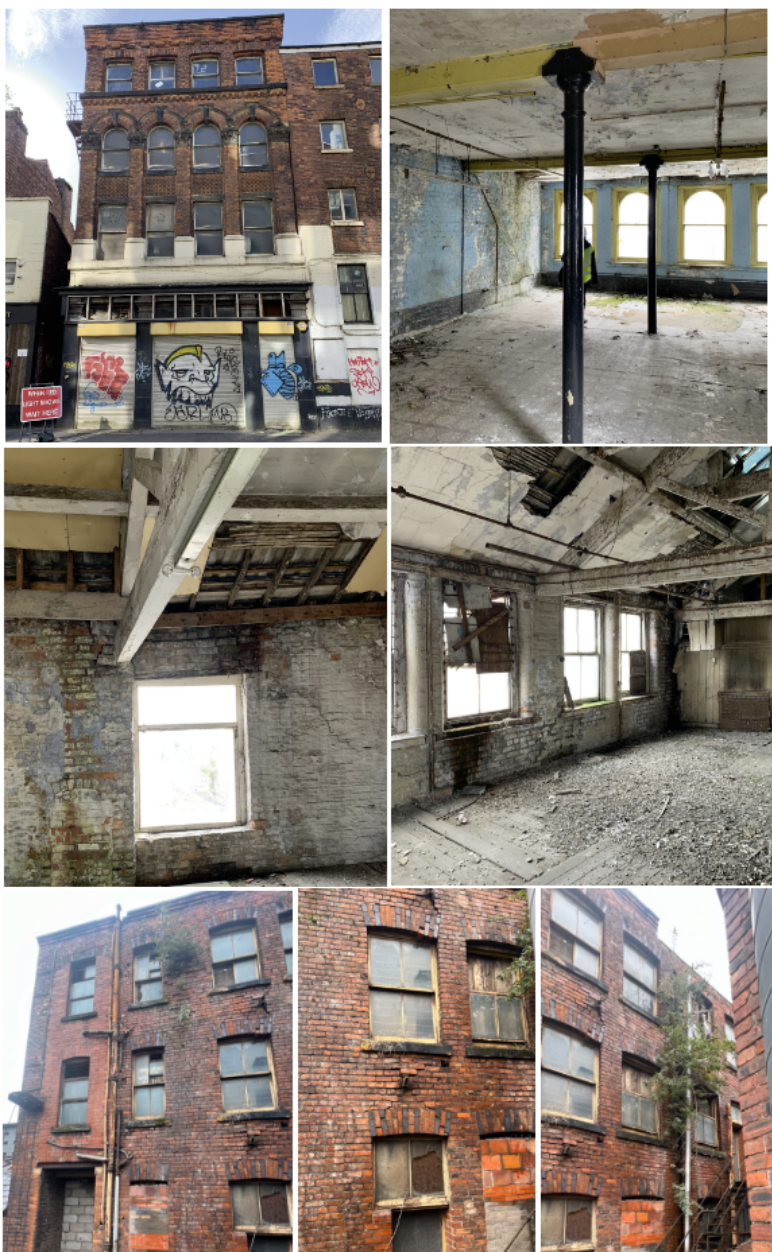
This plot was subject to a partial collapse of the roof and upper façade wall as outlined in Section 3. The internal structures remain in extremely poor condition as described below and are currently exposed and unprotected since the collapse, accelerated degradation is expected.

3 central cast-iron columns were present at ground floor, the iron frame was painted, and no corrosion was observed. In the upper floors the 3 iron columns supported primary timber beams spanning parallel to the facade with timber floor joists spanning perpendicular. Rotten bearings were observed to some of the primary beams with replacements present.

Roof finishes are compromised allowing water ingress. This has resulted in rot to the roof trusses which have significant deflections and failed bearings. Typical external brickwork defects are present as elsewhere on the site with spalling brickwork, cracking to the masonry, vegetation growth and rebated joints.

**Figure 9 - Plot 7 defects**
