# Design Note

| Project | SIM - Gantry Conservation |
| Subject | Conservation Philosophy |
| Project no | 054704 |

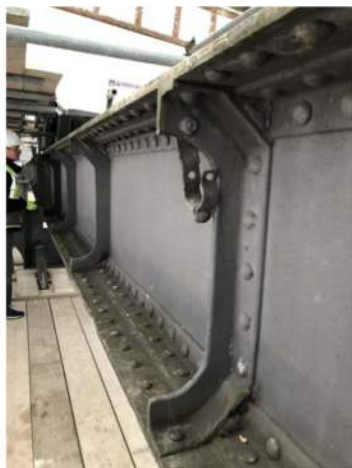
Figure 3-1 Paint sampling for Gantry beam

A properly installed, appropriately specified paint finish is the Gantry structure’s most important line of defence against corrosion and future decay. Failure of the current paint finish is the primary reason for the widespread corrosion present on the Gantry. It is understood that the last re-painting took place in the 1980’s, and as such it is not surprising that the existing paint covering has failed. Properly applied paint finishes typically have a design life of 20-25 years, meaning that the finish applied in the 1980’s is c. 20 years beyond its anticipated design life. Paint sampling carried out for the Gantry shows that the 1980’s finish was also applied directly over the top of the previous paint layers which was likely detrimental to its longevity (see Figure 3-1).

All of the Crane Gantry samples showed the same surviving history or traces of, that tie in with the representative sample shown here.

To safeguard the Gantry superstructure against future deterioration a new paint coating is required. To achieve the maximum design life and reduce the risk of failures it is proposed that this should be applied onto the prepared bare metal of the Gantry, rather than over existing coatings. Failure to properly prepare the surface is likely to have a detrimental effect on the life of any applied coating, and it is unlikely that an adequate warranty could be provided for coatings applied over existing paint finishes.

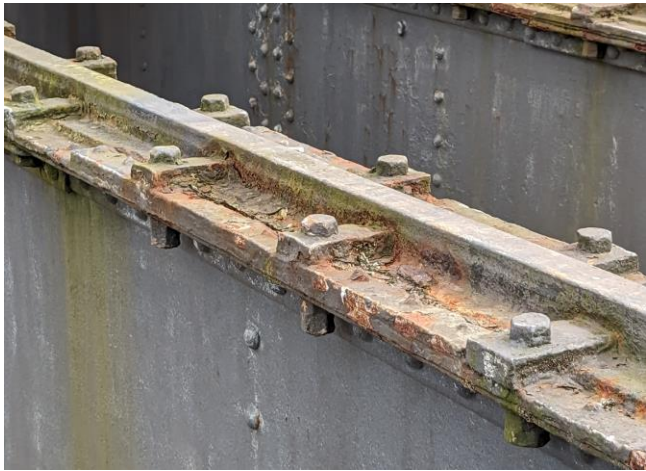
Figure 2-23 Corrosion top face crane beam

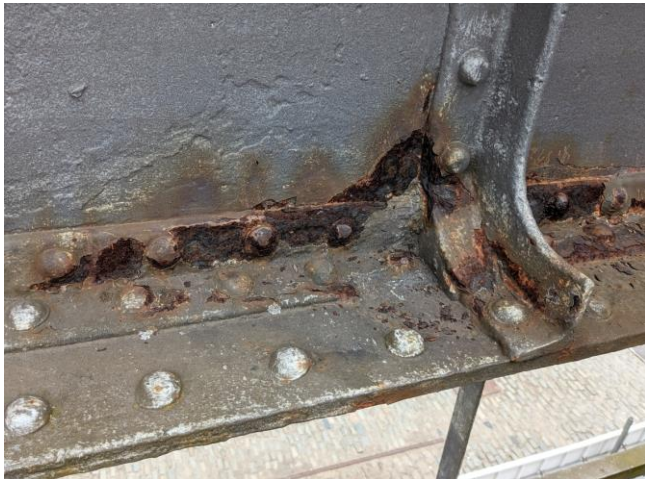
Figure 2-36 Typical corrosion to Gantry beam at stiffener
