## Site Investigation Summary Report

Louisa Street

Openshaw

**Report Ref: A4755/22/SISR/V2**

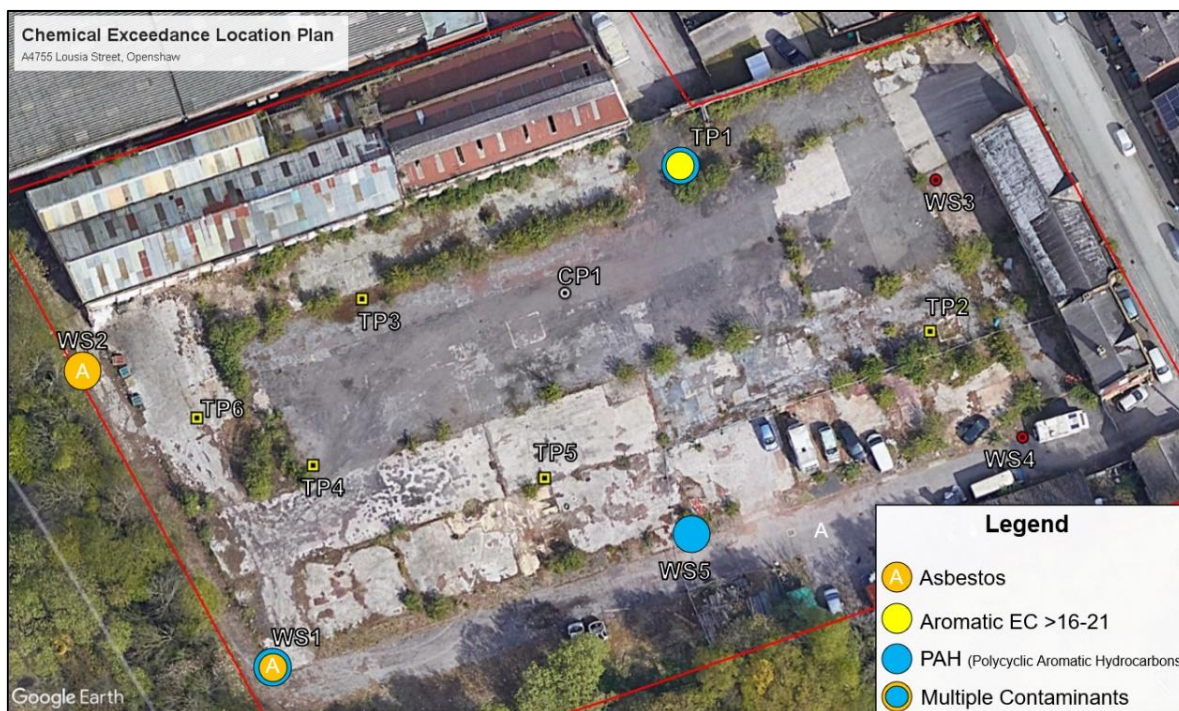
**Figure 4: Chemical Exceedance Location Plan – Original Investigation**

The samples with identified contaminant exceedances include WS1 at 0.30m, WS5 at 0.65m, and TP1 at 0.40m. The exceedances are included in Tables 2 & 3 and Figure 4 below.

Follow up testing on the 8<sup>th</sup> September 2023 found these hotspots to be free of the previously identified contamination due to removal of the material during the archaeological excavations.

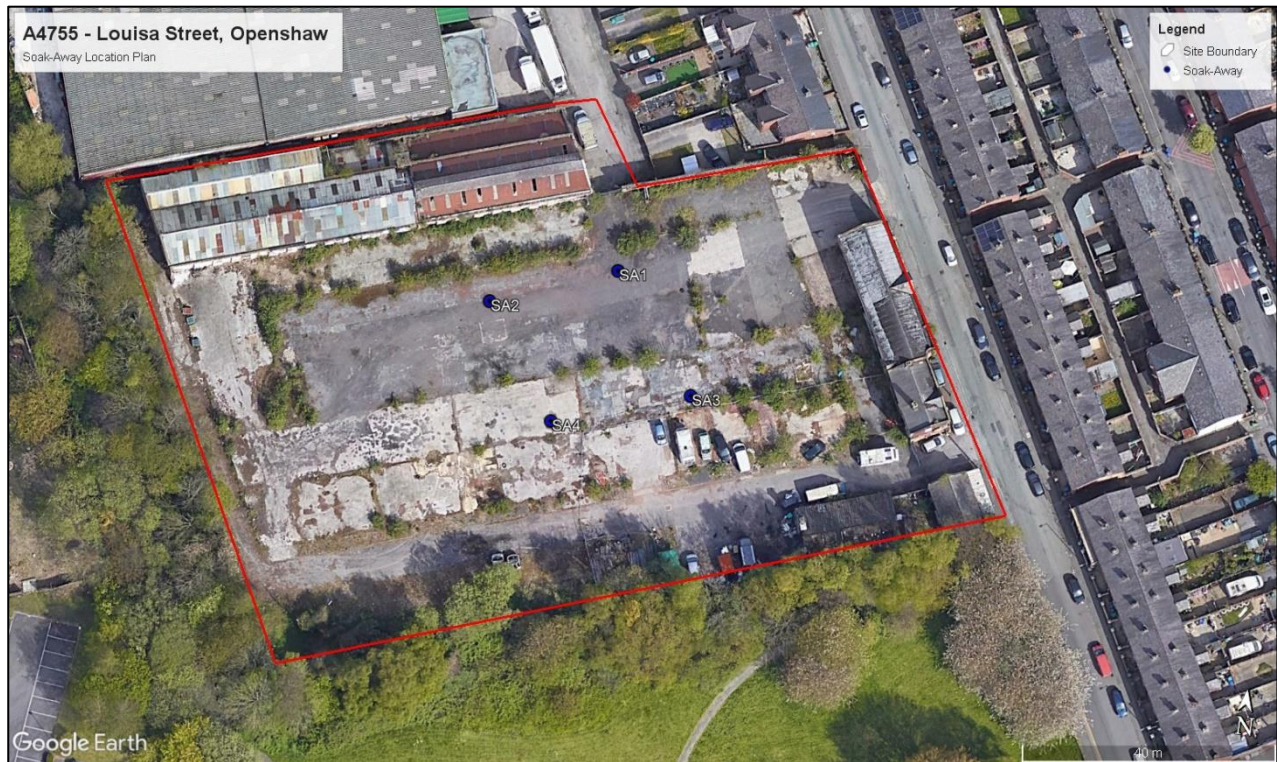
**Figure 5: Soakaway Testing Location Plan – May 2023**

Over the course of one day (5th May 2023), four locations (SA1 to SA4) were excavated by means of a tracked hydraulic excavator. All of these pits were designated for soakaway testing. Due to the slow infiltration rate of the pits, only one fill with water was carried out at each location. This was carried out by filling the excavation rapidly with water from a towed water bowser. A plan of the testing is provided as Figure 5 overleaf.

The infiltration rate of each location could not be calculated due to the slow rate at which the water drained away.

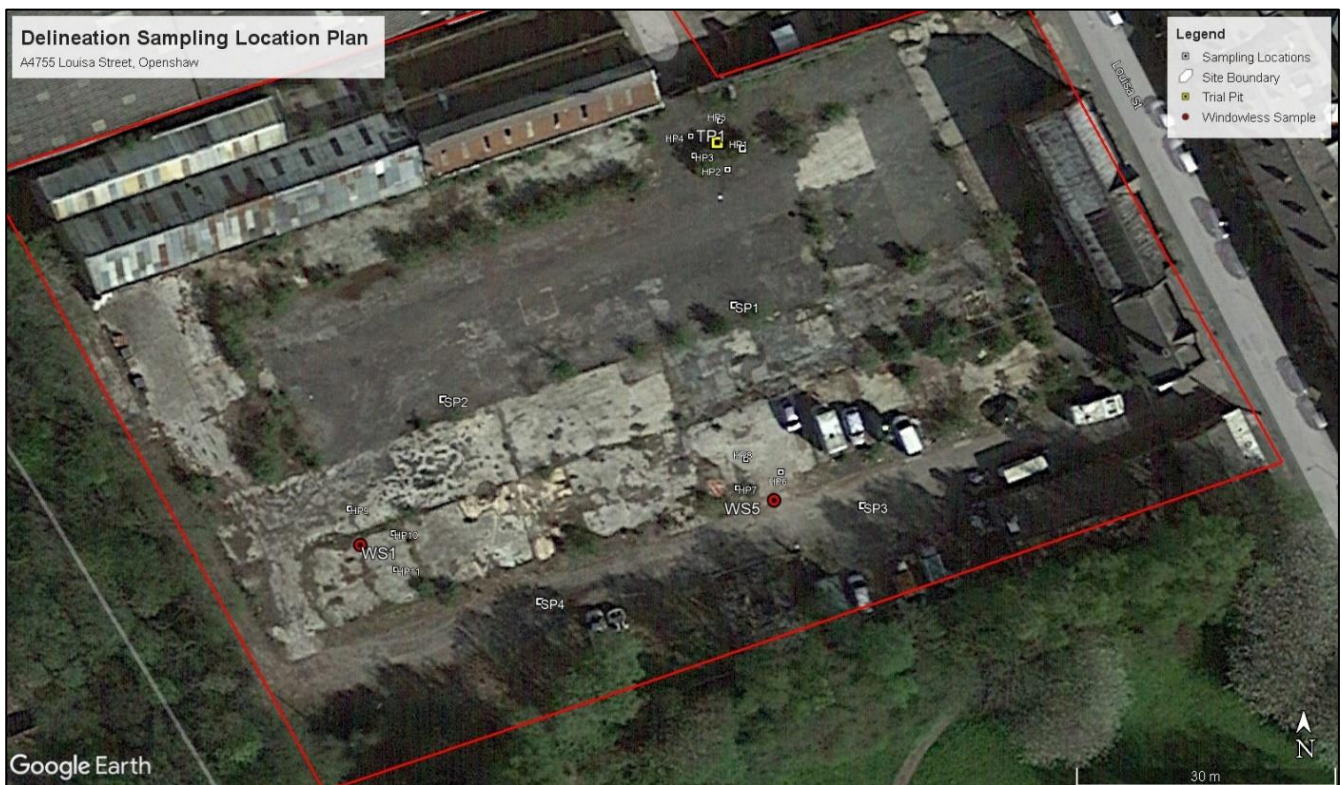
**Figure 7: Delineation Sampling Plan – September 2023**

It should be noted that the samples from surrounding WS1 and WS5 (HP6 to HP11) were taken from inside the archaeological excavation, as this encompassed the area where these hotspots were previously located. Therefore, the samples were taken at depths between 1.05m and 1.55m below the original ground level.

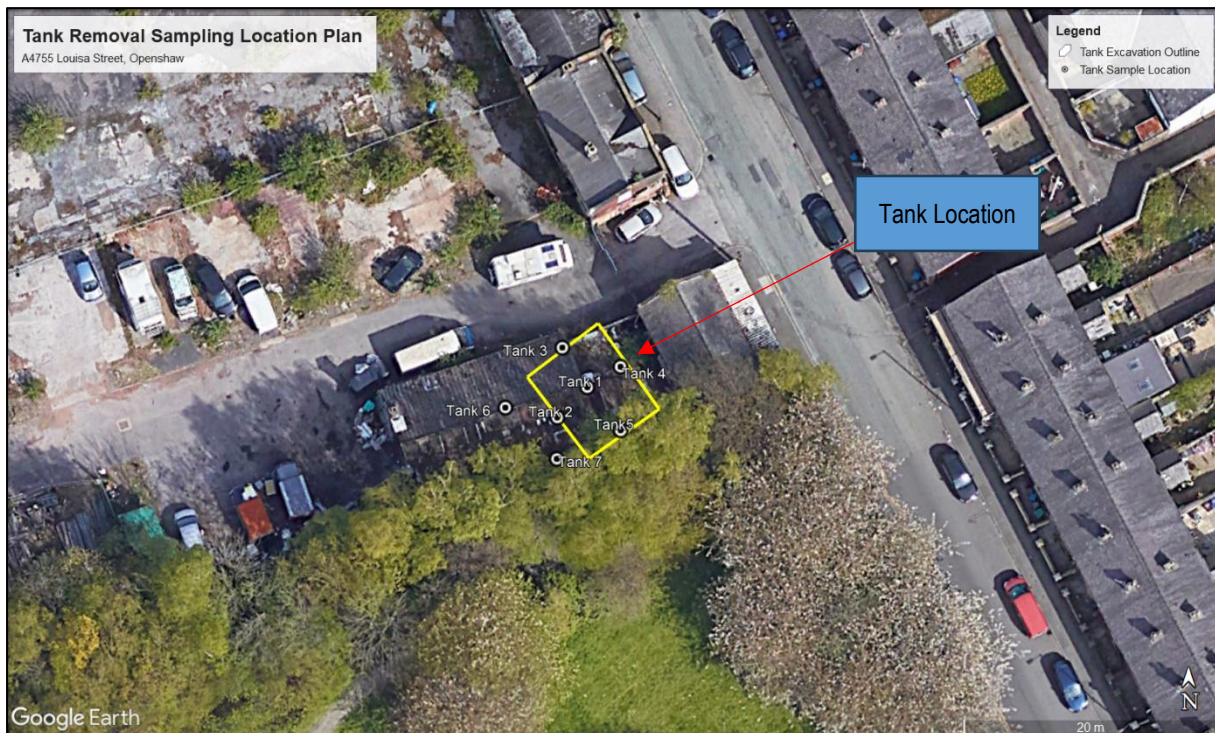
**Figure 8: Tank Removal Sampling Location Plan**

The soil samples collected from the material to be removed off-site (Tank 6 & 7) were classified as Non-Hazardous for the purpose of off-site disposal, based on the WM3.1 classification. Further WAC testing showed the material to be classified as Inert Waste.

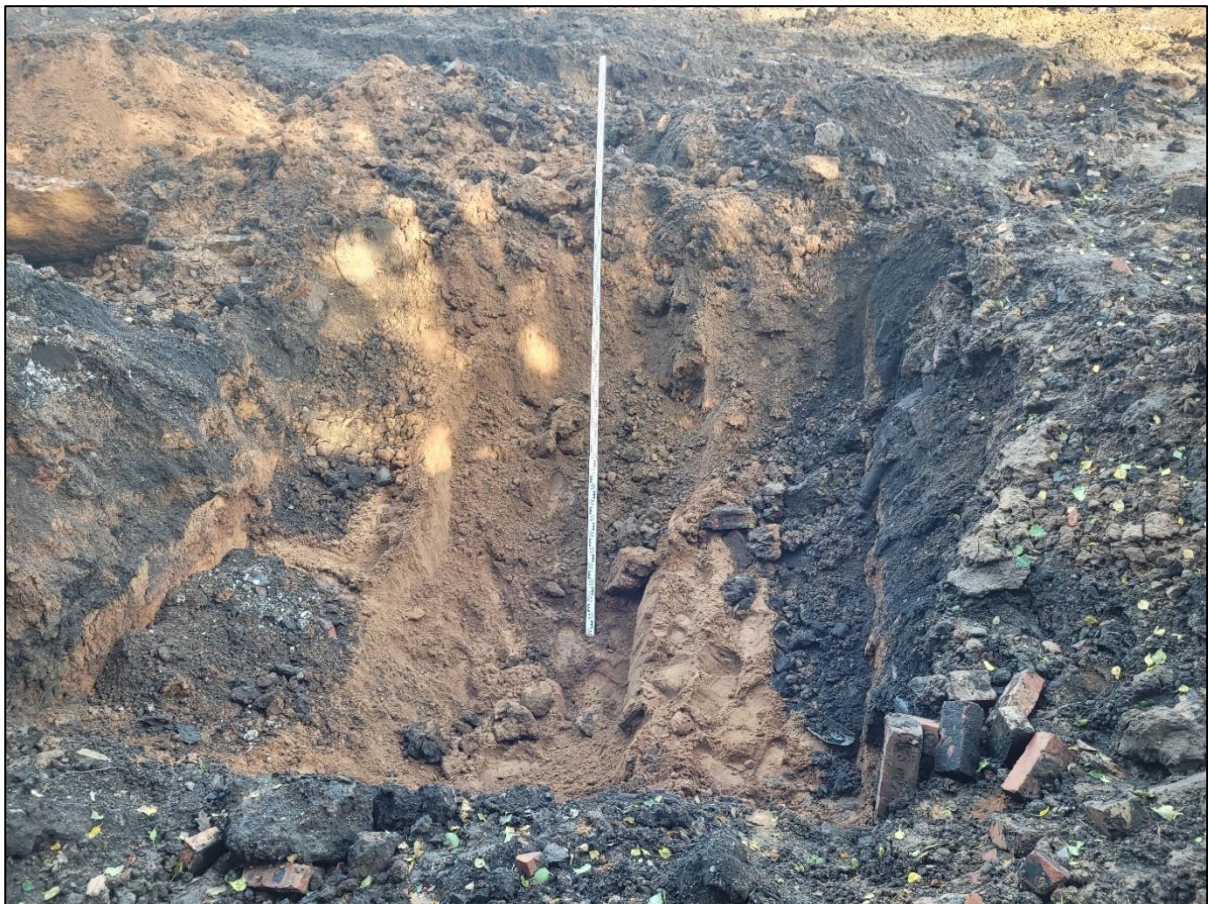
**Figure 9: Photograph of Tank Trial Pit, Post Tank Removal**

A concrete foundation slab, that the steel tank was originally placed on, was uncovered during the removal of the contaminated material. This slab was removed along with the impacted soils. A strong hydrocarbon odour was identified during the removal of the slab, along with the observation of an oily sheen. All remaining visually, and olfactory contaminated soils were excavated and stockpiled.

A photo-ionisation detector (with 10.6eV lamp) was used to measure the concentration of volatile organic compounds in the headspace of soil samples. All measured concentrations were below 5ppm.
