# Royal London House, 196 Deansgate

Schedule of Works & Method Statement - Level 5, Attic & Roof

July 2024

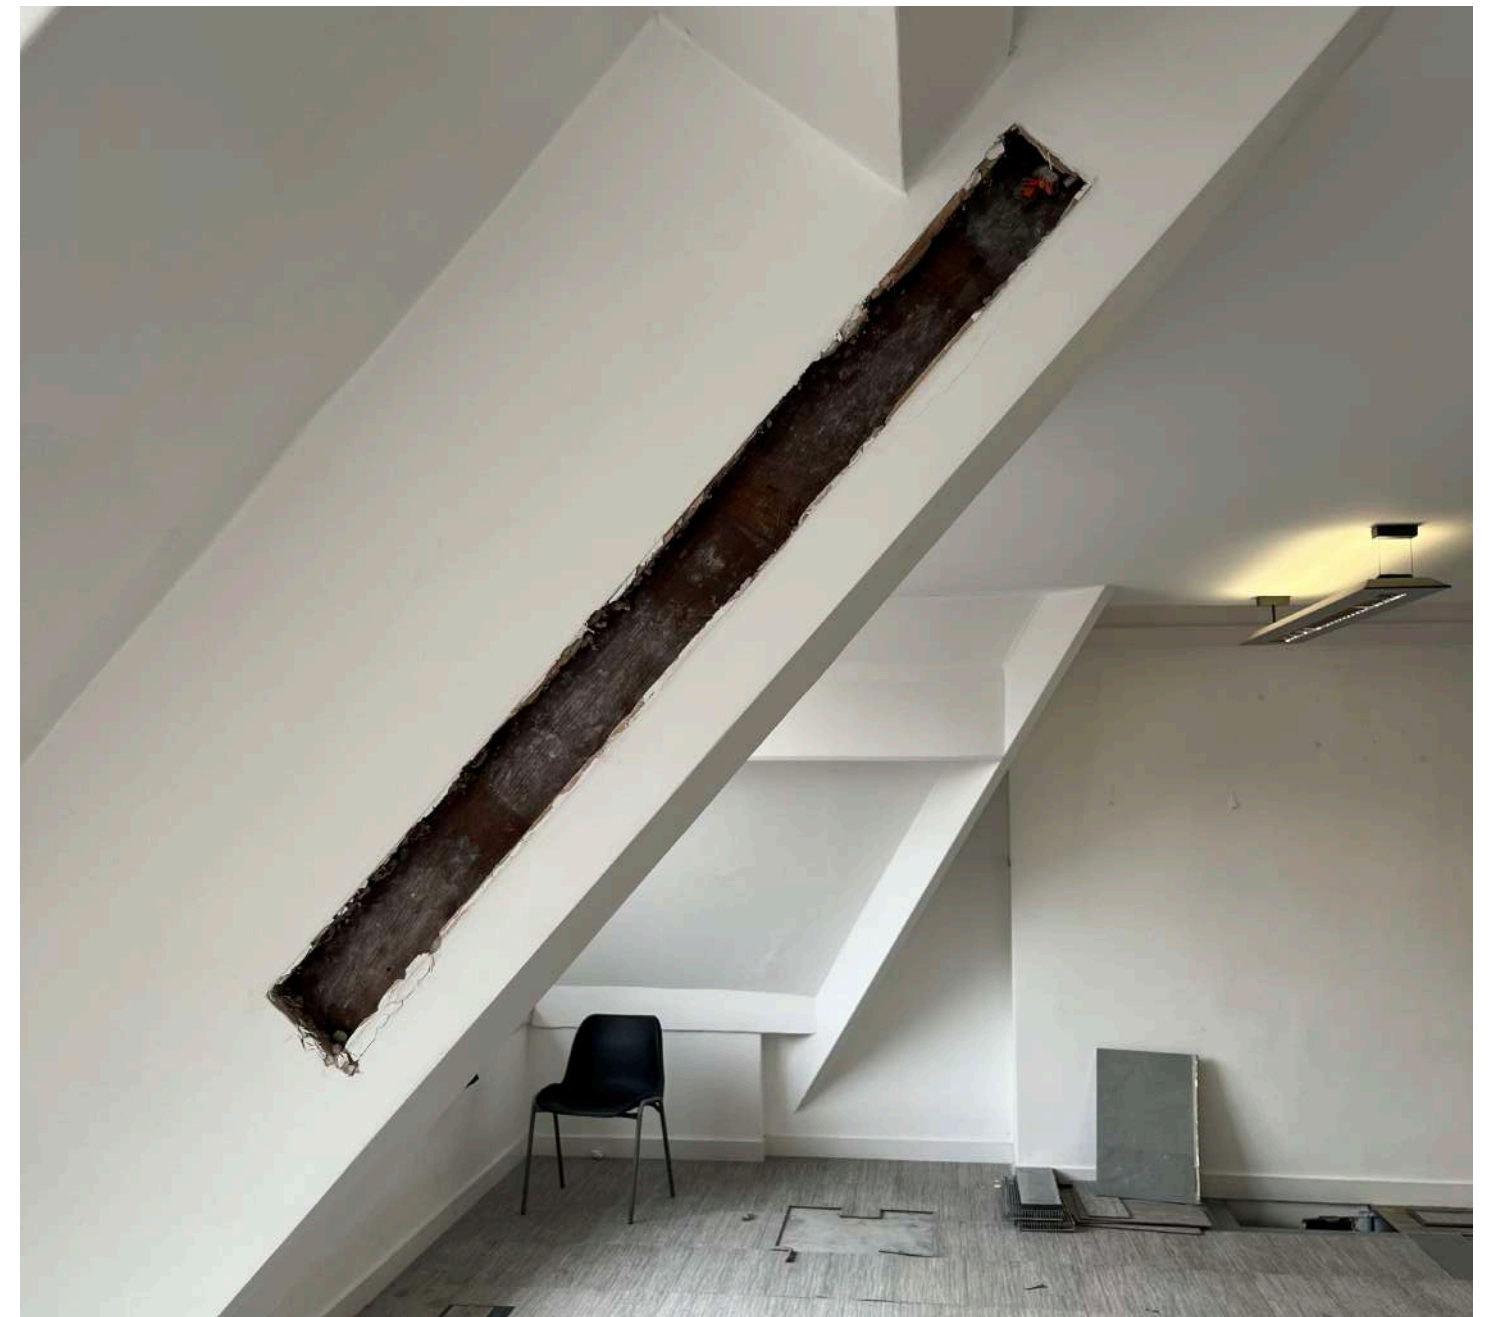
Original expamet plaster encasement to timber rafters exposed following removal of a non original light fitting

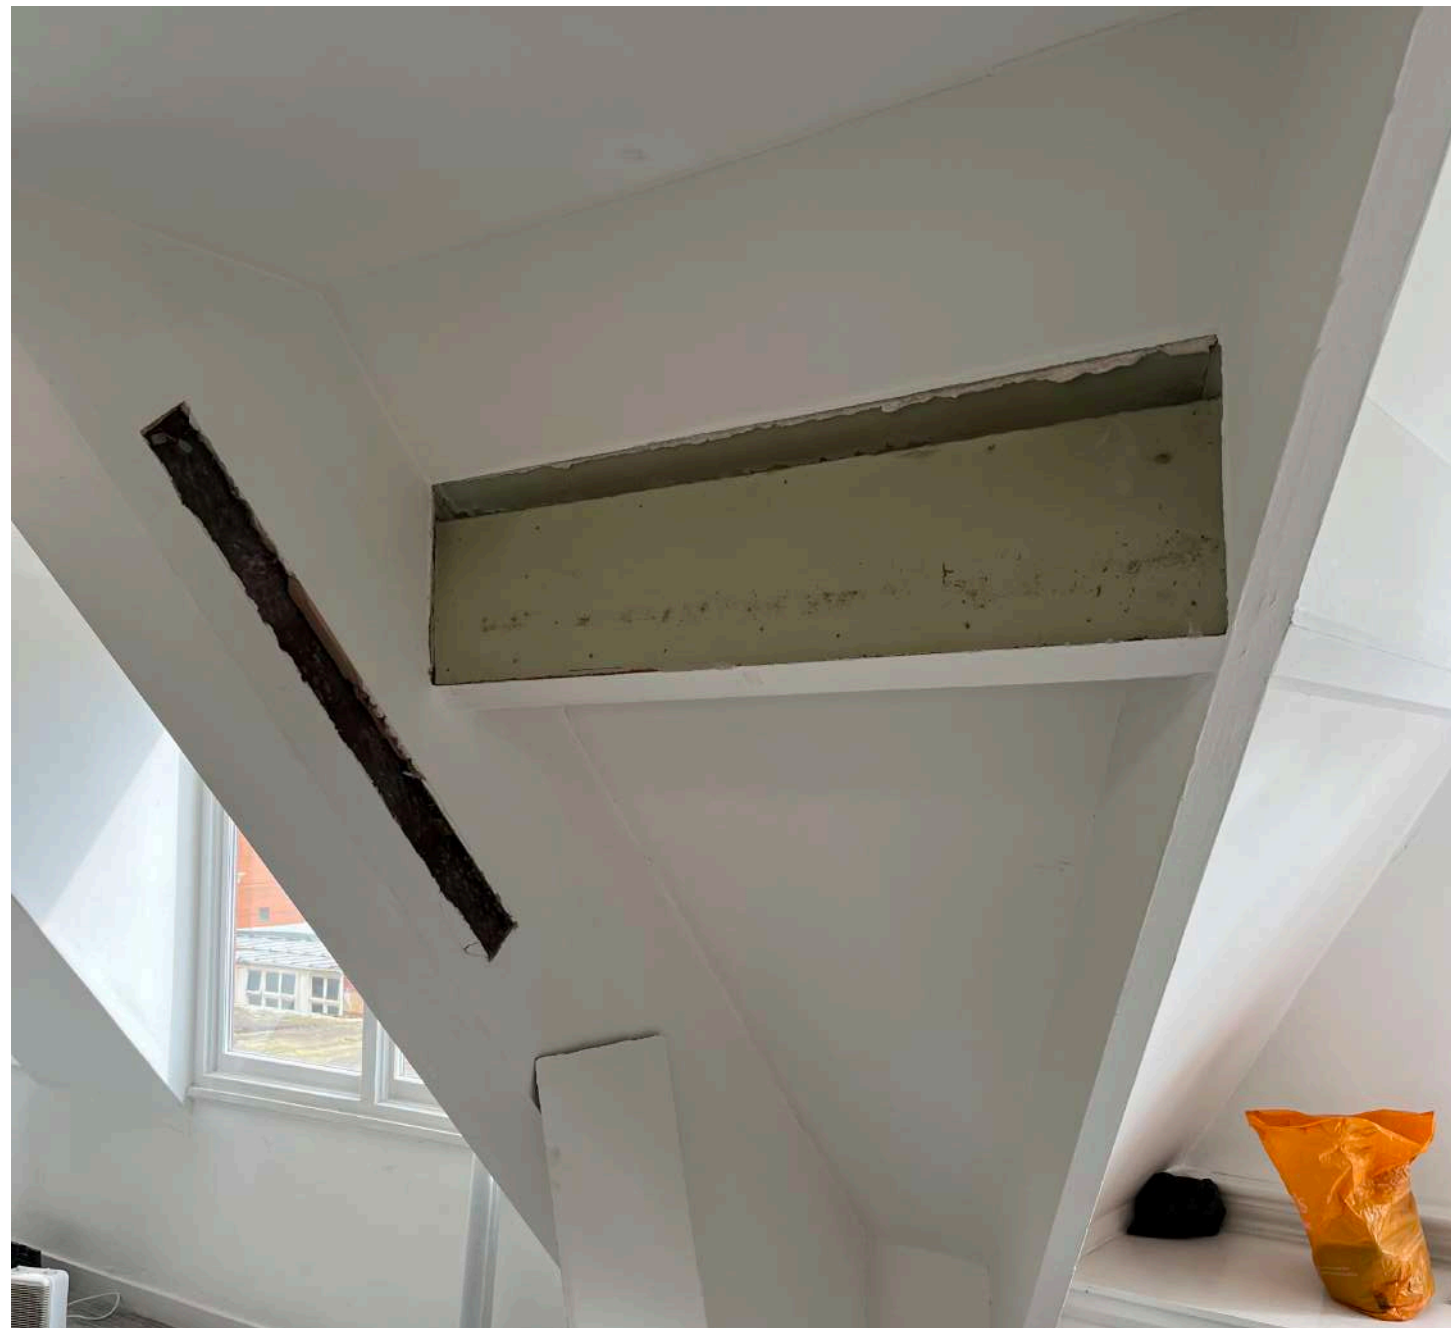
Earlier paint finish beneath fibreboard cloaking to timber purlins

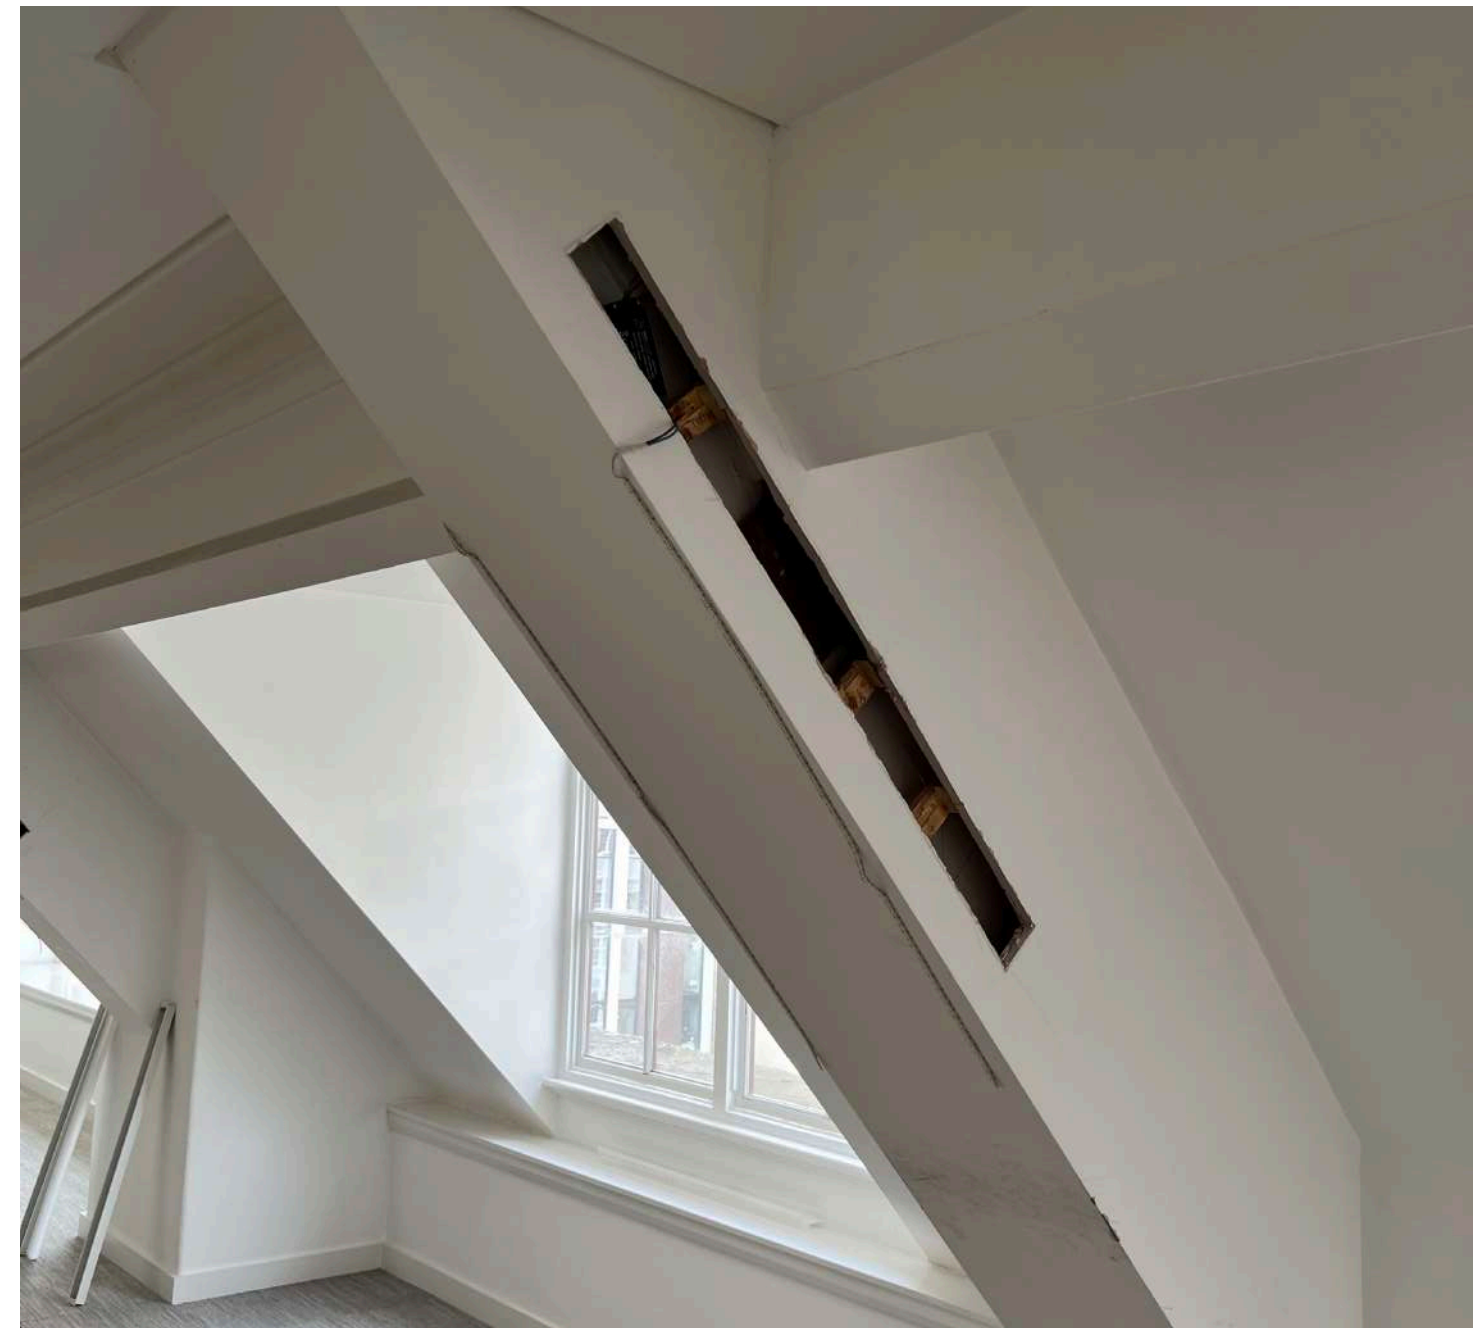
Non-original plasterboard lining and timber framework around original plastered timber rafter

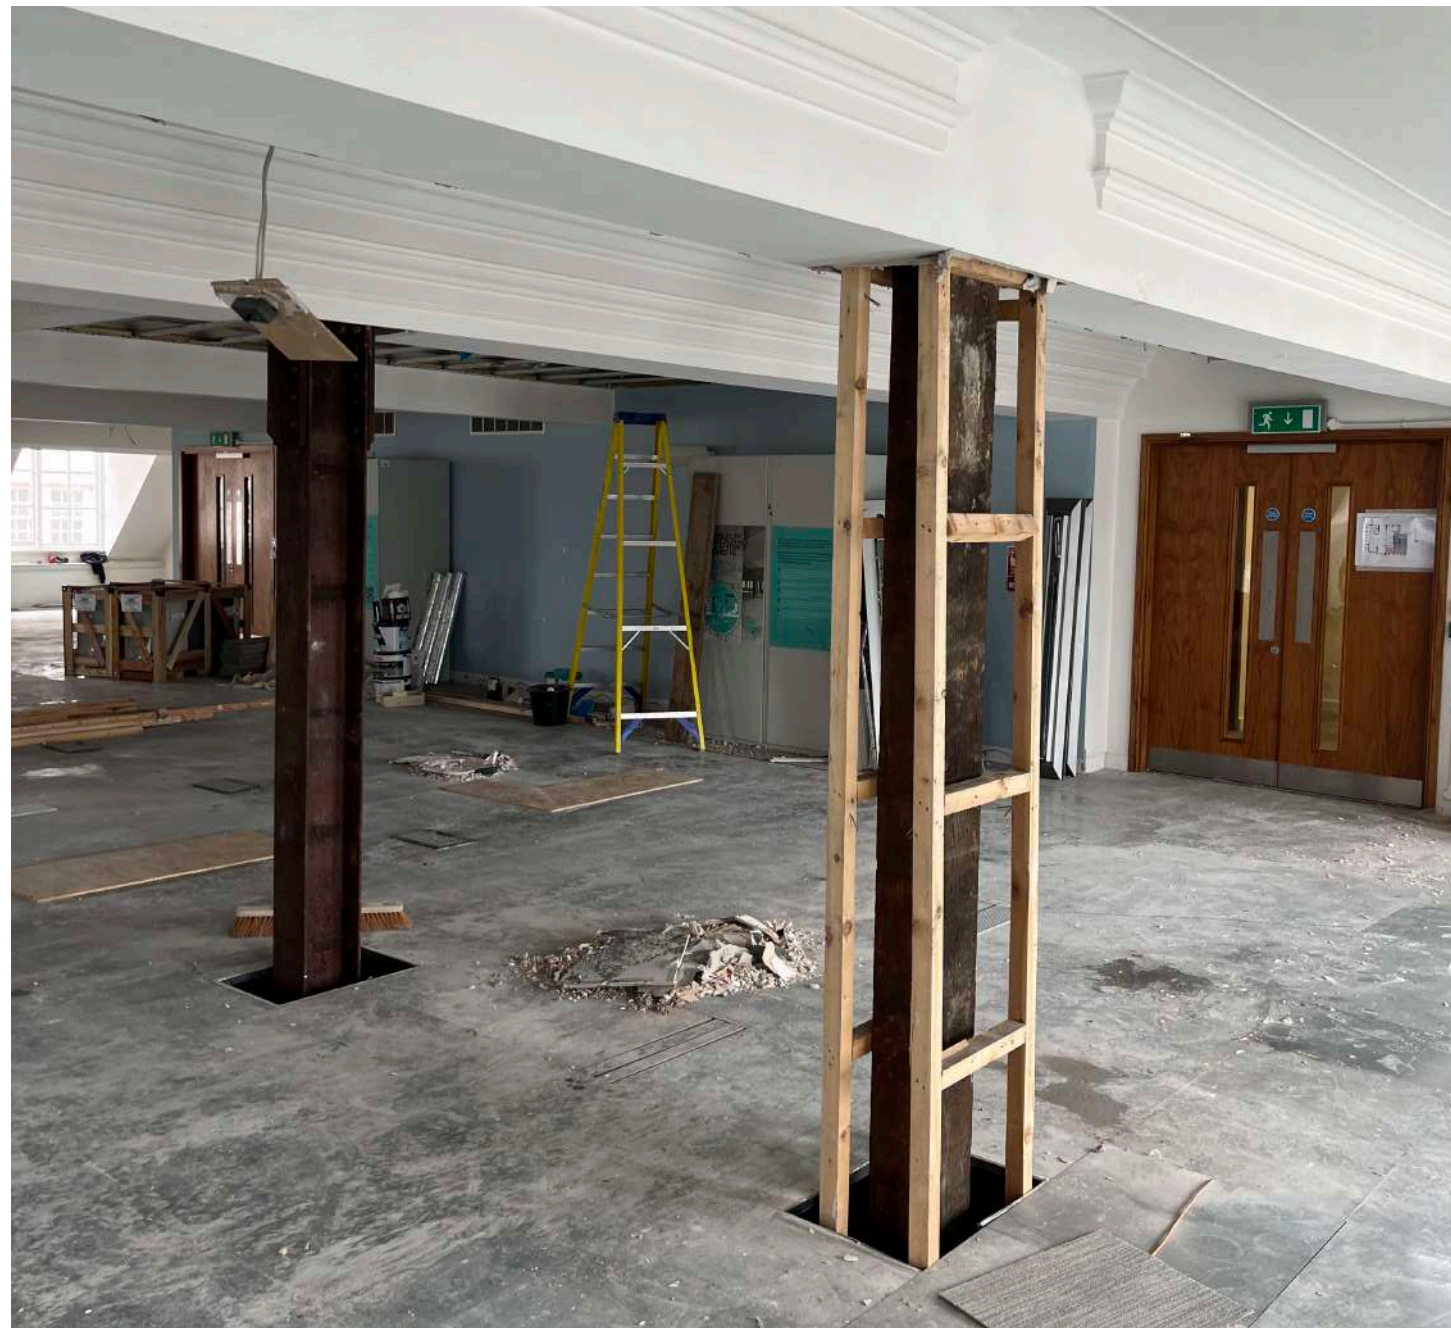
Timber column exposed following removal of non-original plasterboard lining.

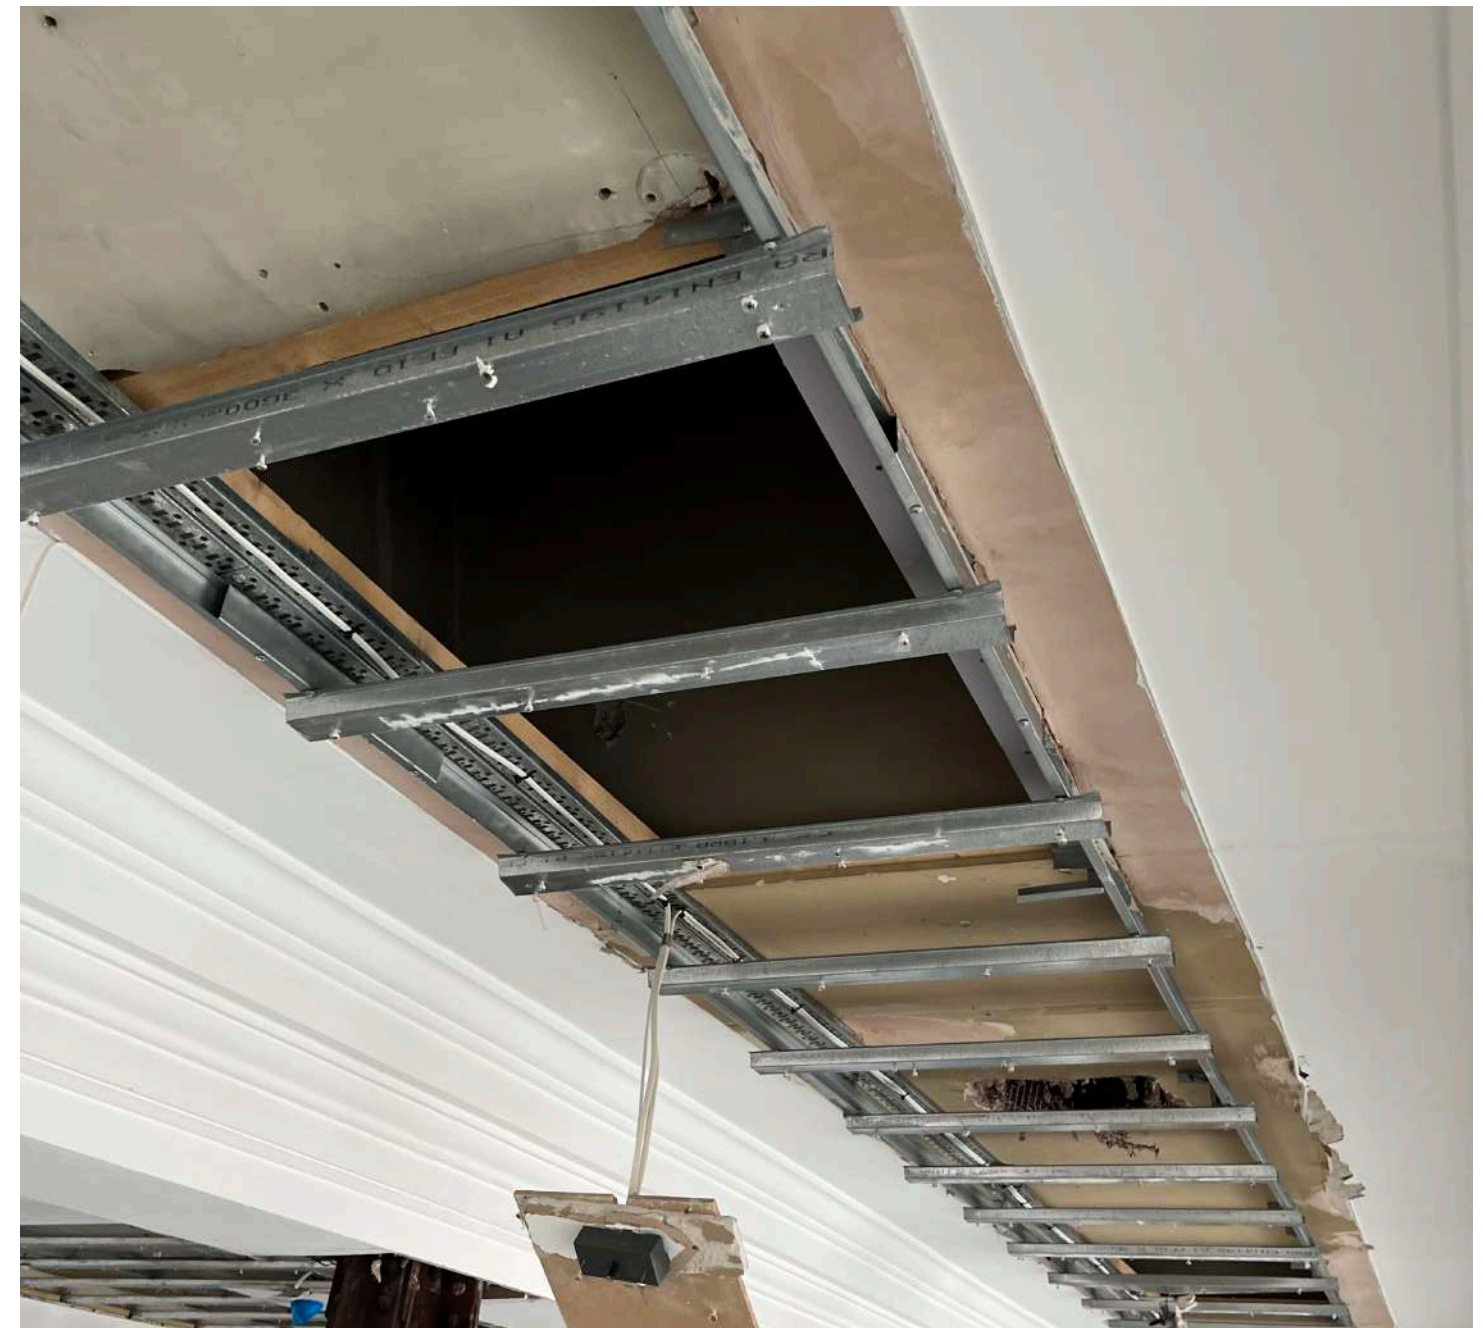
Interior of lightshafts identified within the attic following removal of the non-original drop ceiling

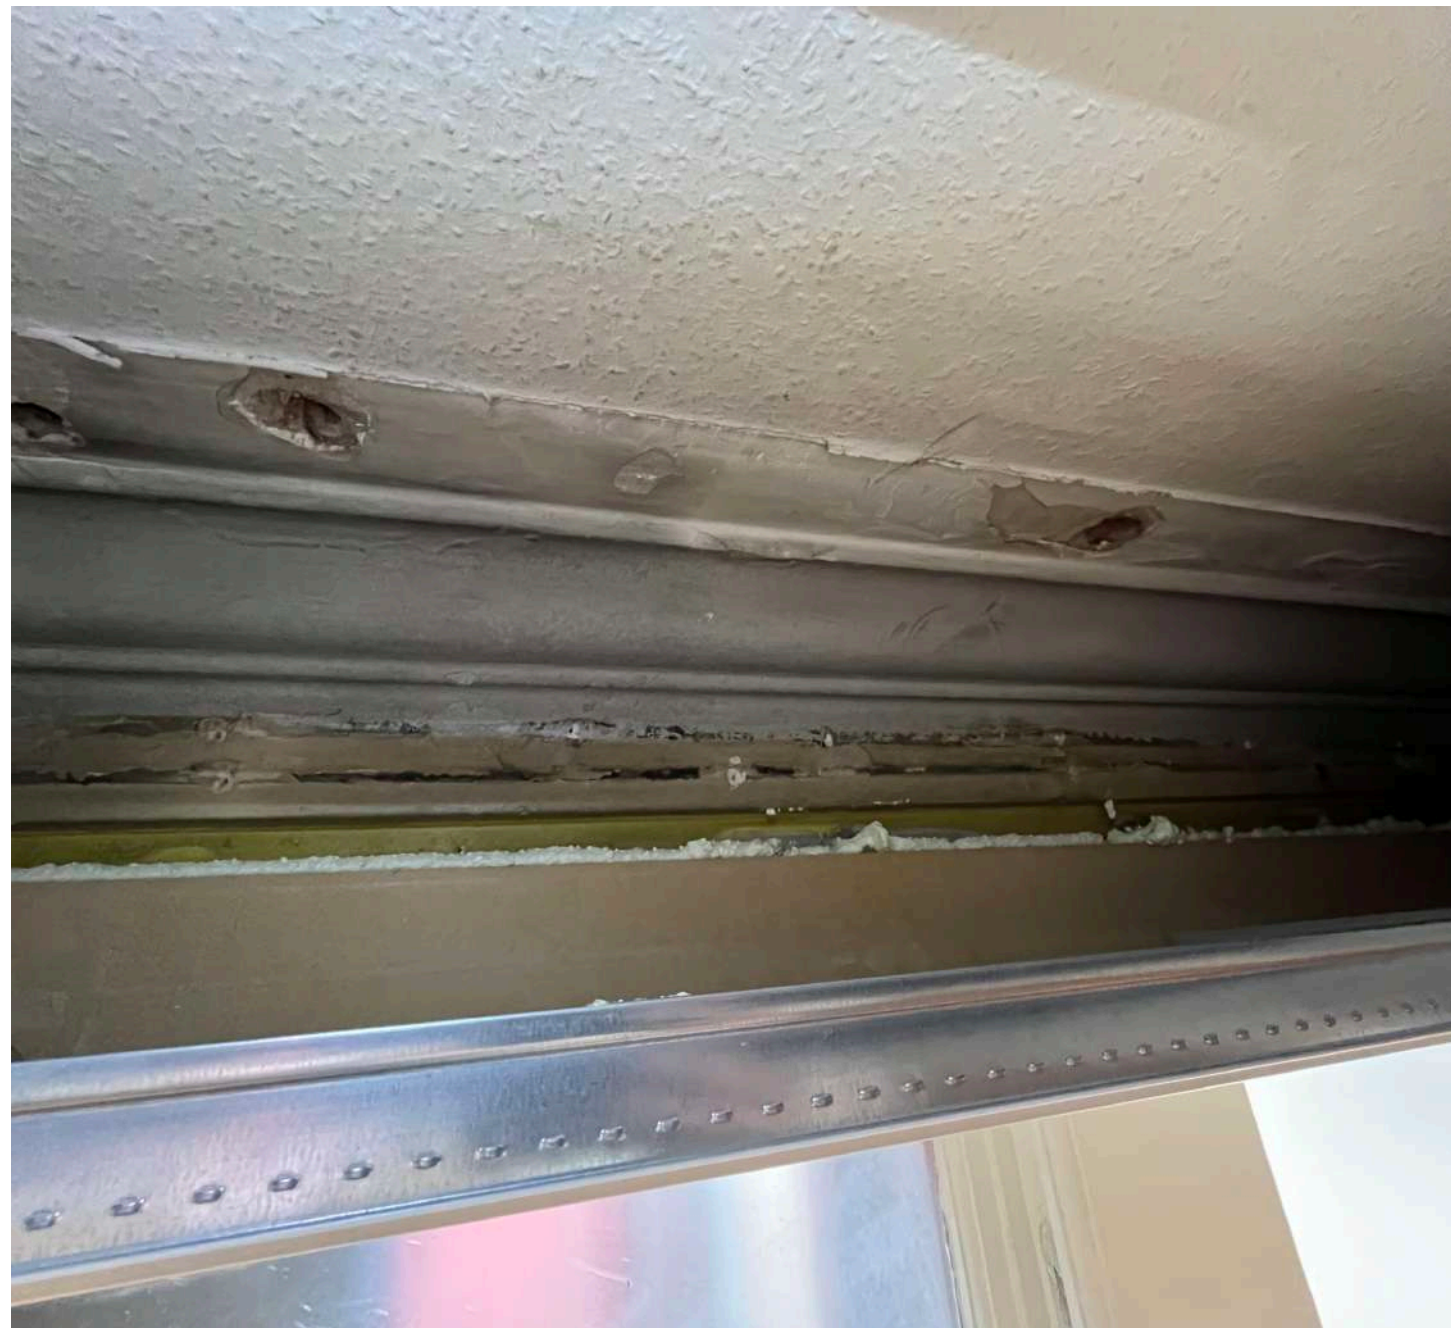
Original un restored cornicing above suspended ceilings to WCs

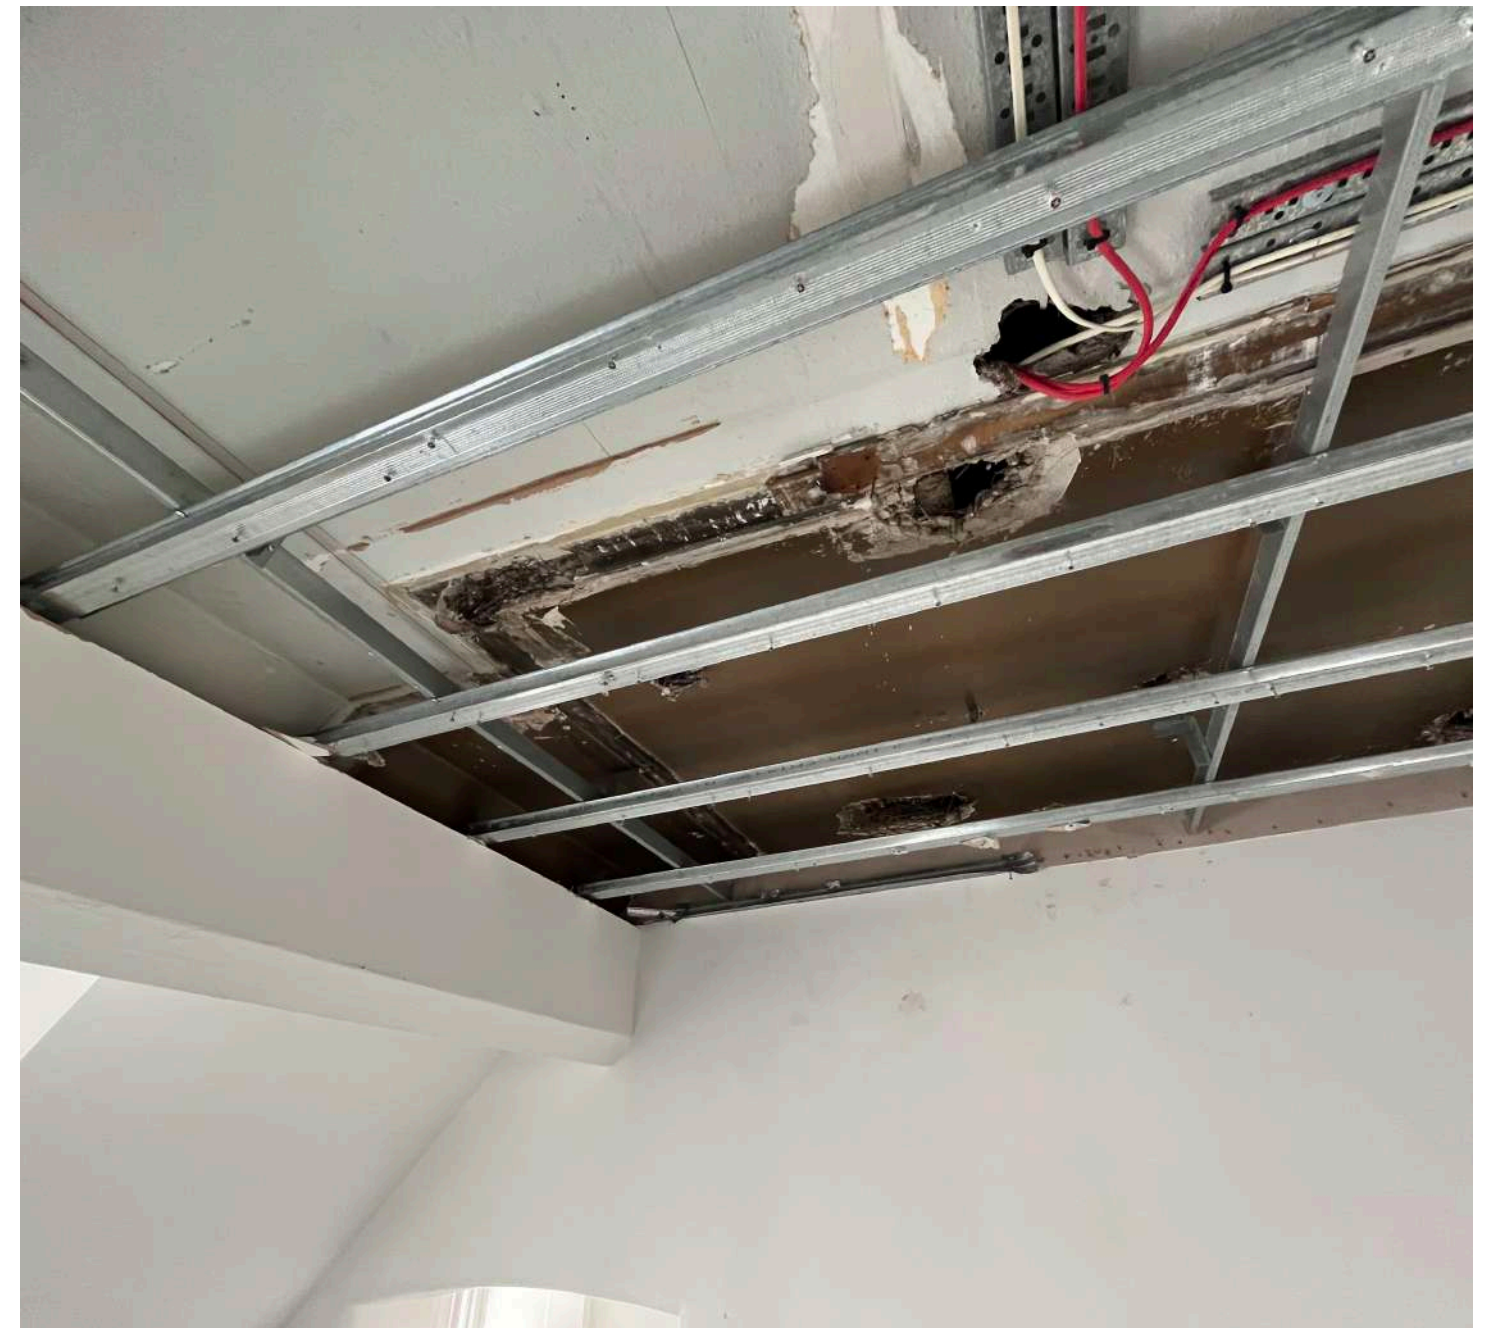
Evidence of earlier partition layout visible following removal of non-original drop ceiling

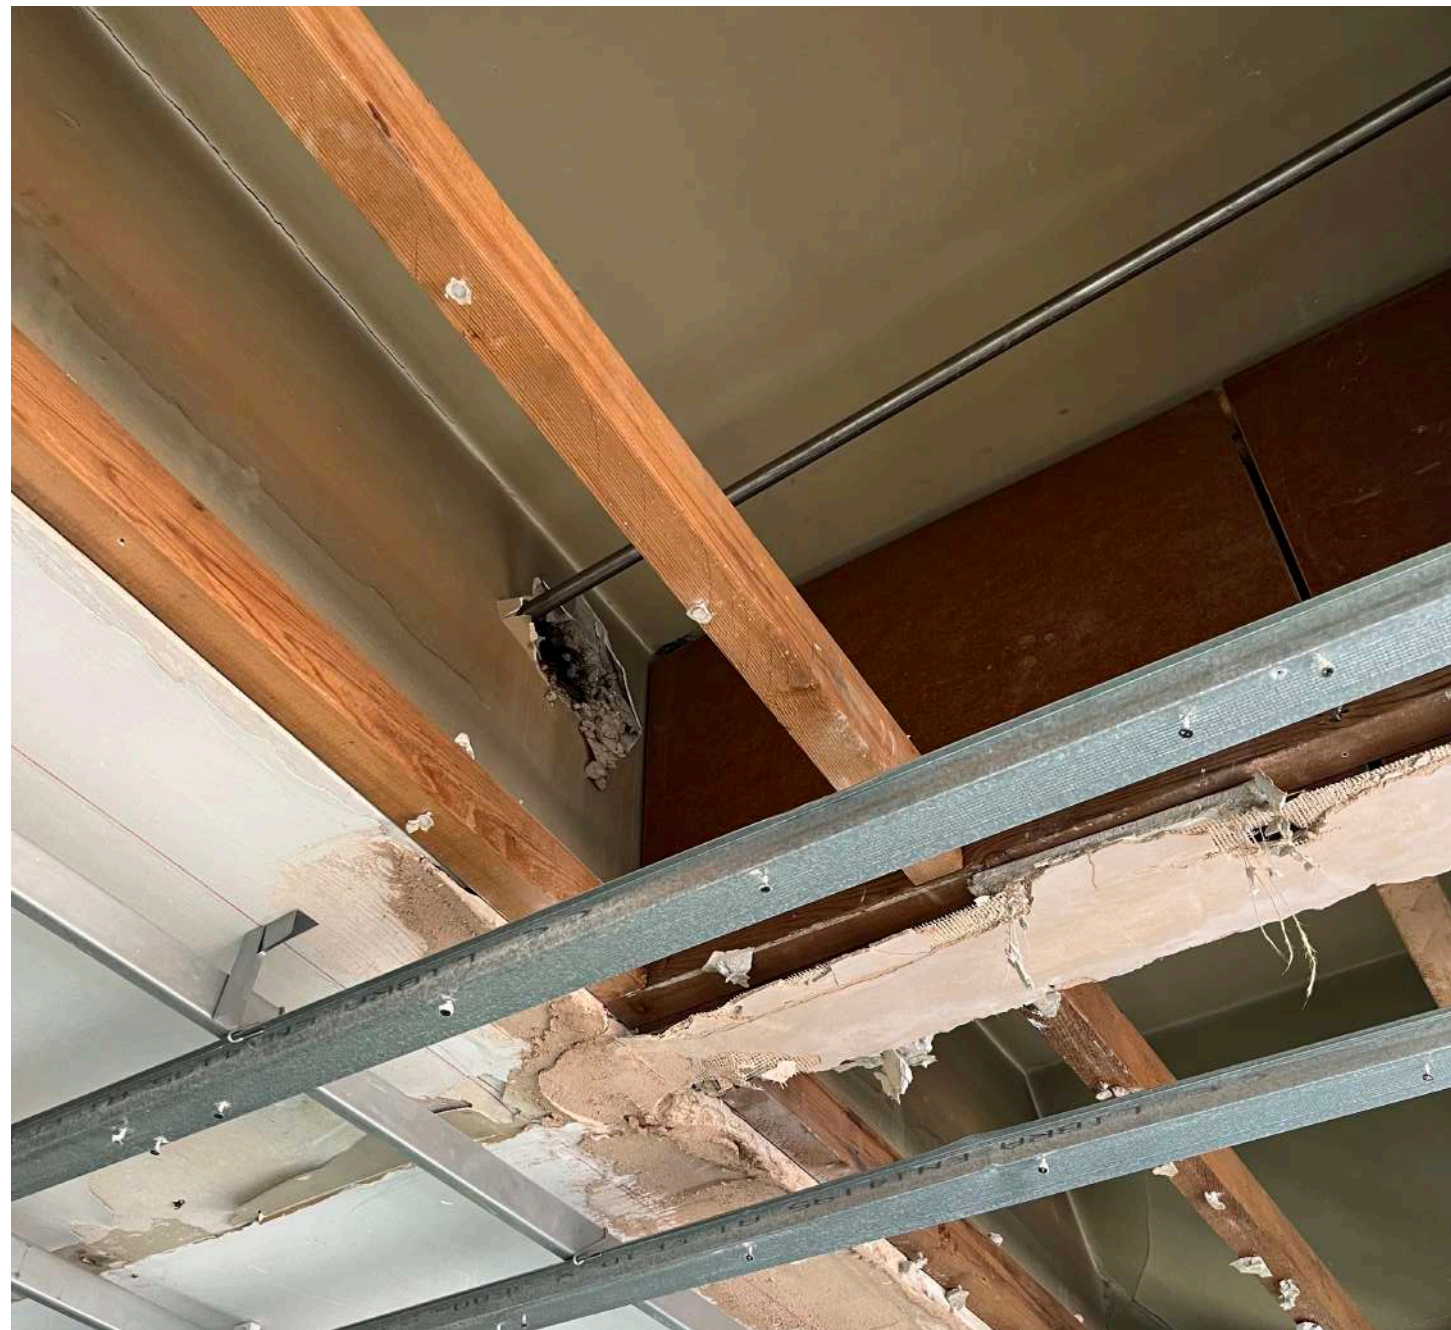
Raised area of ceiling to gable above window uncovered following removal of non original ceiling. Note retrofit stainless steel tie rod

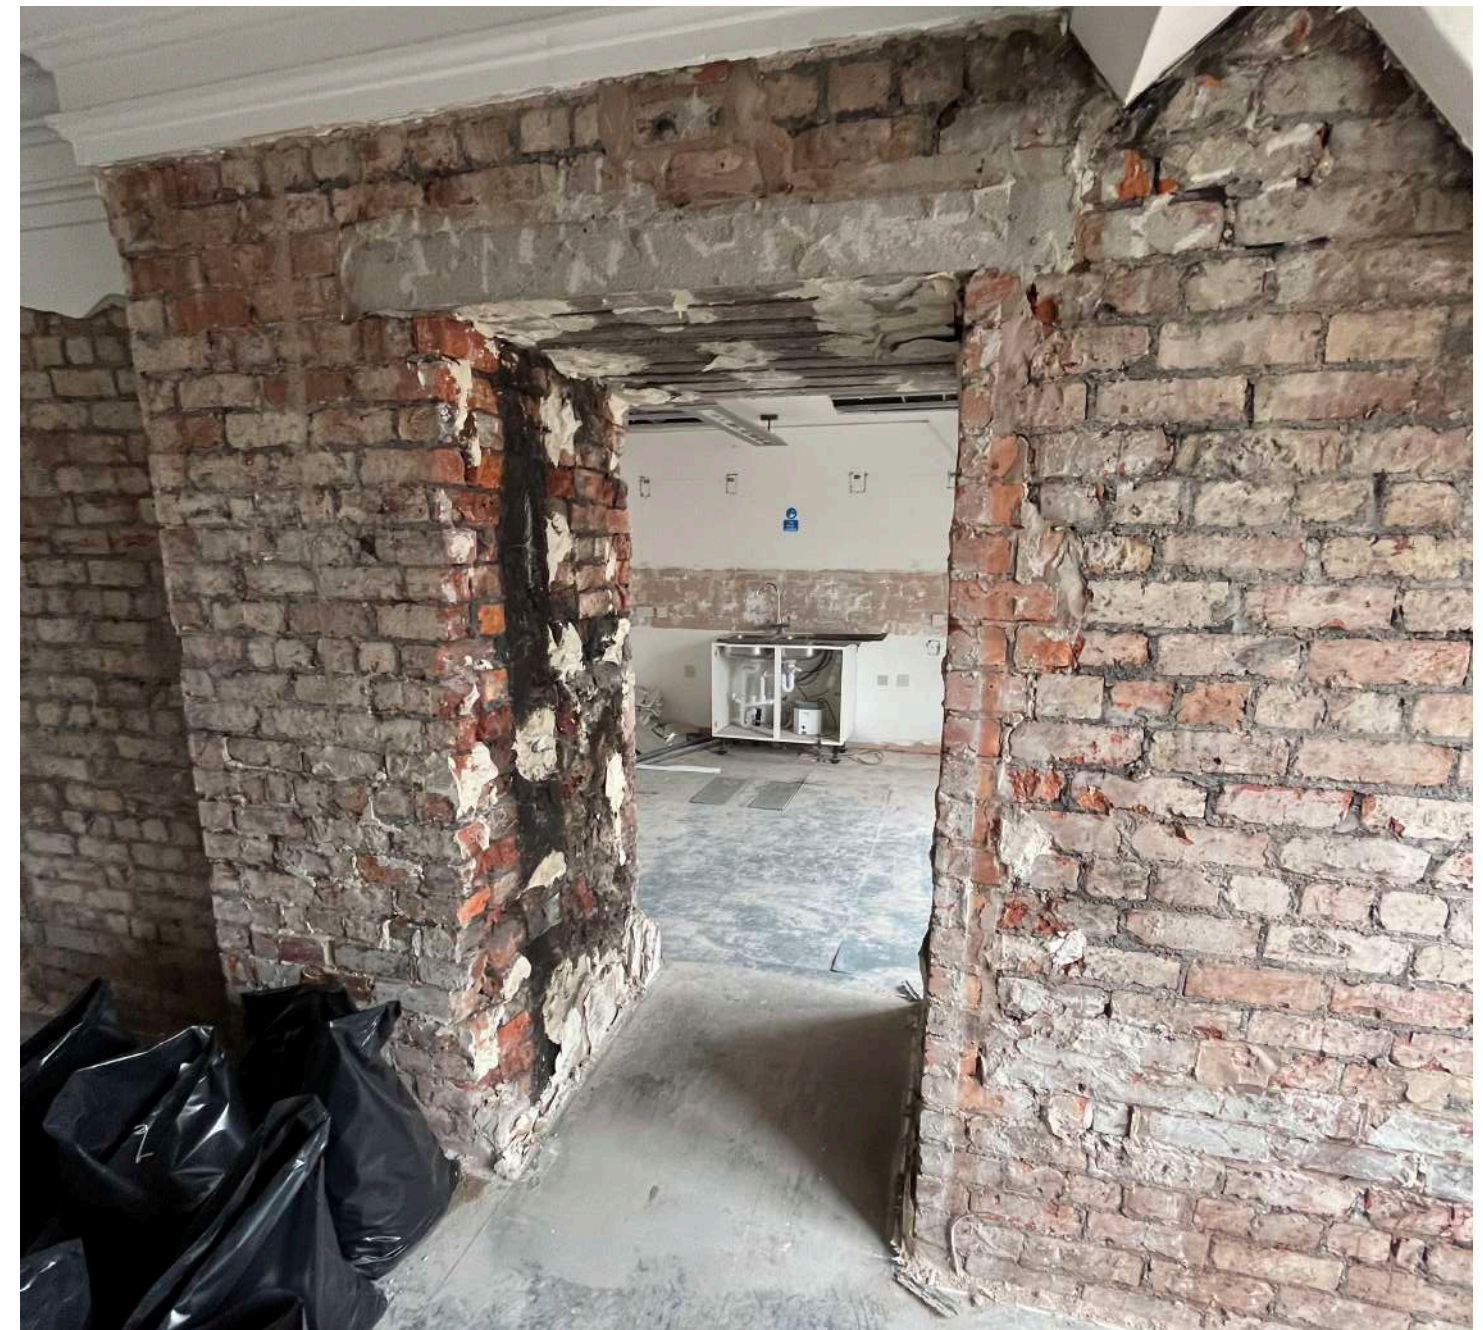
Structural intervention to chimney breast and former fire places uncovered following removal of non original plaster

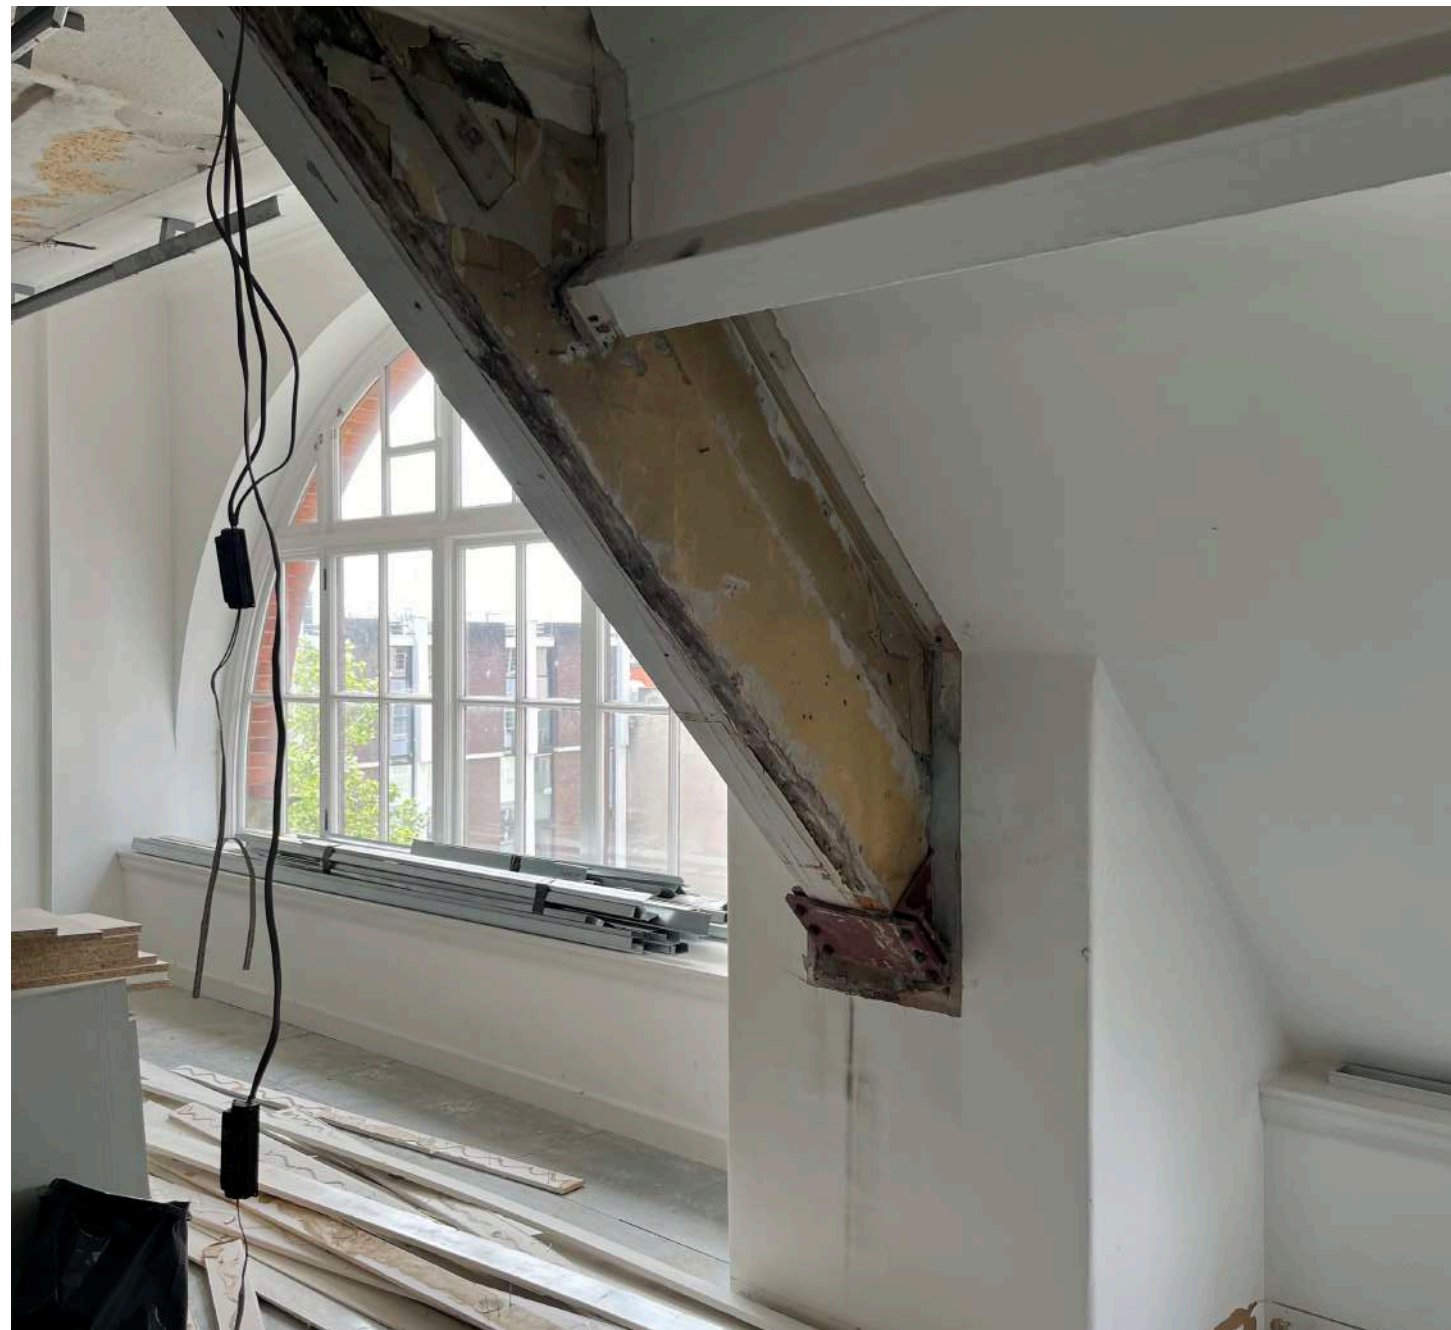
Earlier finishes, structural interventions and original cornicing exposed following non-original encasement removal

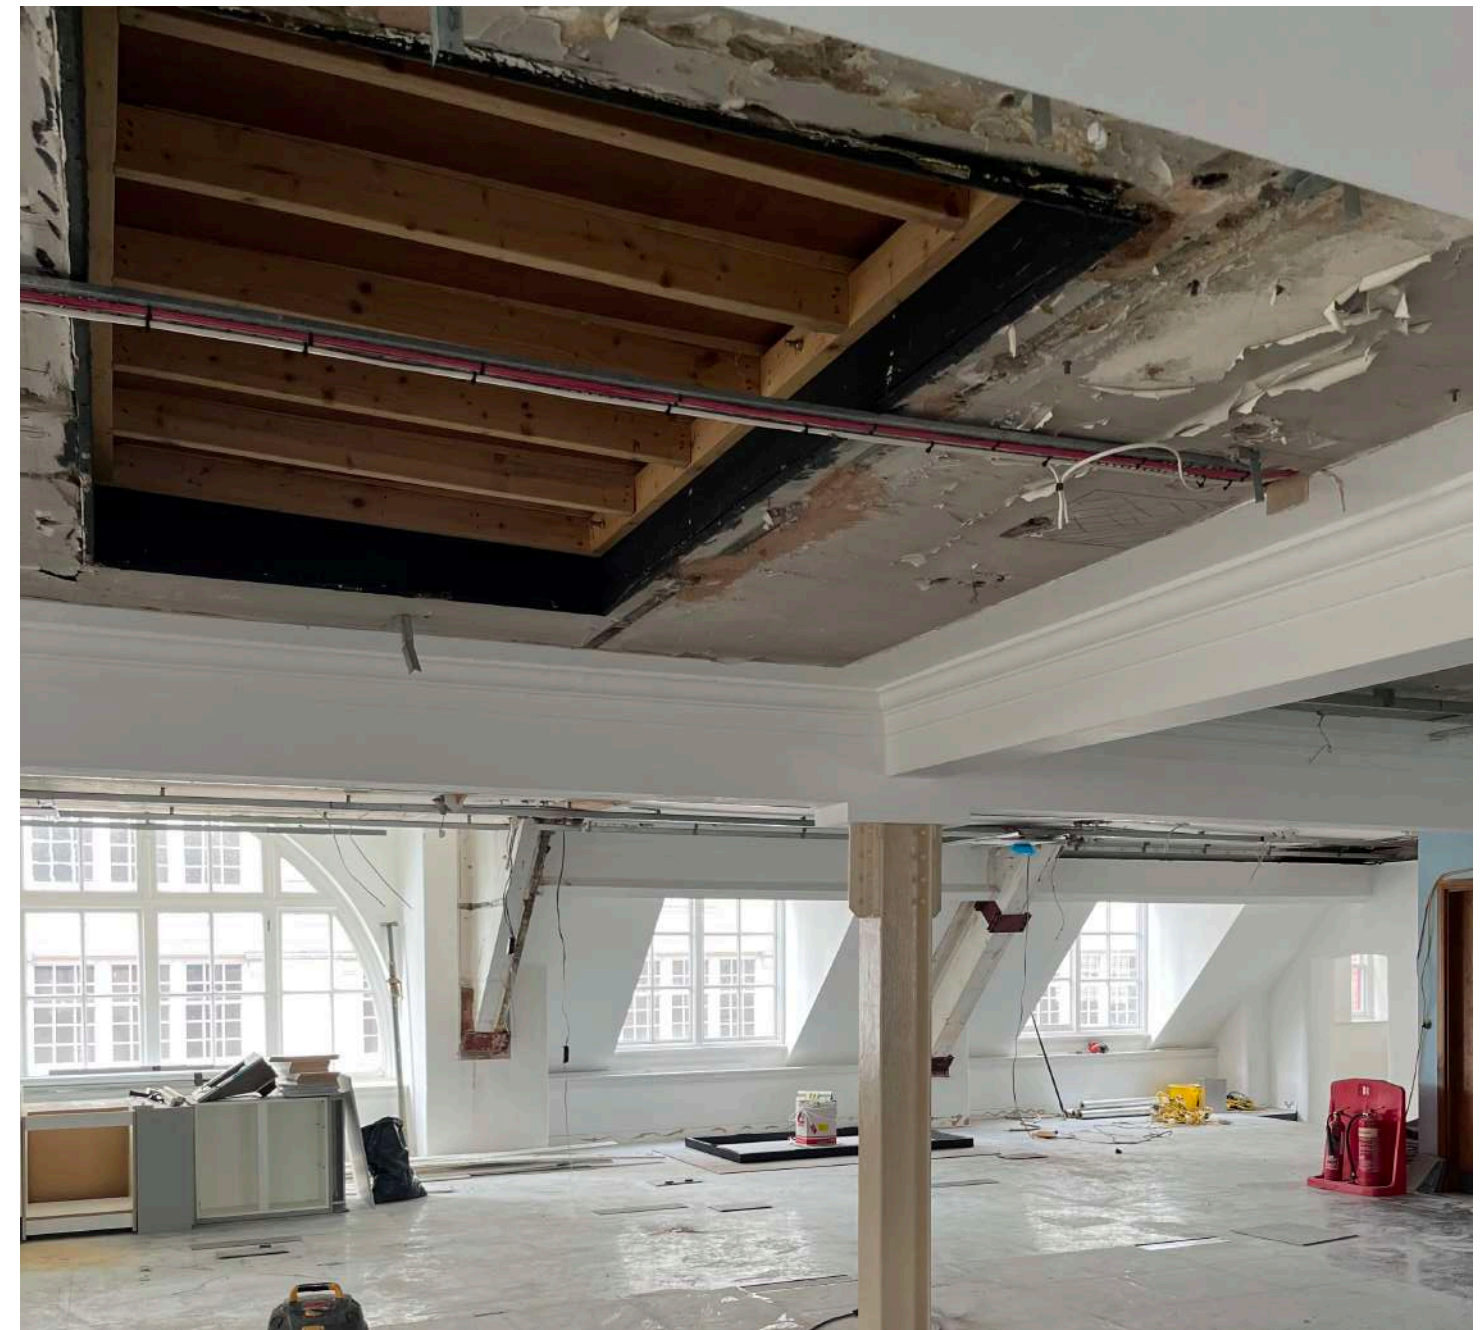
Original infilled rooflight openings uncovered to flat roof area of the building following drop ceiling removals.
