# Royal London House, 196 Deansgate

Schedule of Works & Method Statement - Level 5, Attic & Roof

July 2024

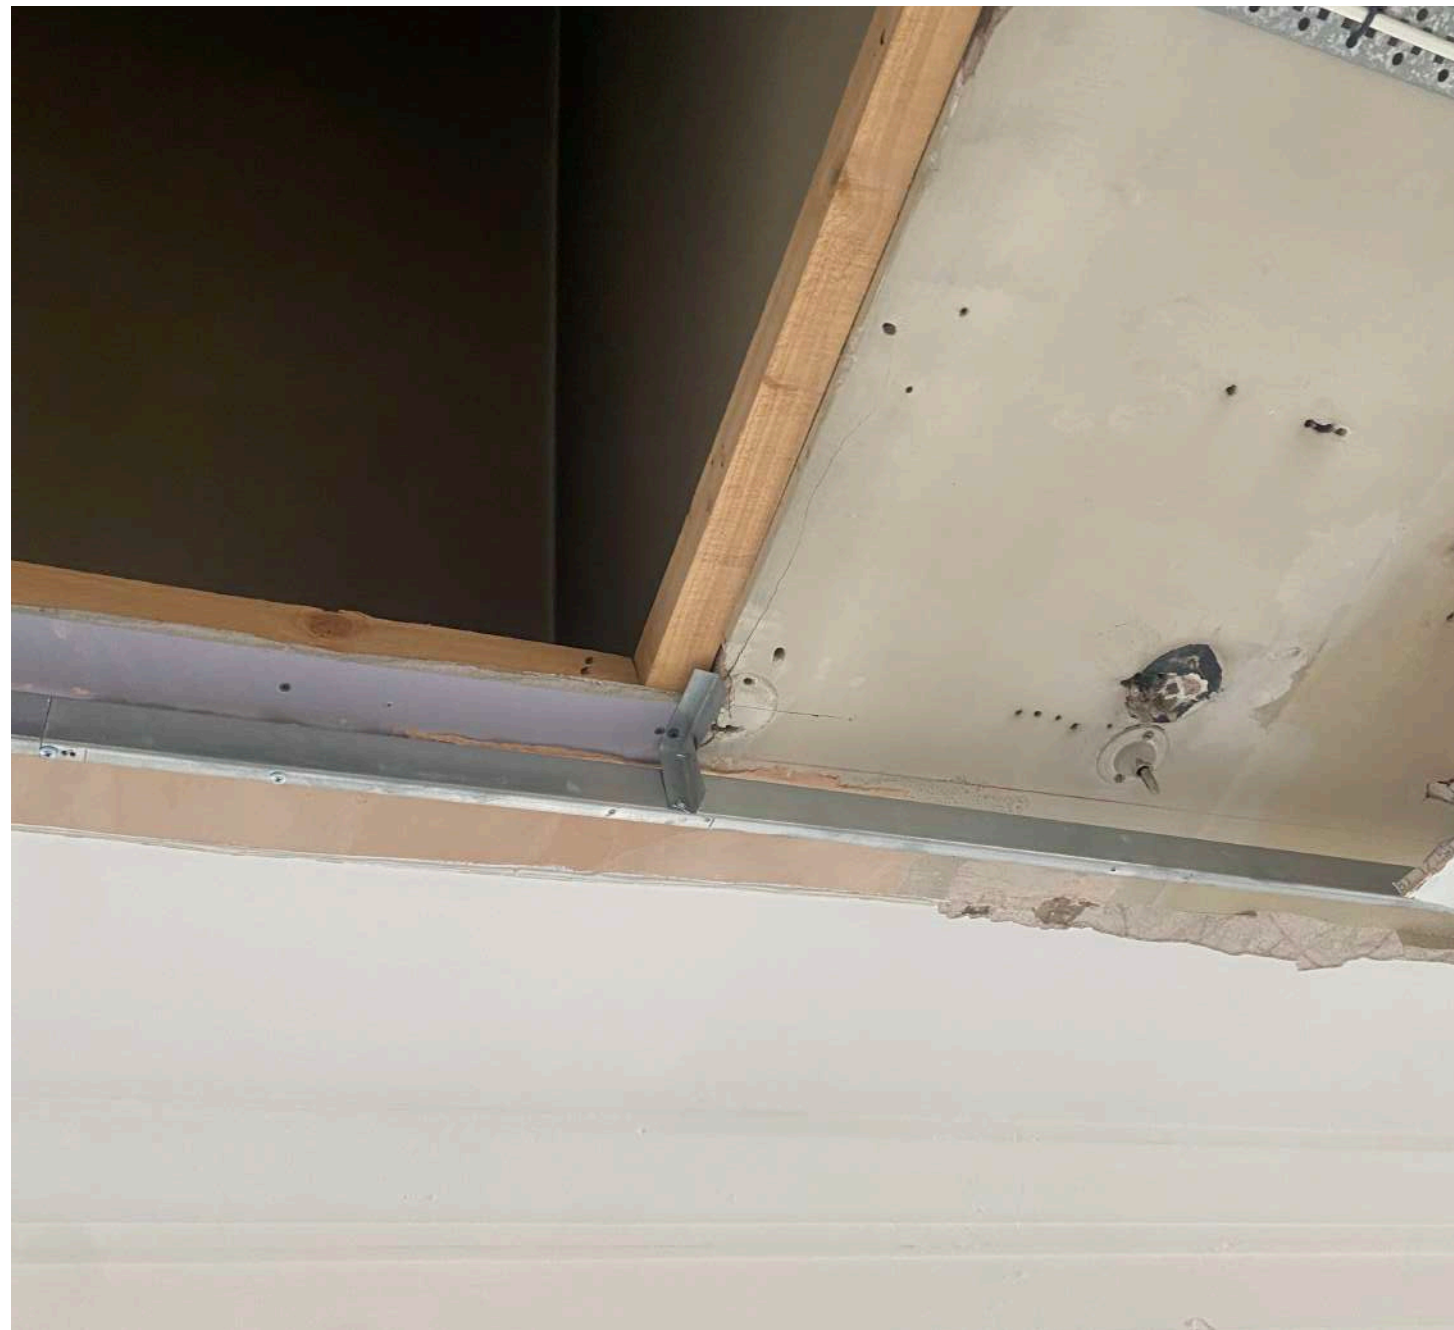
Partial infill and original plastered edge to original light shaft

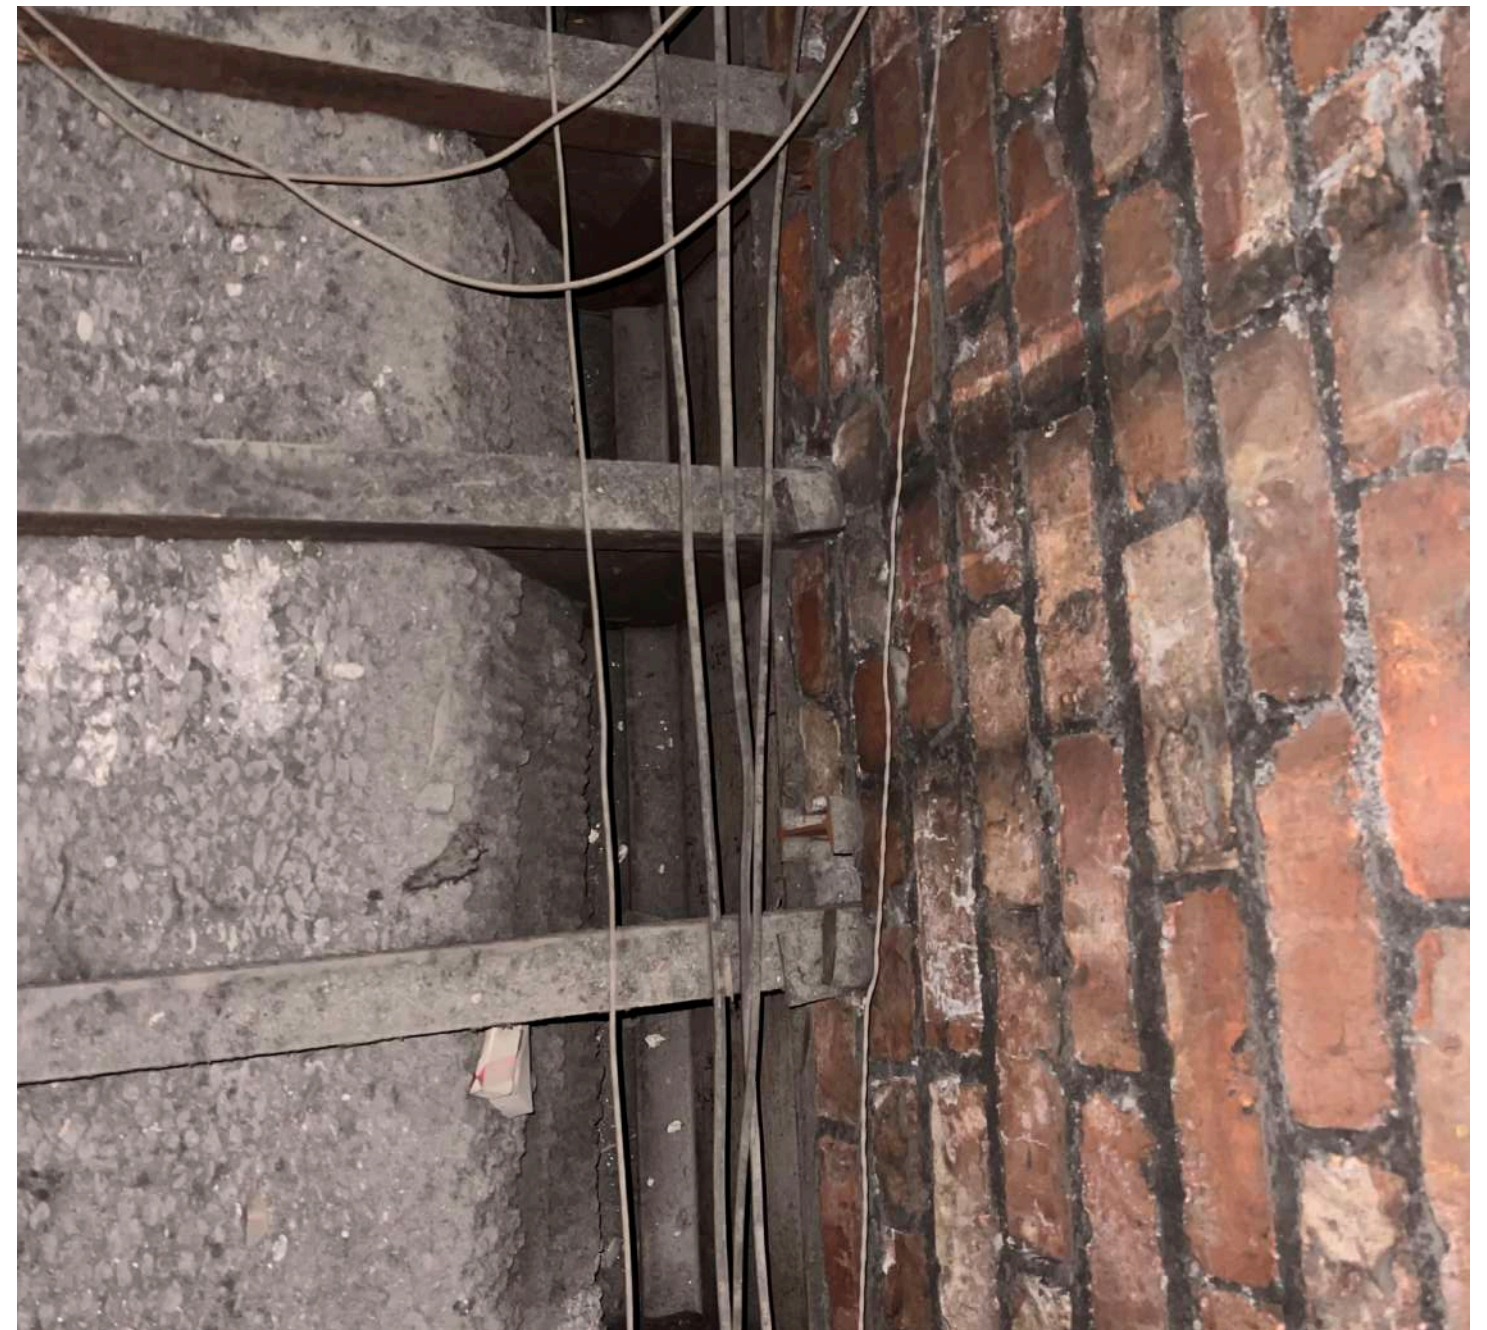
Upper side of beam and cornicing visible from within attic space
