22<sup>nd</sup> October 2024

## **Brunswick Mill, Manchester - Heritage Methodology: Condition 7 – Repair works to interior and exterior masonry and stonework**

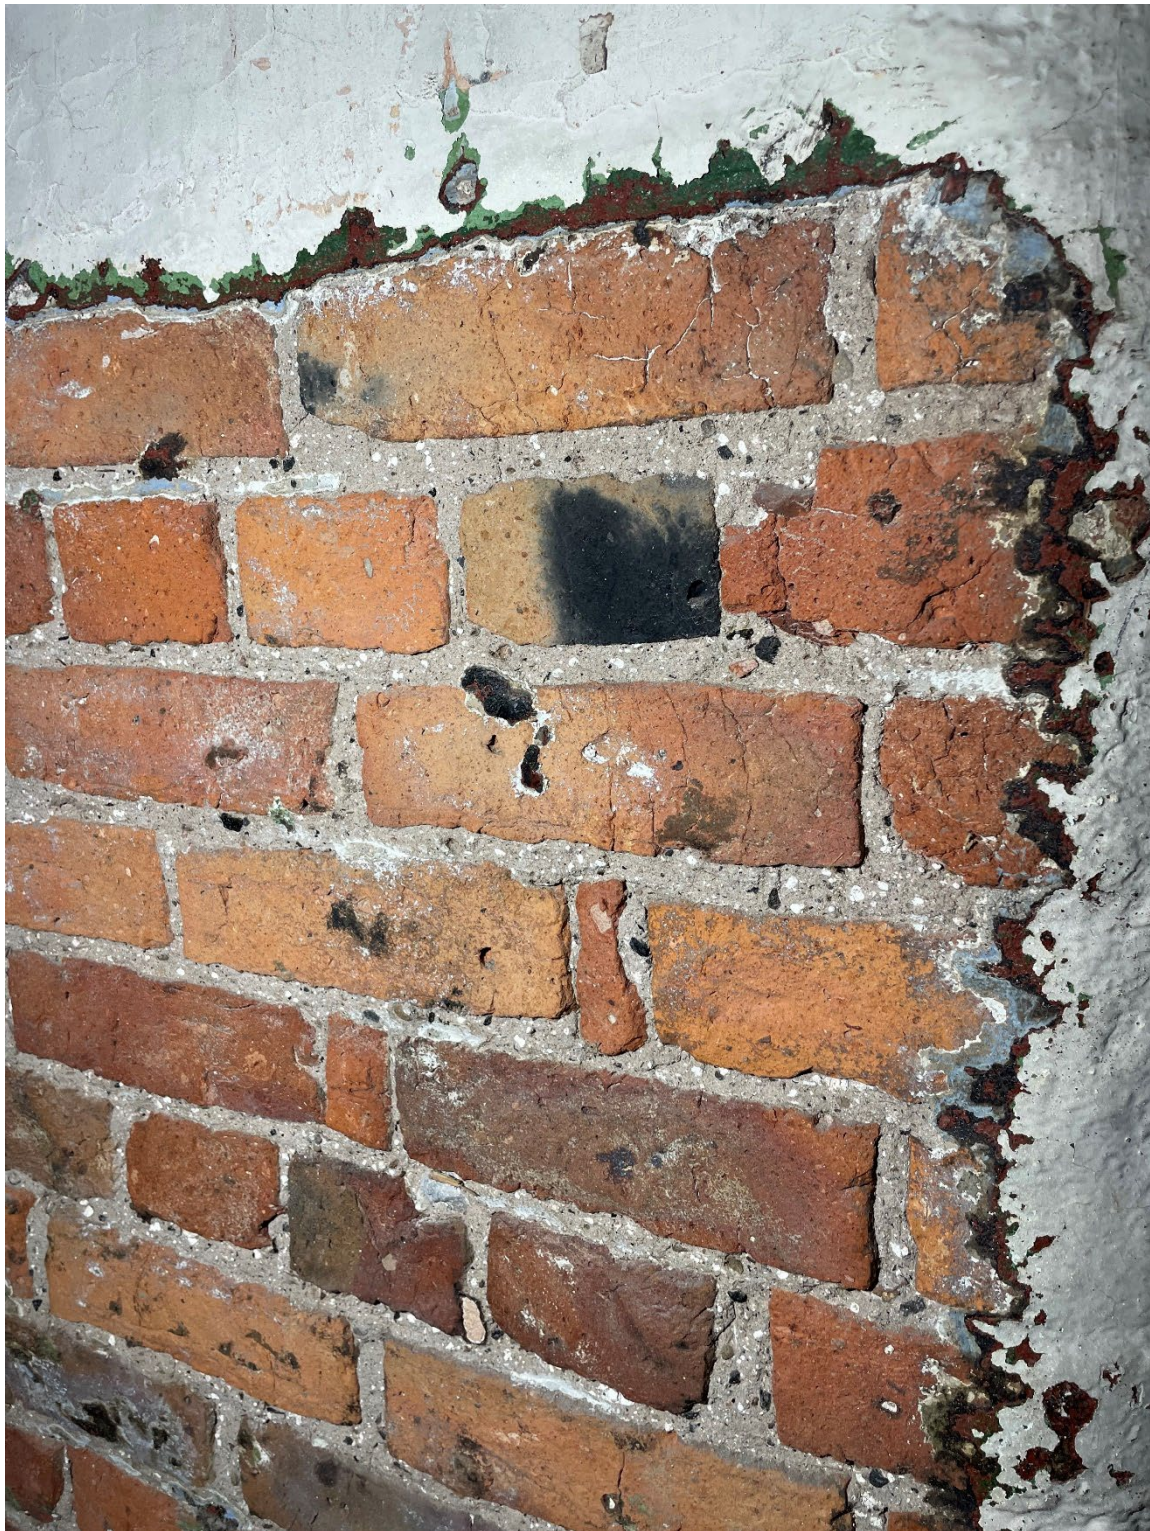
These trials successfully removed almost all paint layers from the internal brickwork and did not damage the face of the brick nor eat into the historic lime mortar, whilst allowing small particles of paint to remain within a number of gaps within the face of the brickwork.

*The resulting finish following the successful low-pressure shotblasting machine fitted with fine glass media process, which removed paint layers but retained small pockets of paint in undulations within the brick. This process did not damage the face of the brick nor the original lime mortar.*

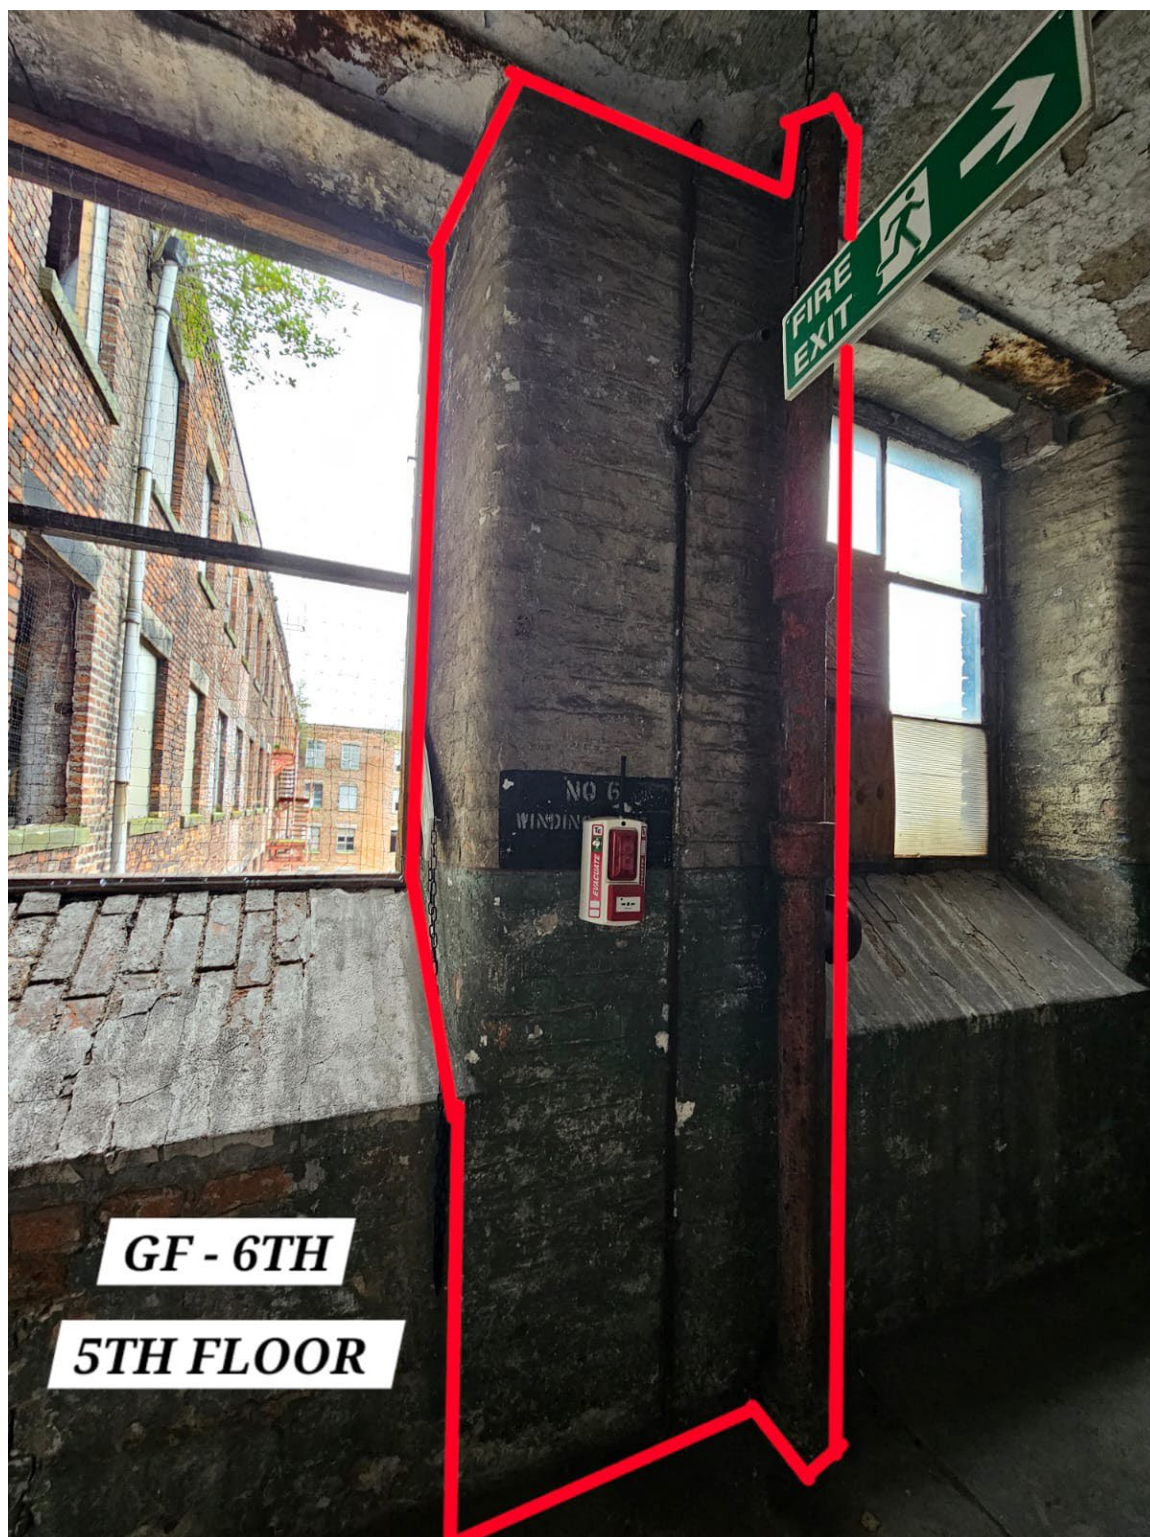
*East staircase - 5th floor. Early 20th century painted floor level sign for "No 7 Spinning Dept". The red outline denotes the extent of paint retention, which includes the pier from floor to ceiling, both returning reveals to either side, and the late-Victorian/Edwardian vertical red fire sprinkler pipe.*

In order to create a crisp line between the retained paintwork and the grit-blasted brickwork, timber boards should be secured to the walls/sills to create a straight and crisp line that will protect the paintwork from the grit-blasting procedure. It is likely this will largely concentrate on the junction between window reveal and window sill, so boarding can be wedged in place within the width of the reveal to avoid the need for fixings into the brickwork.

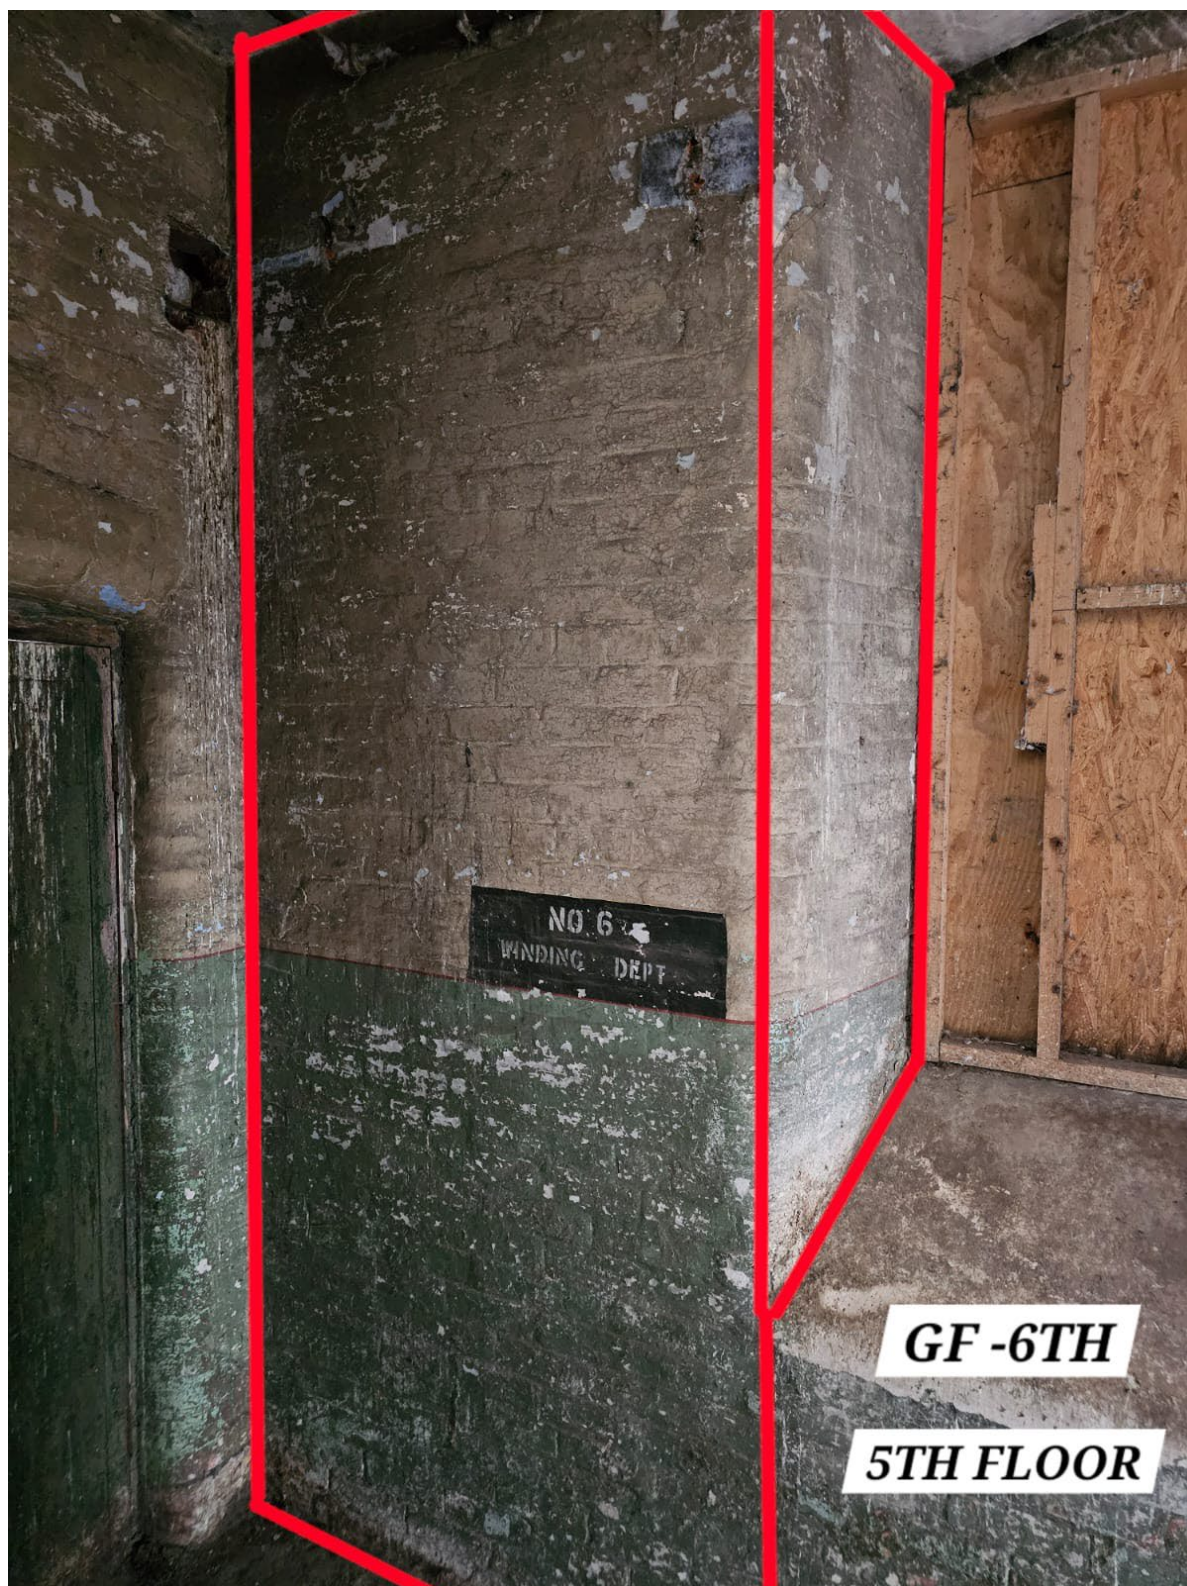
*West staircase - 5th floor. Early 20th century painted floor level sign for “No 6 Winding Dept”. The red outline denotes the extent of paint retention, which includes the pier from floor to ceiling and returning reveal to the window side.*

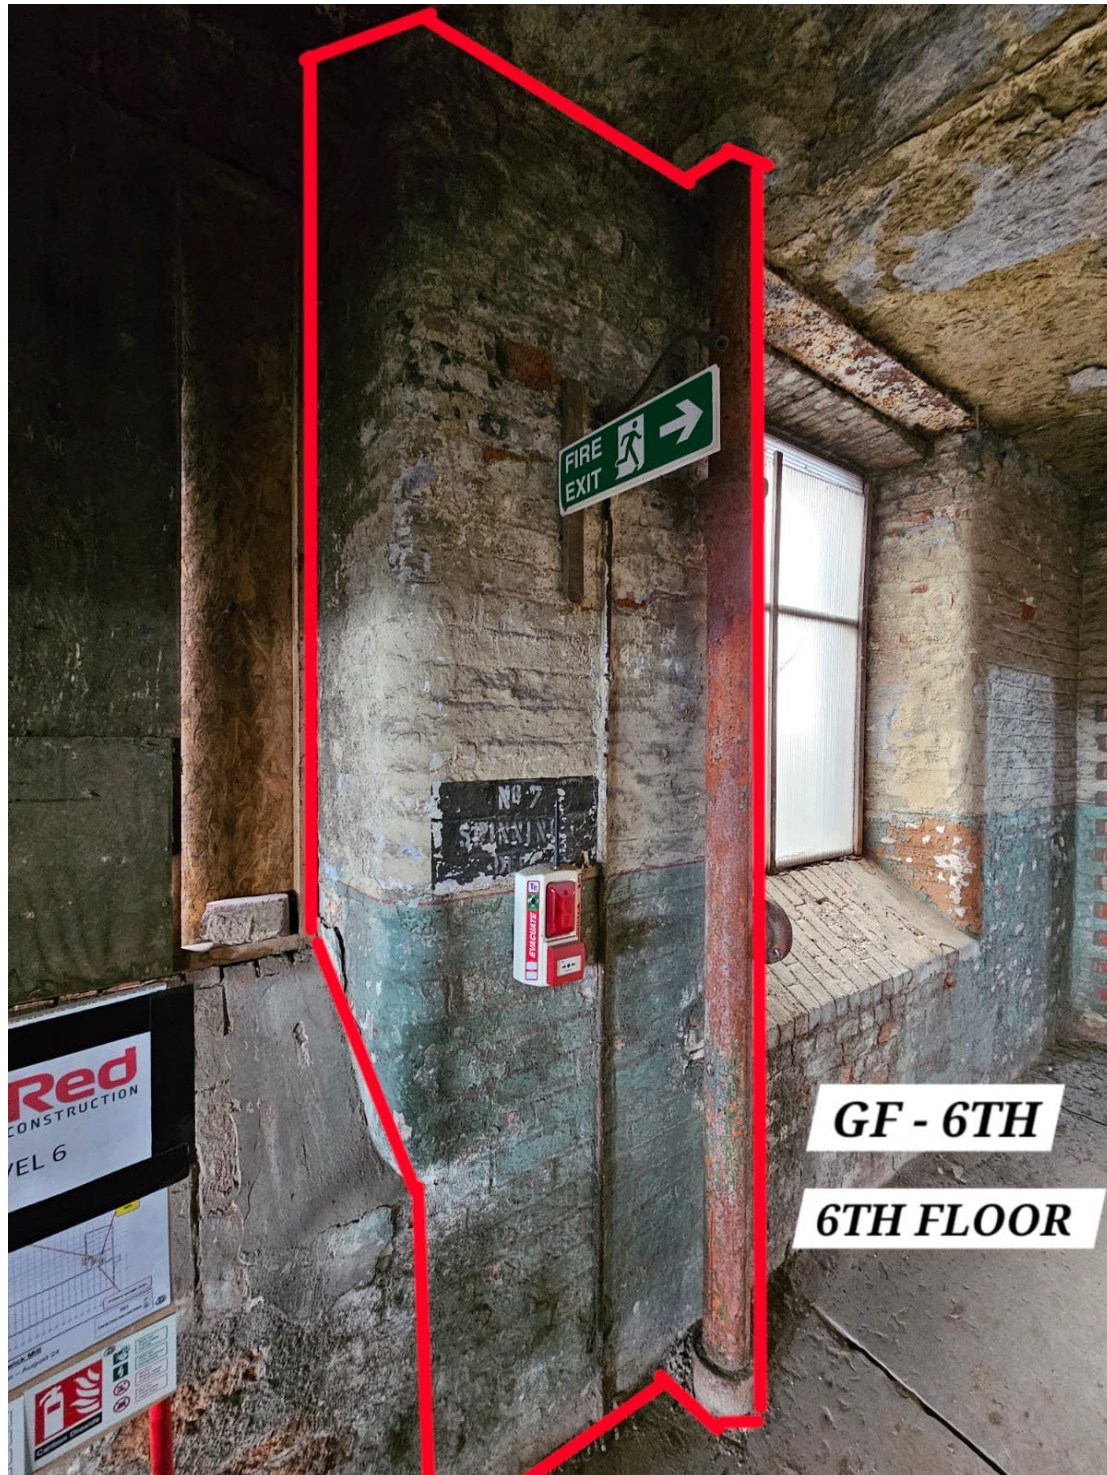
*East staircase - 6th floor. Early 20th century painted floor level sign for “No 7 Spinning Dept”. The red outline denotes the extent of paint retention, which includes the pier from floor to ceiling, both returning reveals to either side, and the late-Victorian/Edwardian vertical red fire sprinkler pipe.*

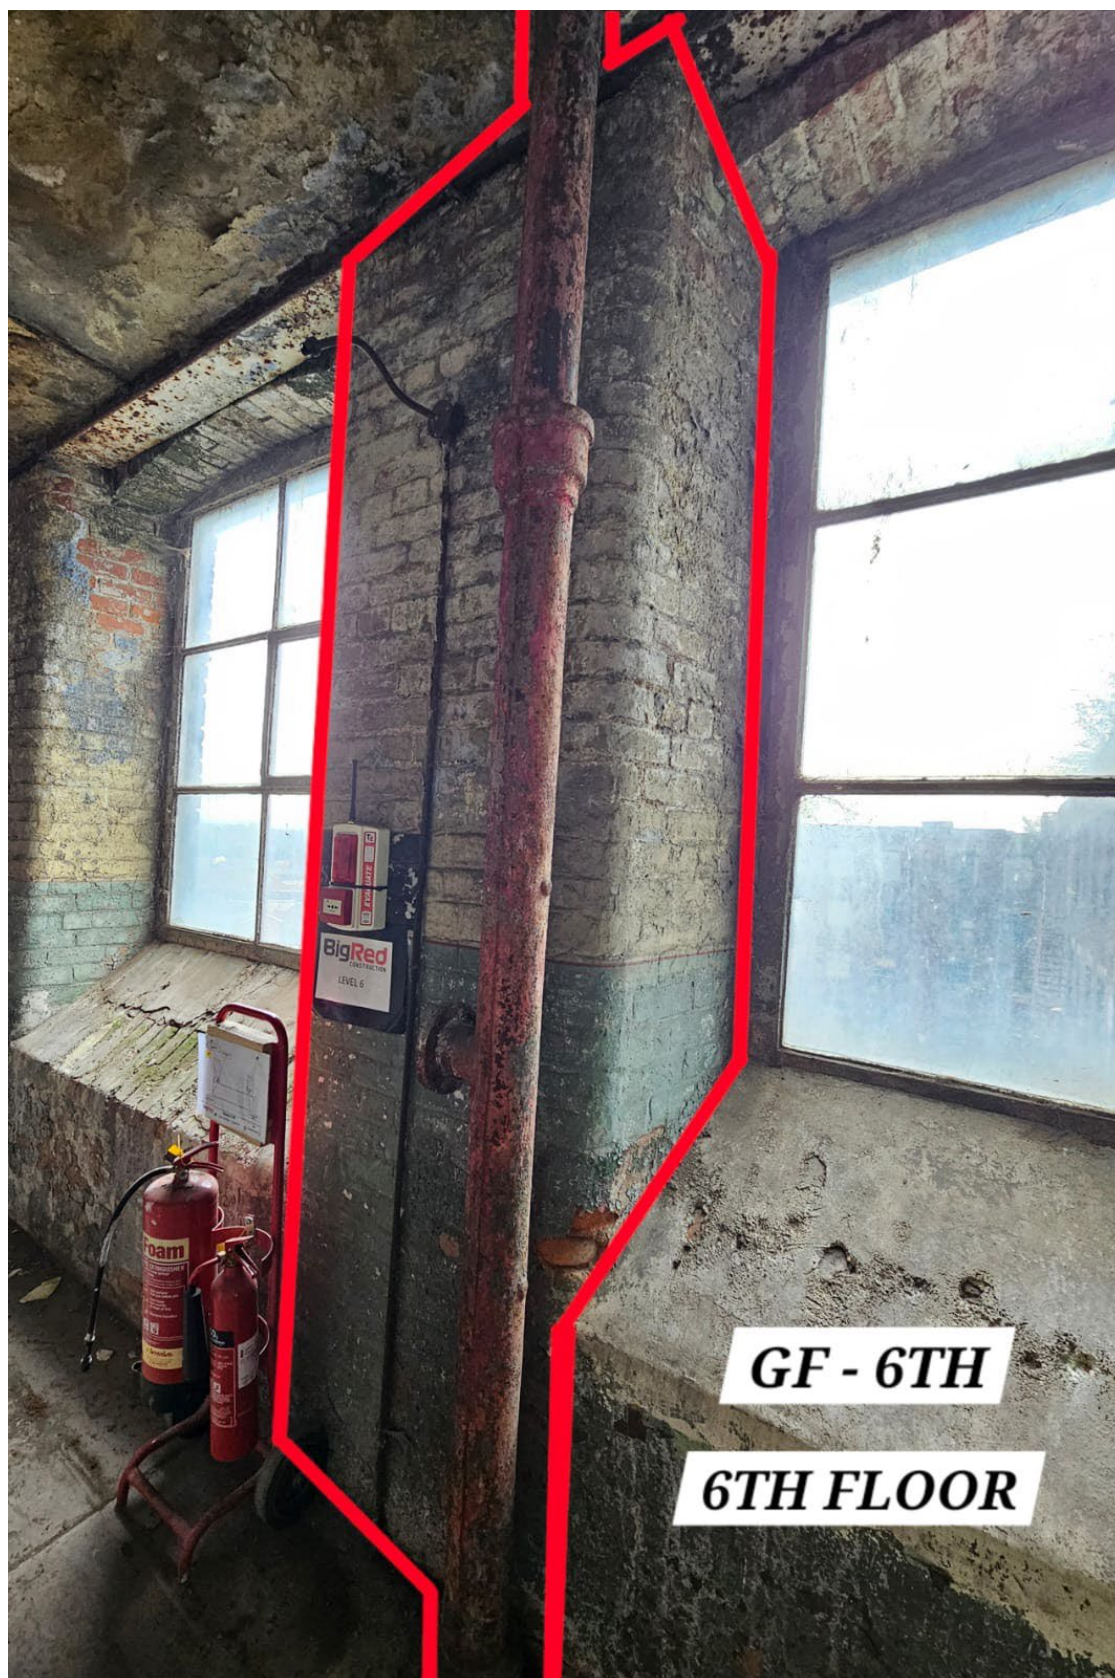
*West staircase - 6th floor. Early 20th century painted floor level sign for "No 7 Spinning Dept". The red outline denotes the extent of paint retention, which includes the pier from floor to ceiling, both returning reveals to either side, and the late-Victorian/Edwardian vertical red fire sprinkler pipe.*

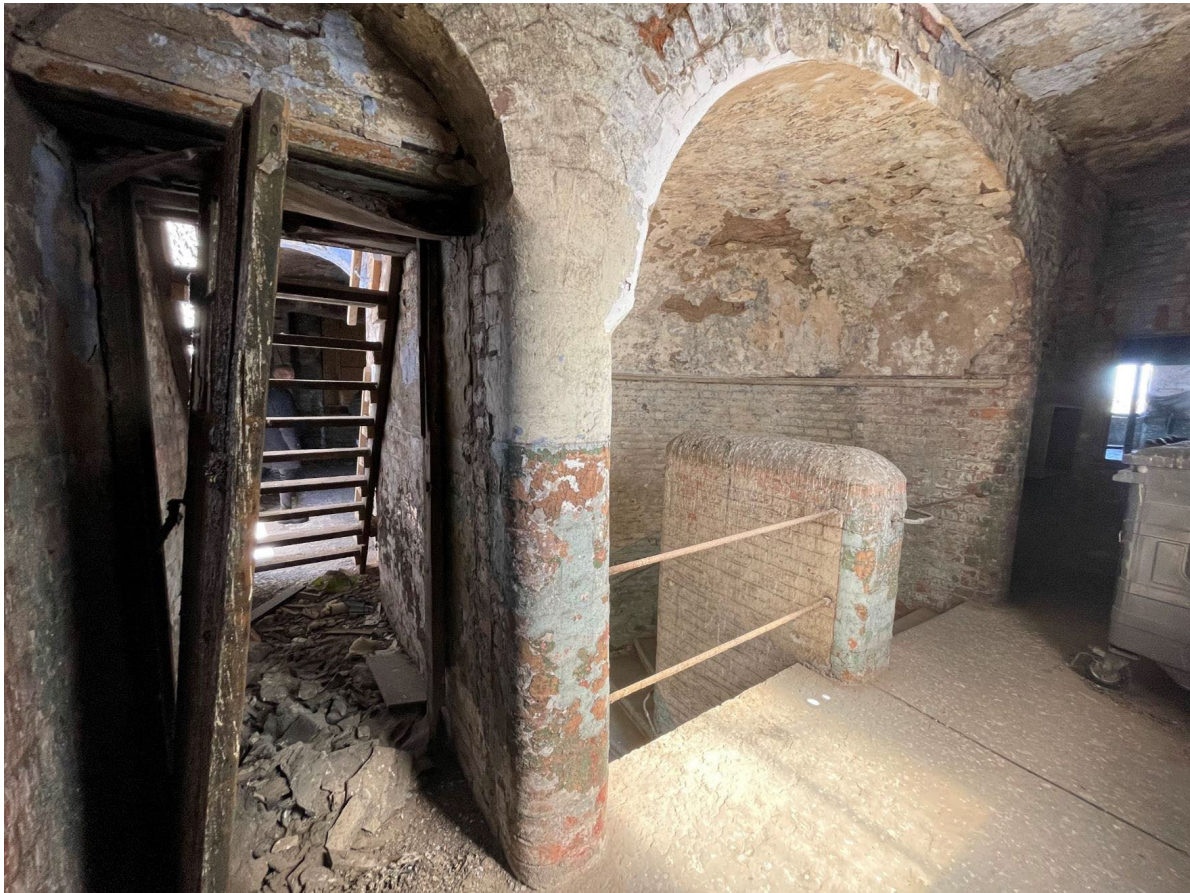
*The landing of the east staircase at 6<sup>th</sup> floor level, showing the original plastered domed ceiling of the staircase, which will be retained as part of the paint removal process.*

The two final areas of retention concentrate on areas of original lime plaster to the domed ceilings of the east and west staircases (at 6<sup>th</sup> floor level), which will be repaired/replastered as part of the consented scheme.

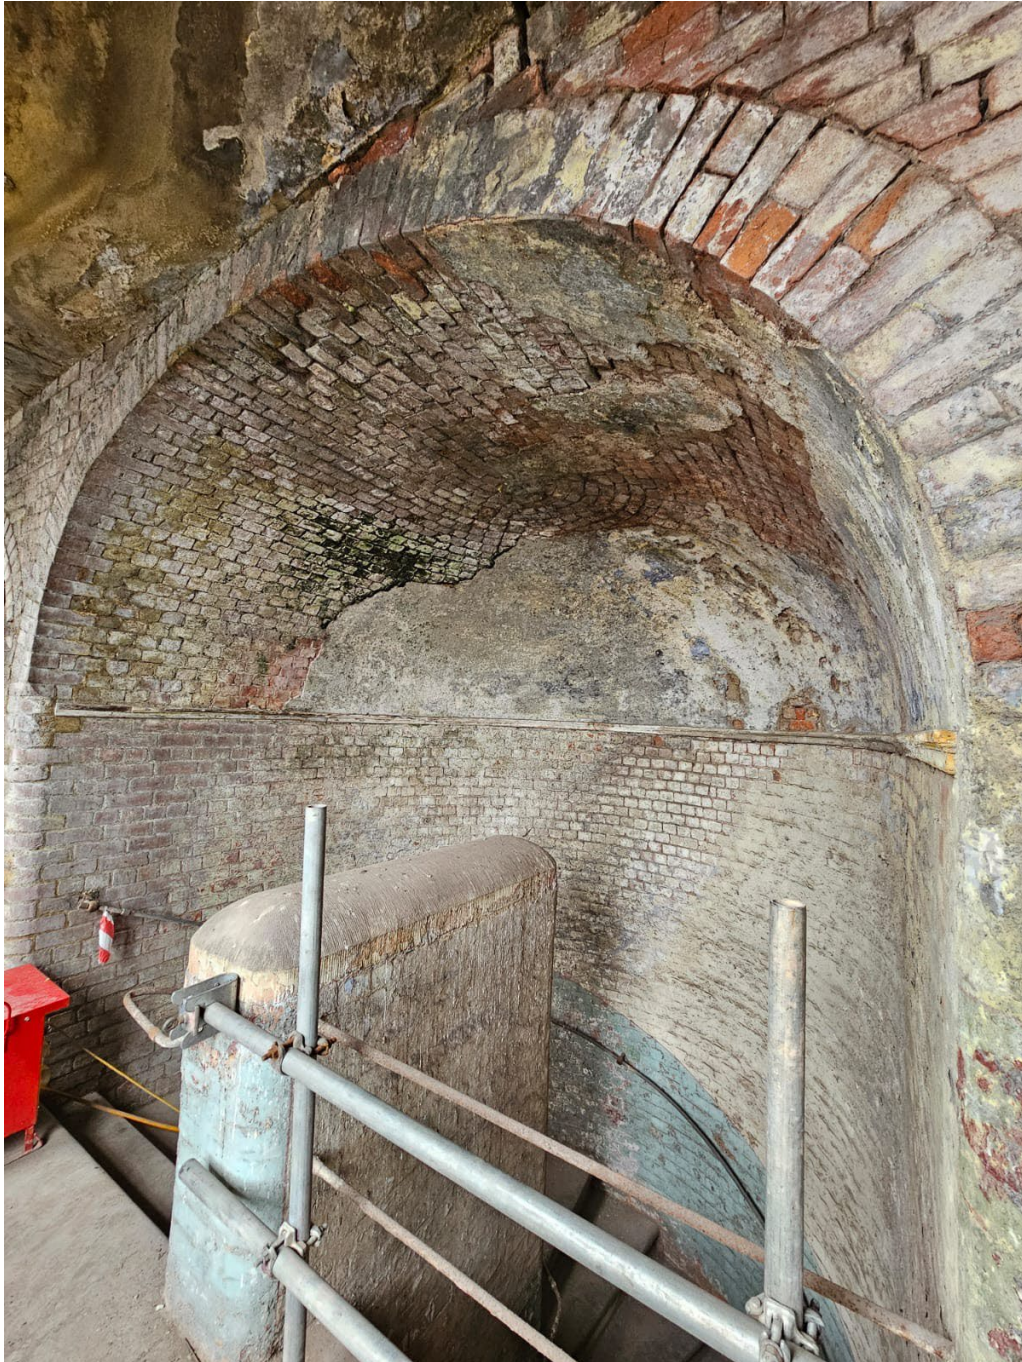
*The landing of the west staircase at 6<sup>th</sup> floor level, showing the remains of the original plastered domed ceiling of the staircase, which will be retained as part of the paint removal process.*

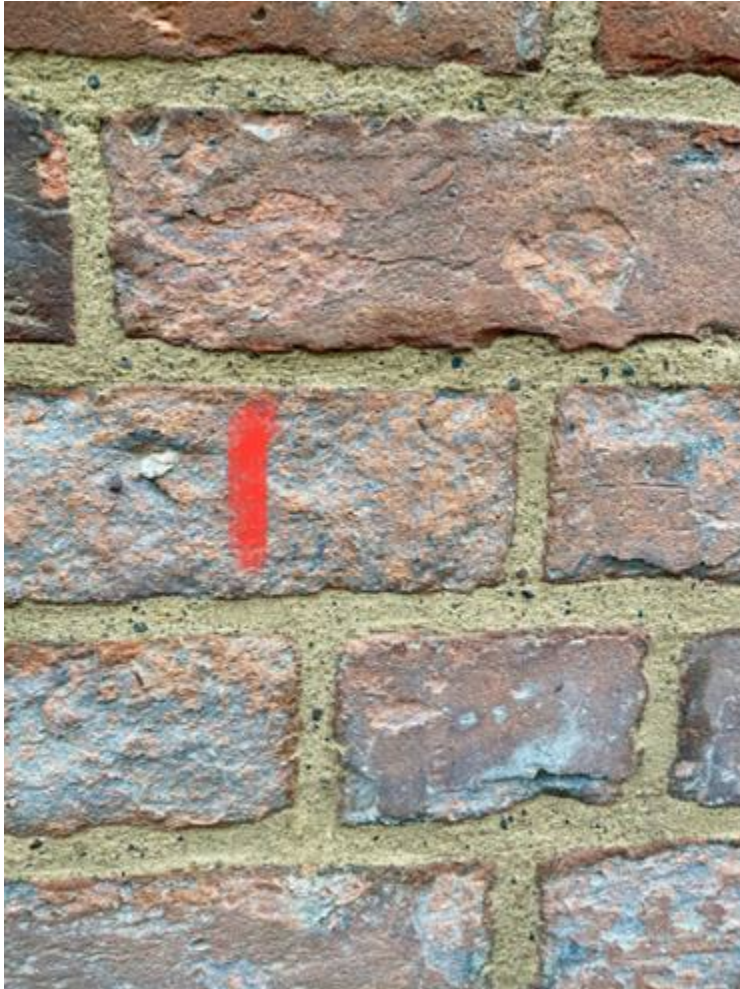
*Photo 1. 3 parts Nosterfield 1 part Sherbourne and 1 part NHL 3.5*

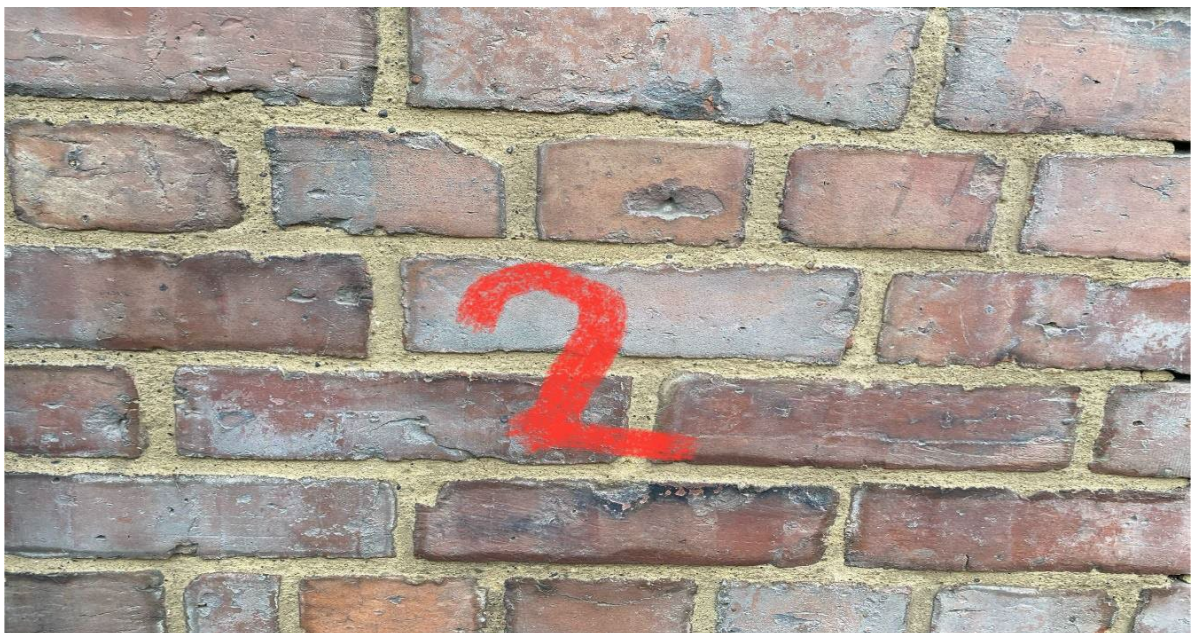
Out of the three samples, it is considered that the sample shown in photo 2, containing 3 parts Sherbourne 1 part Nosterfield 1 part NHL 3.5, provides the closest visual match to the original 1840s mortar mix in terms of colour and aggregate.

*Photo 2. 3 parts Sherbourne 1 part Nosterfield 1 part NHL 3.5. (preferred option)*

When applying the chosen lime mortar mix, the areas of brickwork will be dampened down with mortar being firmly pushed into the joint as deeply as possible and left to start curing. The mortar will then be tamped back with a stiff brush and lightly brushed off to allow the aggregate in the mortar to become exposed.

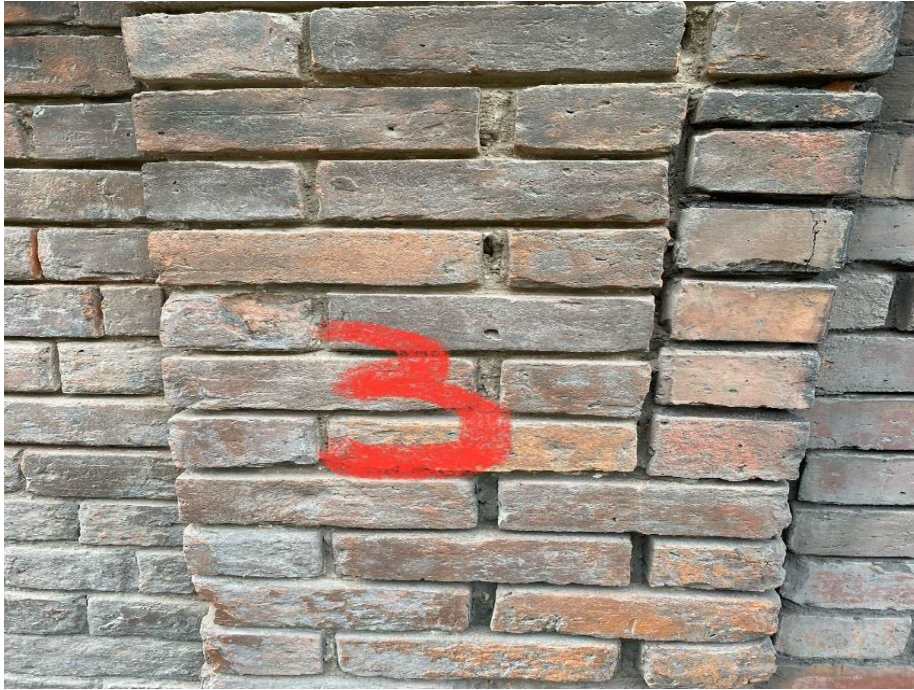
*Photo 3 - Raked out cutting through the centre of the mortar with a thin blade and then taken out the mortar using handheld tools to the required depth and brushed out leaving the area clean.*

Consequently, it is considered that it will create less brick damage to run a cut through the centre of the mortar using a 2mm diamond blade was used to cut through the centre of the mortar and then use hand tools to remove the modern mortar.

The raking out will be carried out to a depth of not more than twice the width of the joint and any loose matter or materials will be brushed out of the joint leaving the area clean and washed out using a water spray to allow for repointing.

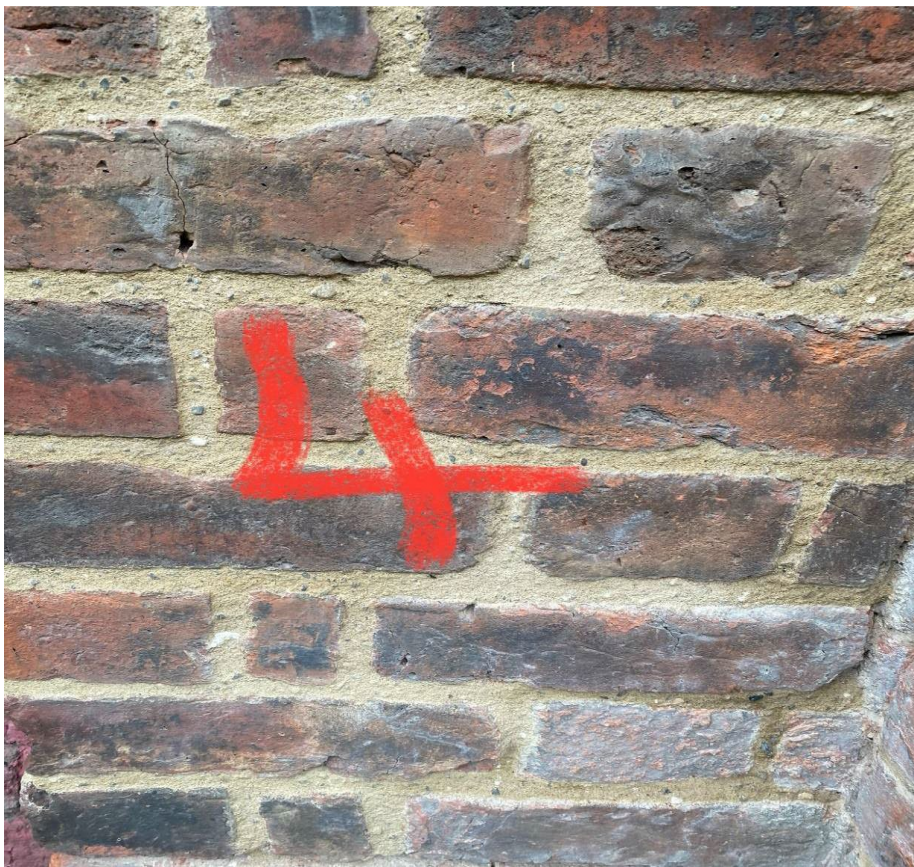
*Photo 4. parts 2 Sherbourne 2 parts Leighton Buzzard 1 part NHL 3.5.*
