# Reception Slab Condition

| Project Name | | Sunlight House | |
| Sketch Title | | Ground Floor Reception Slab Condition Report | |
| Project No. | 24131 | Sketch No. | SLH-EOC-RP-240919 |

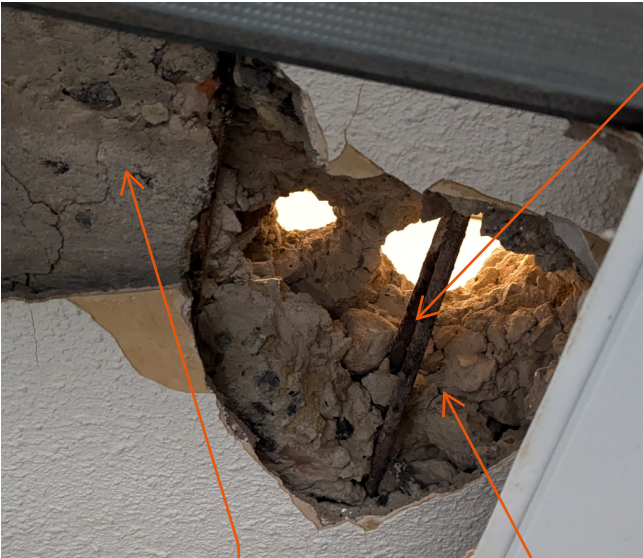
**Observation:**  
Reinforcement bars are currently exposed.  
**Recommendation:**  
Use appropriate primer to protect steel bars prior to mortar repair.

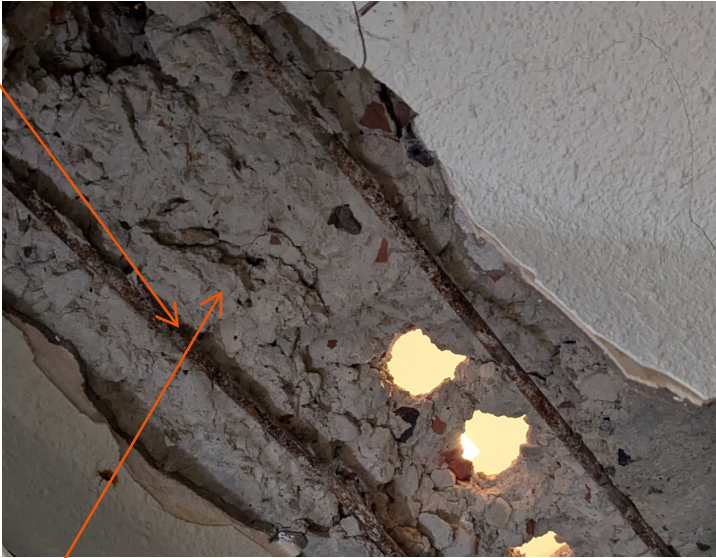
**Observation:**  
Concrete dislodged during screed removal works, concrete appears to be cracked and loose.  
**Recommendation:**  
Locally break out loose and cracked concrete, and repair using appropriate mortar repair.

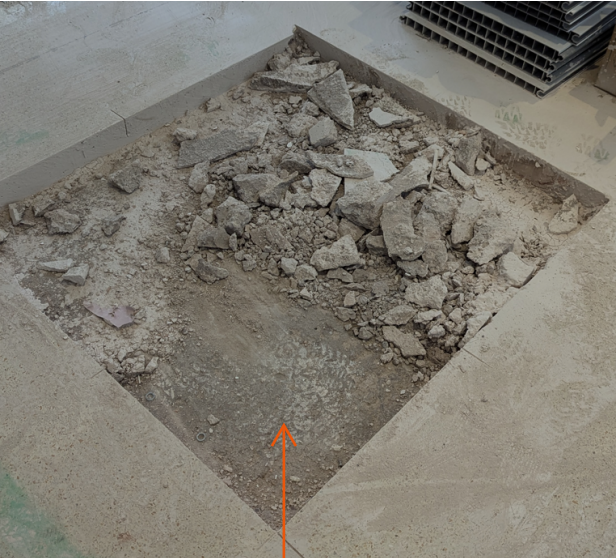
**Observation:**  
The above photo shows the condition of reception slab surface. The revised screed removal approach does not impose additional structural distress visually, no apparent crack formed. It is acceptable by inspection.

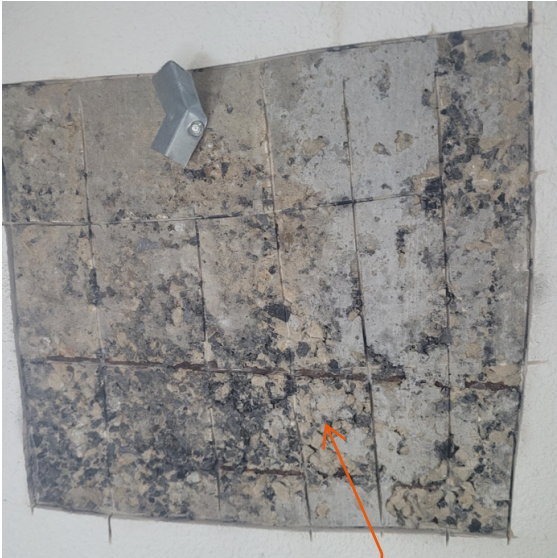
**Observation:**  
At the underside of structural slab, ceiling was removed and concrete slab was exposed. Although there is no evidence of any crack formed that originated from screed removal, existing concrete appeared to have a rough surface potentially from poorly compacted concrete during original construction. Reinforcement bars were exposed.  
**Recommendation:**  
Use mortar repair product to provide additional cover. Pending to phase 2 confirmation of usage for durability and fire requirement.

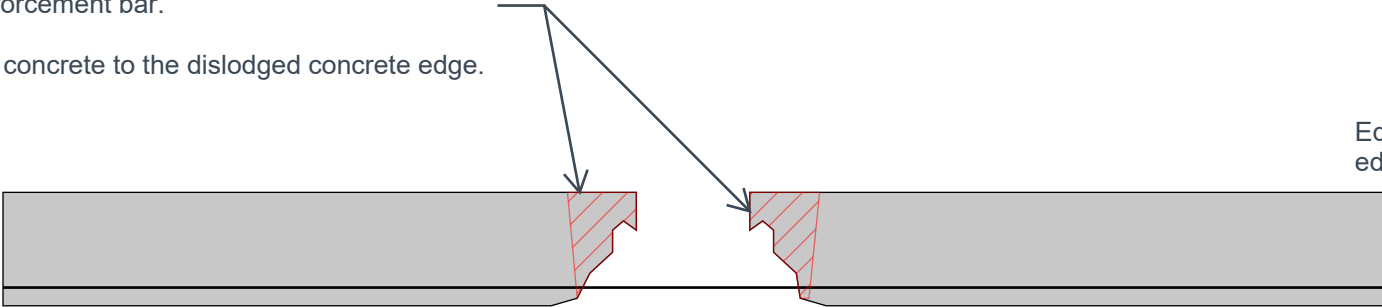
Remaining concrete portion of existing slab appears to be cracked. Portion to be broken out carefully and not disturbing the reinforcement bar.

Break out cracked concrete to the dislodged concrete edge.

Edge of breakout, to the edge of dislodged concrete.

Cracked Concrete breakout location
