## SITE VISIT REPORT

| Project: | Manchester College Phase 2 | Job No. | 60594458 |

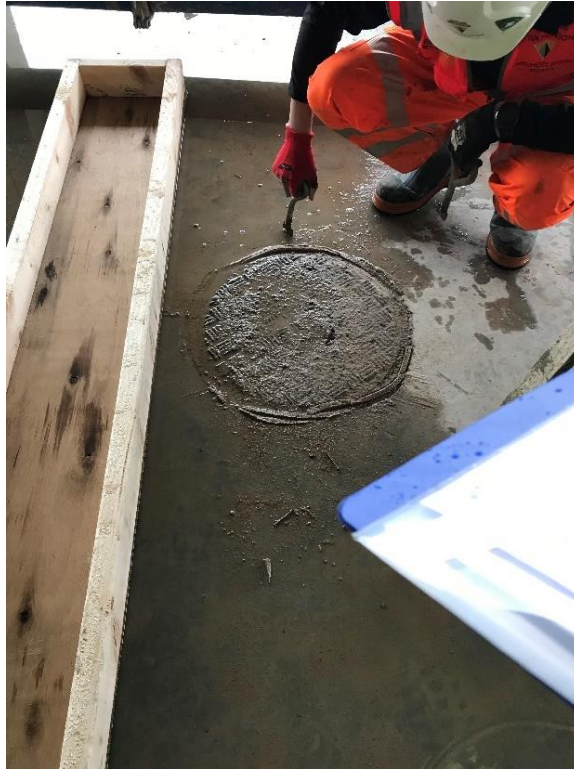
11. P2 FW MH4 – Manhole lid could not be lifted

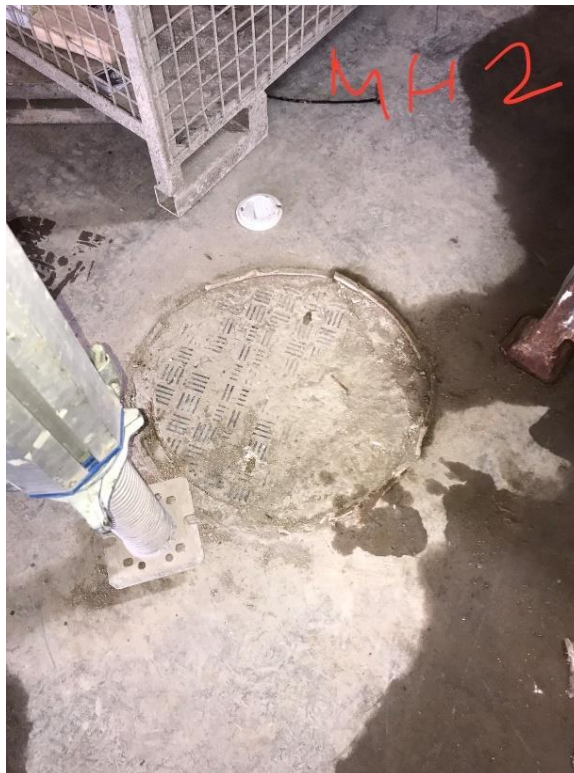
12. P2 FW MH2 – Manhole lid could not be lifted

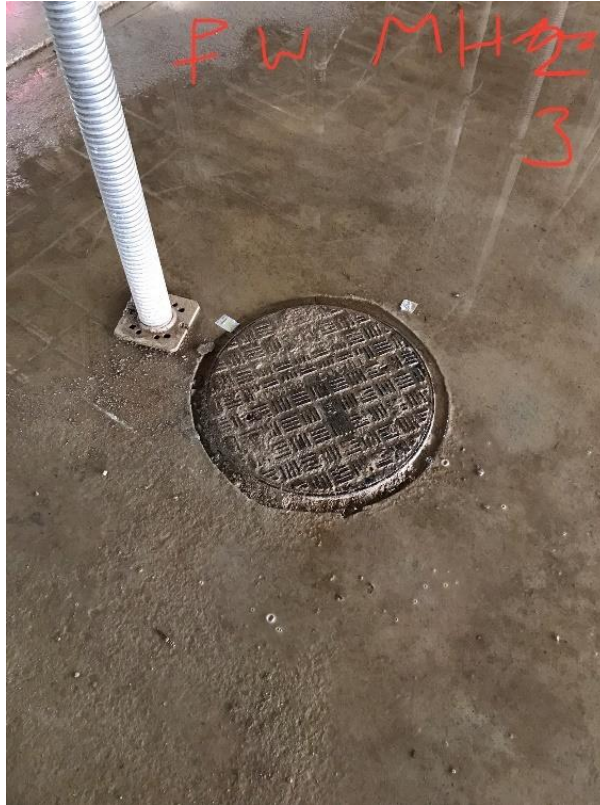
13. P2 FW MH3 – Manhole lid could not be lifted
