## Ground Improvement Risk Assessment

Louisa Street

Openshaw

**Report Ref: A4755/22/GRA/V2**

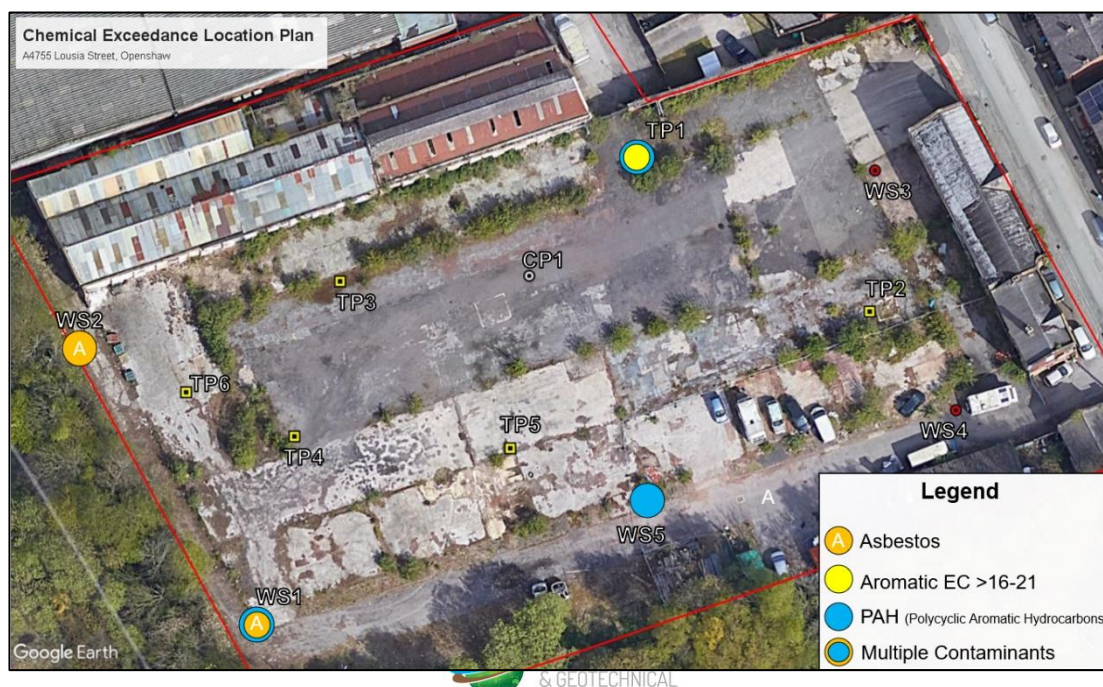
**Figure 1 Chemical Exceedance Location Plan**

Eleven contaminant concentrations were found in exceedance of the screening criteria relevant to a Residential End Use.

The samples with identified contaminant exceedances include WS1 at 0.30m, WS5 at 0.65m, and TP1 at 0.40m.

The contaminants found in exceedance of the screening criteria relevant to a Residential End Use with Plant Uptake include Petroleum Hydrocarbon Aromatic EC >16-21 and several Polycyclic Aromatic Hydrocarbons: Benzo(a)anthracene, Chrysene, Benzo(a)pyrene, Benzo(b)fluoranthene and Dibenzo (a, h) anthracene.

Elevated Naphthalene, which is volatile, was identified at WS1 (0.30m).

Follow up testing on the 8<sup>th</sup> September 2023 found these hotspots to be free of the previously identified contamination due to removal of the material during the archaeological excavations.

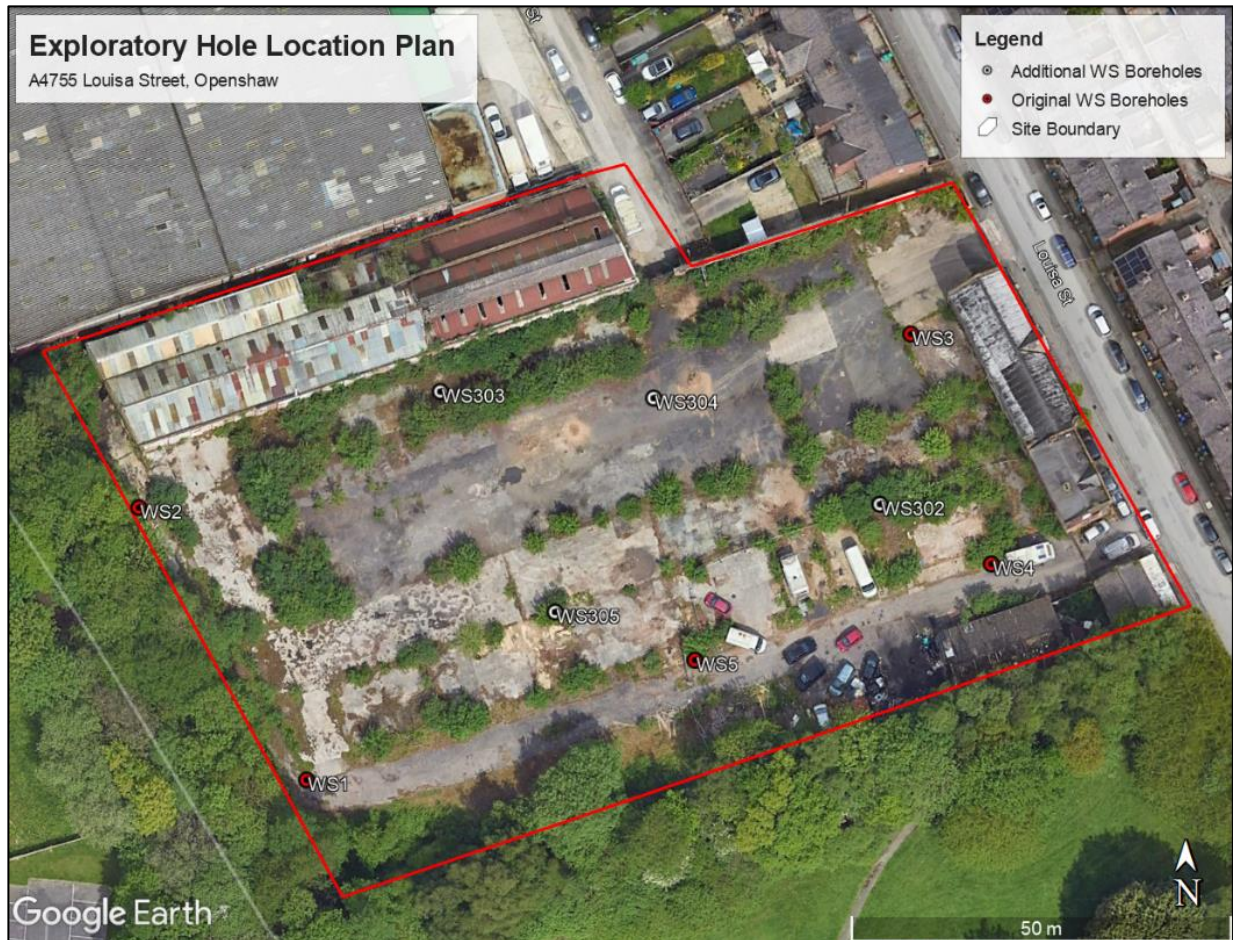
**Figure 4 Location of Boreholes WS302 to WS305**

No significant contamination was encountered and the risk to controlled waters was considered to be low.

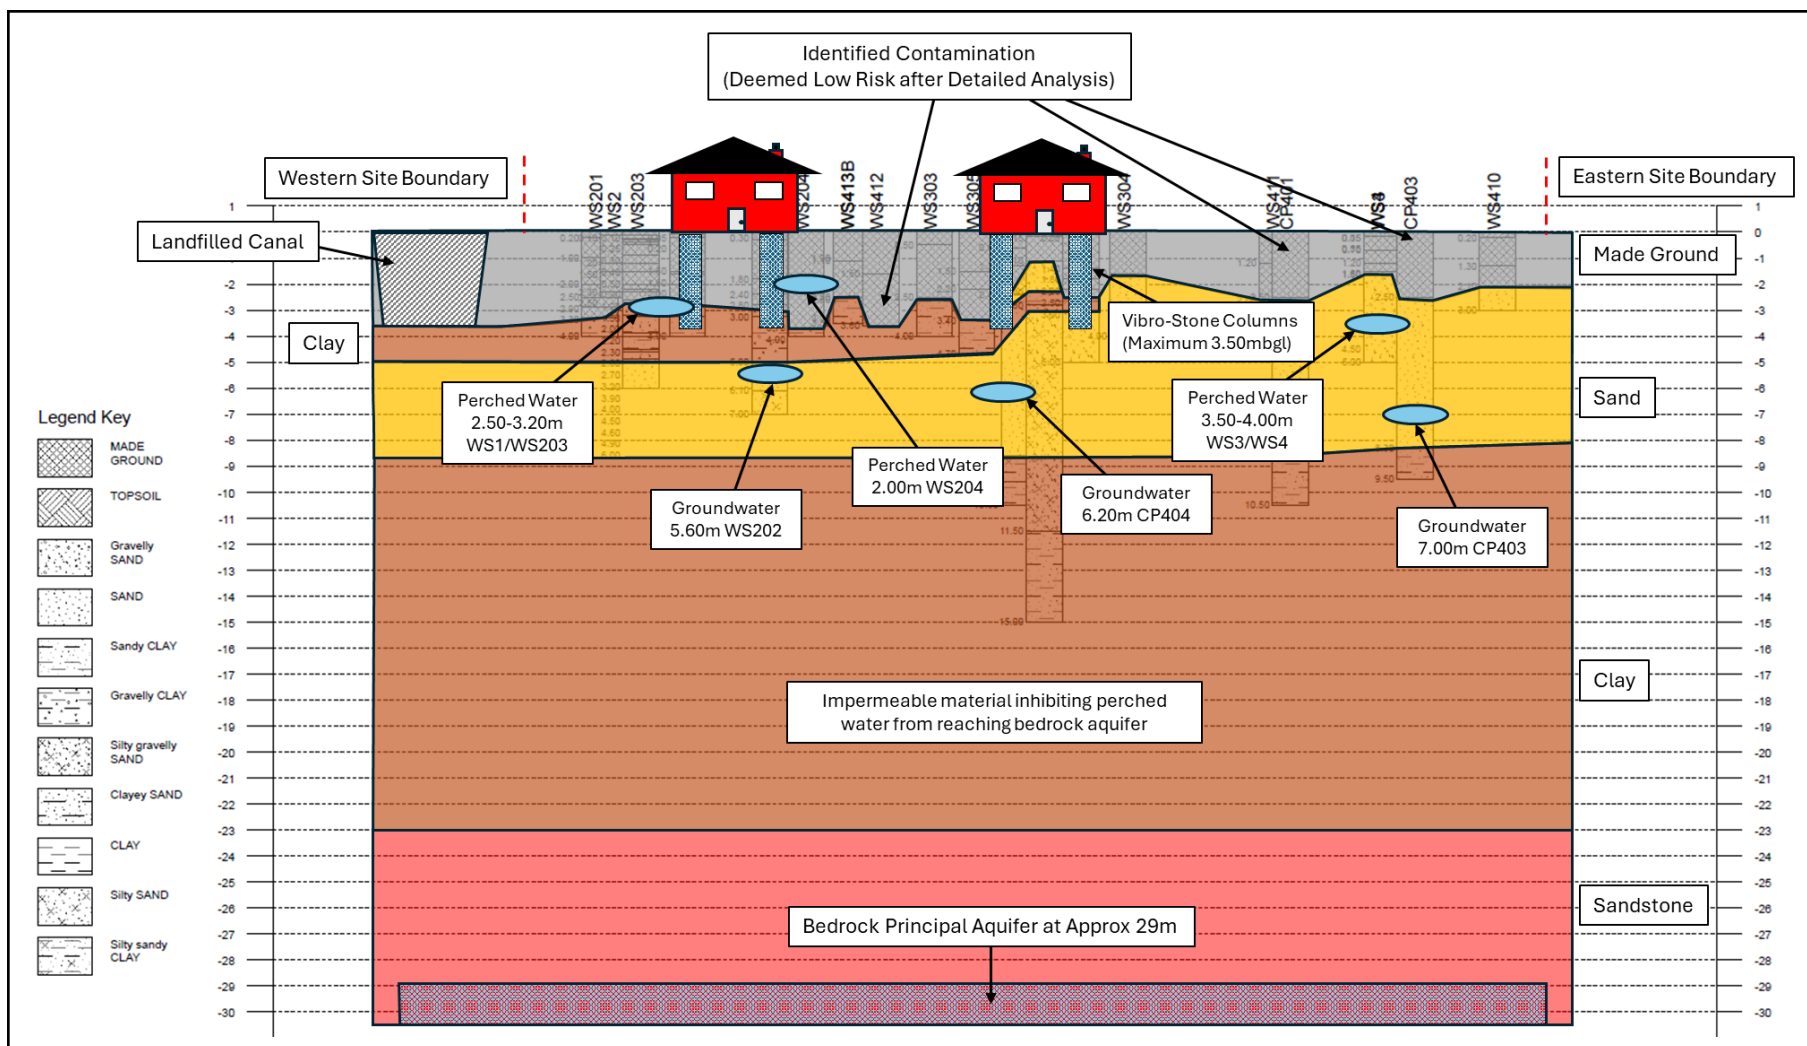
Figure 5 Conceptual Site Model

A conceptual side model was developed which is presented in Figure 5.

The Conceptual Site Model (Figure 5) indicates that the site is underlain by a variable thickness of made ground underlain by clay and sand.

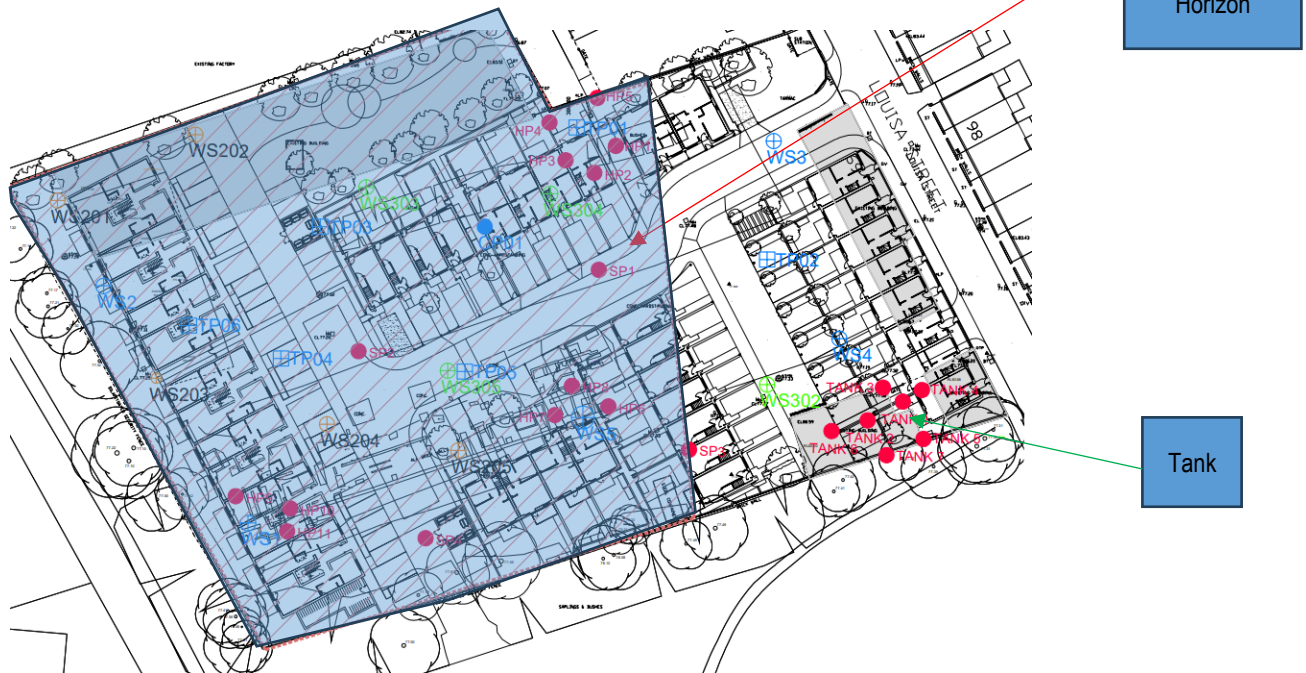
**Figure 6 Extent of Shallow Clay Horizon**

Figure 6 below shows the extent of a clay horizon beneath the made ground.

The stone columns are planned to extend to a maximum depth of 3.5m below existing ground level. As shown in Figure 6, roughly 85% of the site is underlain by shallow impermeable clay. The vibro-stone columns in this area are proposed to not penetrate through this clay layer. In the remaining 15% of the site, the stone columns will be within already mostly granular made ground.

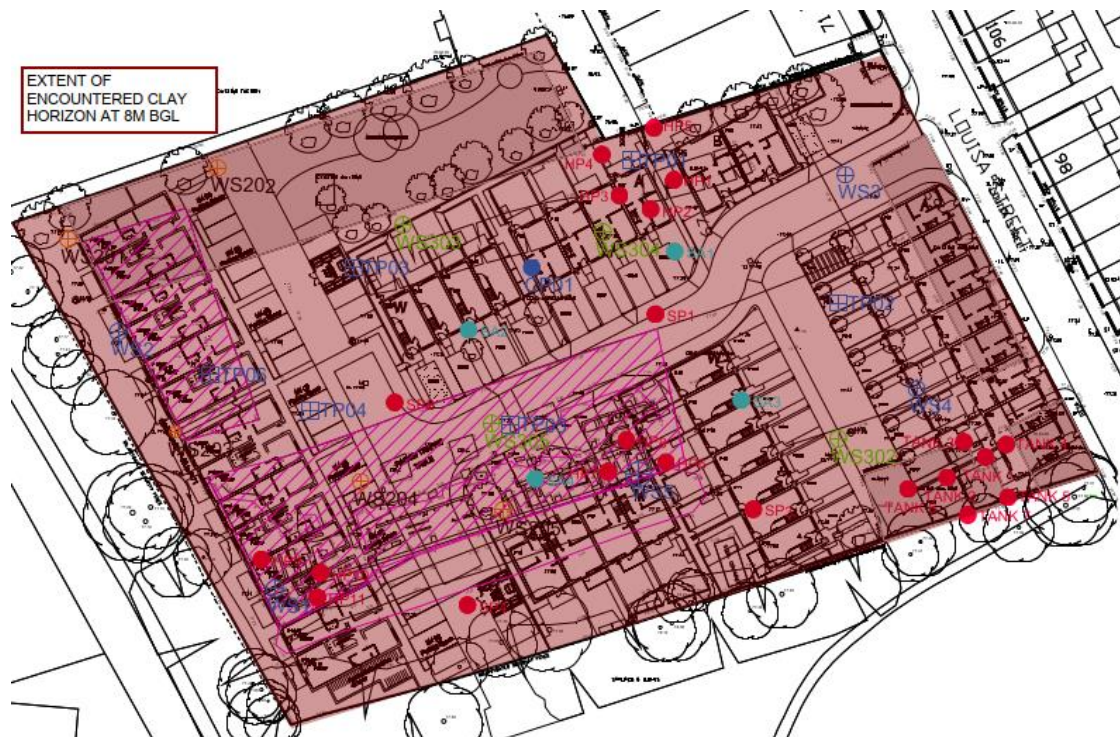
**Figure 7 Extent of Deep Clay Horizon**

It should be noted that a deeper thick clay horizon was encountered below the entire site that forms an impermeable barrier to the underlying principal bedrock aquifer, the presence of which was definitively established in the September 2024 investigation. A plan of the deeper clay horizon is shown as Figure 7.

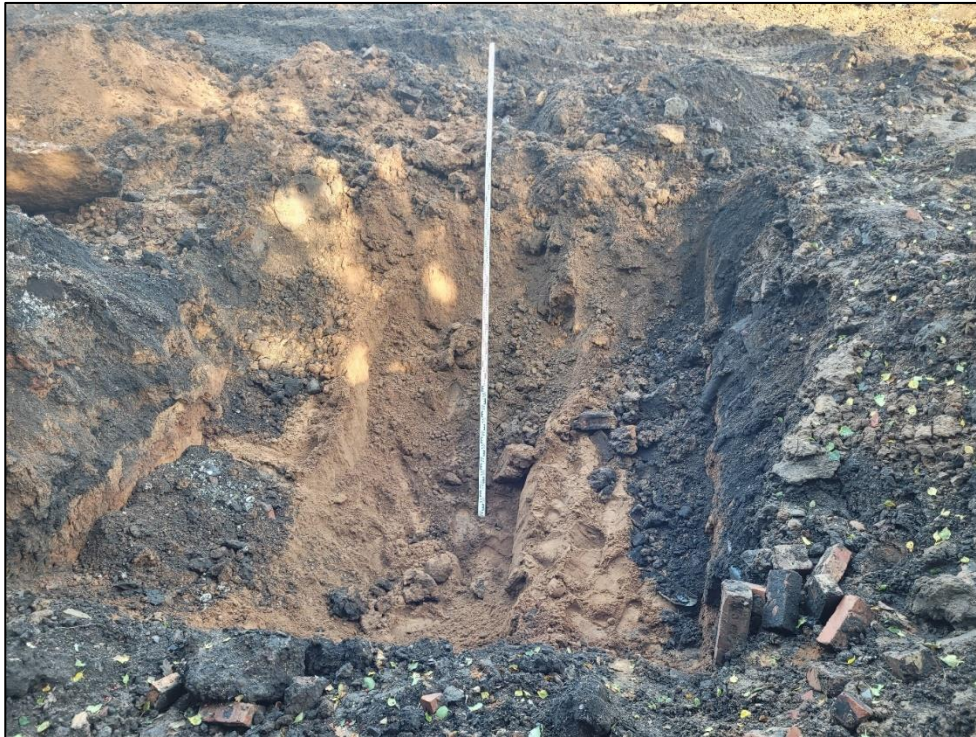
**Figure 8 Excavated Tank**

Figure 8 shows the location of an underground tank that was encountered during site works. This tank was removed offsite with the sidewalls and base sampled and chemical testing.
