| 29 Red Lion Street<br>Chesham Bucks<br>HP5 1EJ | Phase 1 Only<br>Grimshaw Lane<br>Manchester | |

PIPELINE SCHEDULES for 9762 - SW

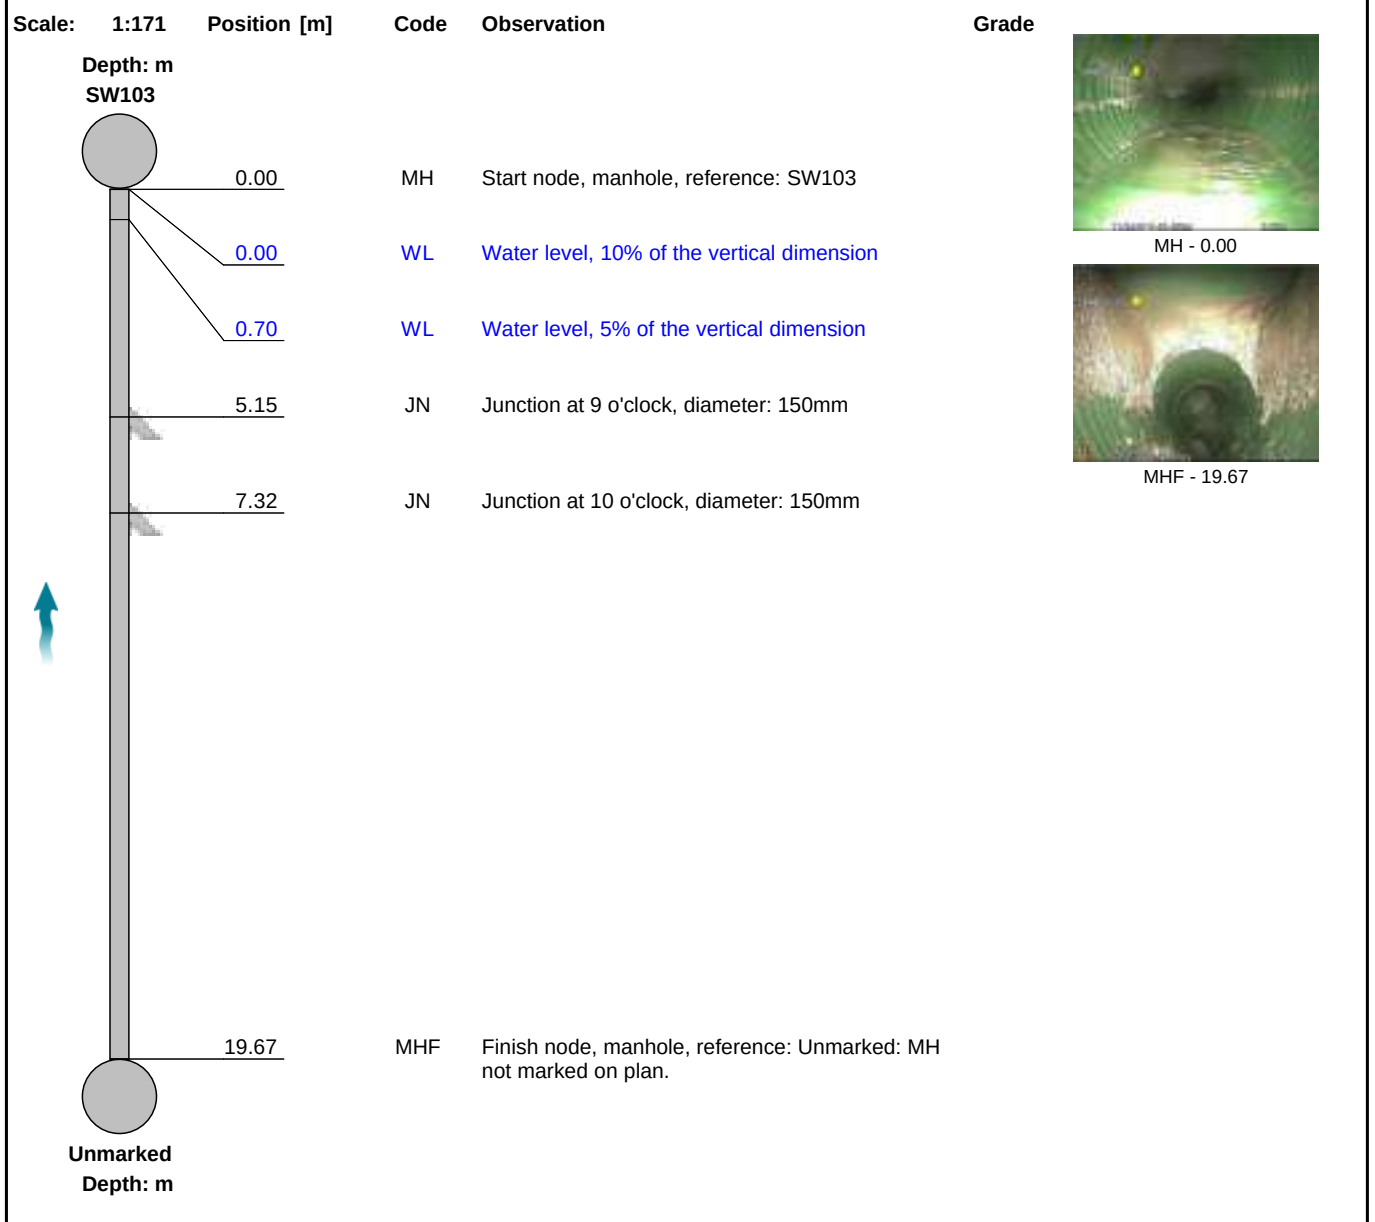
| Comments: | MHF not marked on plan | | | | |
