# **APPENDIX A**

**PROPOSED RESIDENTIAL DEVELOPMENT**

**58 RICHMOND STREET,  
MANCHESTER, M1 3LY**

**Job Ref: 12,764**

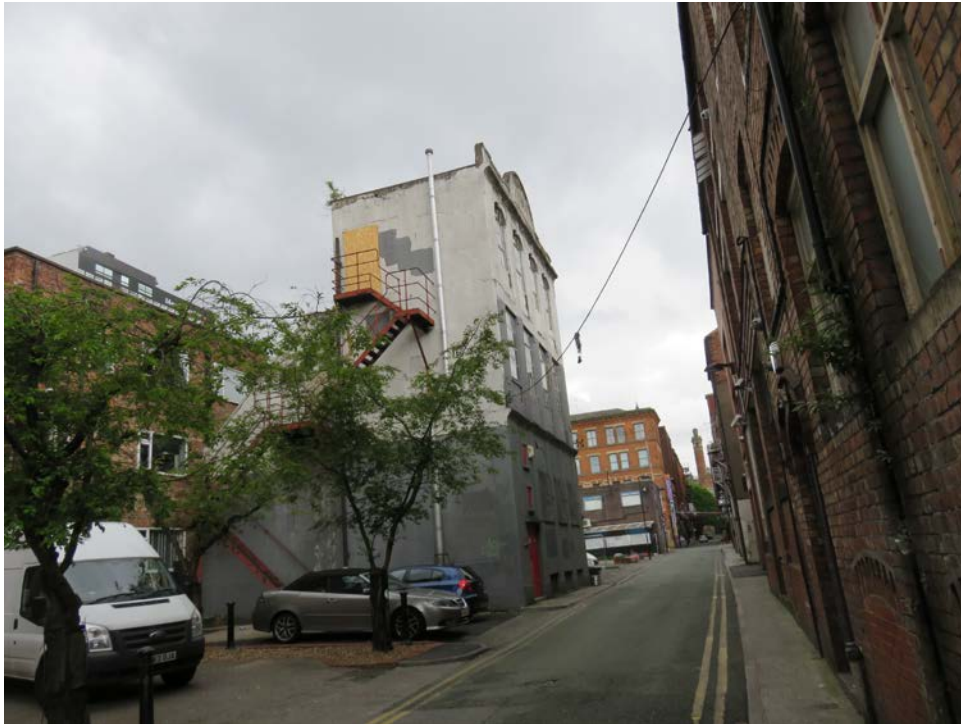
Photograph  
No. 1  
(img. 2132)

View showing from west side of Richmond St of the existing building.

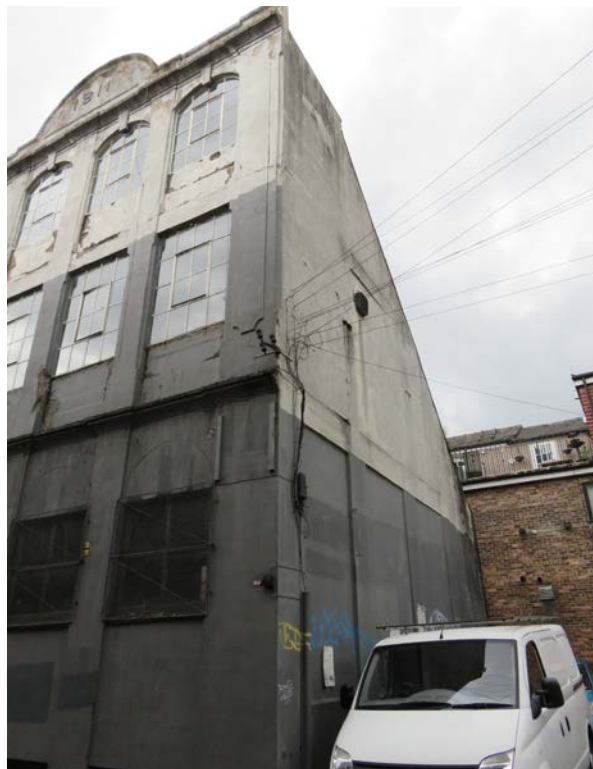
Photograph.  
No. 2  
(img. 2138)

View showing from east side of Richmond St of the existing building.

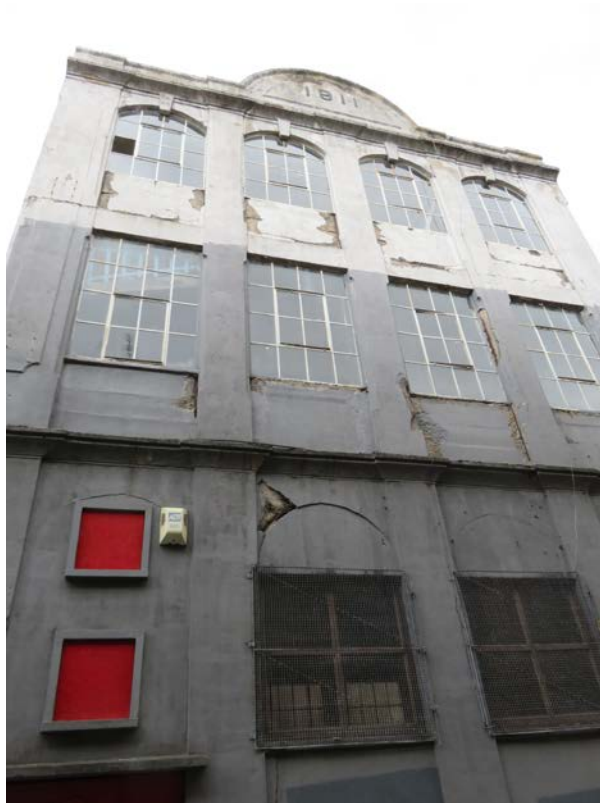
Photograph  
No. 3  
(img. 2136)

View looking to the front Facade.

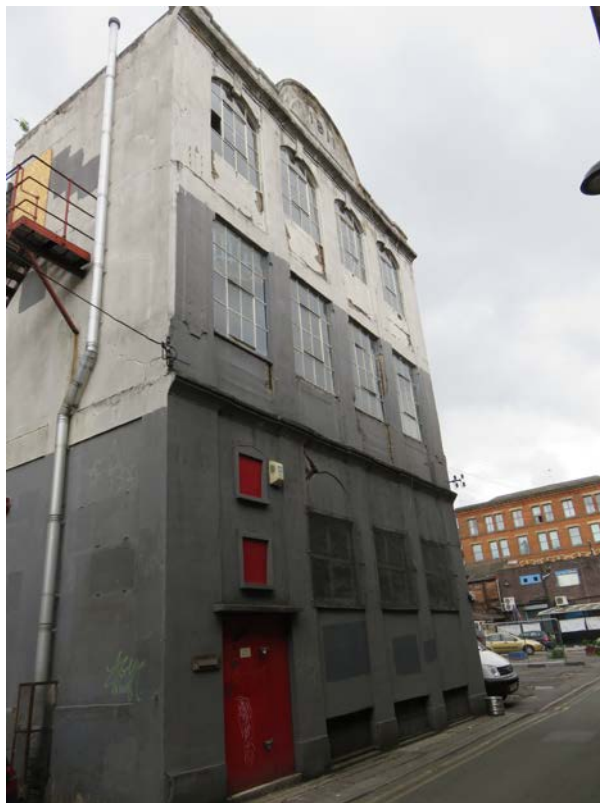
Photograph.  
No. 4  
(img. 2135)

View showing the existing buildings and site's access road.

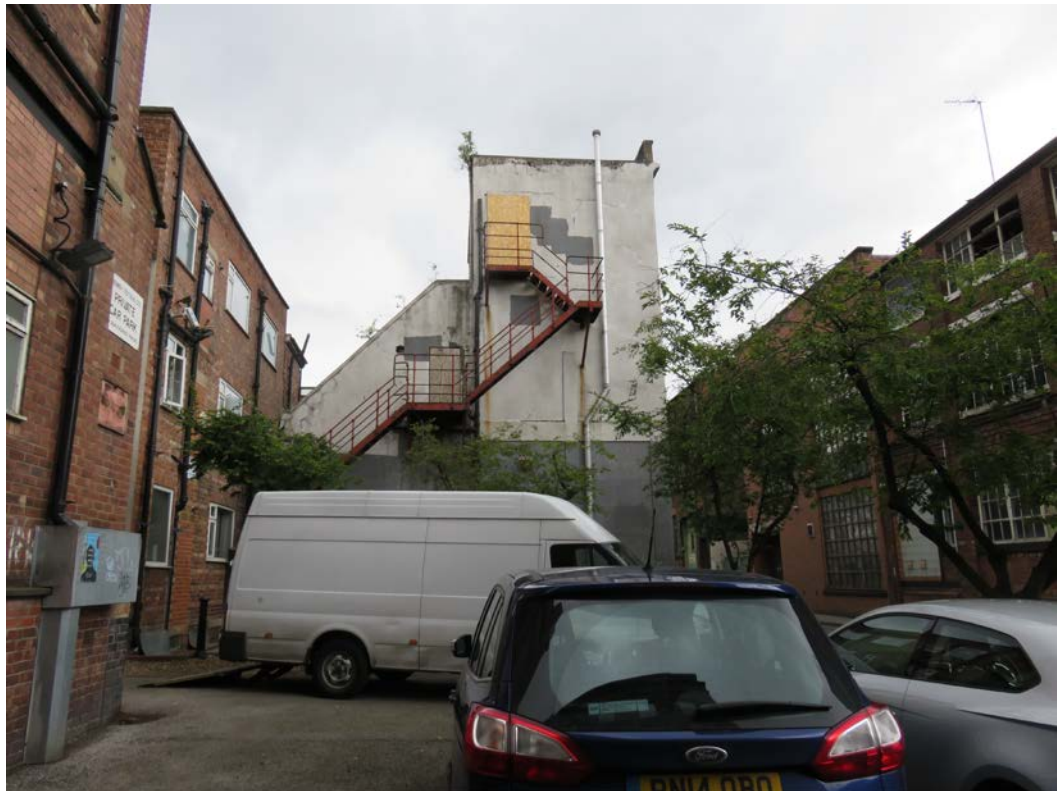
Photograph  
No. 5  
(img. 2130)

View of the East side elevation.

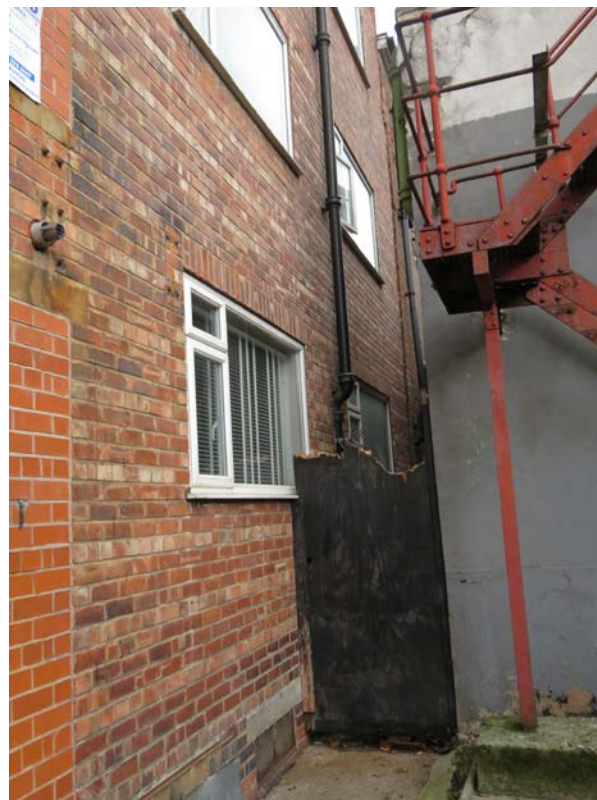
Photograph.  
No. 6  
(img. 2153)

Side view of rear aisle from existing parking.

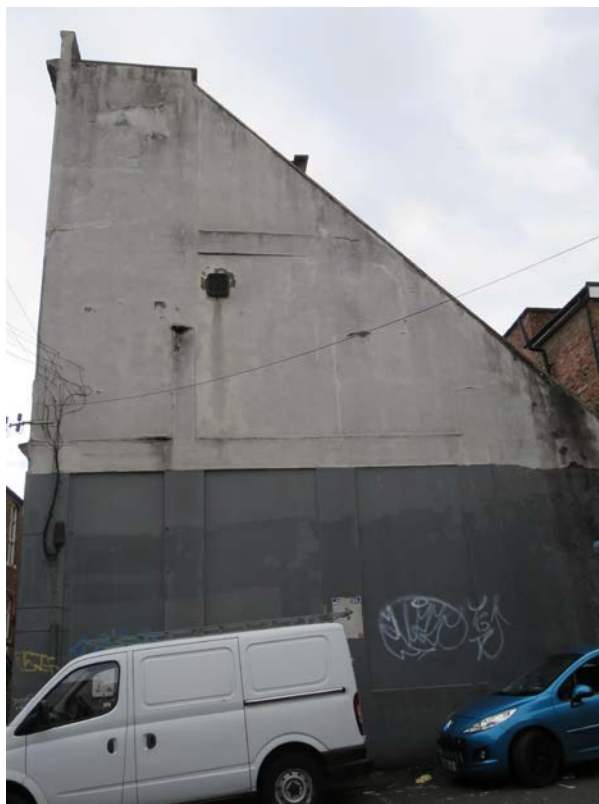
Photograph  
No. 7  
(img. 2140)

View of the East side elevation.

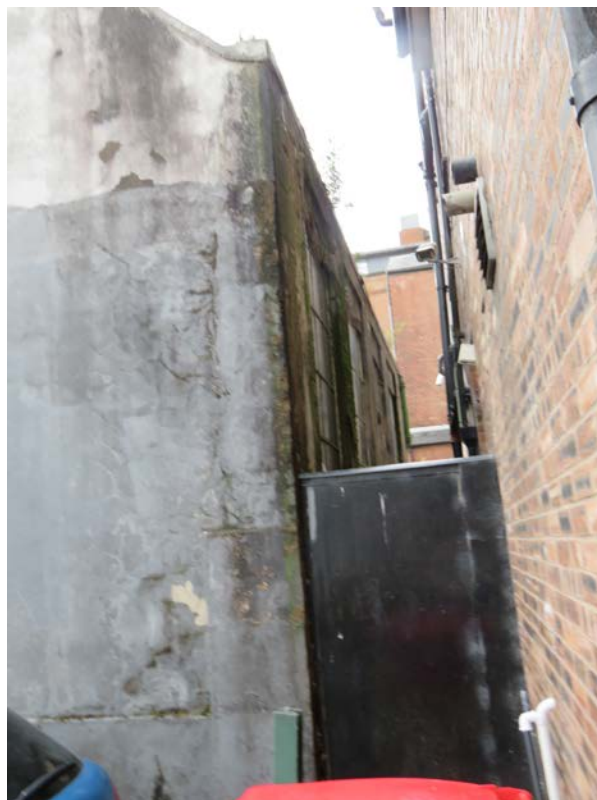
Photograph.  
No. 8  
(img. 2141)

Side view of rear aisle from adjacent plot.

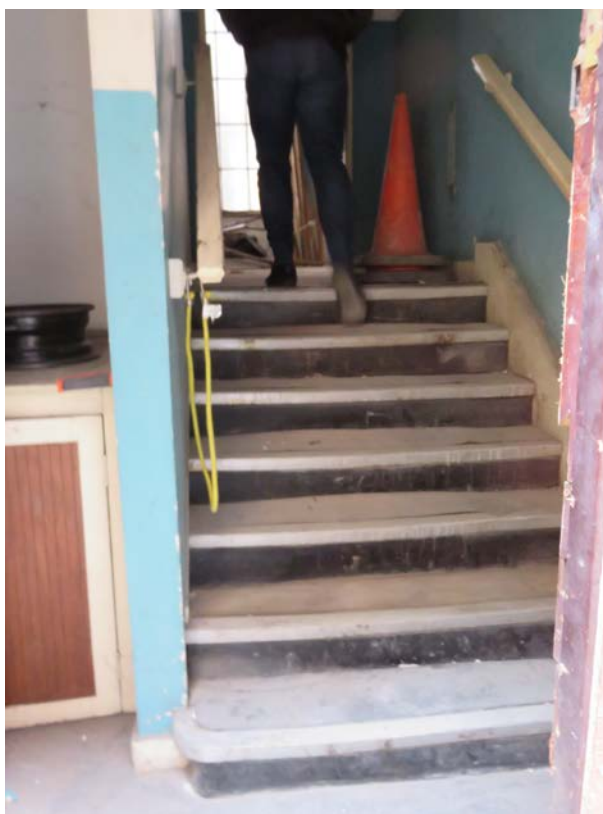
Photograph.  
No. 9  
(img. 2157)

View of the stairs at the existing main entrance.

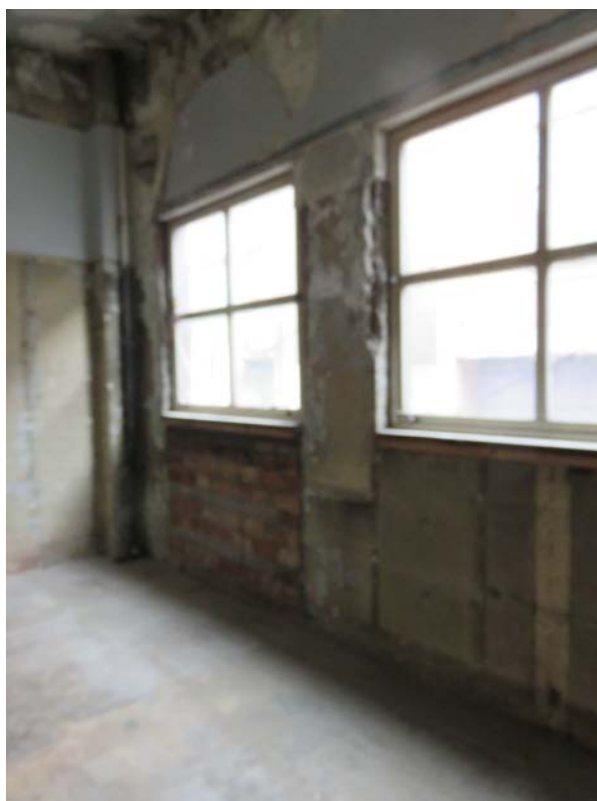
Photograph  
No. 10  
(img. 2161)

View looking at Richmond St from Ground floor.

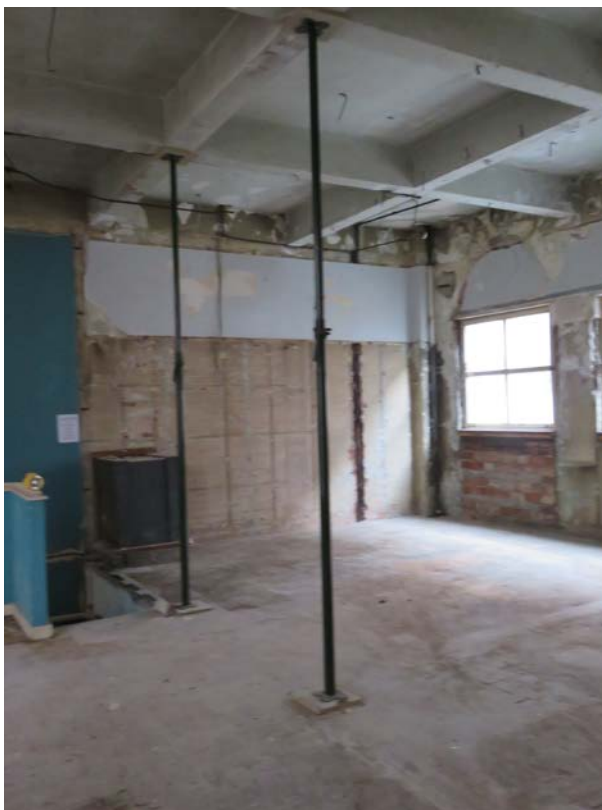
Photograph.  
No. 11  
(img. 2158)

View of the main room and stair to basement at the Ground floor.

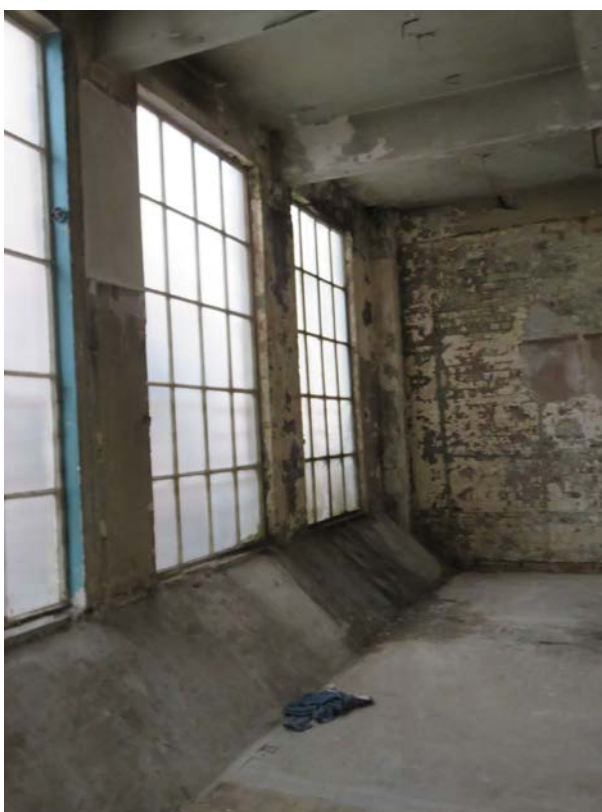
Photograph.  
No. 12  
(img. 2159)

View of the windows to back alley on Ground floor.

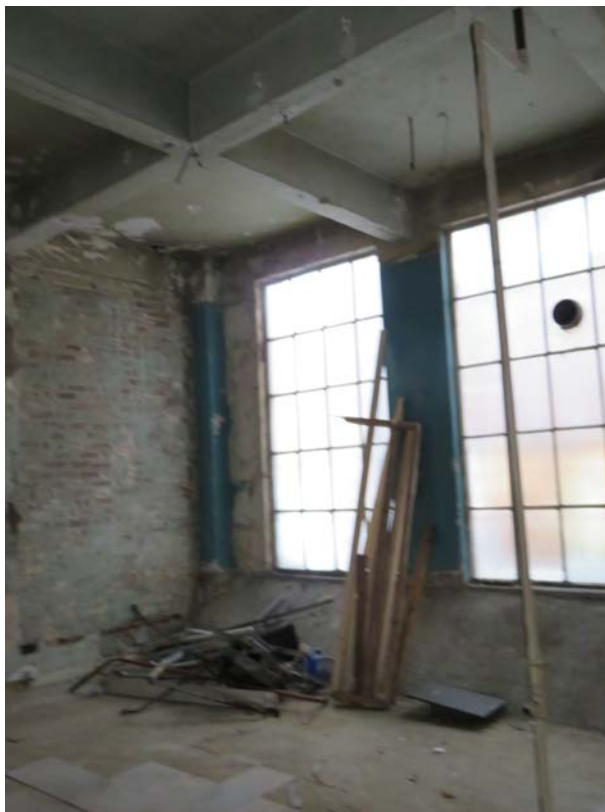
Photograph.  
No. 13  
(img. 2160)

View of the windows to back alley on Ground floor.

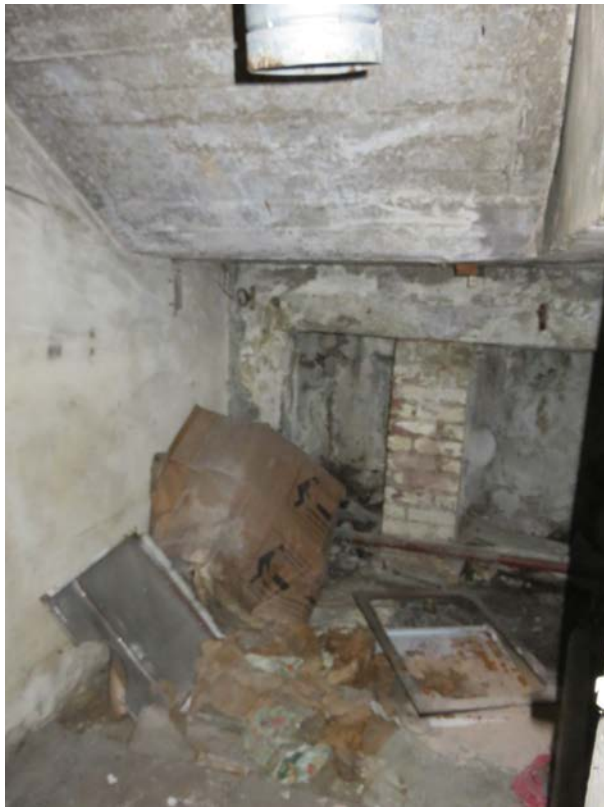
Photograph.  
No. 14  
(img. 2165)

View of the bottom of the stair on the Basement.

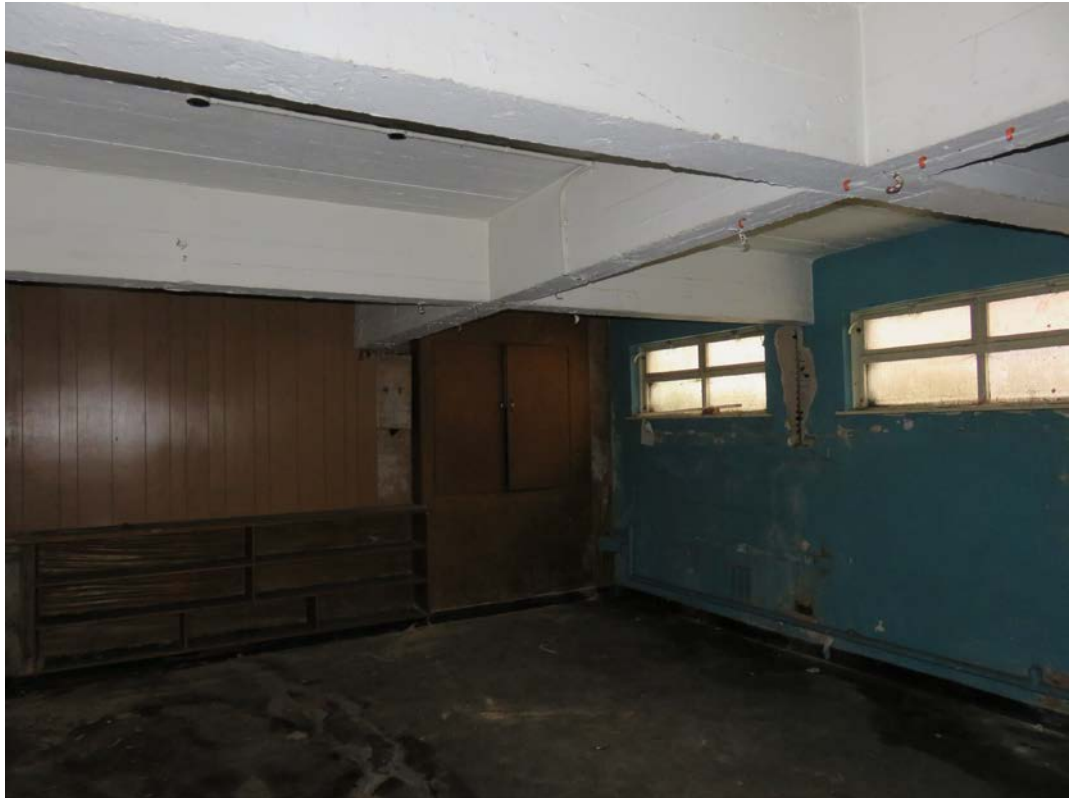
Photograph.  
No. 15  
(img. 2164)

View of the front facade from Basement.

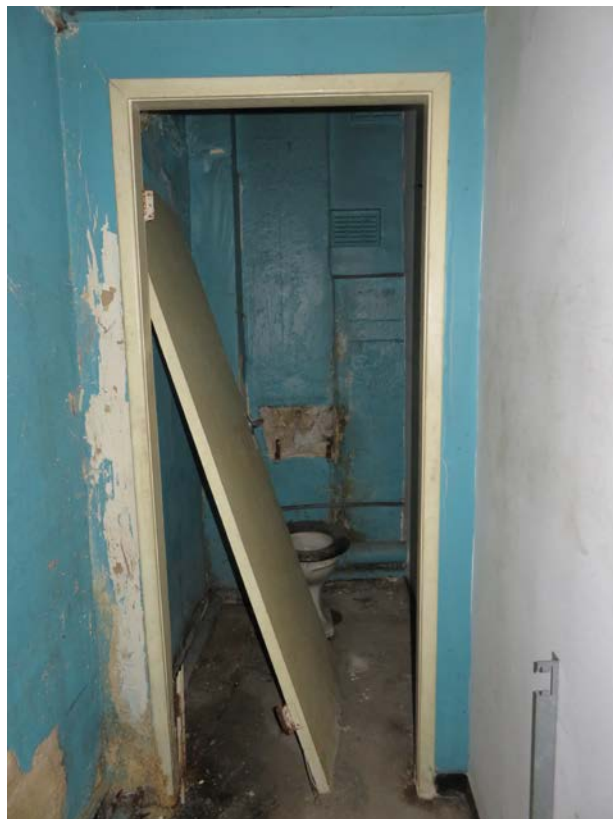
Photograph.  
No. 16  
(img. 2166)

View of the existing toilets at the Basement.

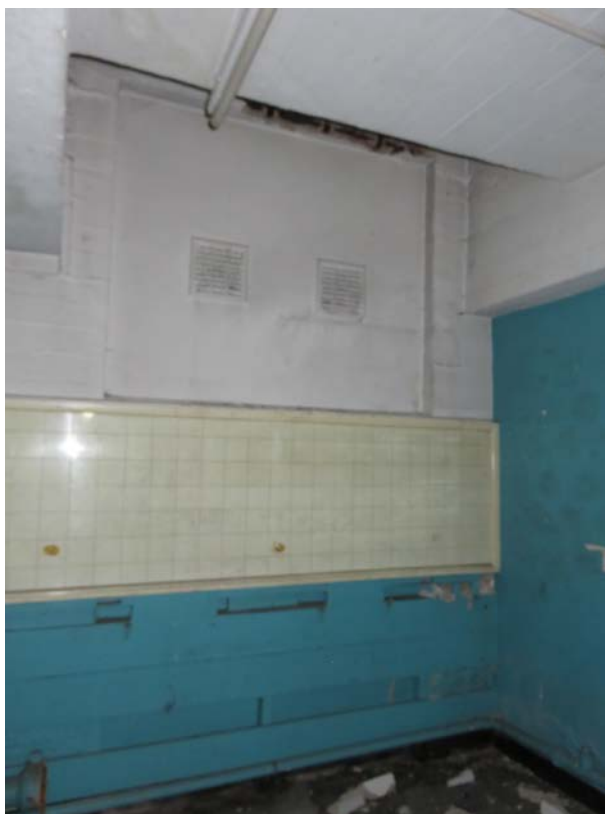
Photograph.  
No. 17  
(img. 2167)

View of the back room on the Basement.

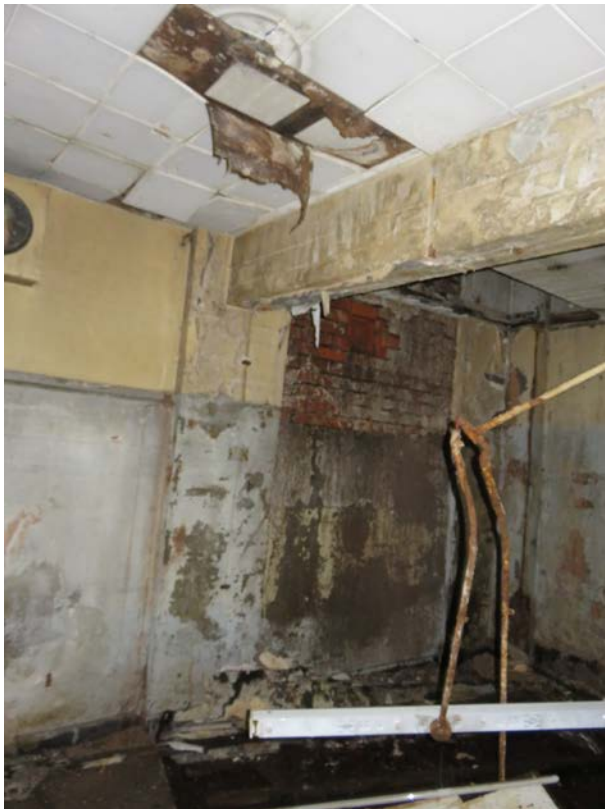
Photograph.  
No. 18  
(img. 2169)

View of the back room on the Basement.

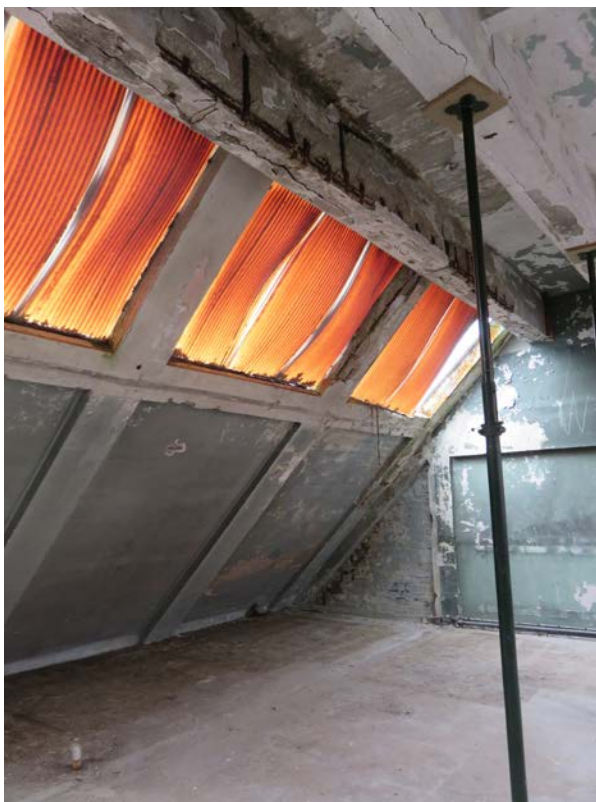
Photograph.  
No. 19  
(img. 2171)

View of the rear pitched roof and windows on the 1<sup>st</sup> Floor.

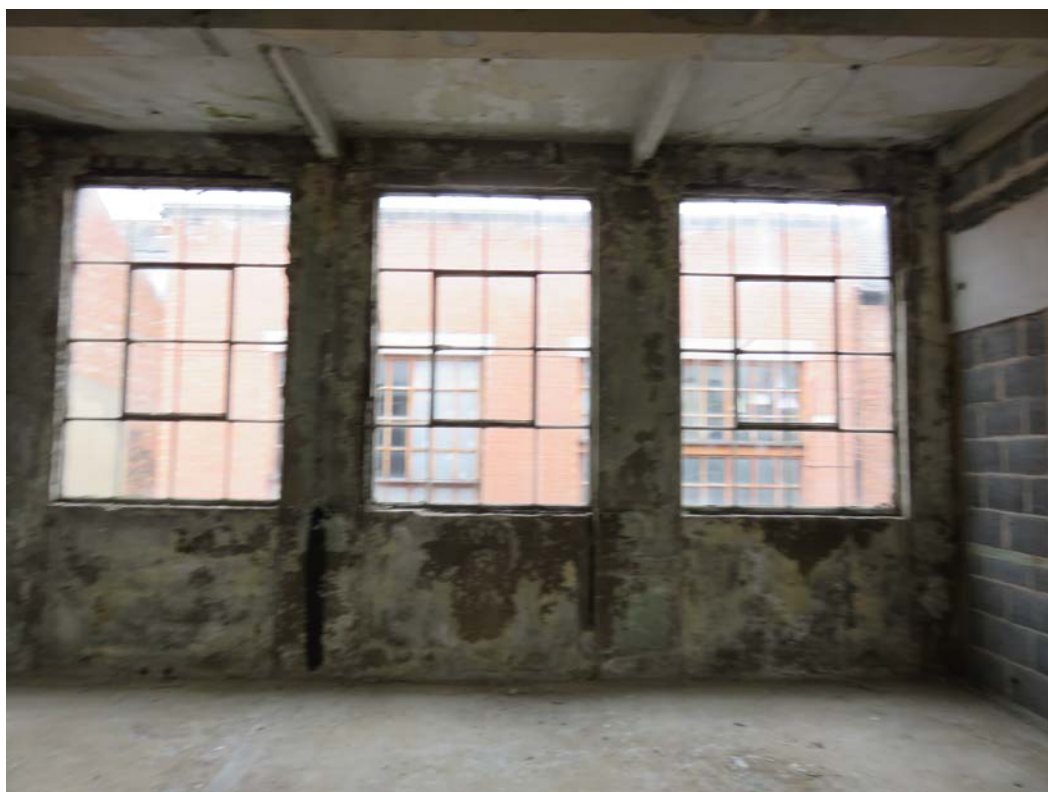
Photograph  
No. 20  
(img. 2161)

View of the windows in the front facade on 1<sup>st</sup> Floor.

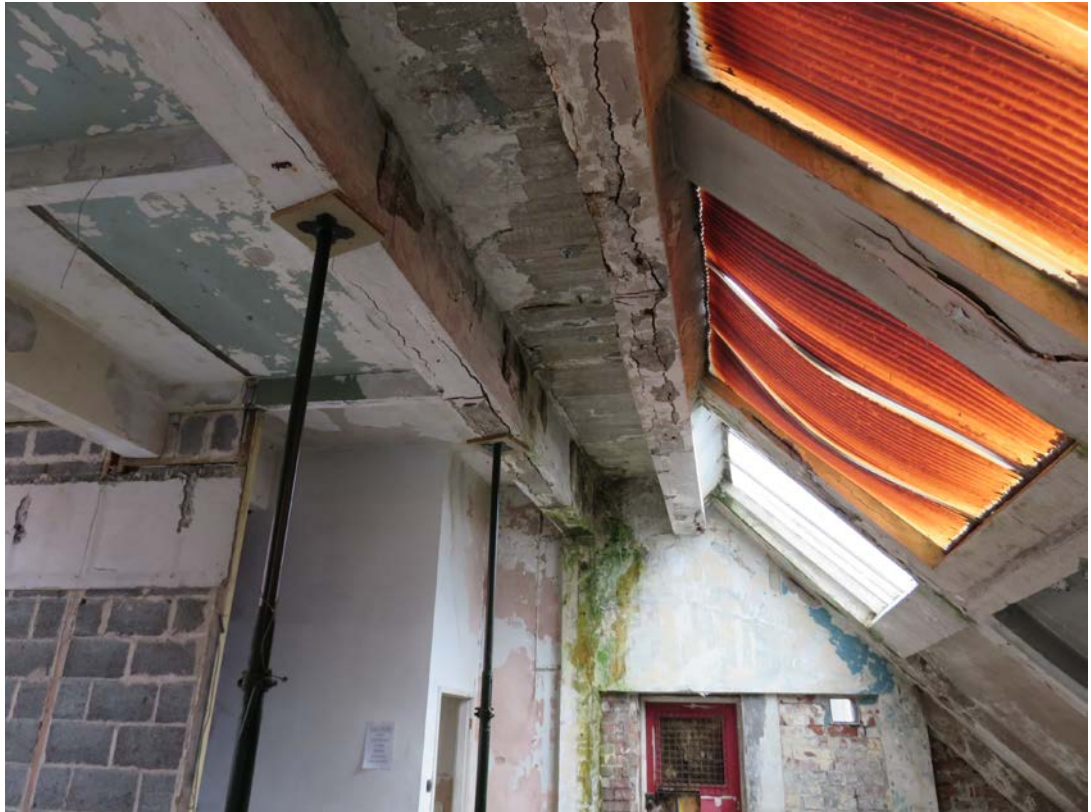
Photograph.  
No. 21  
(img. 2174)

View of the concrete beam, windows and emergency door on the 1<sup>st</sup> Floor.

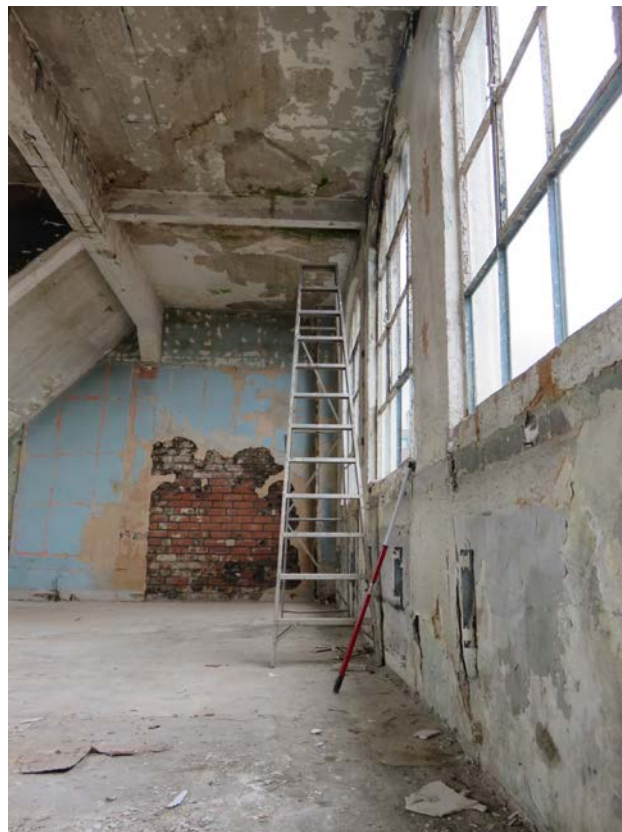
Photograph  
No. 22  
(img. 2183)

View looking to front windows from the top of the stairs on the 2<sup>nd</sup> Floor.

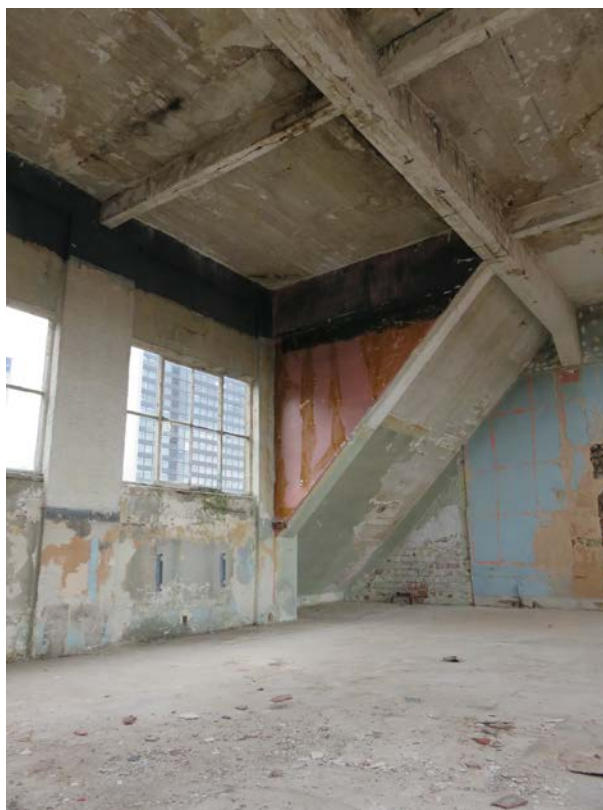
Photograph.  
No. 23  
(img. 2182)

View looking to rear windows from the top of the stairs on the 2<sup>nd</sup> Floor.

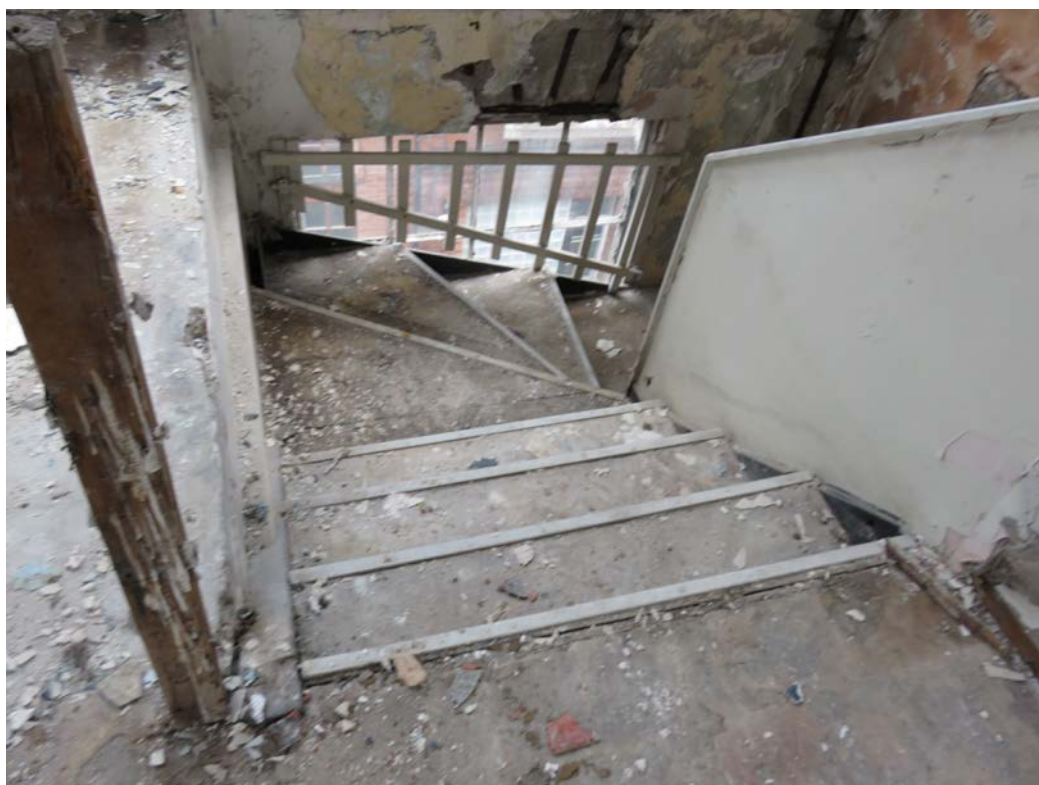
Photograph  
No. 24  
(img. 2189)

View looking at the landing of the stairs on the 2<sup>nd</sup> Floor.

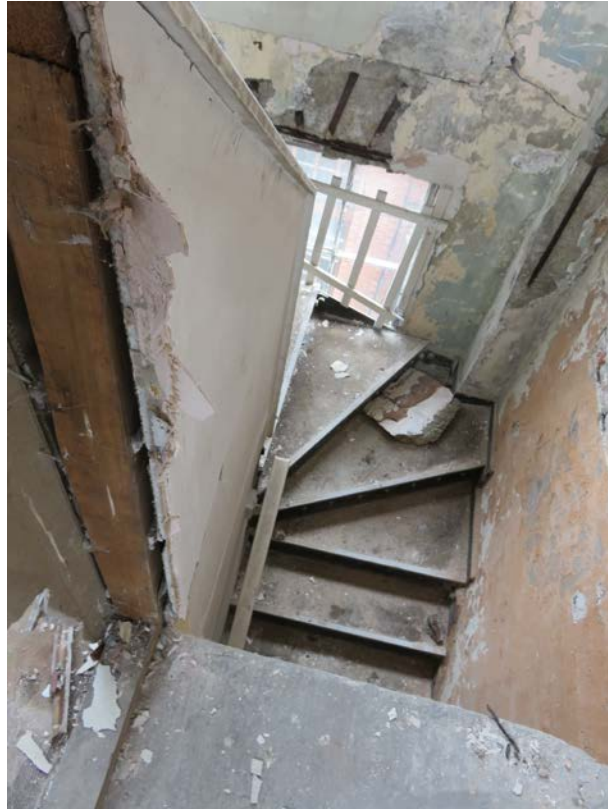
Photograph.  
No. 23  
(img. 2190)

View looking to missing parapet of the stairs on 2<sup>nd</sup> Floor.

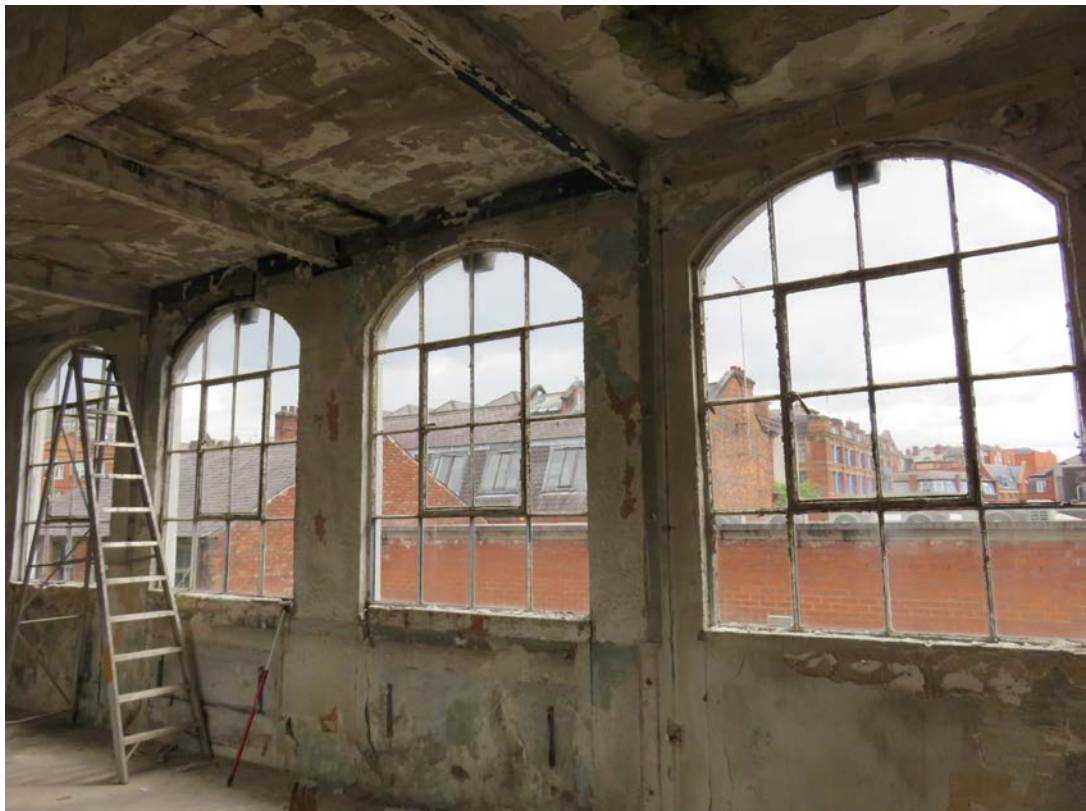
Photograph  
No. 24  
(img. 2191)

View looking at Richmond St from Ground floor.
