# 111 DEANS\_GATE M3 2BQ - photographic audit in support of LBC application

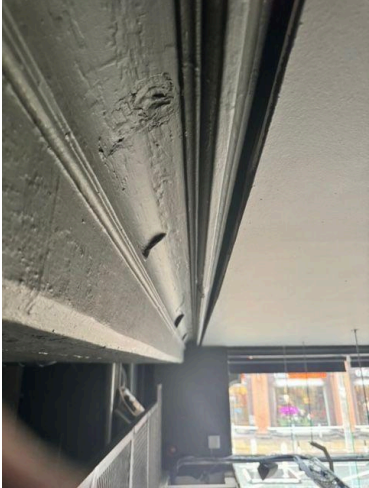
| <p>1 - Detail of RHS original cornice abutting recent plasterboard ceiling</p> | <p>2 - Existing high level mesh panels to be retained - cornice / plasterboard ceiling abutment to RHS</p> |
