# Structural Report

79-87 Cheetham Hill Road, Manchester, M4 4ER

2919-430\_L01

03 June 2024

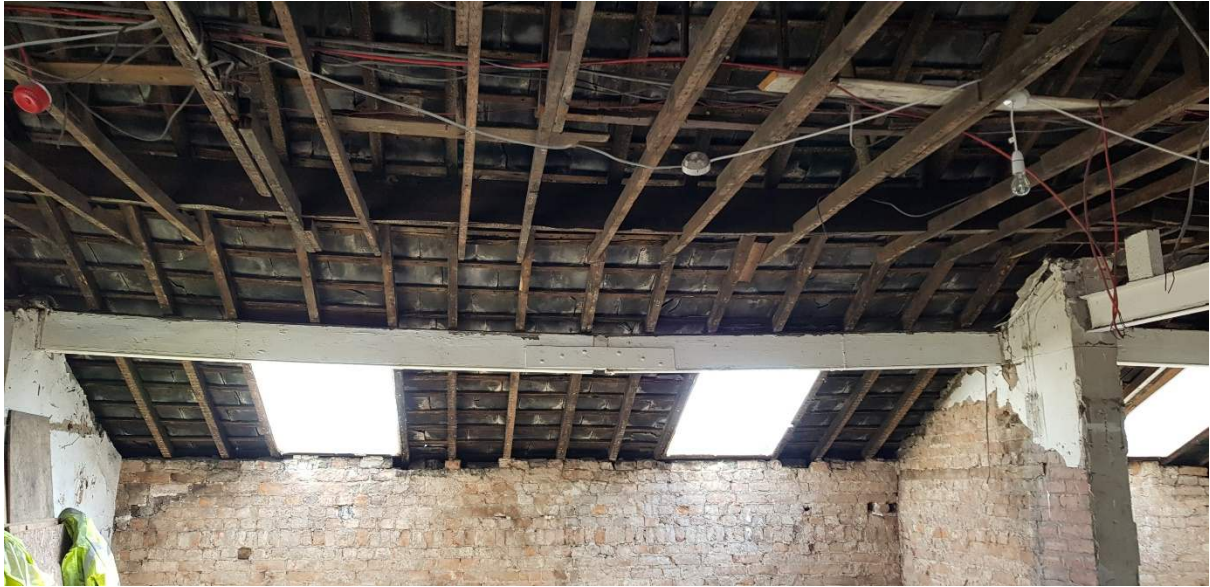
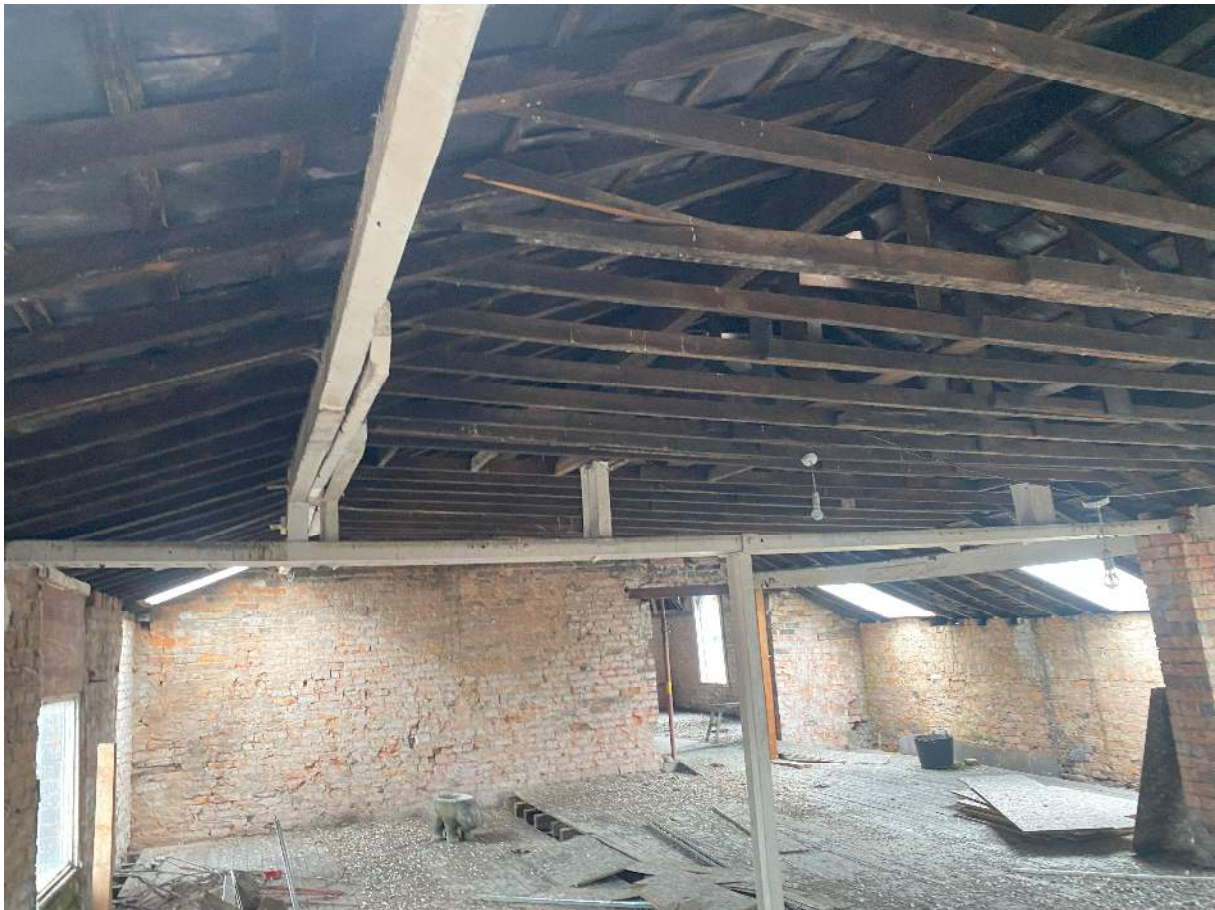
- 4.1.1 No observations were able to be made externally of the roof.
- 4.1.2 The roof is of typical high collar construction with a series of supporting timber purlins. The outer purlins are supported by the remaining party wall returns and the inner purlins are supported by timber props poorly propped off steel beams which in turn are

inadequately bearing onto piers / party wall returns each end. The timber purlins and collar ties are poorly spliced which has caused excessive deflection throughout the whole roof structure and has resulted in a horizontal thrusting force at the eaves causing it to 'kick out'. See Photographs 1 and 2.

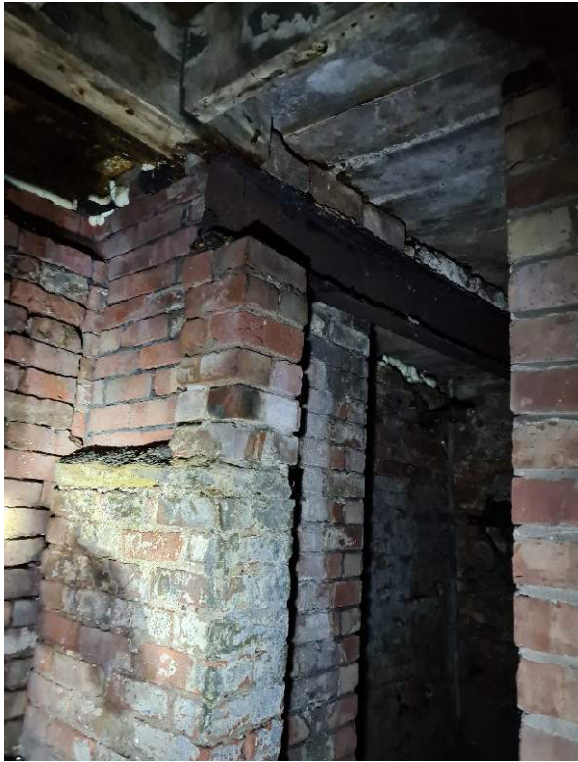
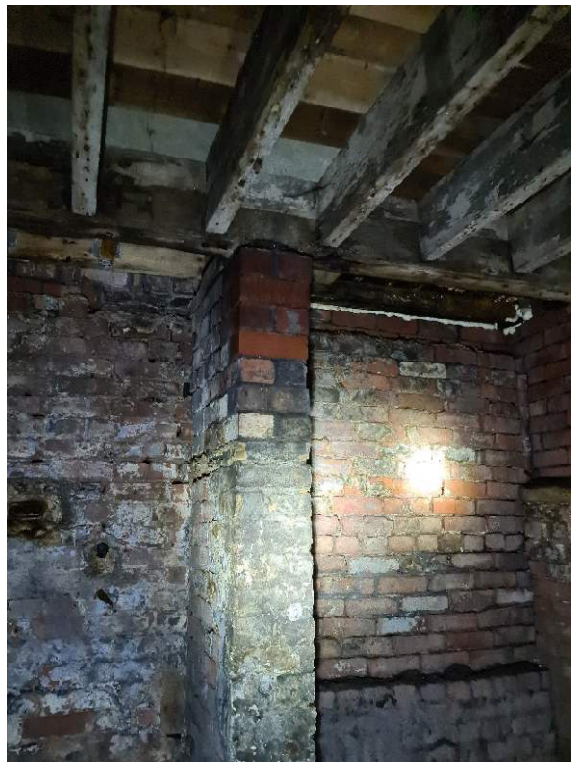
- 4.4.1 The ground floor structure appears to be a mixture of concrete and timber joists construction supported by a series of steel beams and in a condition expected for the age of the building. The joists have been subject to damp conditions due to lack of adequate ventilation and maintenance as is evident from the wet rot spread across the joists. See Photographs 3 and 4.

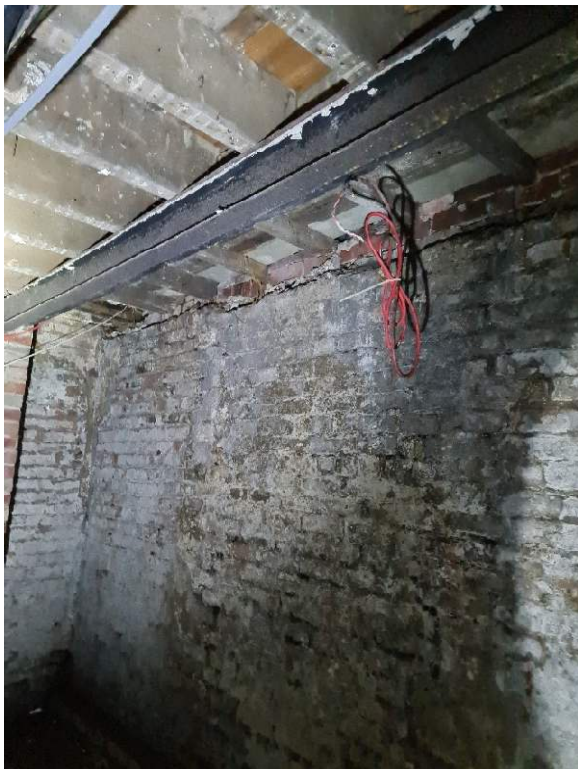
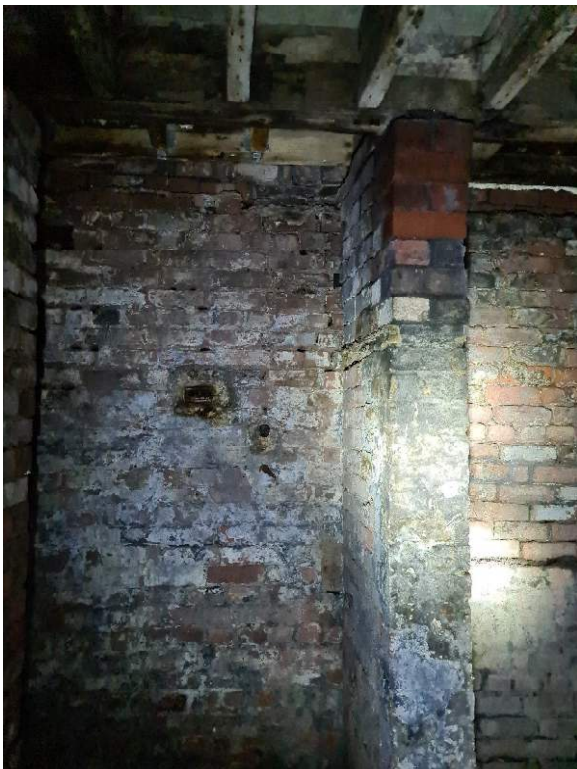
- 4.5.1 There is a cellar that appears to cover the footprint of the property. The masonry walls generally appear to be in sound condition with no visible cracks or obvious signs of settlements. However, the walls are riddled with efflorescence due to the un-tanked retaining walls and lack of any adequate ventilation which has caused weathering to most of the walls. See Photographs 5 and 6.

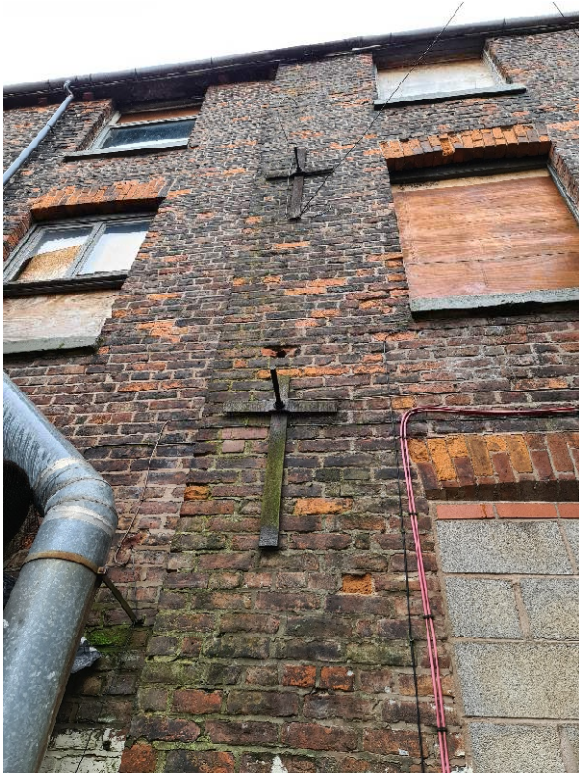
*Photograph 7*

- 4.6.1 The original external walls are of solid 215mm wide brick construction as is evident along the rear elevation and the inside face of the front and side elevations, where the brick header courses are visible. See Photographs 7 and 8. It appears the external leaf

- 4.6.5 The presence of the wall tie rods and anchor plates further illustrate the lack of restraint present in the elevations, particularly to the front elevation, which would have been installed to control any bowing to the front of the structure. See Photographs 7, 15 and 16.

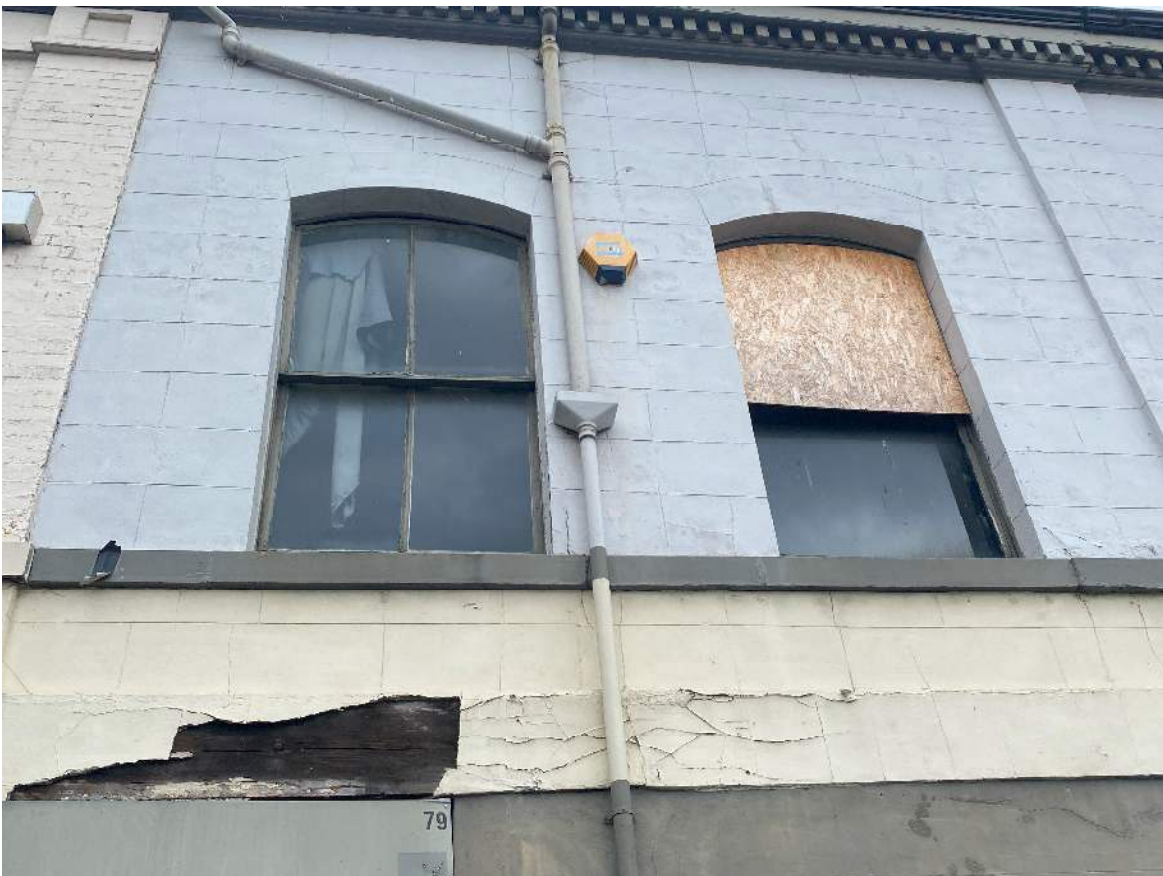
*Photograph 9*

of the original solid brick wall has been removed and rebuilt with a cavity to the front and side elevations. The reason for this is unknown, however the rebuilt leaf has been finished with a render, engraved with a blockwork pattern, see Photograph 9.

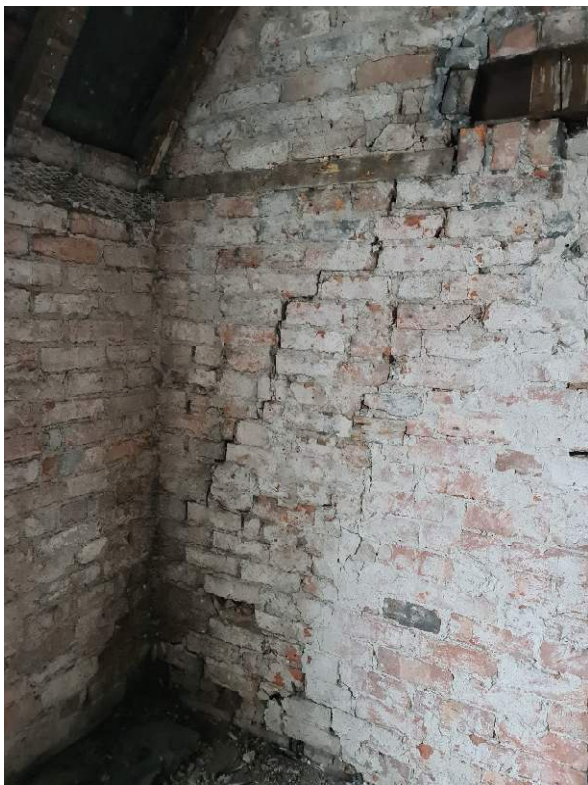
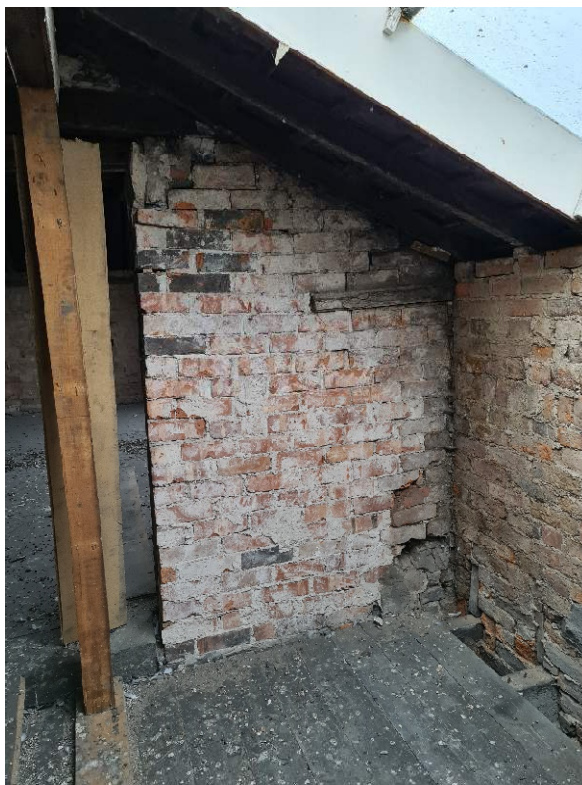
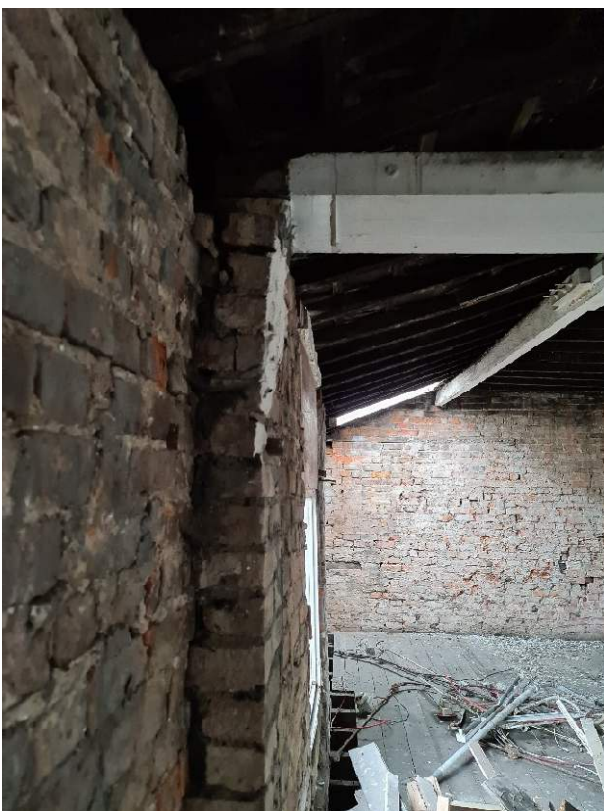
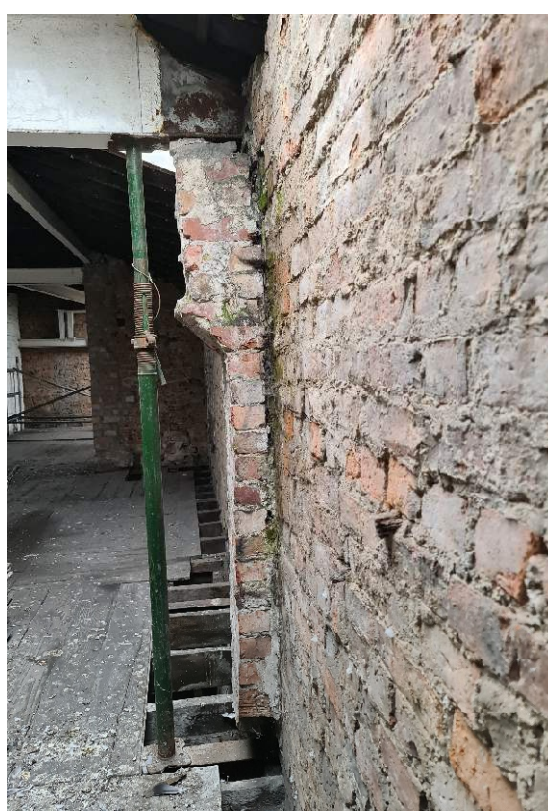
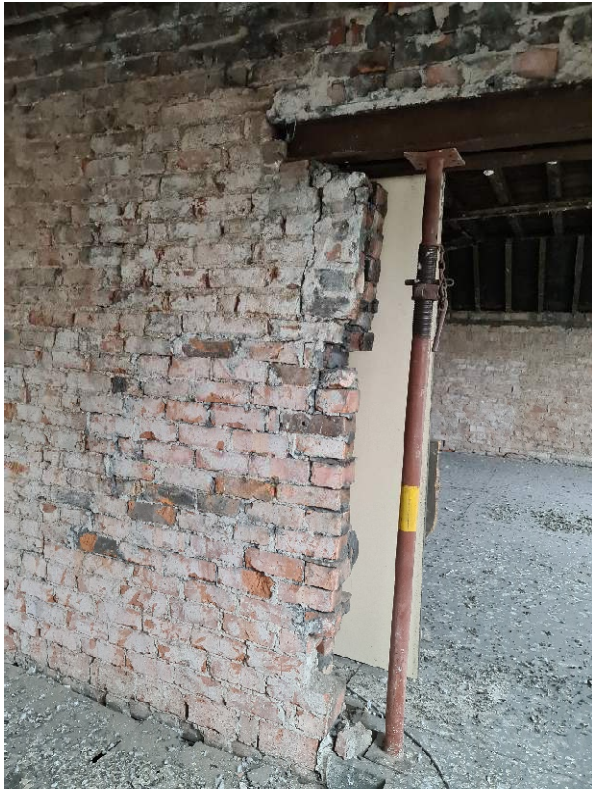
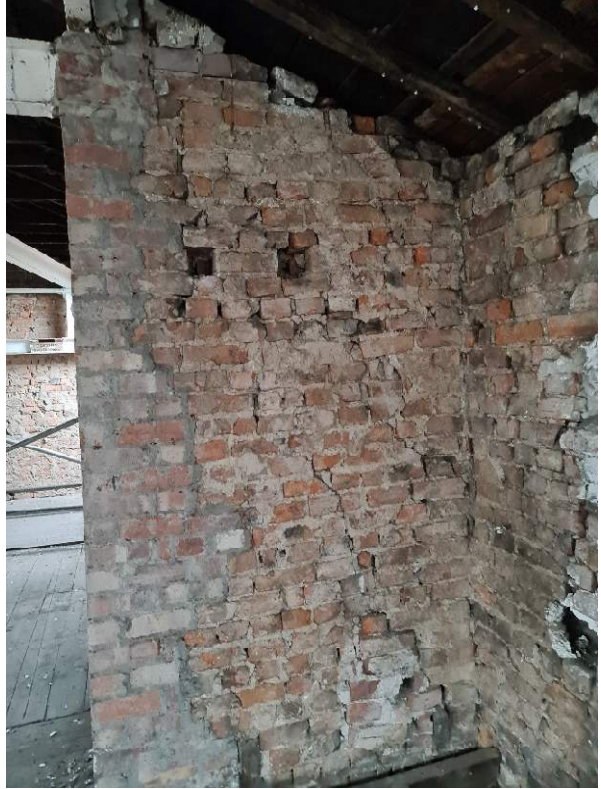
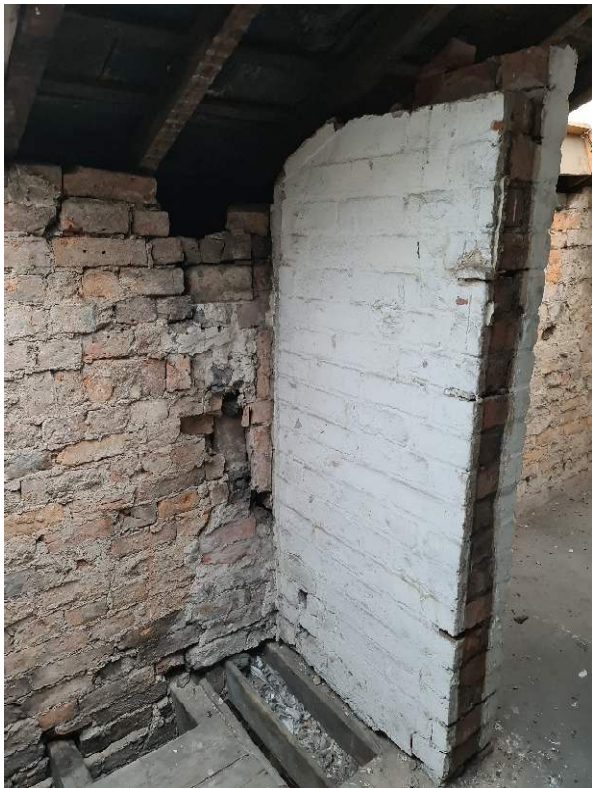
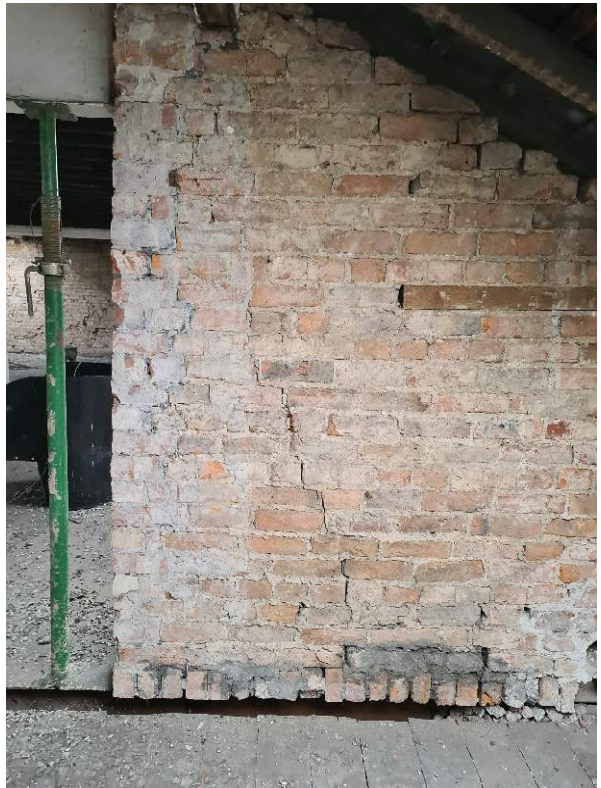
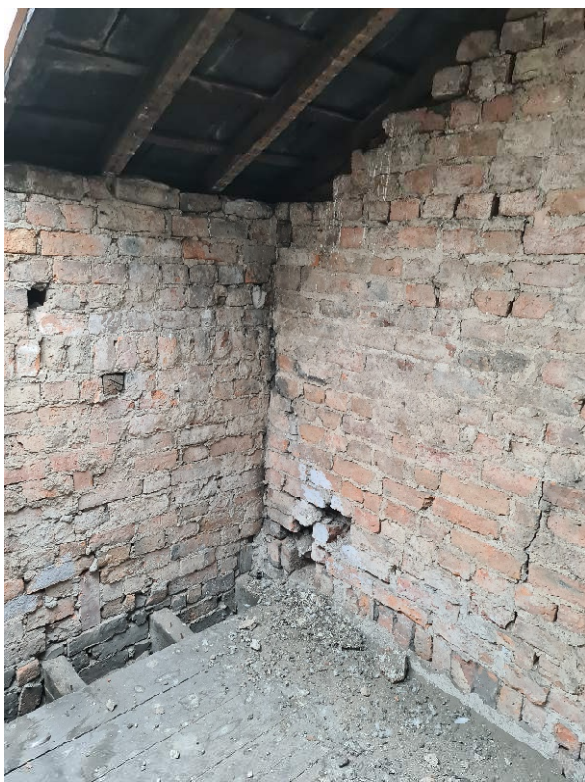
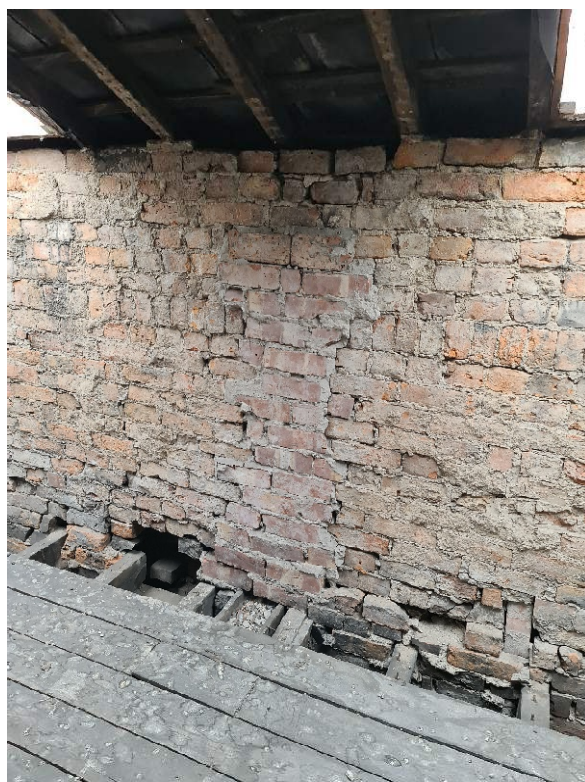
- 4.6.6 The condition of the structure is mirrored at second floor level. Extensive cracks in the walls and piers, bricks have collapsed into the cavity, piers have separated and are buckling away from the external walls. see Photographs 17 to 26.

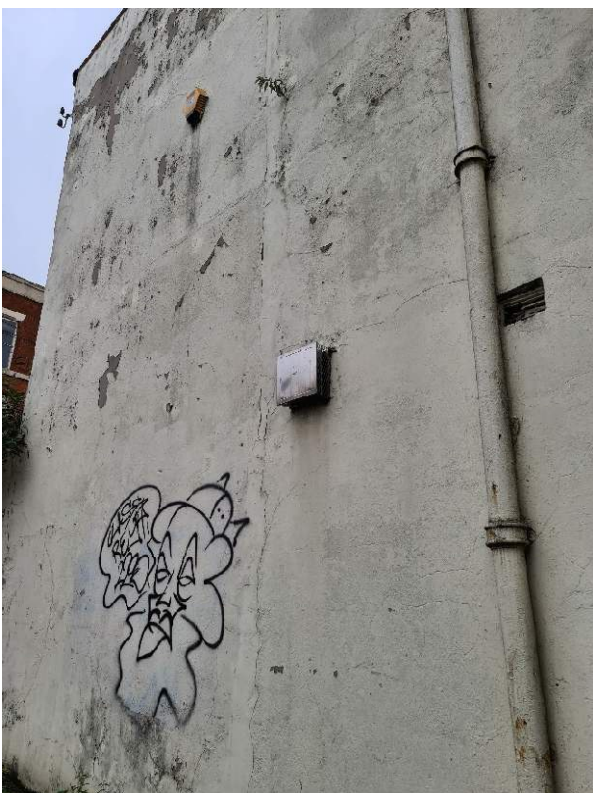
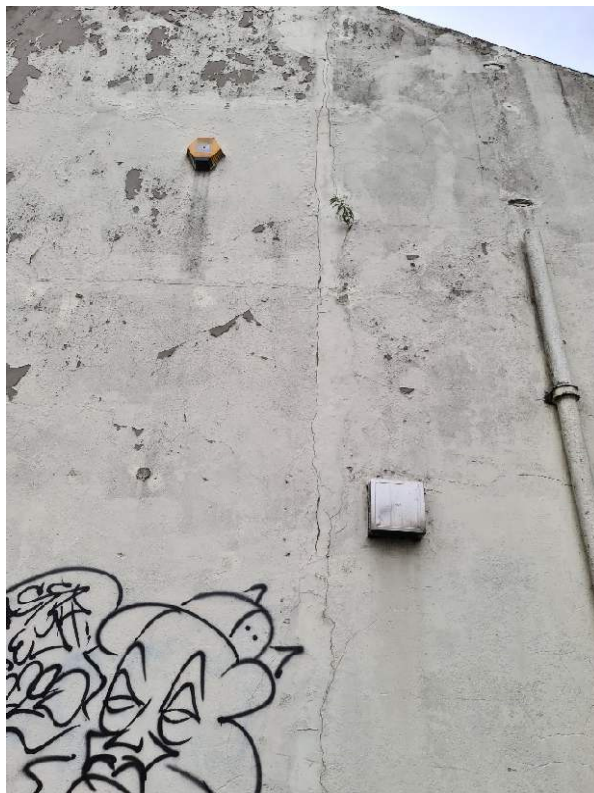
- 4.6.7 There is noticeable vertical bowing to the rear wall of the outrigger where there is cracking to the render spanning from ground to roof level. See Photographs 27 and 28
