**Just Drain Surveys**  
**23 Kingsgate Road Chellaston**  
**Derbyshire DE73 6WY**  
**0800 195 2646 - 07742 103 106**  
**help@justdrainsurveys.co.uk**

2nd September 2022

Ref: **Drain Survey**  
Site Address: **102-104 Waterloo Road, Manchester. M8 8AW**

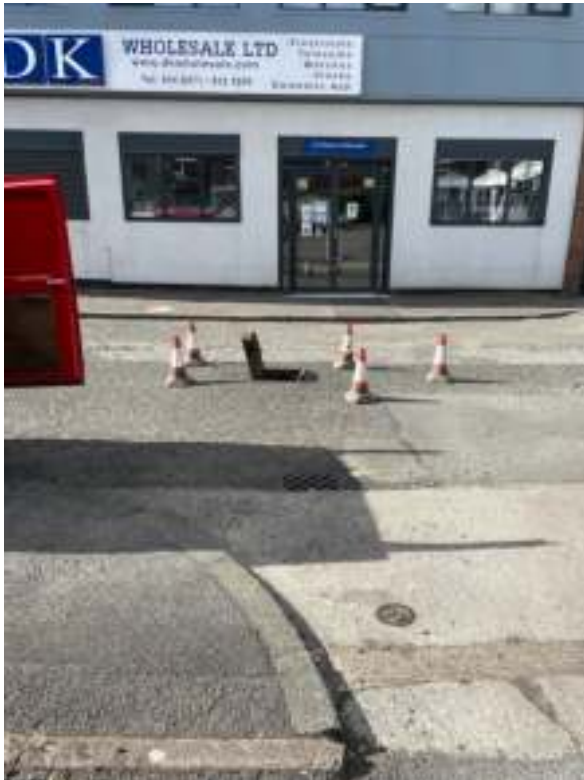
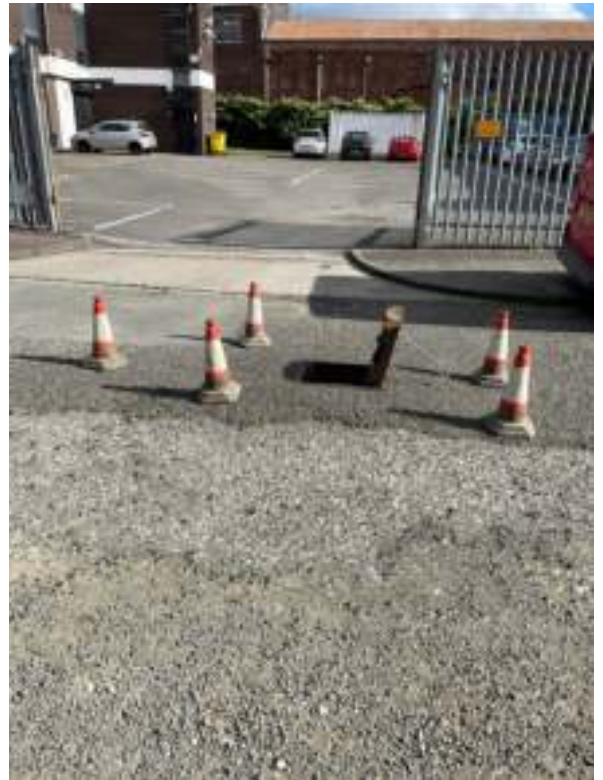
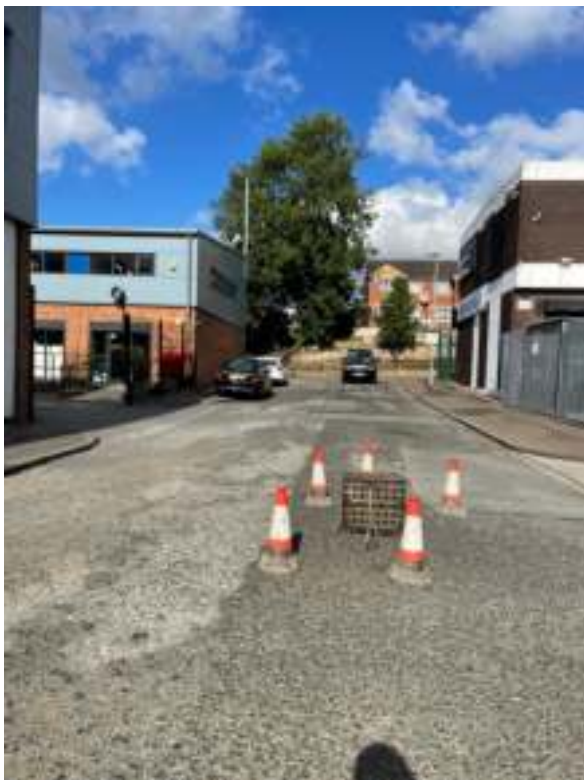
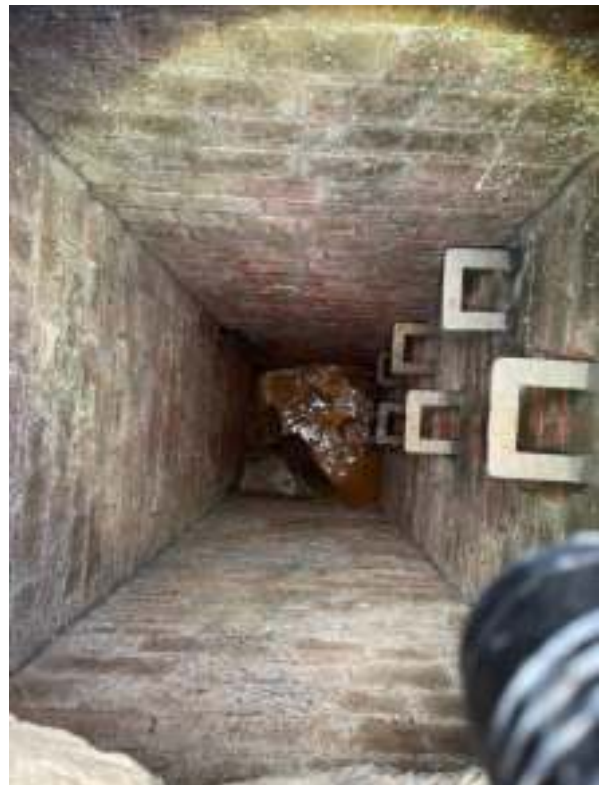
## Harthill Street Upstream Inspection Chamber

The up stream inspection chamber located on Harthill Street (identified in blue on the drain plan provided) is confirmed as being a live culvert. Photographs and a video of this chamber are attached. However we were unable to locate the down stream chamber that is being shown on Waterloo Road. A number of inspection chambers and access points were inspected throughout the surrounding area on both Waterloo Road and Broughton Street but none were found to be related to the culvert in question.

Unfortunately a number of factors prevented us from carrying out a CCTV drain survey. This was due to the silt level in the base of the culvert chamber, the flow rate of the water, and the lack of down stream access. For your information, the invert of the chamber on Harthill Street is approximately 3800mm.

I have spoken with a company who specialise in surveys for this type of situation, and we are currently awaiting a cost for them to carry out a CCTV drain survey.
