**UNDERWATER TACTILE INSPECTION OF ROCHDALE CANAL WALL –  
MANCHESTER**

**October 2023**

**DOCUMENT REF: 2345874-R-01(01)**

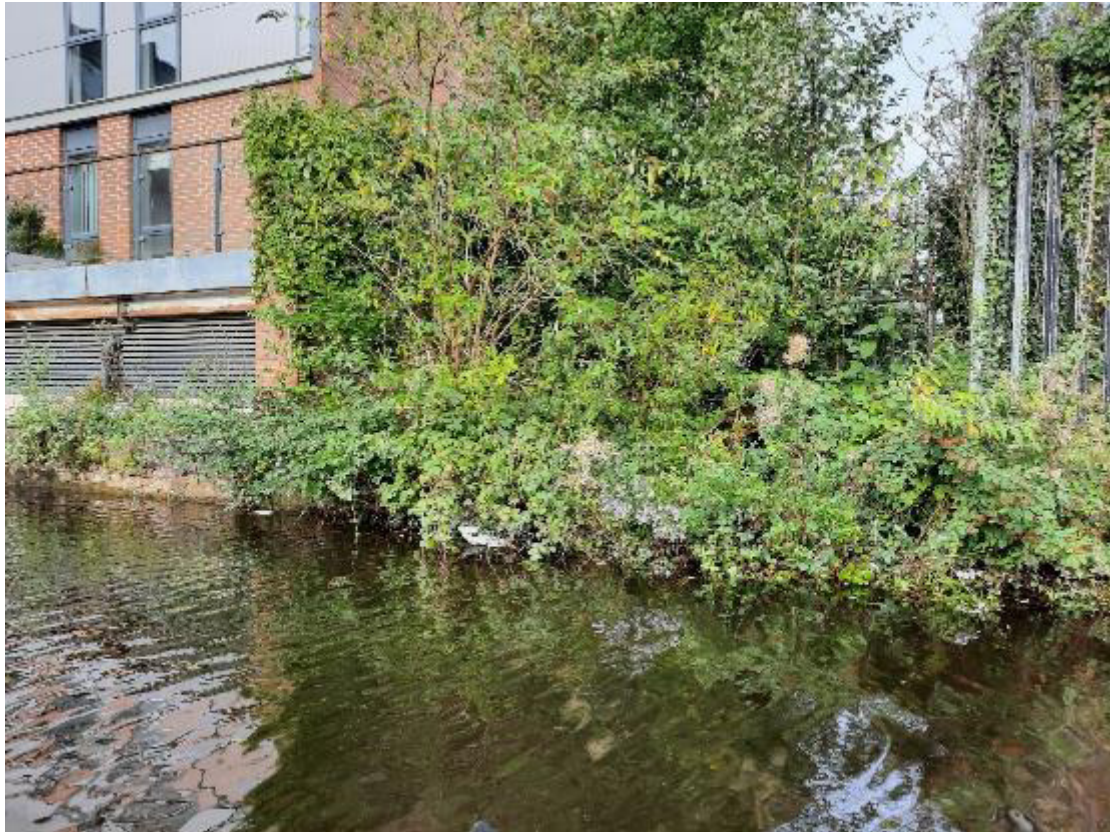
- 4.3.4 Overgrown vegetation was noted at various locations, some of which affected access and visibility during the inspection (chainage 20m – 36.5m).  
There were two particular areas where vegetation growth was causing upwards displacement of the wall, one at chainage 42m (brickwork displaced by up to 65mm) and the other at chainage 145.1m (stonework displaced by up to 45mm).

Photo 11: Overgrown vegetation covering wall and affecting full inspection at ch.0.7m (defect no.1)

- 5.2 As no previous inspection records were available for review, the rate of deterioration and therefore urgency of works is unclear.  
Overgrown vegetation should be cut back to help with the access for any future inspections, with larger saplings removed / poisoned to prevent any further structural damage to the wall.  
Localised masonry/concrete repairs to any spalled, missing or loose sections of the wall, as well as repointing works to any sections of mortar loss should also be considered to help prolong the longevity of the structure.

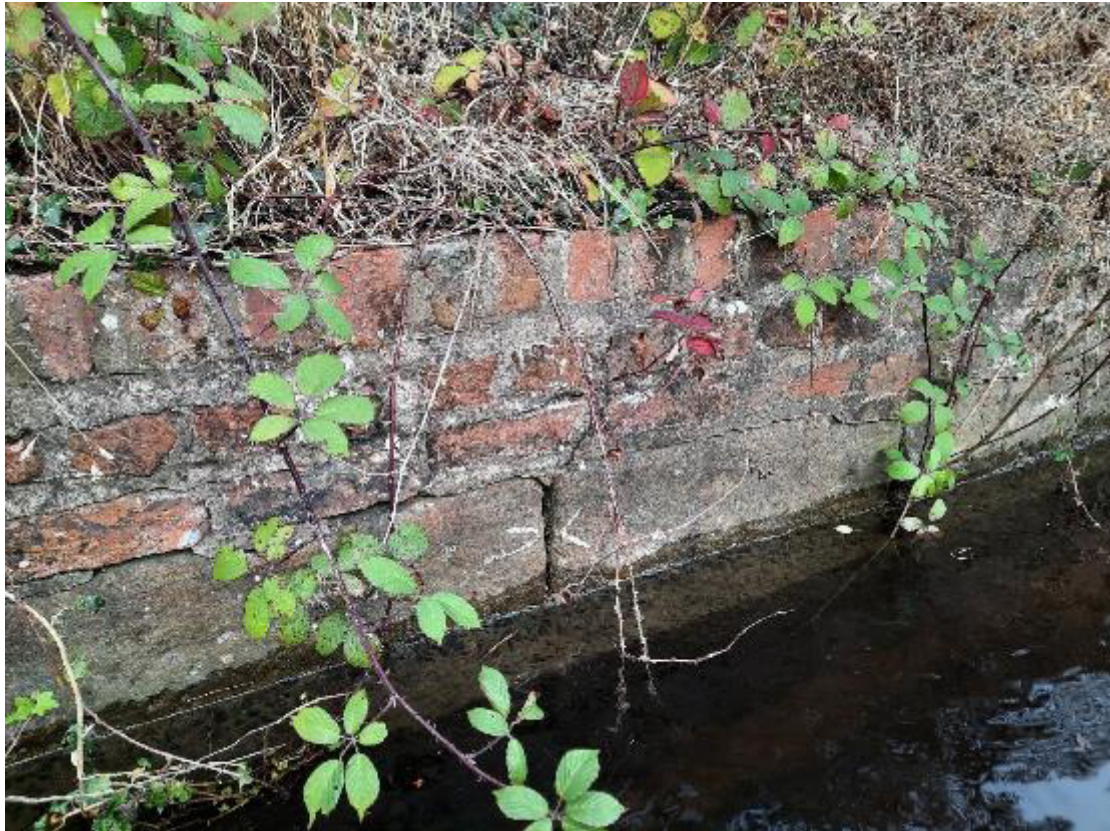
Photo 12: Typical example of joint mortar loss to stonework between ch.10m & ch.50m (defect no.2).

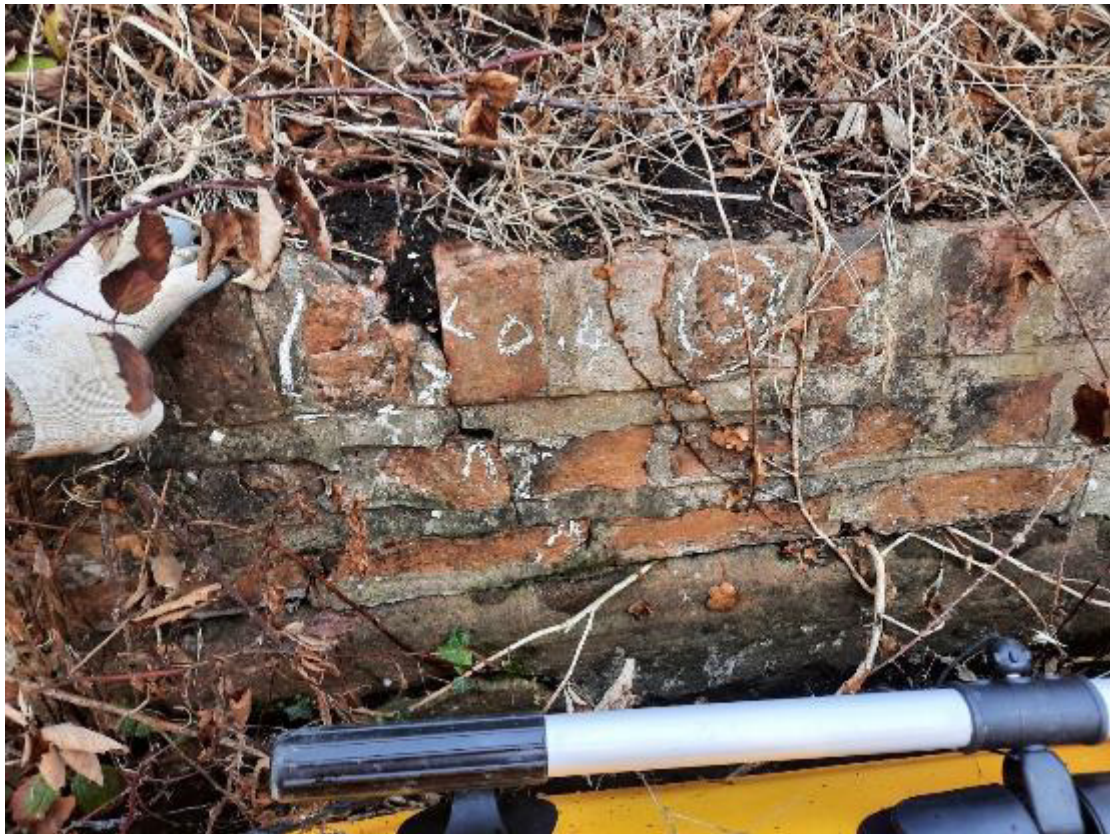
- 4.3.3 Vertical stepped cracking was found to the brickwork at chainage 13m and 22m, both cracks were 0.4mm wide.  
Vertical cracking was also found at three locations to the concrete sections (chainage 56.5m, 88.5m & 207.3m) ranging from 0.2mm wide and up to 1.1mm wide.

Photo 13: Vertical stepped crack to brickwork at ch.13m (defect no.3).

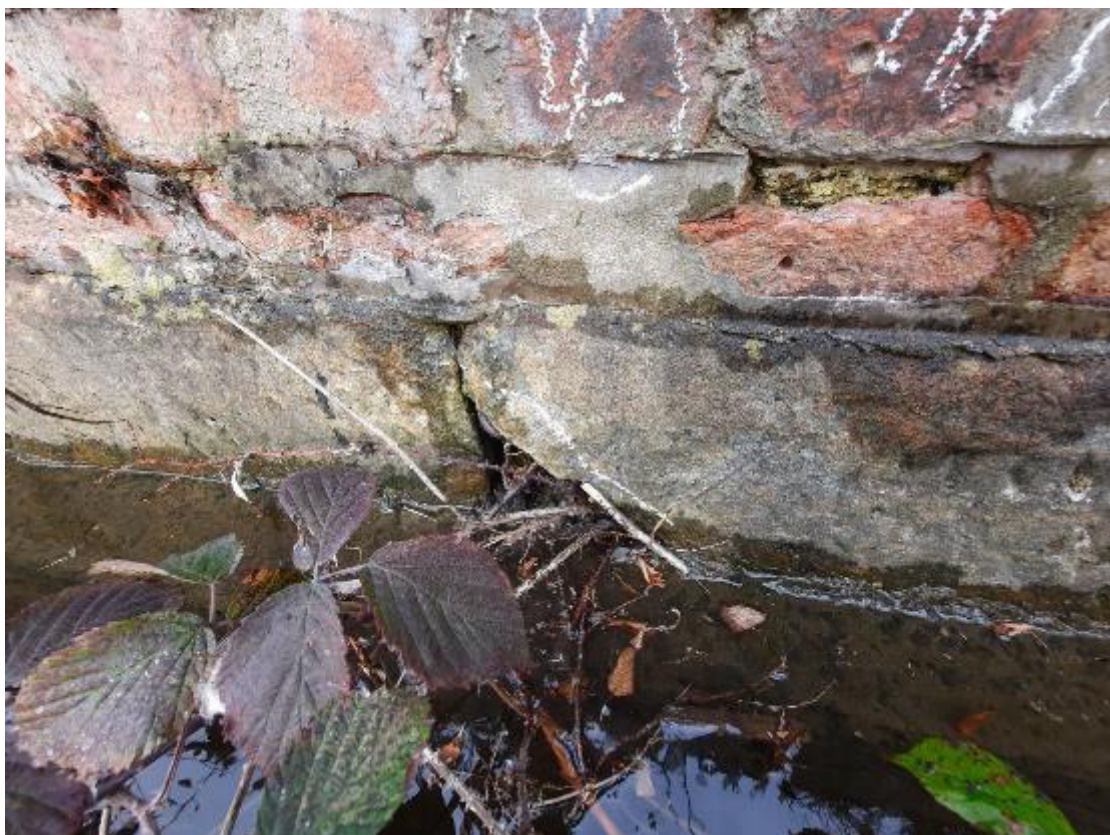
Photo 14: Spall to stonework at ch.15m (defect no.4).

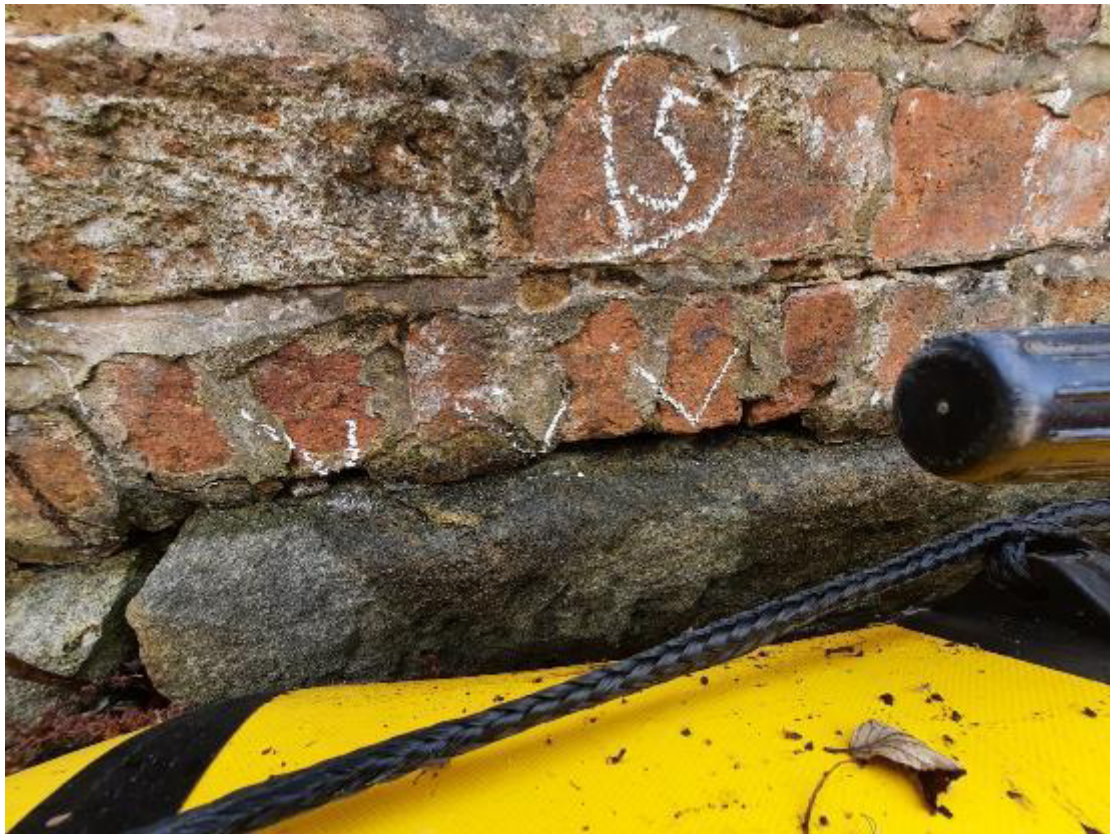
Photo 15: Typical example of joint mortar loss to brickwork between ch.0m & ch.20m (defect no.5).

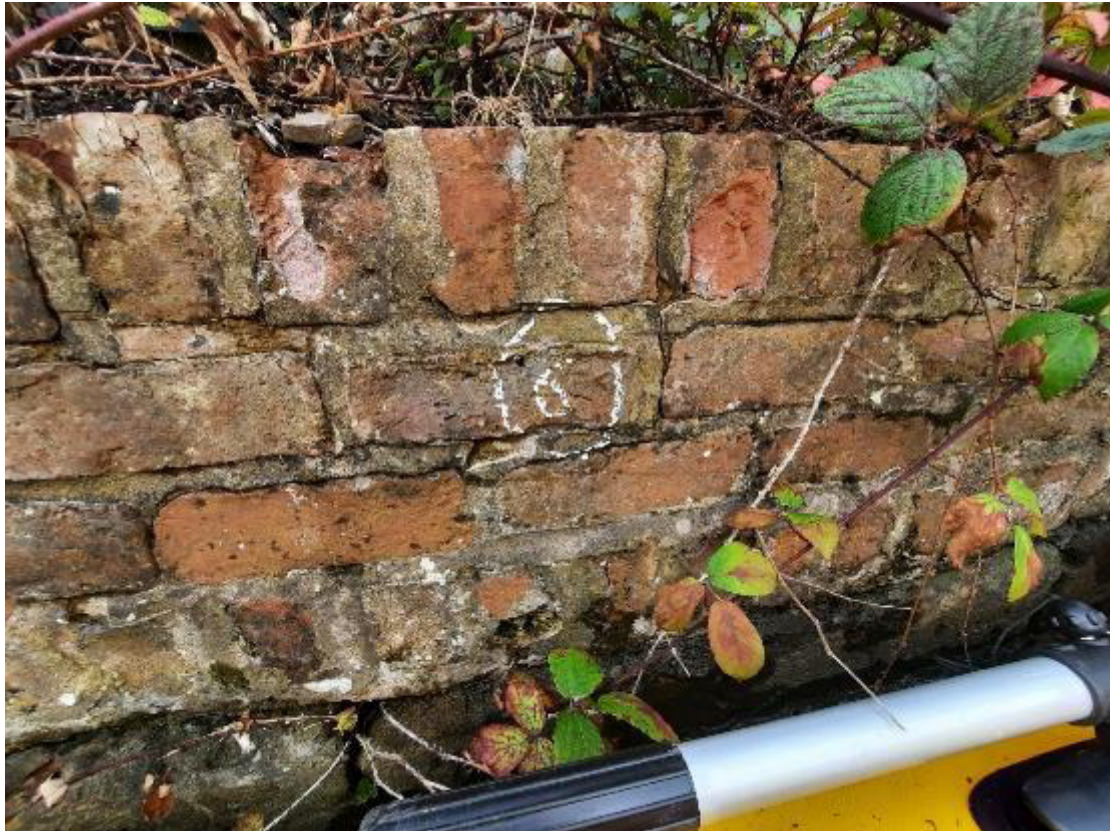
Photo 16: Typical example of face loss to brickwork between ch.0m and ch.20m (defect no.6).

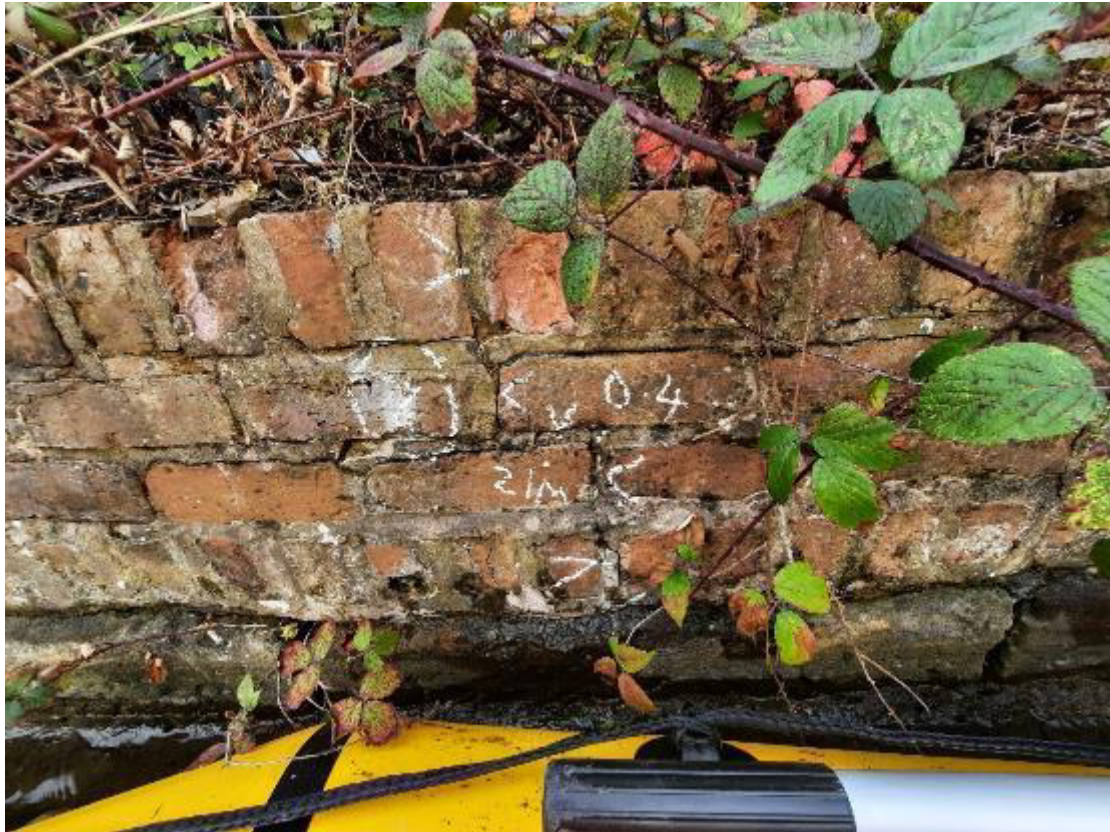
Photo 17: Vertical stepped crack to brickwork at ch.22m (defect no.7).

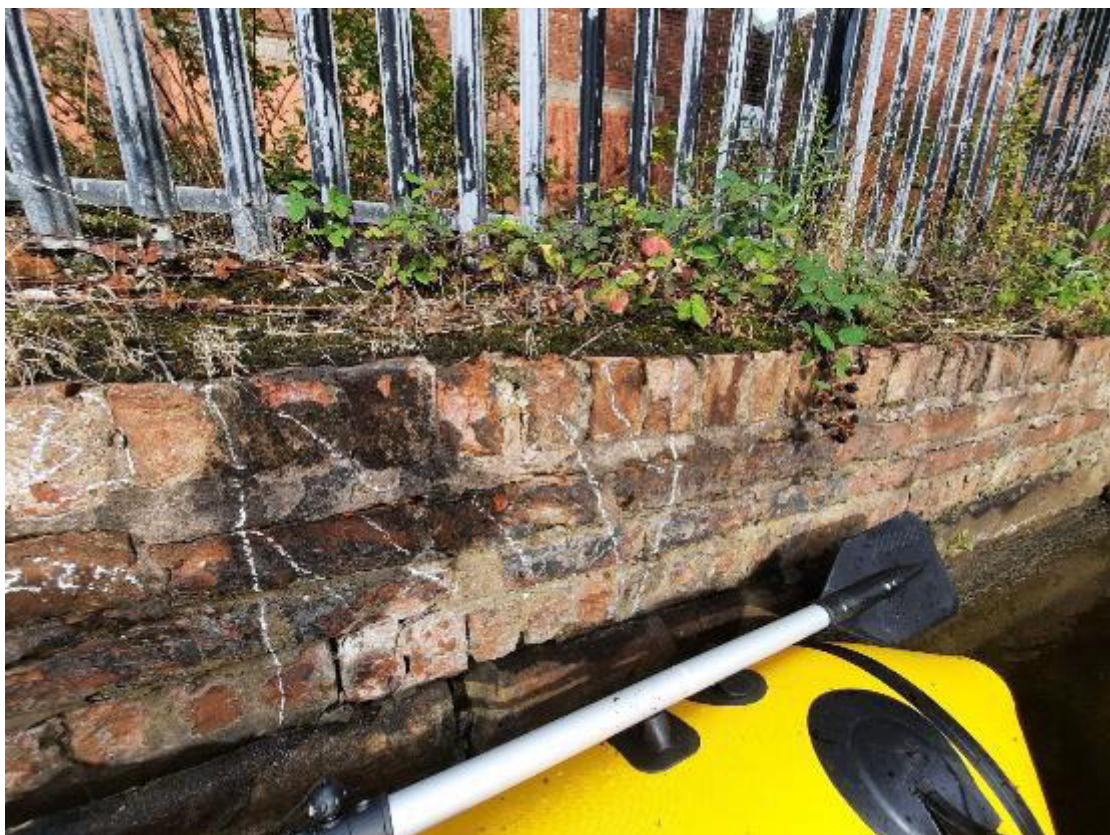
Photo 18: Area of hollow sounding and loose brickwork at ch.22m (defect no.8).

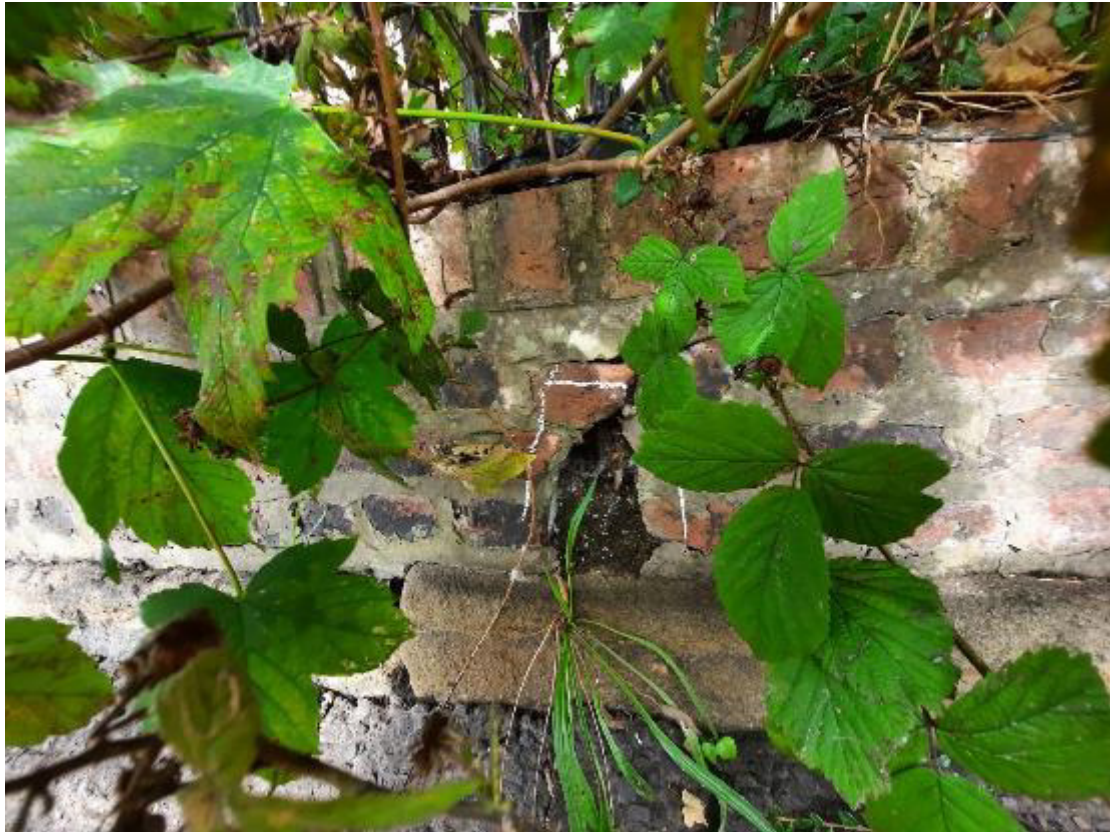
Photo 19: Spall to brickwork at ch.30m (defect no.9).

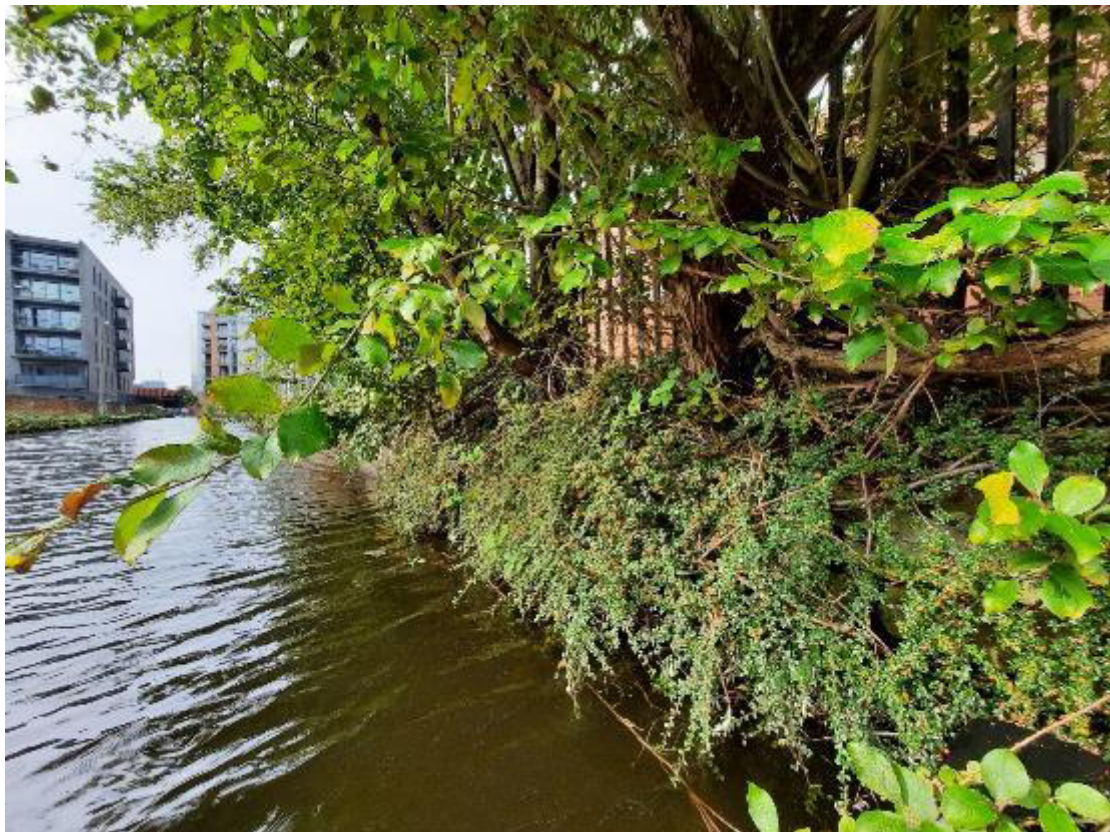
Photo 20: Overgrown vegetation covering wall and affecting full inspection between ch.20m & ch.36.5m (defect no.10).

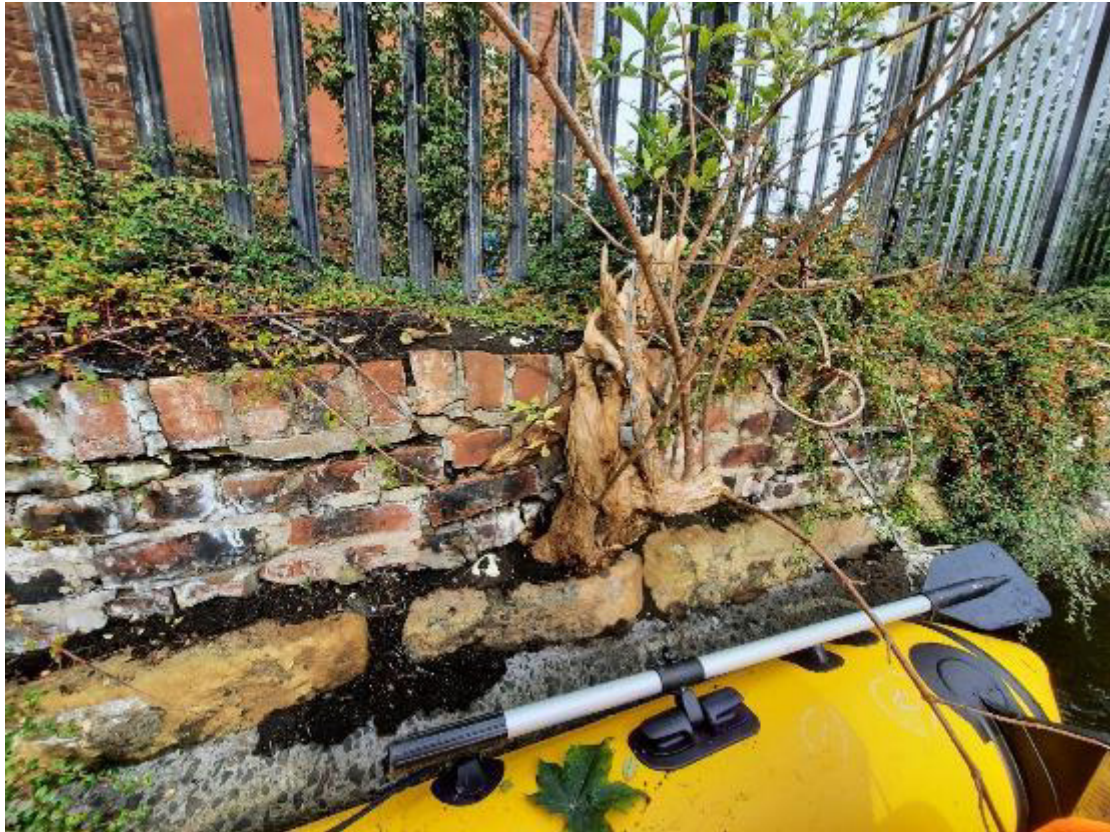
Photo 21: Displaced brickwork and associated root growth from ch.39m to ch.42m (defect no.11).

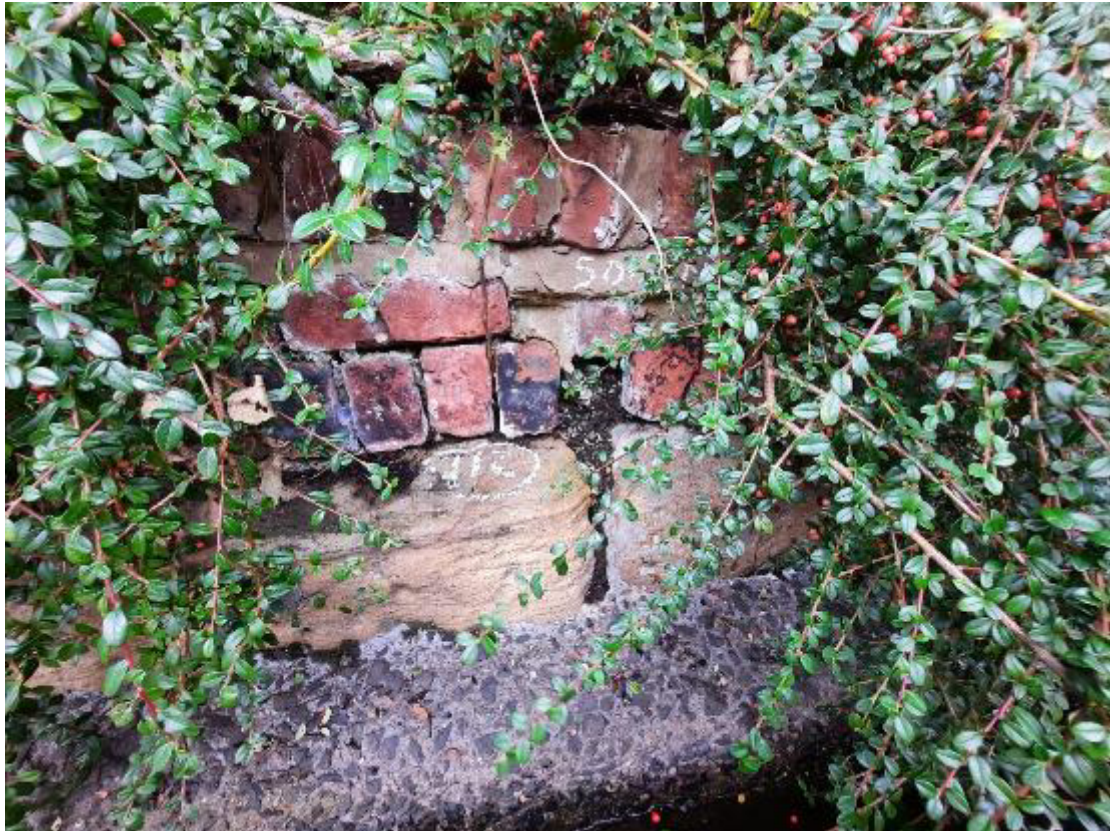
Photo 22: Missing brickwork at ch.50.2m (defect no.12).

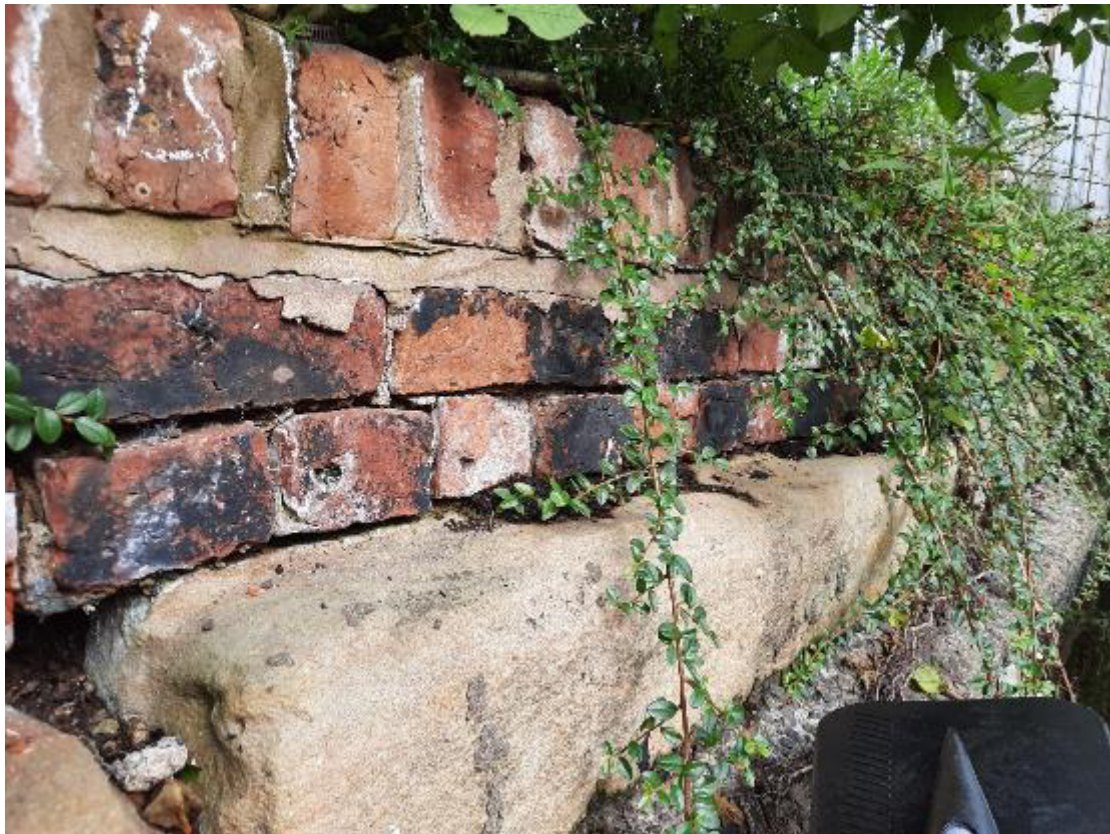
Photo 23: Typical example of joint mortar loss to brickwork between ch.50m & ch.100m (defect no.13).

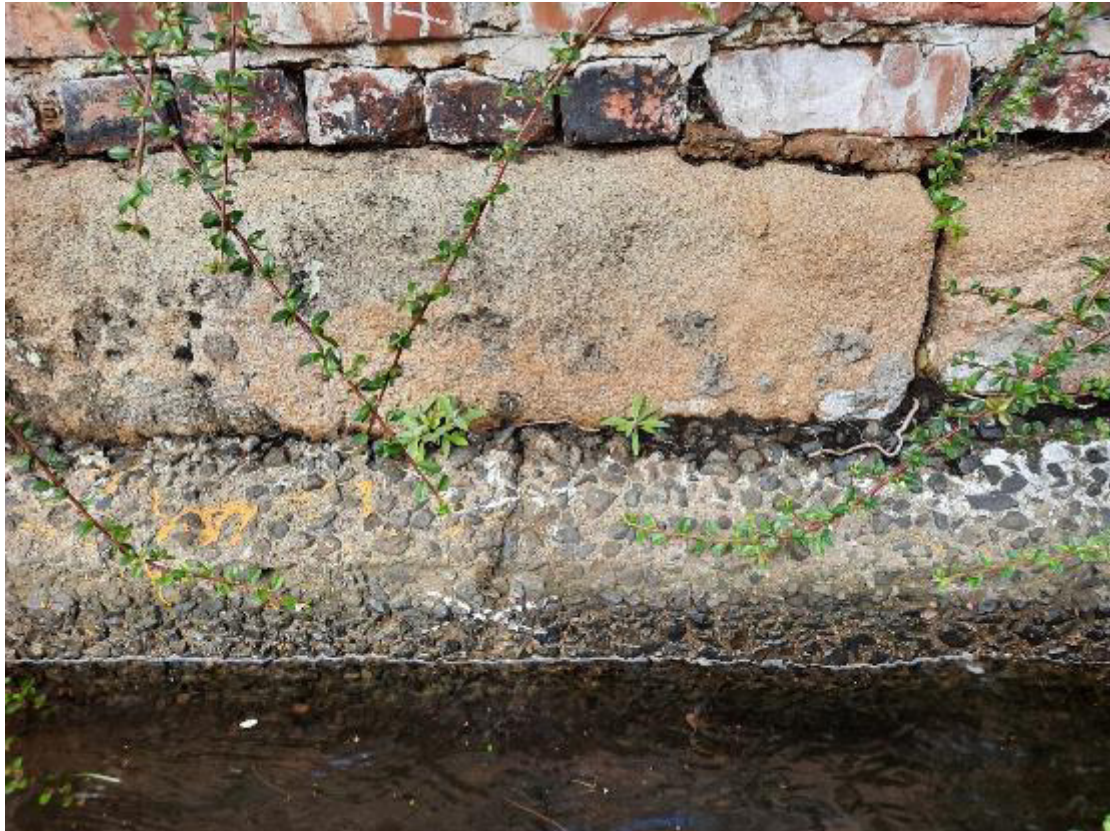
Photo 24: Vertical crack to concrete plinth at ch.56.5m (defect no.14).

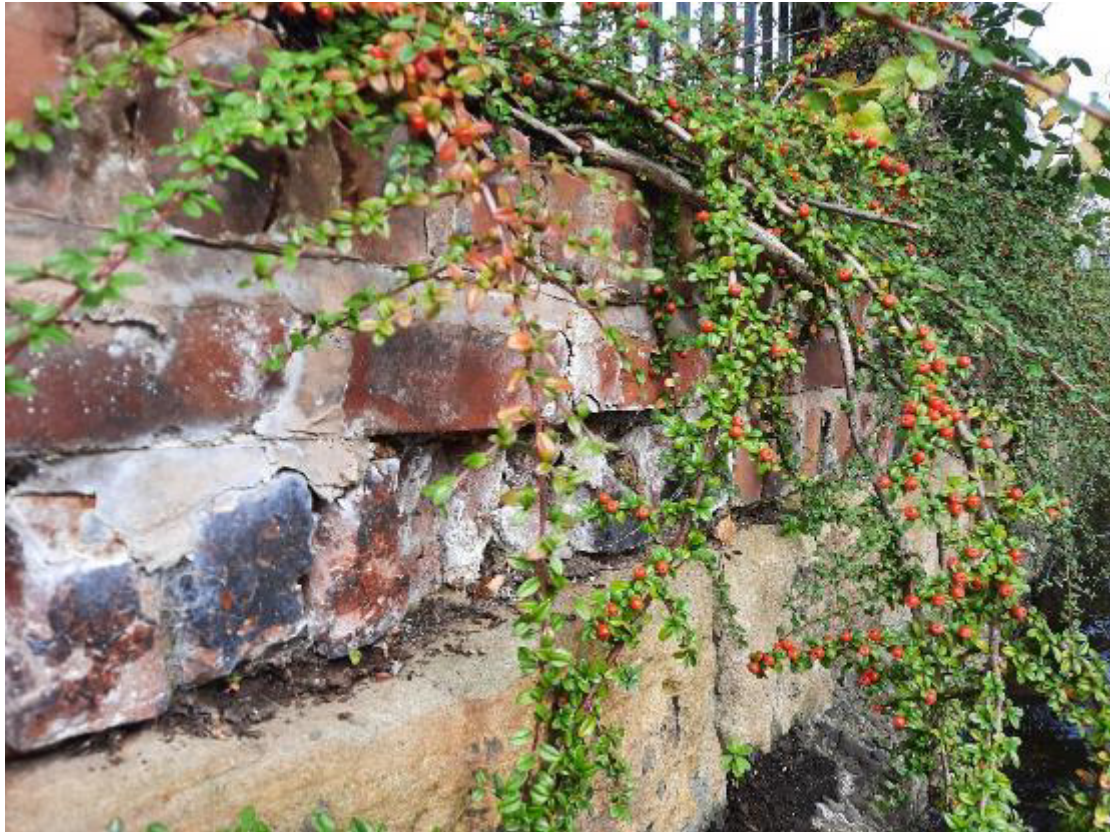
Photo 25: Area of face loss to brickwork at ch.61m (defect no.15).

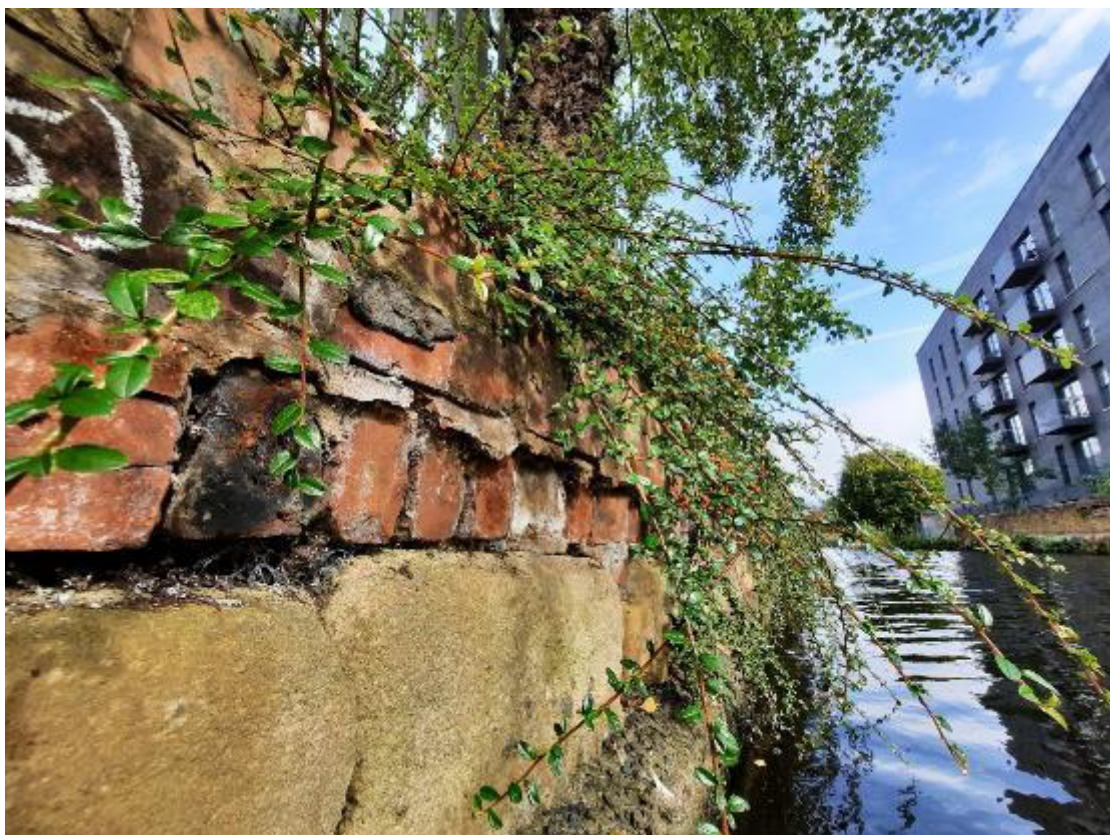
Photo 26: Area of bulged brickwork and associated tree growth from ch.63.6m to ch.65m (defect no.16).

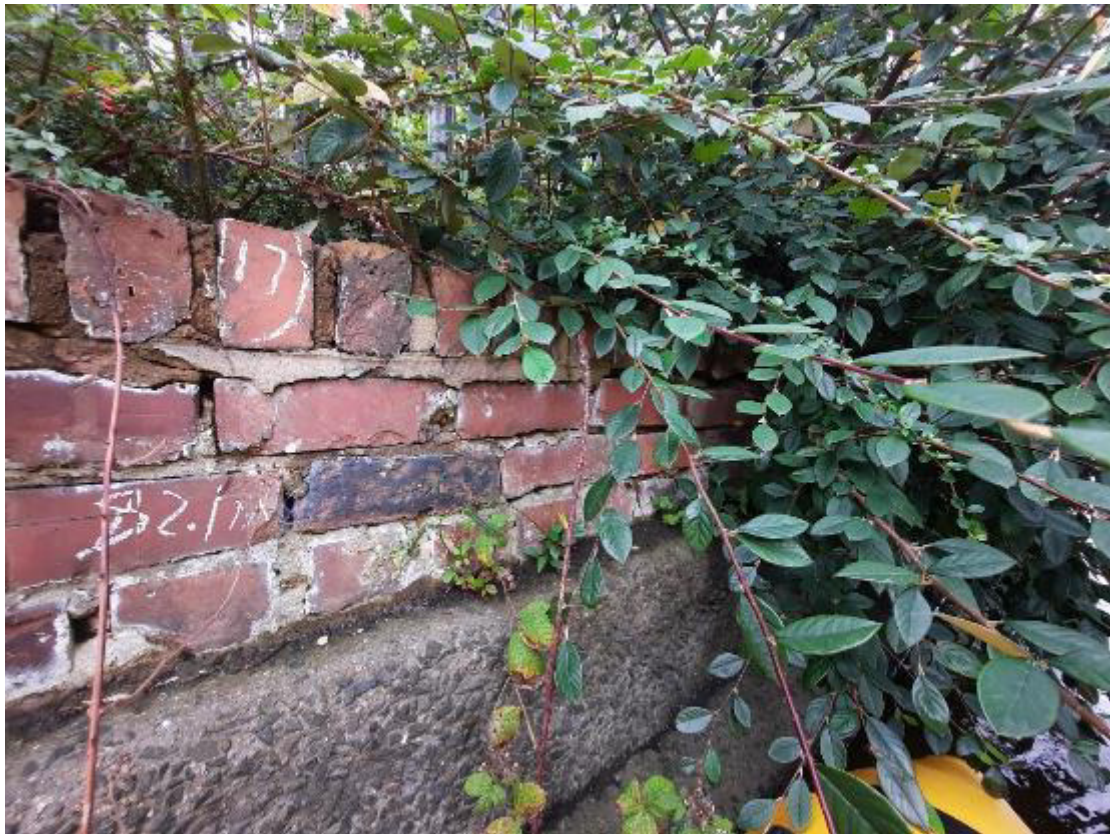
Photo 27: Area of outward displacement to brickwork at ch.82.1m (defect no.17).

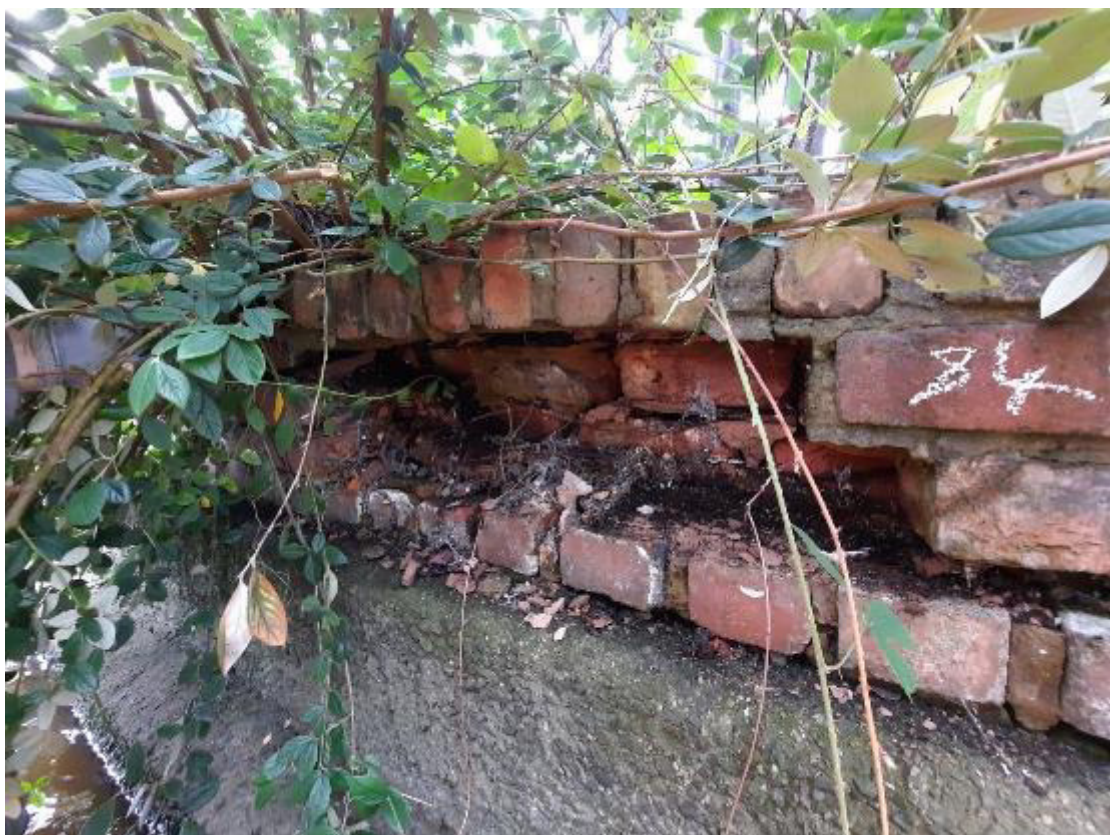
Photo 28: Missing section of brickwork at ch.84m (defect no.18).

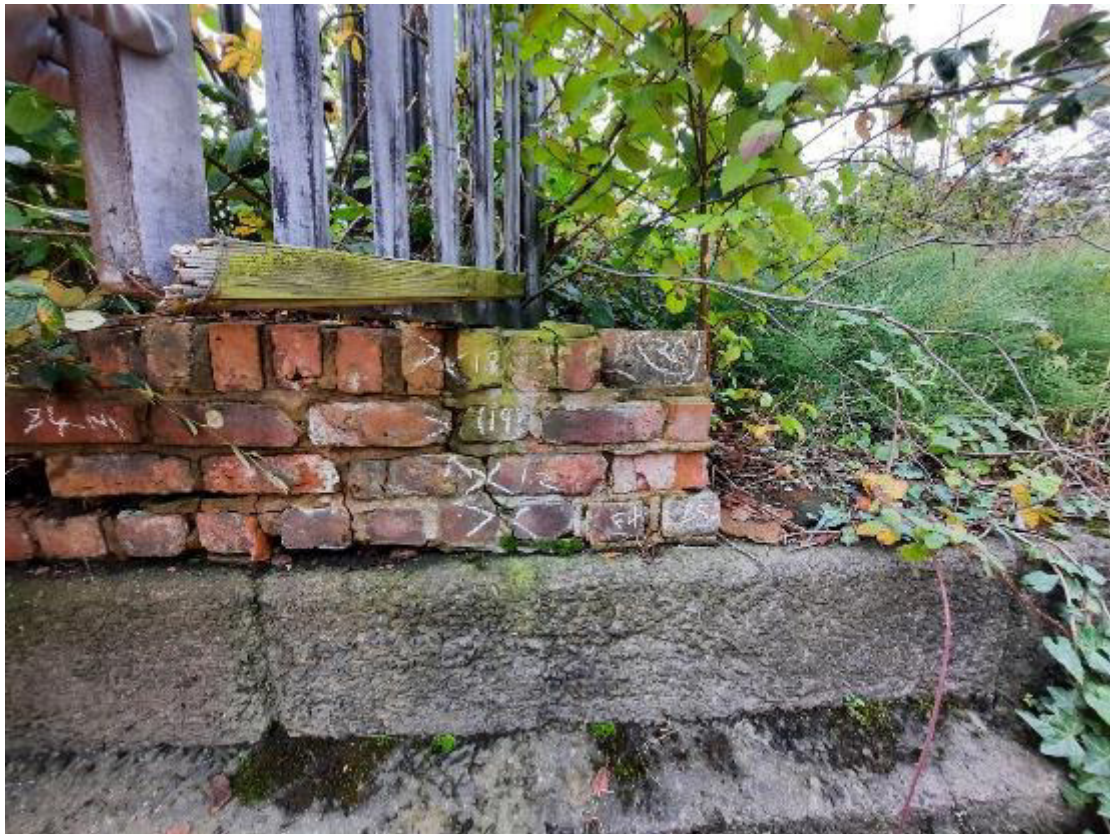
Photo 29: Vertical stepped crack to brickwork at ch.84.7m (defect no.19).

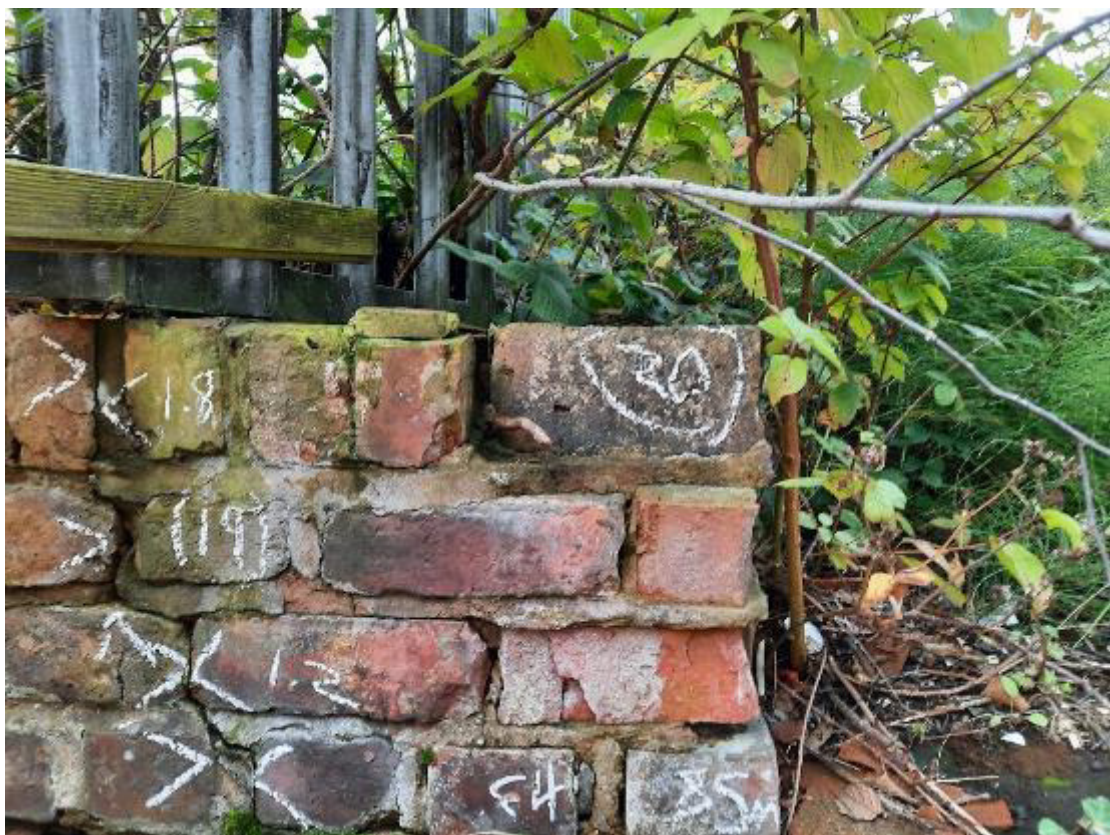
Photo 30: Missing brickwork at ch.85m (defect no.20).

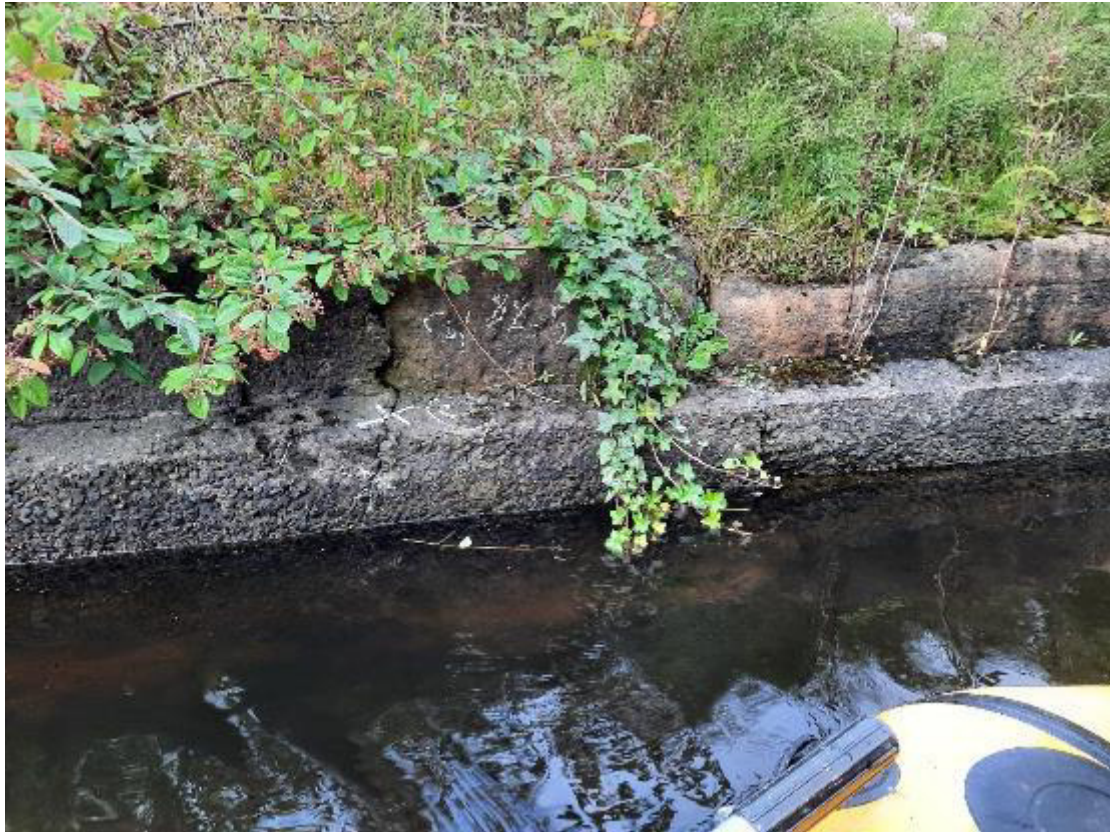
Photo 31: 2 no. vertical cracks to concrete plinth at ch.88.5m (defect no.21).

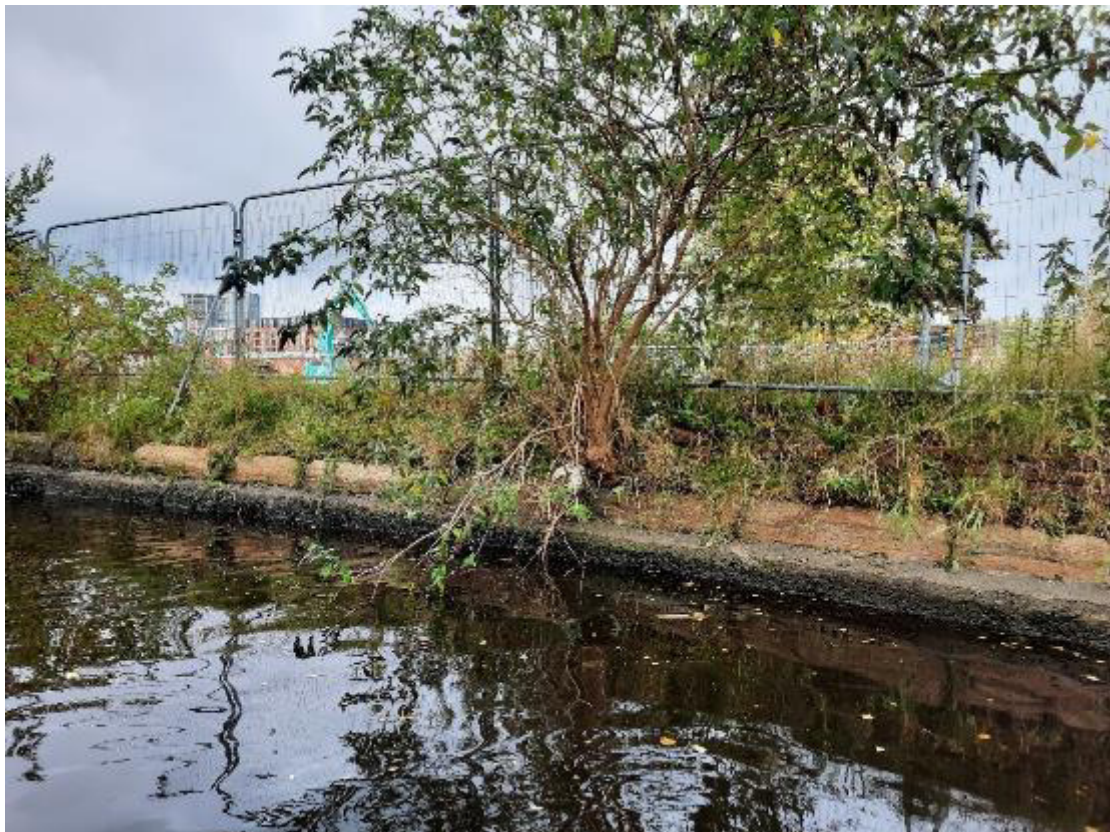
Photo 33: Tree growth adjacent to wall at ch.115m (defect no.22).

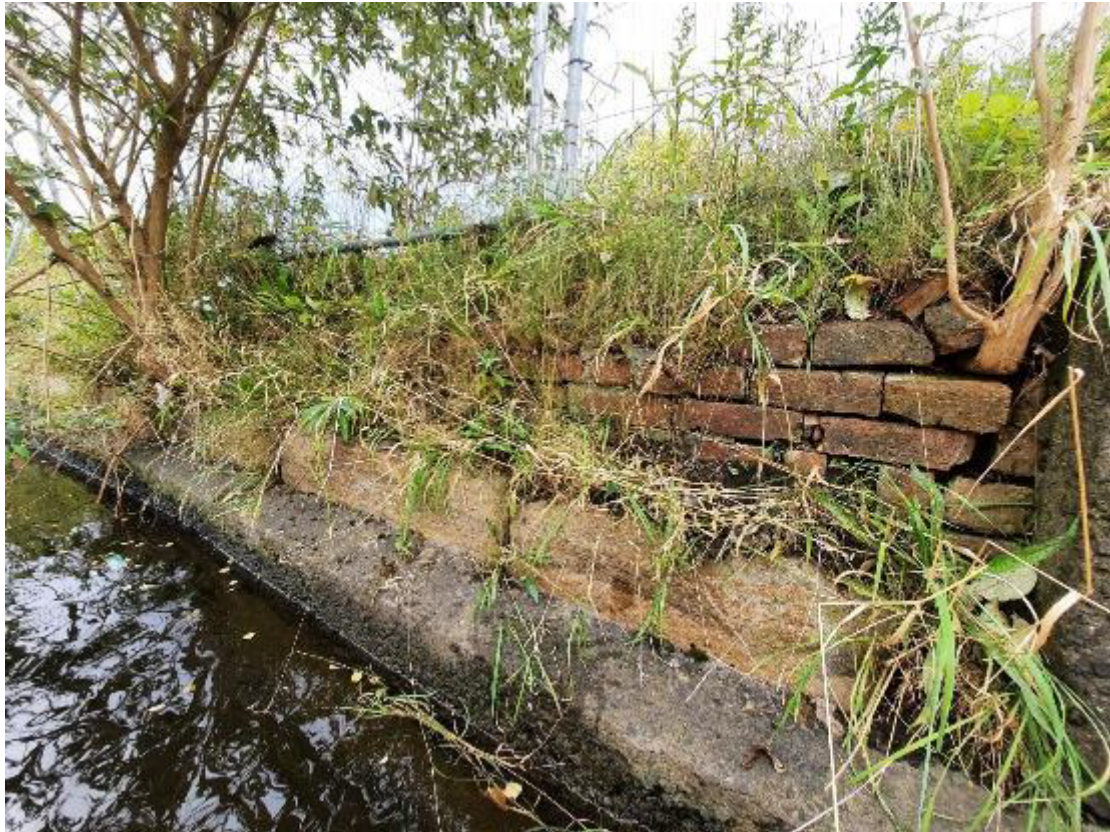
Photo 34: Typical example of joint mortar loss and displacement to brickwork between ch.115m and ch.117m (defect no.23).

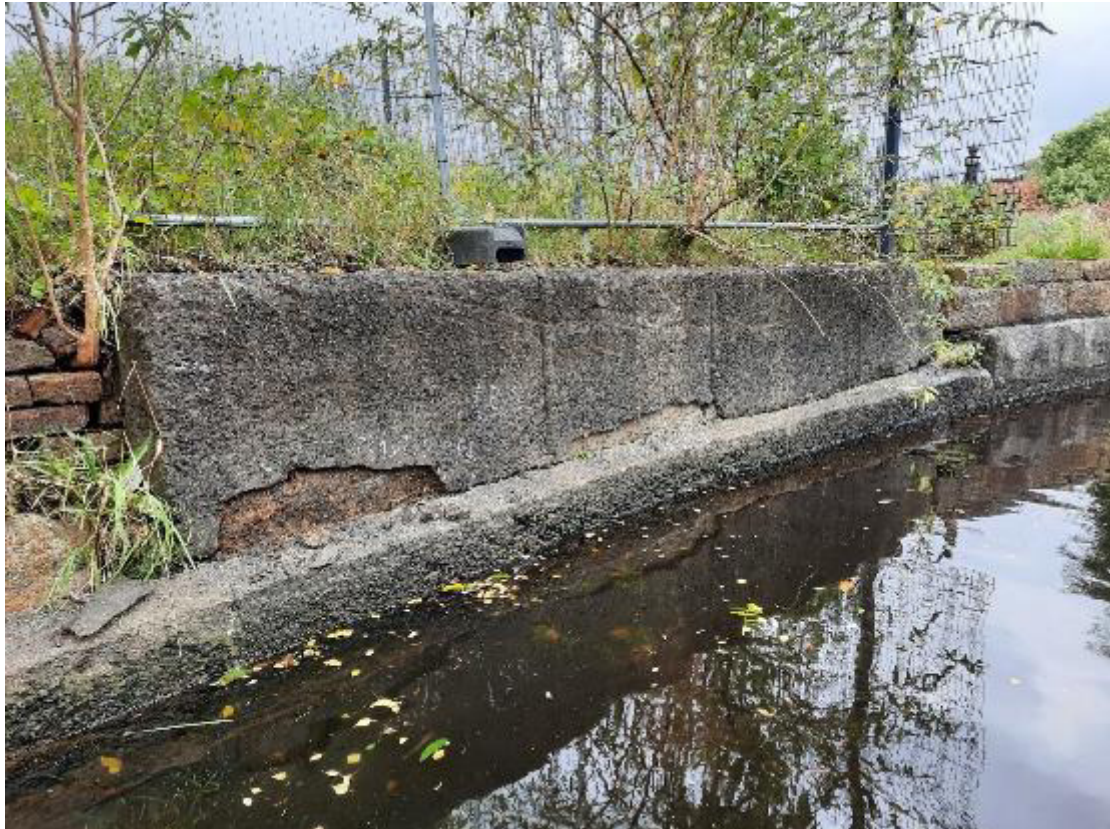
Photo 35: 2 no. areas of spalling to concrete skim over existing stonework at ch.118.6m (defect no.24).
