**UNDERWATER TACTILE INSPECTION OF ROCHDALE CANAL WALL –  
MANCHESTER**

**October 2023**

**DOCUMENT REF: 2345874-R-01(01)**

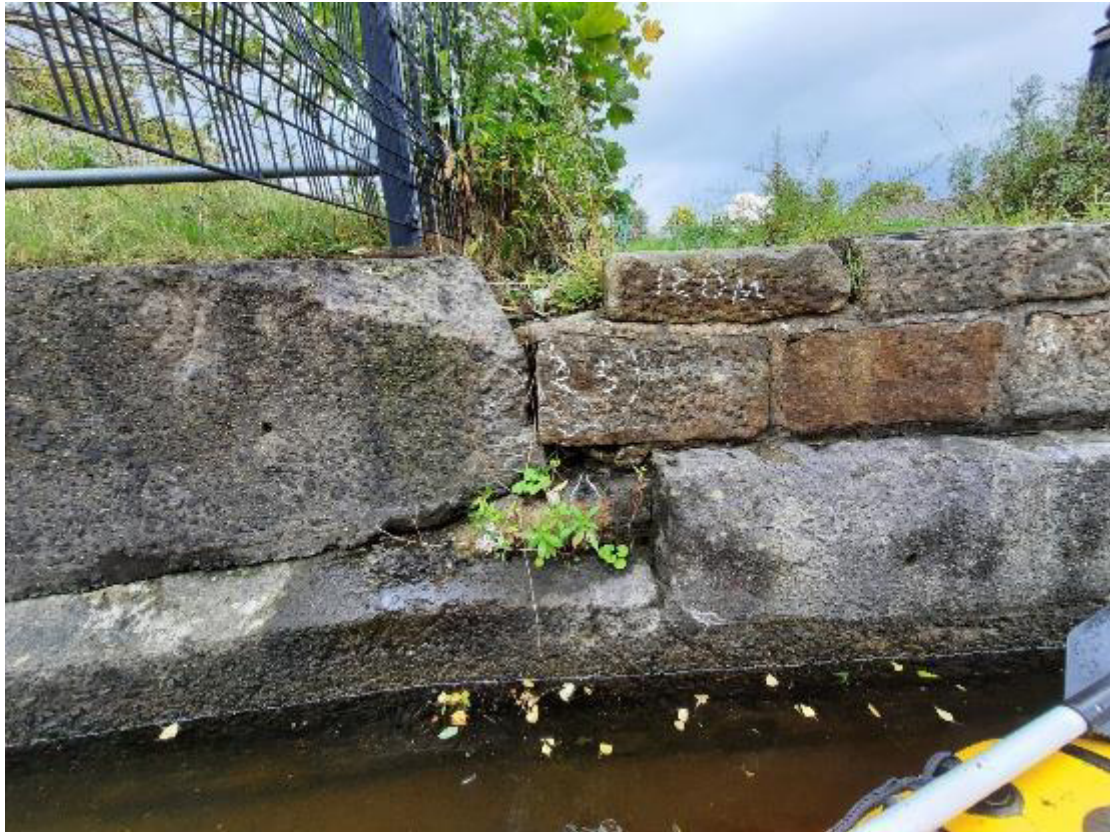
Photo 36: Poor construction joint at ch.120m (defect no.25).

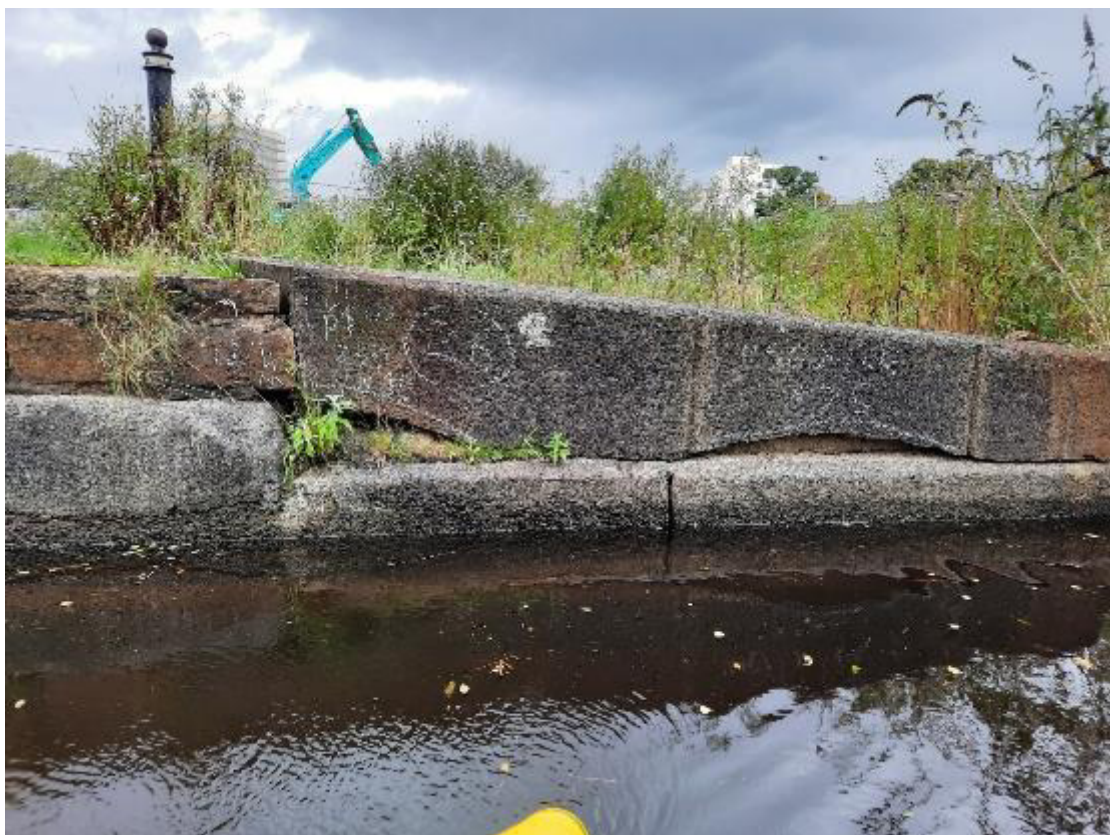
Photo 37: 2 areas of spalled concrete at ch.124m (defect no.26).

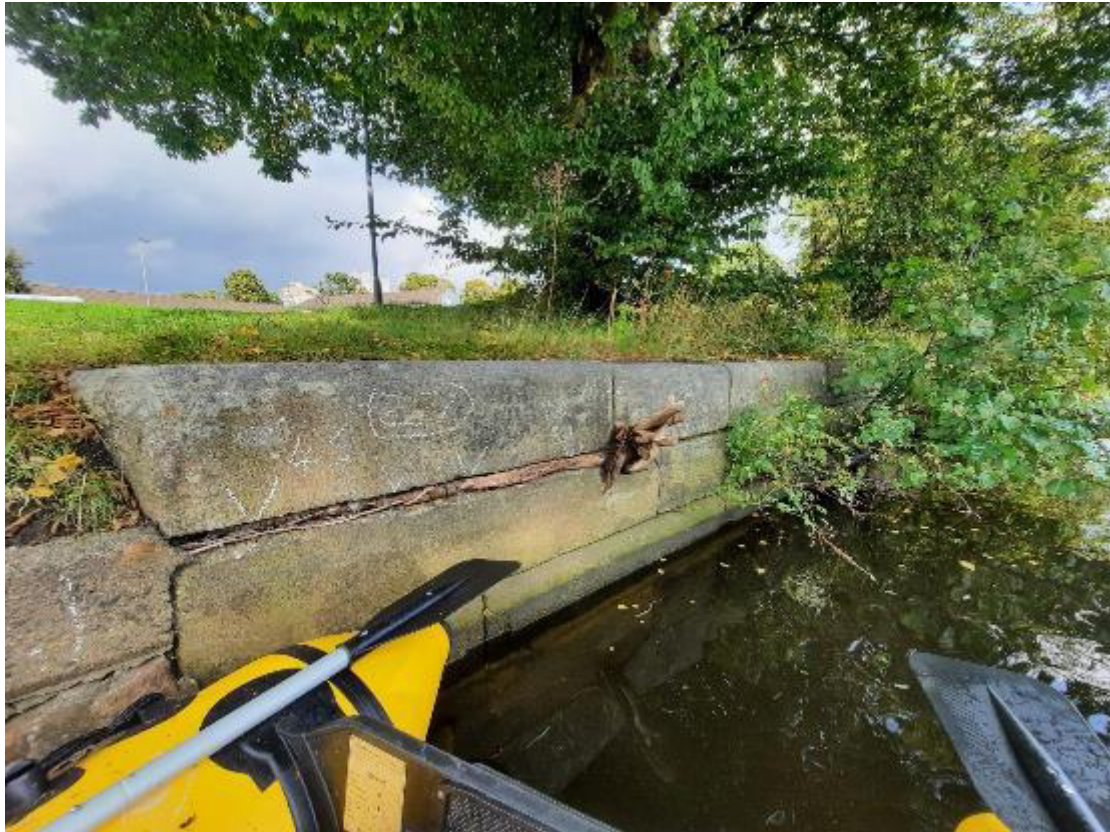
- 4.3.4 Overgrown vegetation was noted at various locations, some of which affected access and visibility during the inspection (chainage 20m – 36.5m).  
There were two particular areas where vegetation growth was causing upwards displacement of the wall, one at chainage 42m (brickwork displaced by up to 65mm) and the other at chainage 145.1m (stonework displaced by up to 45mm).

Photo 38: Displaced stonework and associated root growth at ch.145.1m (defect no.27).

- 5.2 As no previous inspection records were available for review, the rate of deterioration and therefore urgency of works is unclear.  
Overgrown vegetation should be cut back to help with the access for any future inspections, with larger saplings removed / poisoned to prevent any further structural damage to the wall.  
Localised masonry/concrete repairs to any spalled, missing or loose sections of the wall, as well as repointing works to any sections of mortar loss should also be considered to help prolong the longevity of the structure.

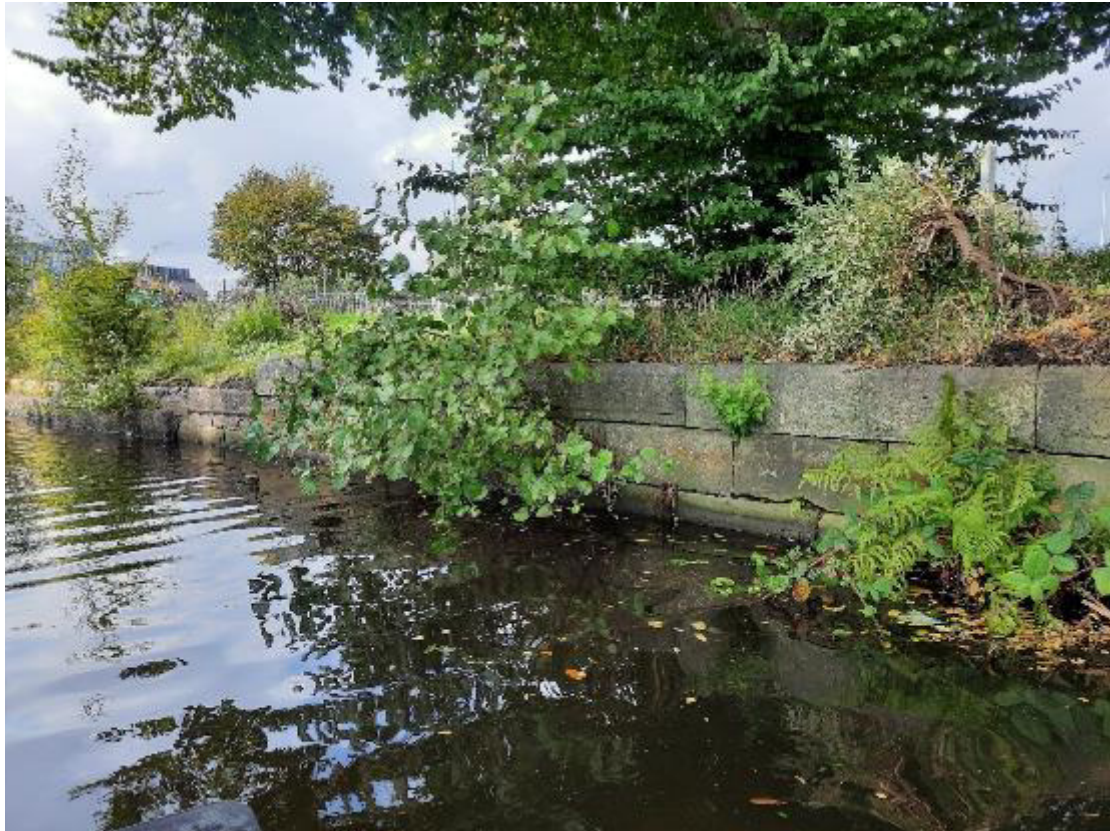
Photo 39: 4 no. areas of sapling growth through stonework between ch.148.5m and ch.160m (defect no.28).

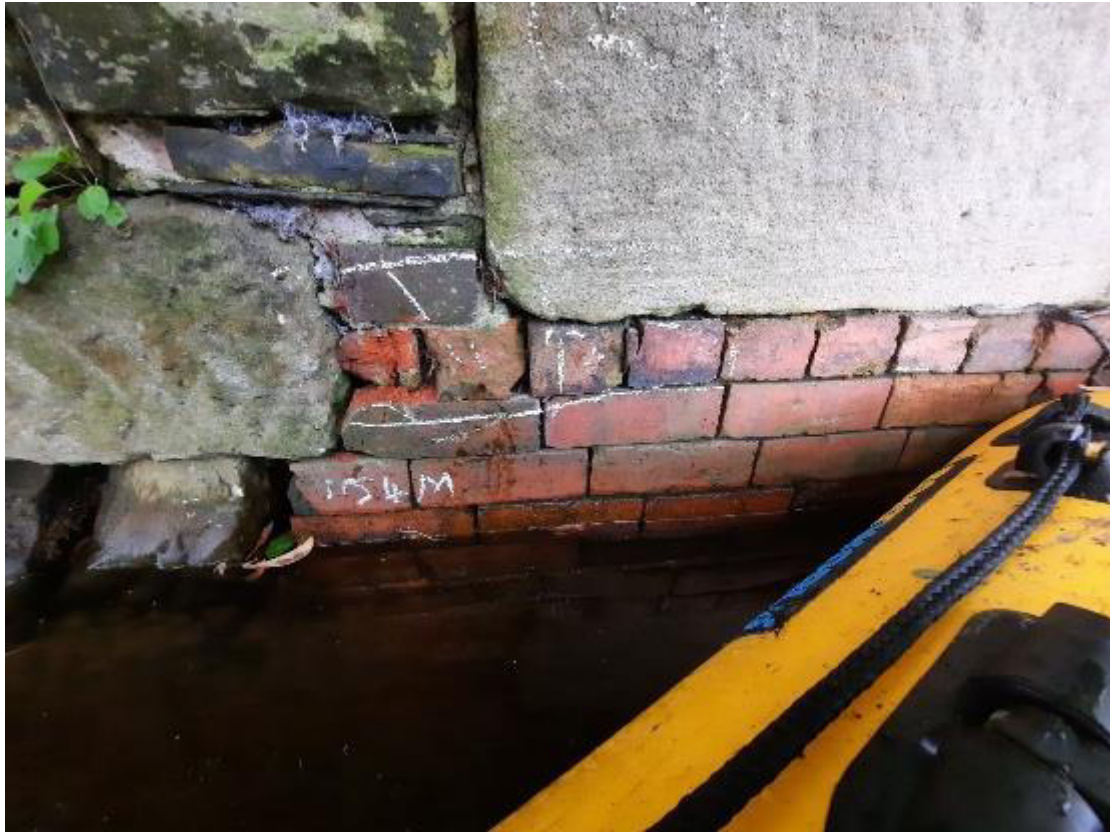
Photo 40: Area of spalled and loose brickwork at ch.154m (defect no.29).

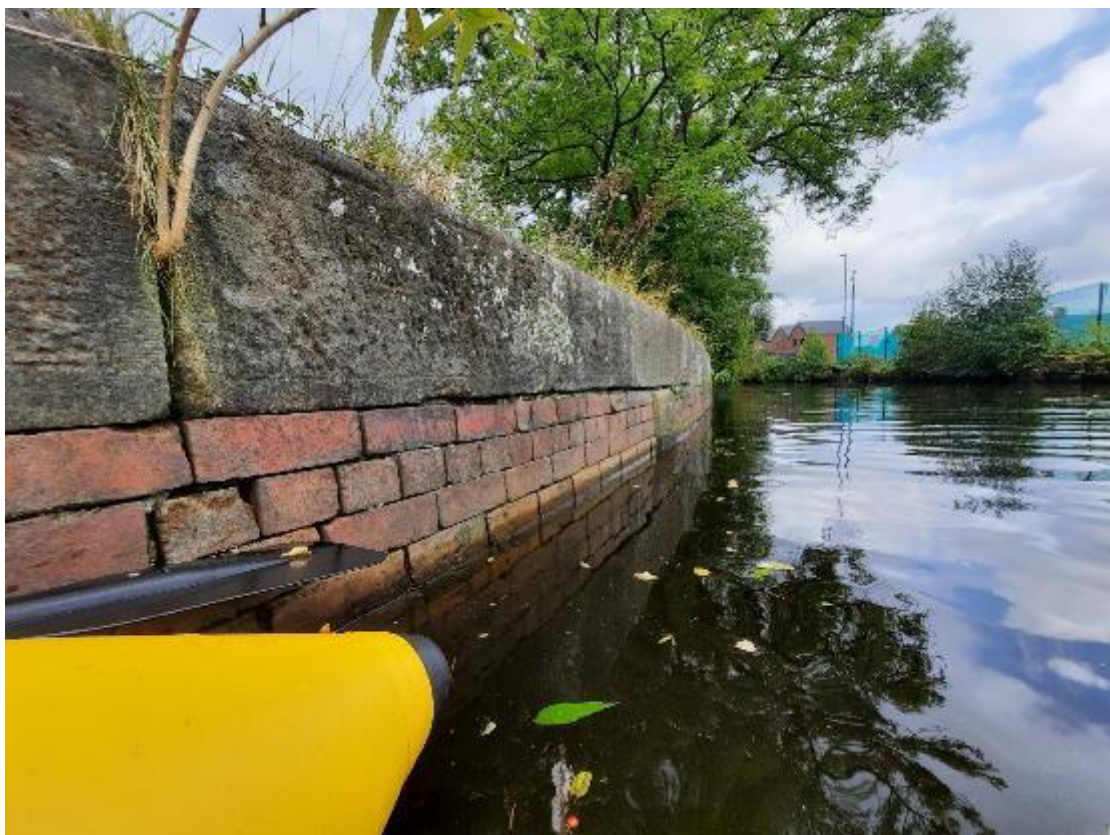
Photo 41: Typical example of joint mortar loss to brickwork between ch.151m and ch.185m (defect no.30).

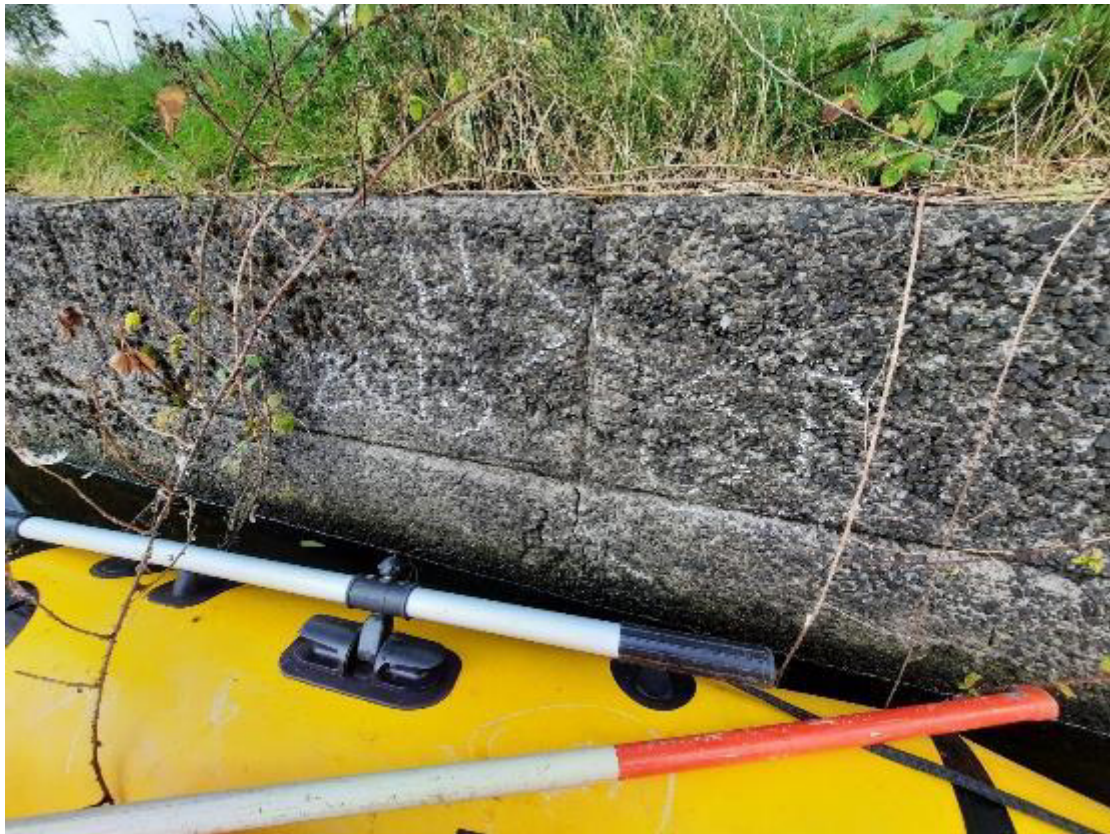
- 4.3.3 Vertical stepped cracking was found to the brickwork at chainage 13m and 22m, both cracks were 0.4mm wide.  
Vertical cracking was also found at three locations to the concrete sections (chainage 56.5m, 88.5m & 207.3m) ranging from 0.2mm wide and up to 1.1mm wide.

Photo 42: Vertical crack to concrete at ch.207.3m (defect no.31).

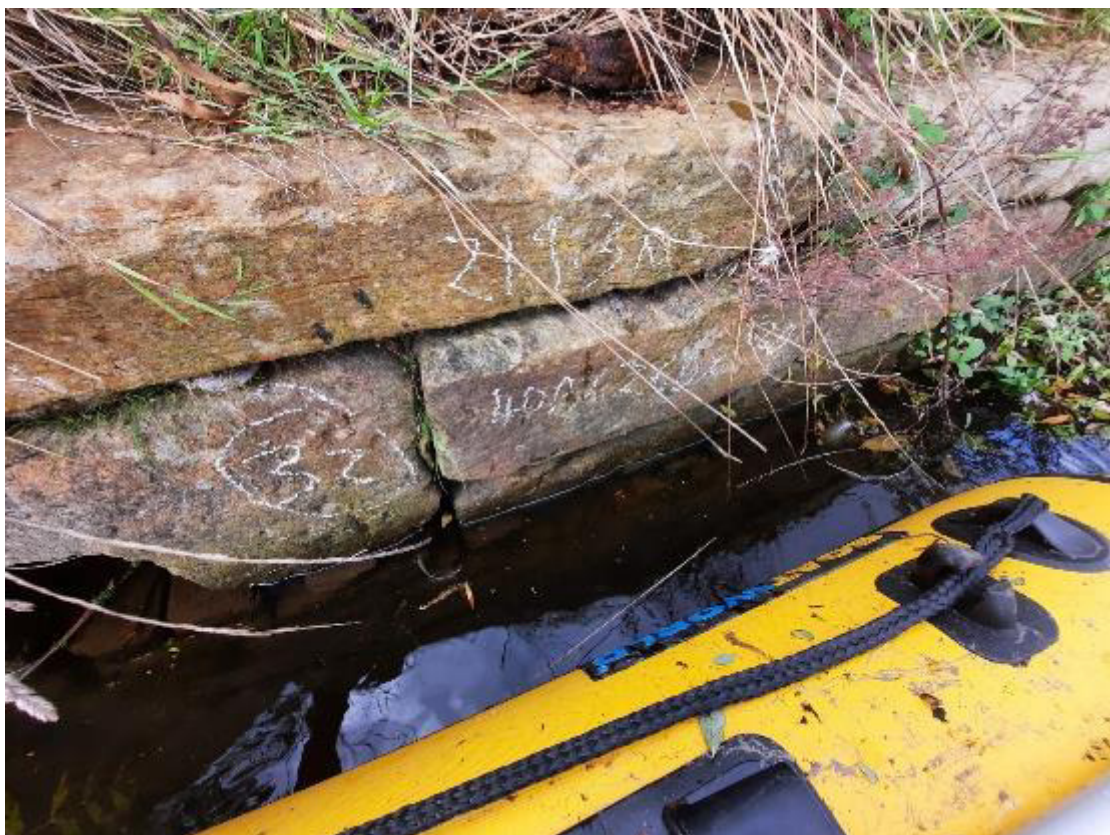
Photo 43: Area of missing stonework below water level at ch.219.5m (defect no.32).

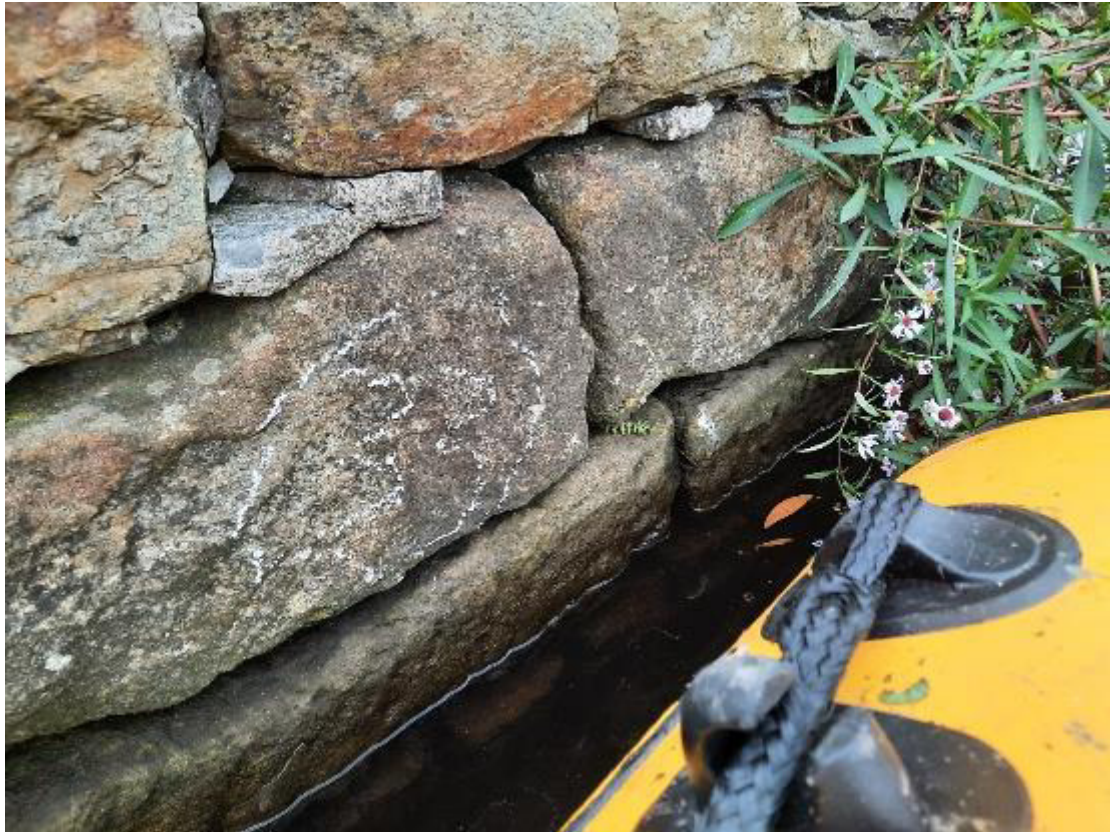
Photo 44: Typical example of joint mortar loss to stonework between ch.219m & ch.230.5m (defect no.33).

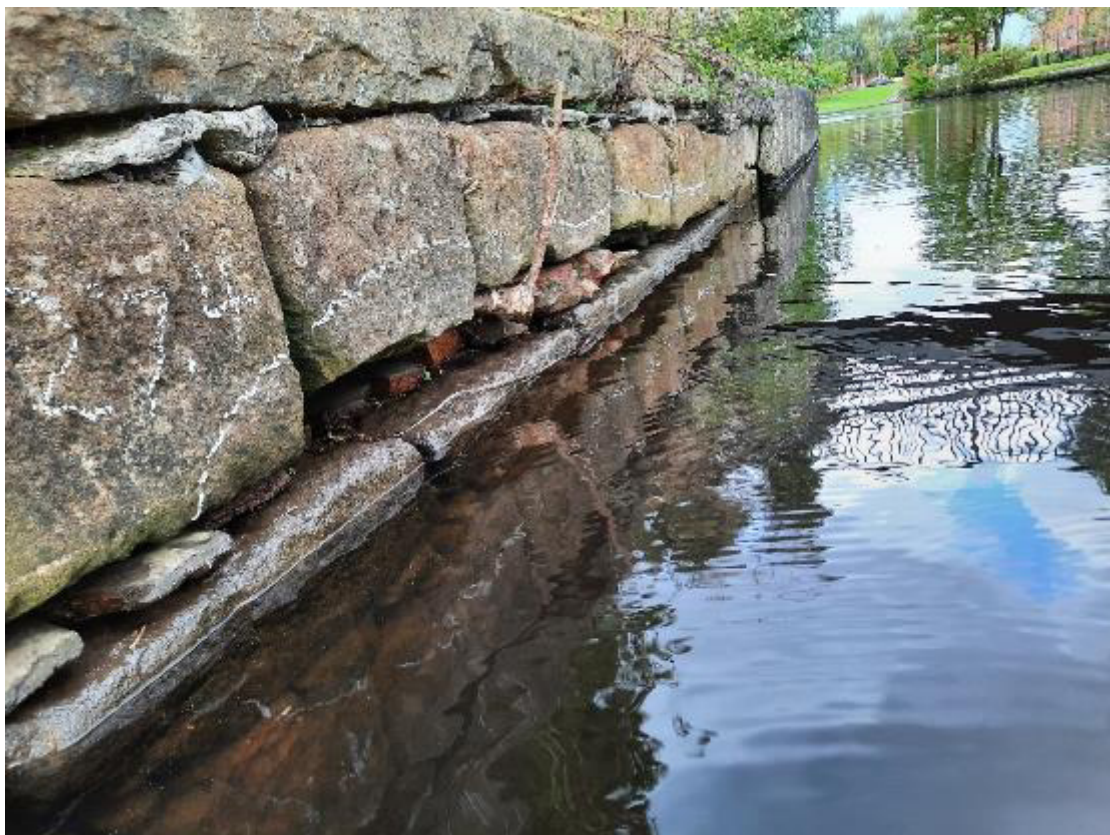
Photo 45: Missing section of stonework at ch.227.5m (defect no.34).

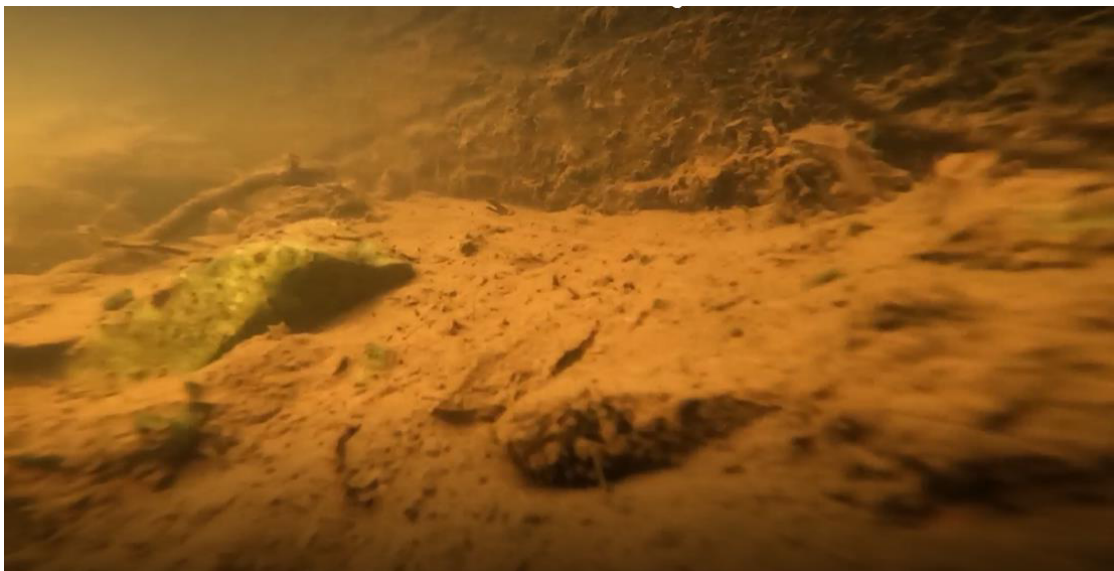
- 4.4.1 The invert at the base of the wall was generally found to comprise silt and stones. Localised areas of debris and branches were also identified.

Photo 47: General underwater view of invert at chainage 148m.

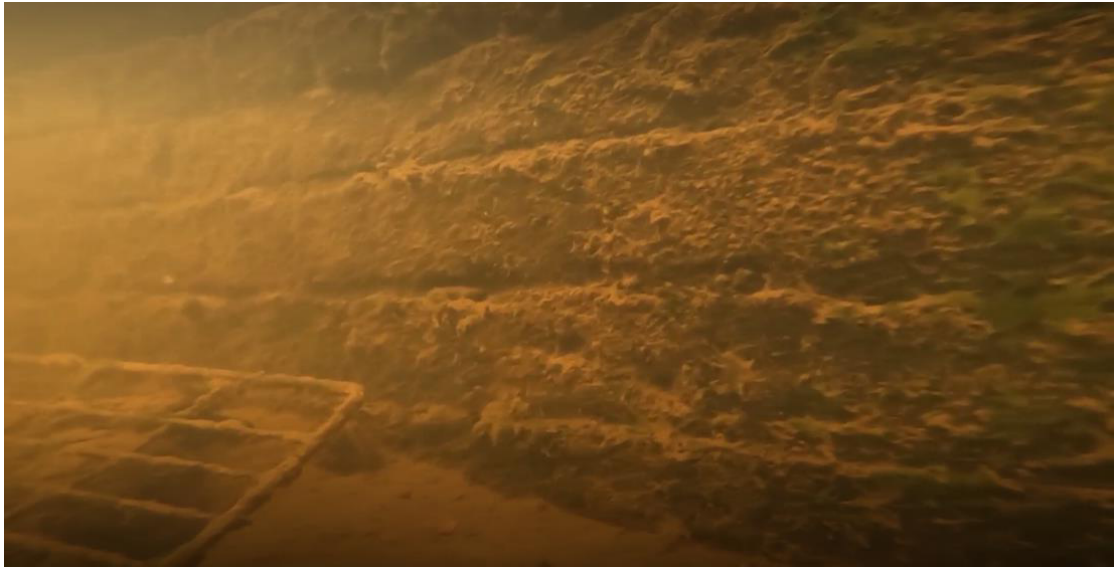
- 5.5 Debris on the invert does not appear to present immediate cause for concern due to its localised nature.
- 5.6 During the inspection, various third party security / boundary fences were noted along some sections of the wall. In order to undertake some of the remedial works, consultation will be required with the owners to request temporary removal as not all works may be feasible from a waterborne works barge.

Photo 48: General underwater view of stonework and debris to invert at chainage 150m.
