## Technical Note 001

### Report on false acacia tree

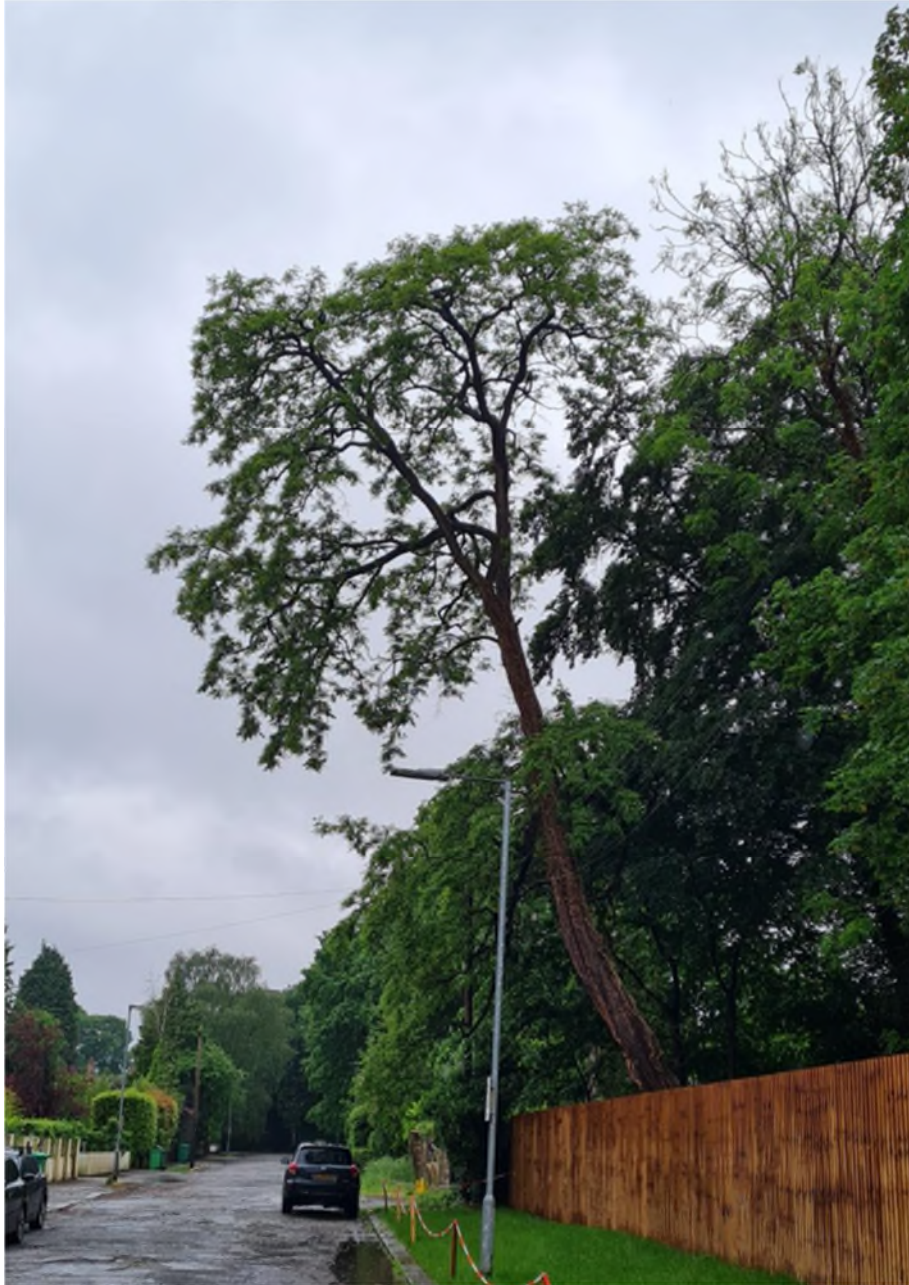
The tree is a false acacia of circa 17m in height with an average crown radius of circa 5m. The stem measures 67cm diameter at 1.5m above ground level. The tree in relation to Lancaster Road can be seen in Figure 1 in the photographs at the end of this note.

The tree has a pronounced lean, biased over Lancaster Road, due to the past competition for light with the adjoining group of mostly beech trees.

*Figure 1: Tree 33 (false acacia) seen from Lancaster Road.*

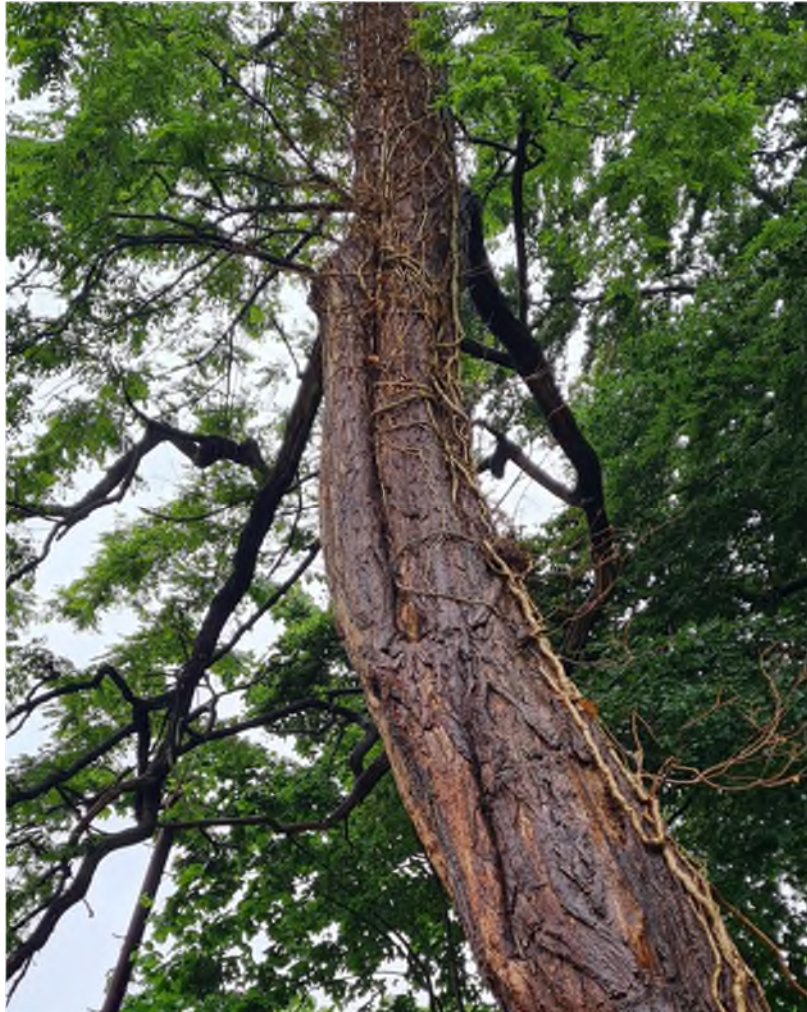
The stem has several vertical 'furrows' in the stem tissue (see Figures 2, 3, 4 and 5). This species naturally produces such furrows but they can also indicate past death of bark and resultant internal decay. In this case there is a combination of both. The prior tree survey identified a vertical strip of decay, associated with a furrow, at circa 7m to 8m above ground level. This is still visible.

*Figure 2: Vertical pocket of decay in 'furrow' in main stem. One of several such features.*

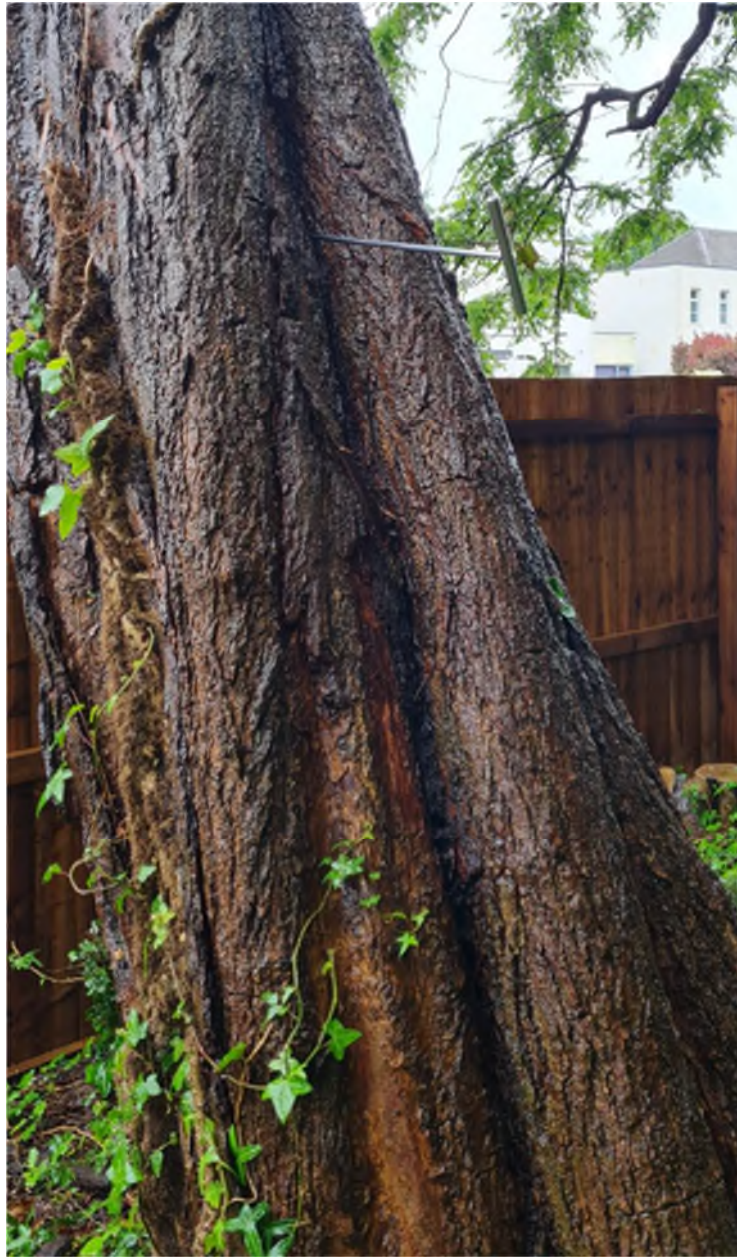
From ground level to circa 2.5m above ground level, on the north western side of the stem, is a further narrow furrow. Probing of the furrow revealed decay to circa 200mm depth, as can be seen in Figure 3. Several other furrows are noted in the main stem and I suspect decay is present in most.

The presence of decay weakens the structural integrity of the wood. It renders it more susceptible to breakage.

*Figure 3: Furrow in lower stem with decay present. Steel probe, seen in upper section of image, is inserted to depth of circa 200mm.*

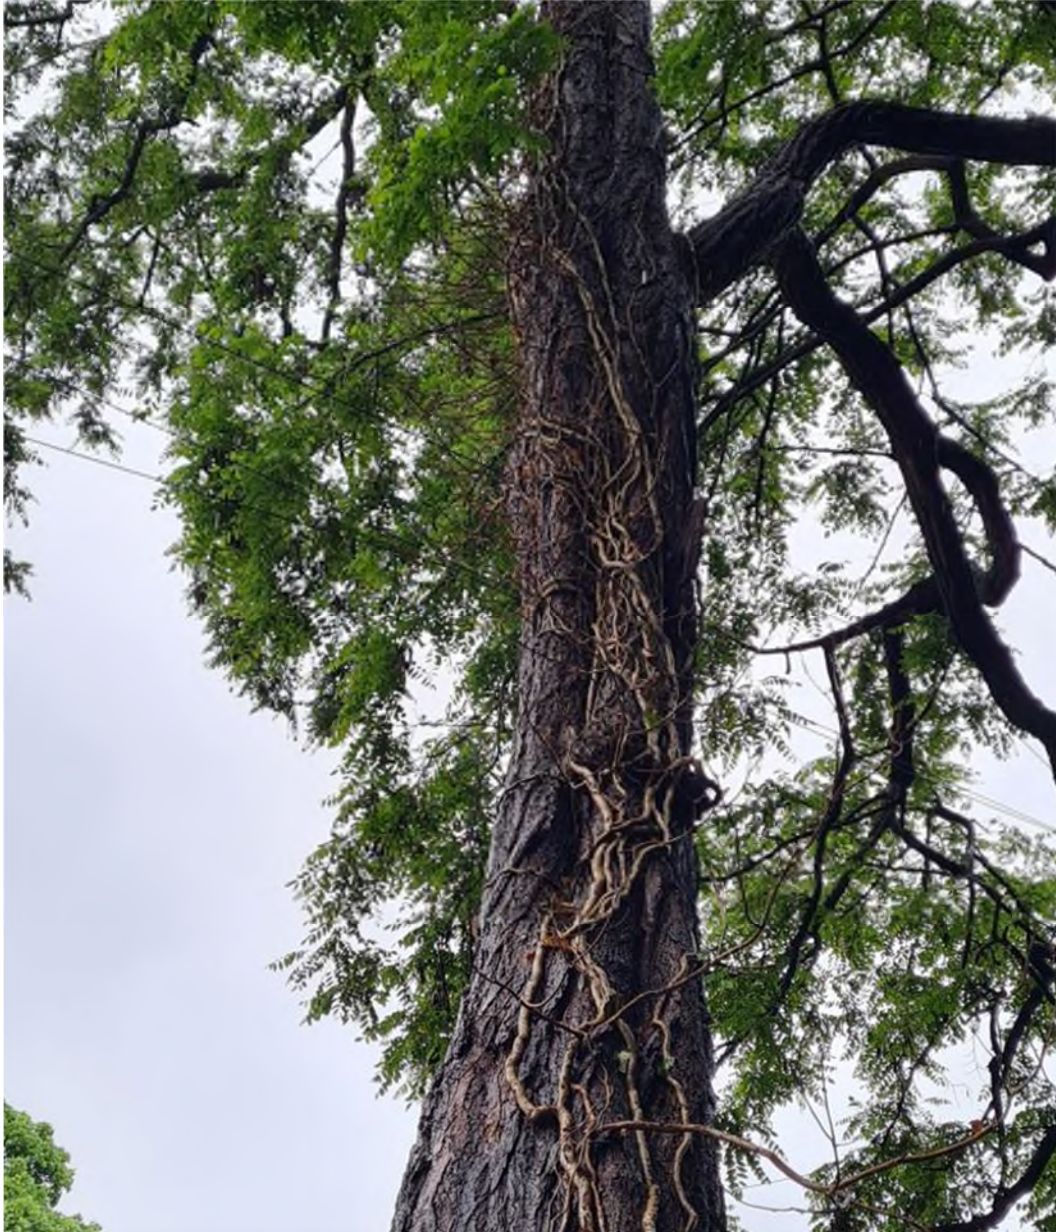
*Figure 4: Further 'furrow' at height on main stem. Decay likely at this point.*

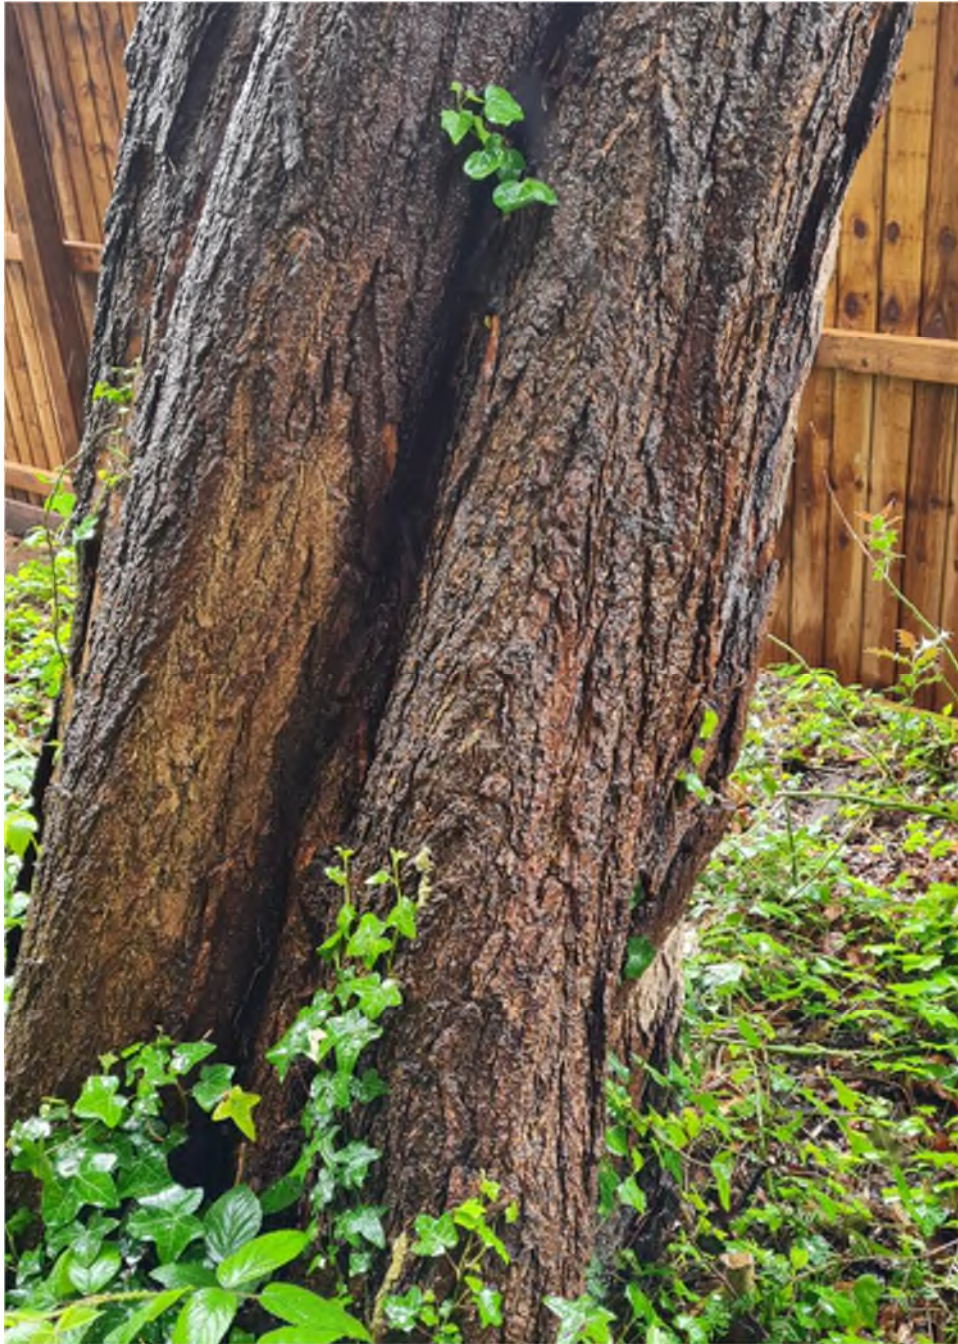
The weight of the tree is biased over the road due to past growth habits. I noted at my visit that there is some separation between the crown of this tree and the adjacent trees indicating that the stem is subsiding to the south east, in the direction of lean (see Figure 6). That movement does not appear to be at ground level so I suspect it is easing of the main stem structure that is resulting in the crown separation. Bark is being shed from one of the buttress sections of the lower stem that does indicate the tree is trying to lay down additional tissues in an attempt to strengthen the stem (see Figure 5).

*Figure 5: Further 'furrow' lower on main stem. No decay identified at this point. Paler section of bark on left hand side of stem indicates bark is being shed due to higher growth stresses as tree seeks to lay down more strengthening tissue.*

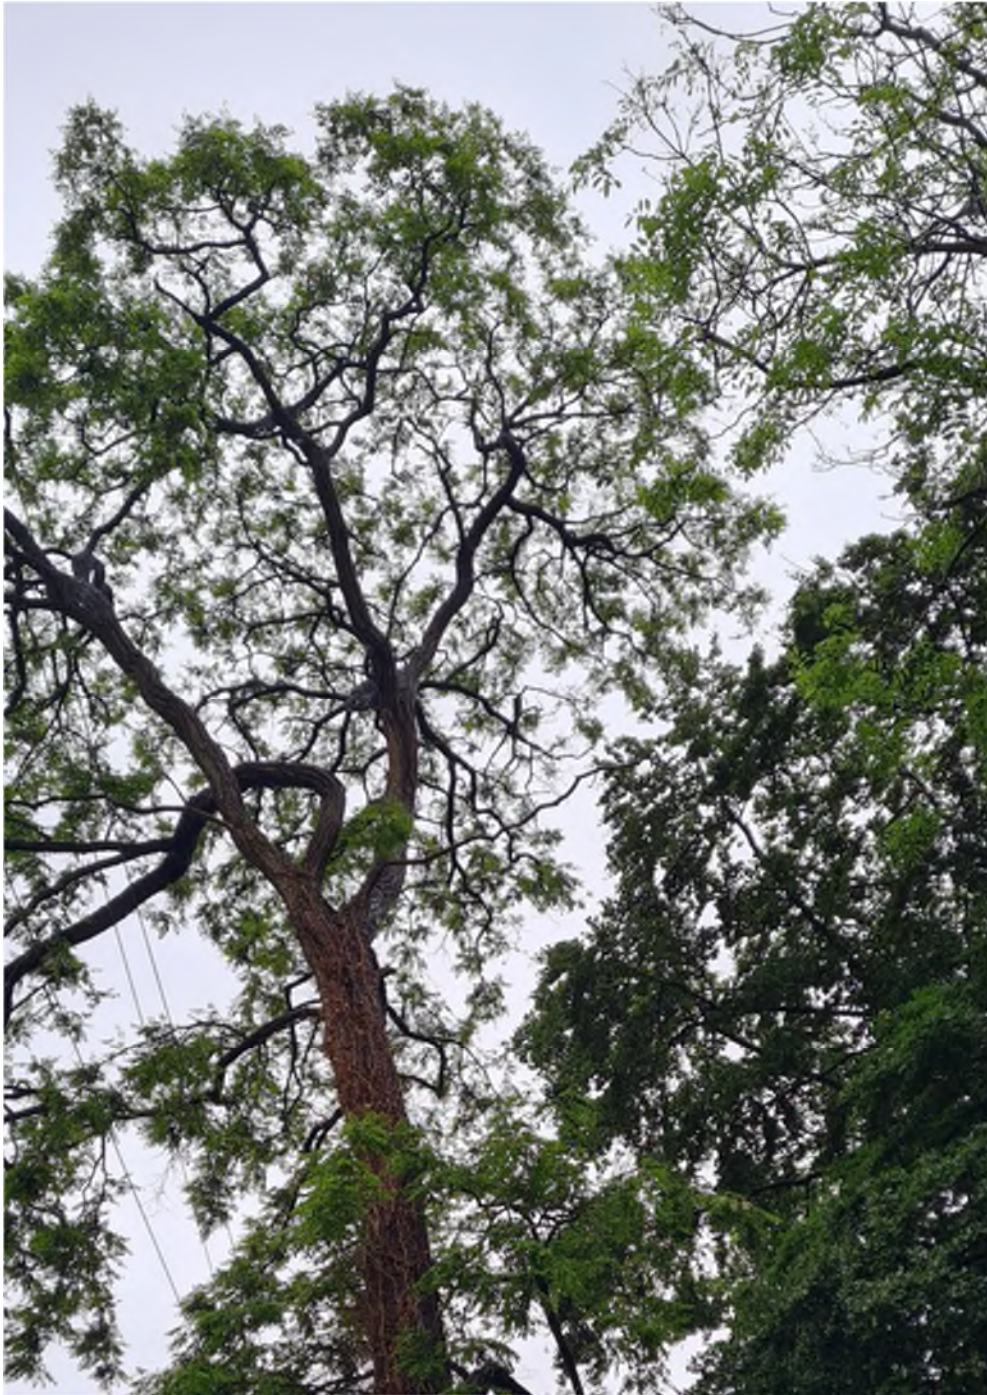
The visible presence of decay and crown separation combine to indicate the structural integrity of the wood of this tree is materially weakened. It renders the stem of the tree liable to failure. That failure is to be expected but its timing is unpredictable.

*Figure 6: Not easy to capture in a photograph, but it is evident on site that the crown of tree 33 is separating from the other trees indicating the tree is leaning more towards the road.*

On balance, in order to avoid the collapse of the tree, secure good quality trees on the site, and to conserve the tree cover of the local area I suggest the removal of the tree followed by replacement planting.

To add a gradient to tree height so that overly large trees on the road boundary are avoided I would suggest a medium height species at maturity. A tree such as hornbeam would be ideal as it is a native tree, is robust, is attractive and supports biodiversity. I would suggest it is planted at a stem size of 10-12cm girth in order that it can quickly establish.
